SOUTHAMPTON OCEANOGRAPHY CENTRE

CRUISE REPORT No. 32

RRS *JAMES CLARK ROSS* CRUISE 52

AutoFlux trials cruise,
UK to Falklands Passage

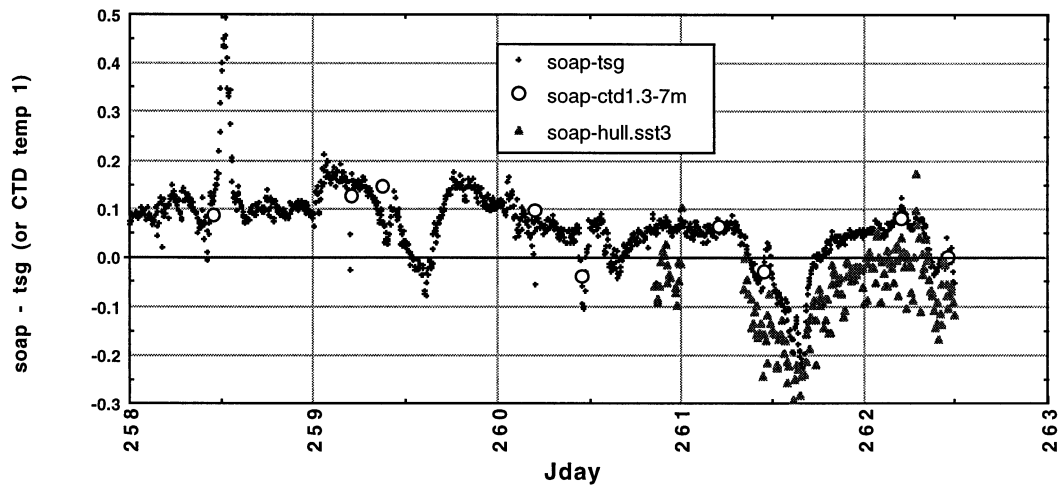
Figure 7. Soap - TSG ssts (crosses) and Soap - CTD1 (open circles) at a depth of 3 to 7 m and Soap -WHOI sst1(triangles) at a depth of 3.5 m.

A direct comparison between the TSG and the soap is shown in Figure 7. It can be seen that the difference between the two varied with time of day. As the day progressed, the soap sst became increasingly colder compared to the TSG, reaching a maximum offset of -0.2° at around 15:00 GMT. This is the opposite trend which would occur if the water temperature at 7 m stays relatively constant, and the surface waters are heated up during the day. Also shown is a comparison of the soap sst with the WHOI sst for one day; the same trend is seen which confirms that it is due to the soap data rather than the TSG. The cool surface "skin effect" is only seen in the first few microns, and can not be the cause of the cooling seen by the soap at a depth of a few cm or more. It was thought that there may have been a problem due to heating of the soap electronics unit on deck. This will not be confirmed until post-cruise calibrations have been performed. However, the AMT PSO kindly agreed to perform an extra CTD dip during the afternoon of day 268 at about 15:00 which confirmed that the surface cooling effect was indeed spurious; repeated shallow surface profiles with the CTD proved that there was no surface cooled layer.

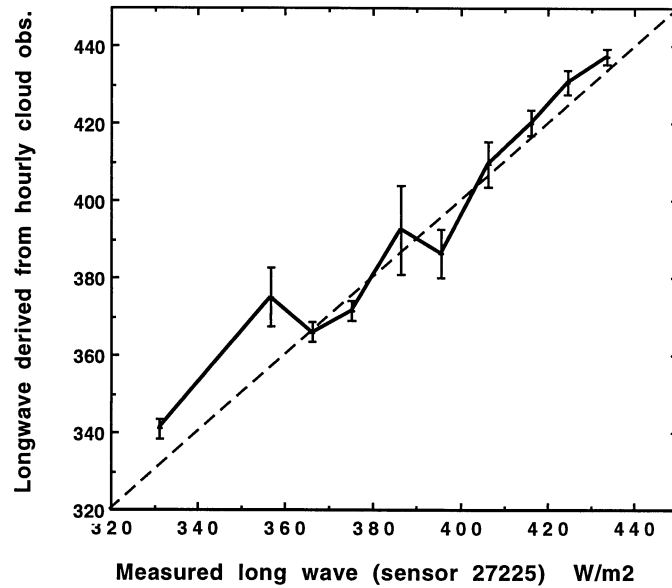
Figure 9. Comparison of longwave radiation derived from the hourly cloud observations against that measured by the Eppley instrument.

The two independent sets of hourly cloud obs were compared. More than 50% of the coincident obs agreed exactly for total cloud fraction, and 80% agreed to within one okta. Obs which disagreed by more than one okta were discarded in this initial analysis. The total cloud fraction was used to derive a downwelling longwave radiation flux (Josey *et al.*, 1997) and this is compared in Figure 9 to the measured downwelling longwave radiation (Pascal and Josey, 2000) from one of the Eppley pyrgeometer sensors on the “bird table”. The comparison is good across most of the longwave range encountered.

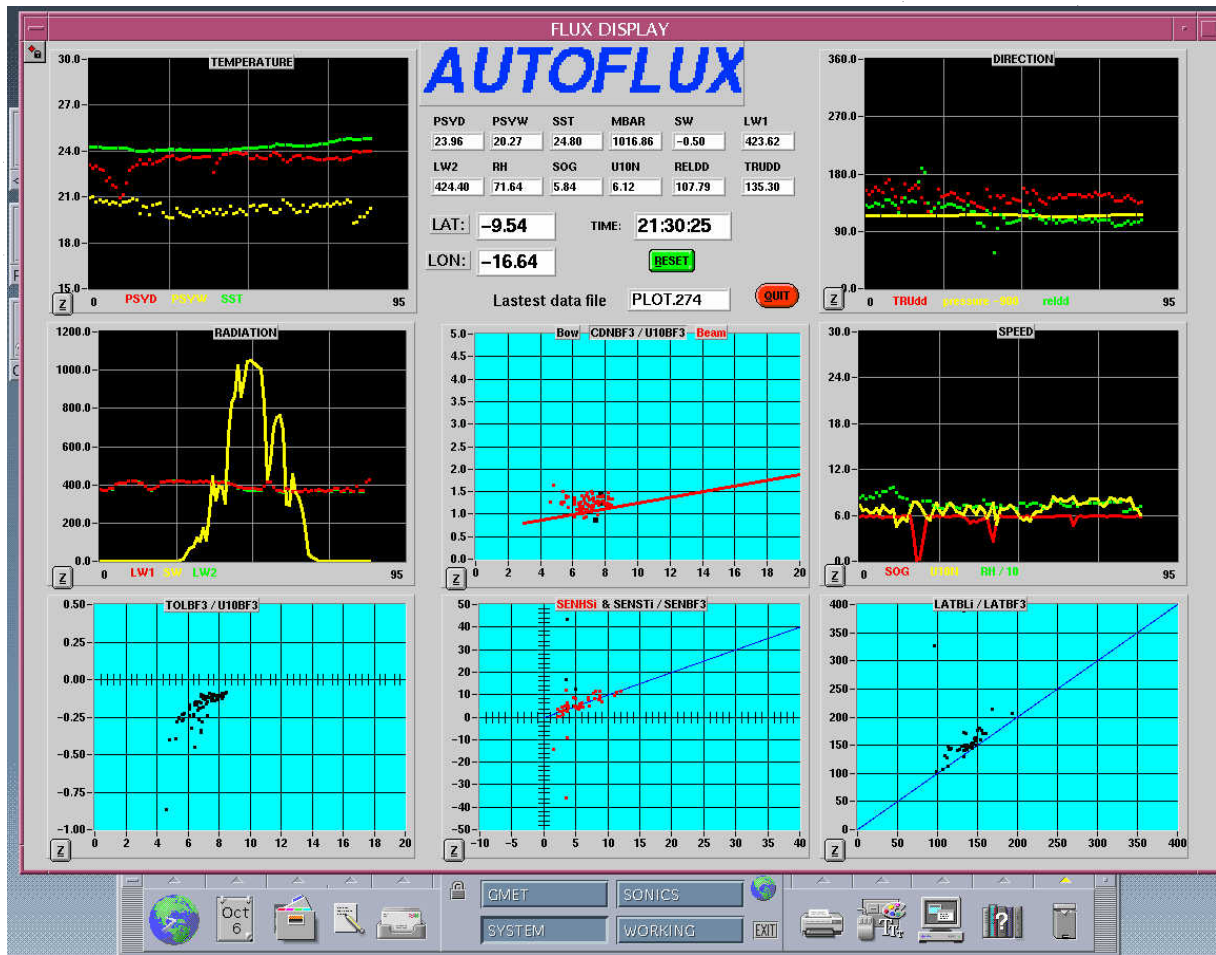
Figure 12. The real-time surface fluxes display, which is split into 9 panels. From left to right and top to bottom these are:-

- 1) A time-series (24 hours) of quality controlled wet and dry bulb air temperatures plus sea surface temperature from the WHOI system.
- 2) Digital data and the name of the data file used.

- 6) A time series of ship speed over the ground, U_{10N} and the relative humidity (% / 10).
- 7) The atmospheric stability parameter, z/L , vs U_{10N} .

A new full-screen display was produced to plot the calculated surface fluxes as well as the mean meteorological parameters in near-real time (using data which are 30 to 60 minutes old). This is illustrated in Figure 12. The performance of the prototype IFM H₂O/CO₂ sensor and the sonic temperature sensor will be examined thoroughly post-cruise, as will the quality of the fluxes produced by these instruments.

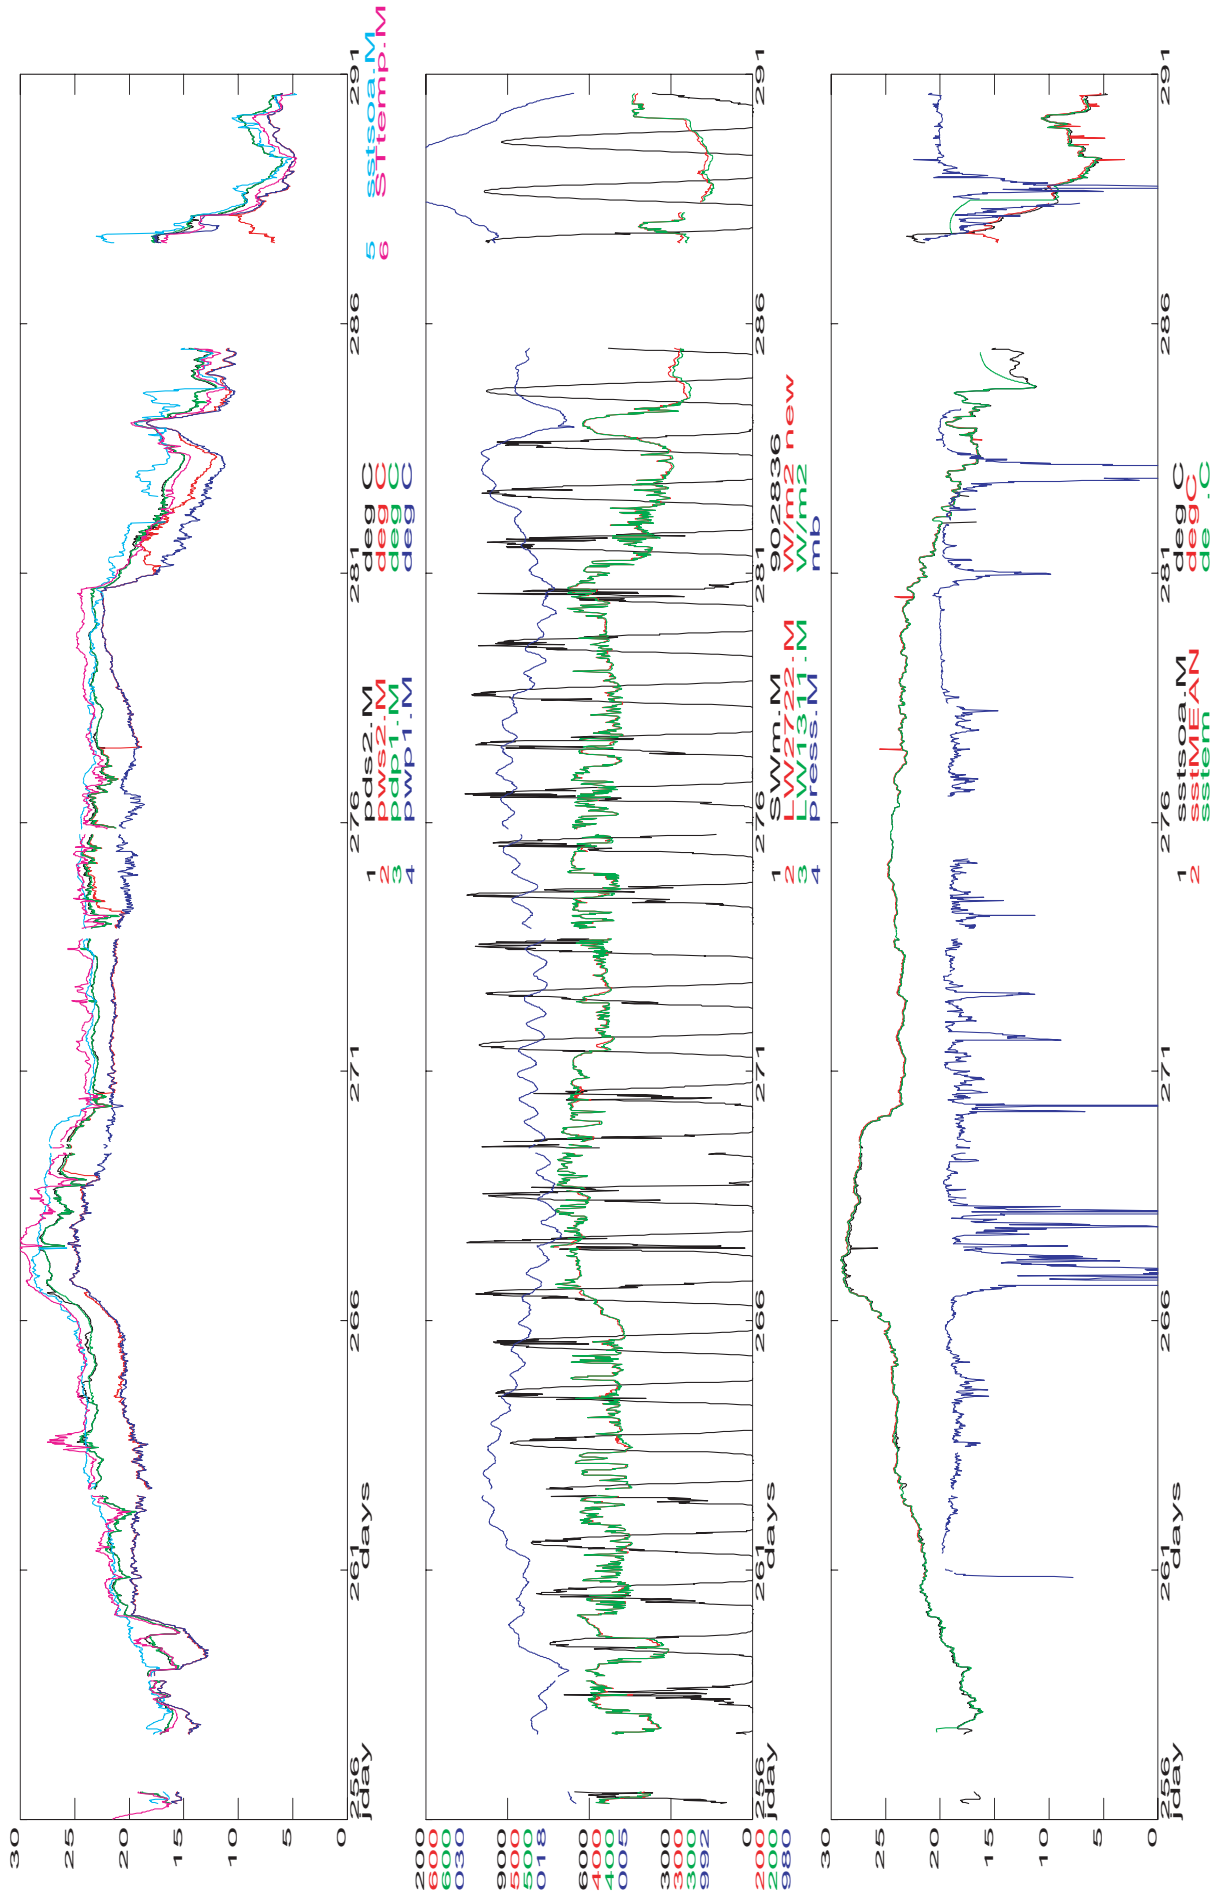
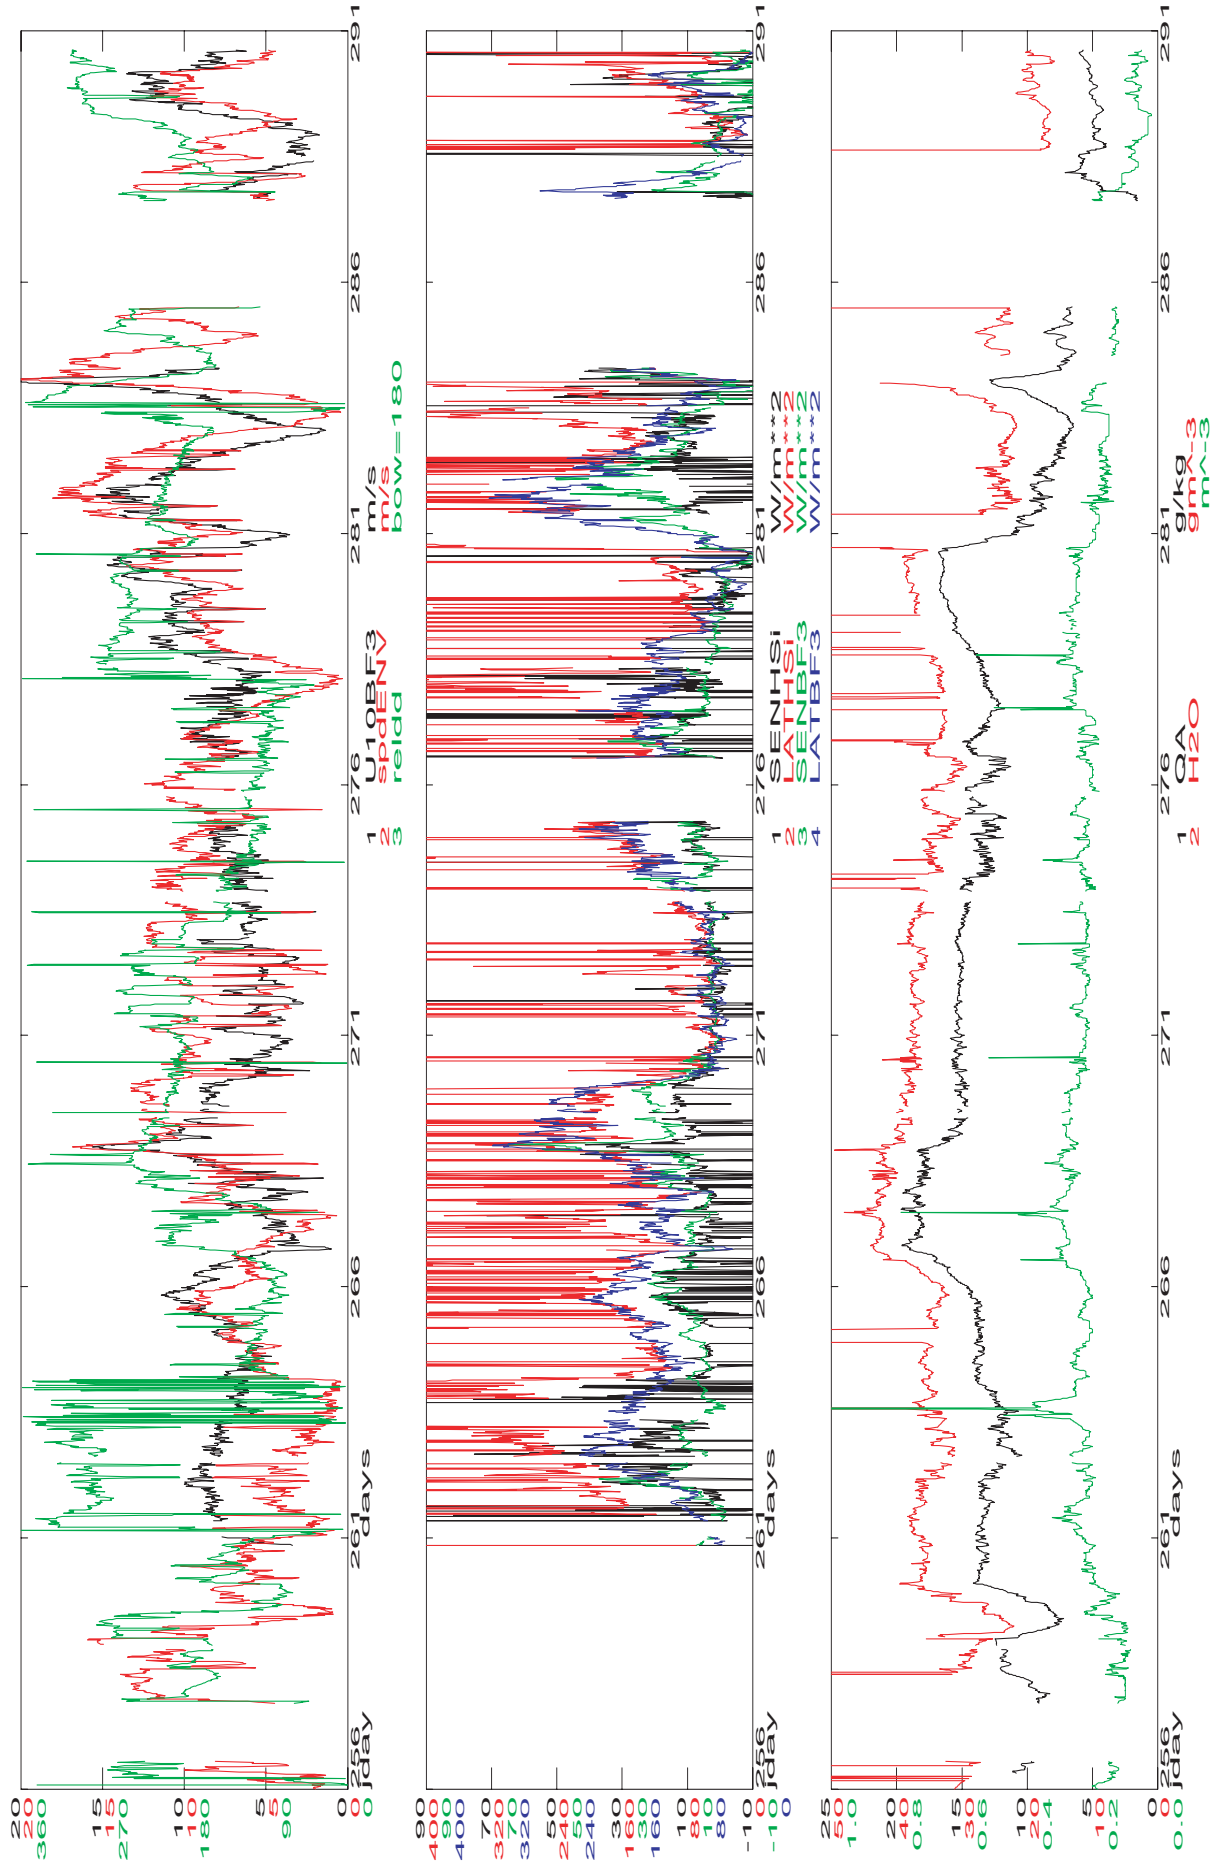
Bottom panel - Specific humidity from the psychrometer data (QA g/kg), mean H2O from the IFM sensor (H2O g/m3) and mean CO2 (CO2 g/m3) from the IFM.

Time series of the mean meteorological conditions and the calculated surface fluxes are displayed in the Figures in Appendix 2.
