Cruise Report No. 46

RRS Discovery Cruise 343

Deepwater trials of the Autosub6000 AUV,
HyBIS, and telemetry systems

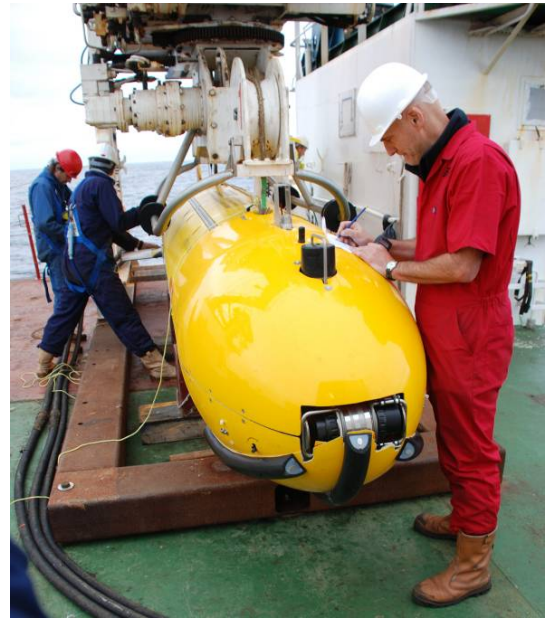
Figure 2. Autosub6000 being prepared for deployment. The Edgetech Seaking sonar is mounted in the nose and the new fenders can be seen mounted under the nose.

On occasions Autosub AUVs have, and in the future will (despite better fault detection), bump into the seabed. What must not happen is that the AUV rubs along the seabed, wearing a hole in the lower front panel, with the result that the AUV takes in mud, and cannot return to the surface. This was the cause of a large insurance claim in 2004 for recovery of Autosub2. The improved fault handling should make this much less likely, but nevertheless we decided to implement an abrasive resistant skid pan, plus rubber fendering on the vehicle. The cost is greater drag and weight (Figure 2). This system was successfully tested during the cruise.

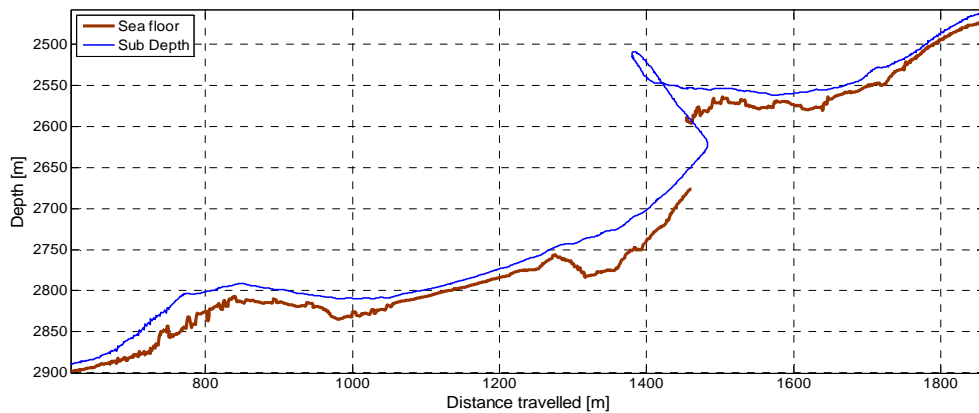
Figure 3. Ocean floor and Autosub6000 depth profile during part of the 10m altitude terrain following ascent of the Casablanca Seamount. Note collision avoidance behaviour after 1.4Km.

average slope of 17° (over the 7.5Km), the AUV was able to remain within 5m of its pre-programmed target.

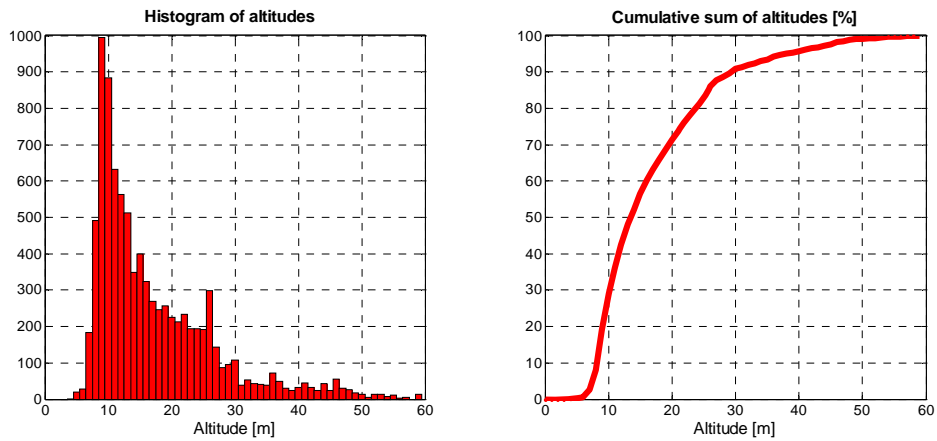
Figure 4. Statistical data during a 10m altitude terrain following ascent of the Casablanca Seamount.

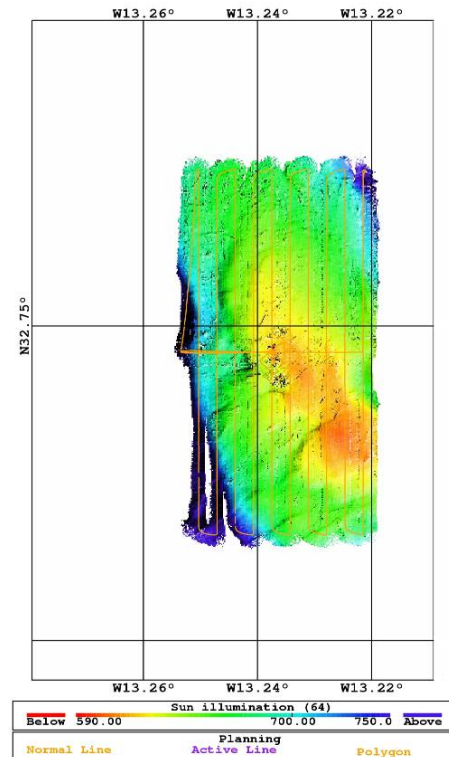
Figure 5. EM2000 multibeam survey data from the top of the Casablanca Seamount. Geothermal activity was identified at the summit (south west orange region).

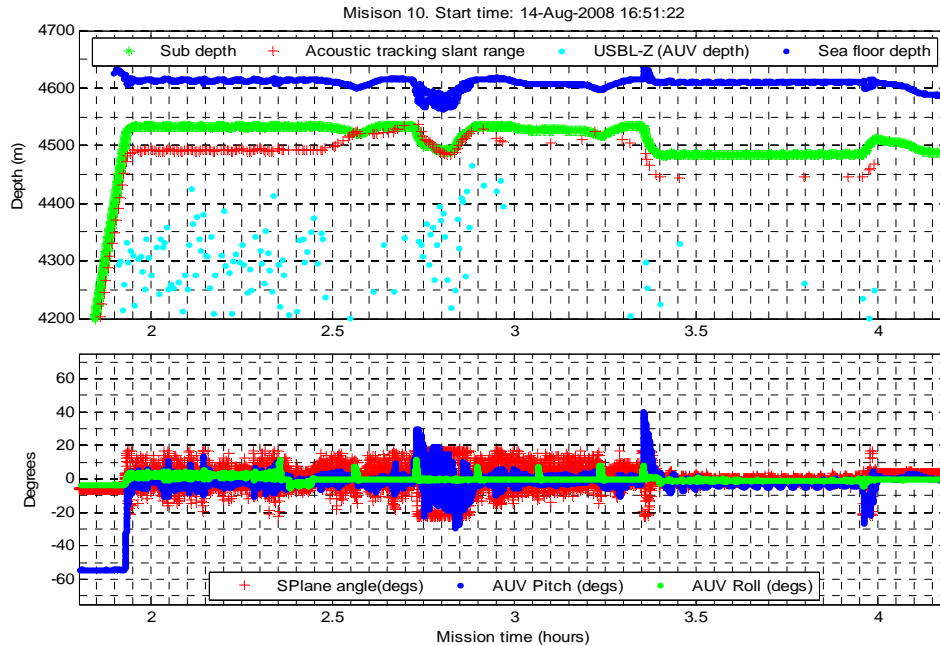
Figure 6. Mission 10 from the 2008 JC027 cruise. Red crosses in the top plot are Linkquest slant-ranges. Acoustic telemetry has been shown to reliably take place every time a slant range is received. Note how the slant range is received when the AUV is pitching, as indicated by the lower plot. Note also that the slant-range/telemetry is a response to a request message from the ship. If the ship is not transmitting then there will also be corresponding gaps in the plot data.

During a previous cruise, JC027, it had been found that the Linkquest tracking and telemetry system did not perform reliably when the AUV was within the region of 100m of the ocean floor and flying straight and level. Figure 6 illustrates the nature of the problem as seen in mission 10. Approximately 30 minutes after reaching the operating depth of 4537 m the tracking and telemetry returns began to drop out. The situation degraded until after approximately 2 hours there were no returns. The last two returns were telemetry data, the 3rd to last was an acknowledgment to the start command message that initiated the navigation calibration box.

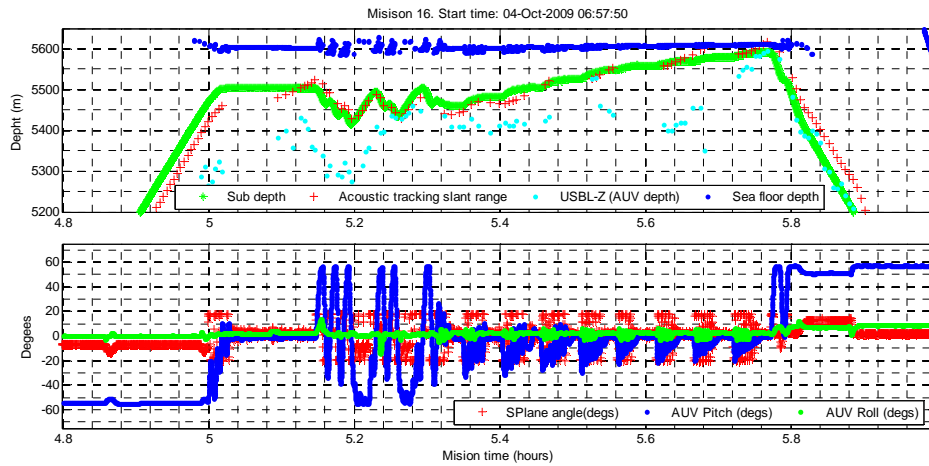
Figure 7. Mission 16, data from the deepest segment of the mission. Returns (red crosses in top plot) show similar characteristics to the mission in cruise JC027 - 6

waypoints with 20m, 3 minute duration steps down from 200m to 20m (altitude limit was set to 10m). The returns from the Linkquest tracking and telemetry during this mission seemed to be very similar to that experienced in mission 10 (and the other JC027 missions). Between 5.1 hours and 5.3 hours there is much variation in vehicle pitch (due to poor altitude returns from the ADCP) and during this time the tracking and telemetry was good. Below the 120m altitude demand the ADCP is providing more stable altimetry and the depth control is able to stabilise. However with runs of only 3 minutes at each altitude and a 180° turn at each transition the AUV is quite often in a disturbed flight pattern. During these disturbances the Linkquest tracking and telemetry is responsive to messages from the ship.

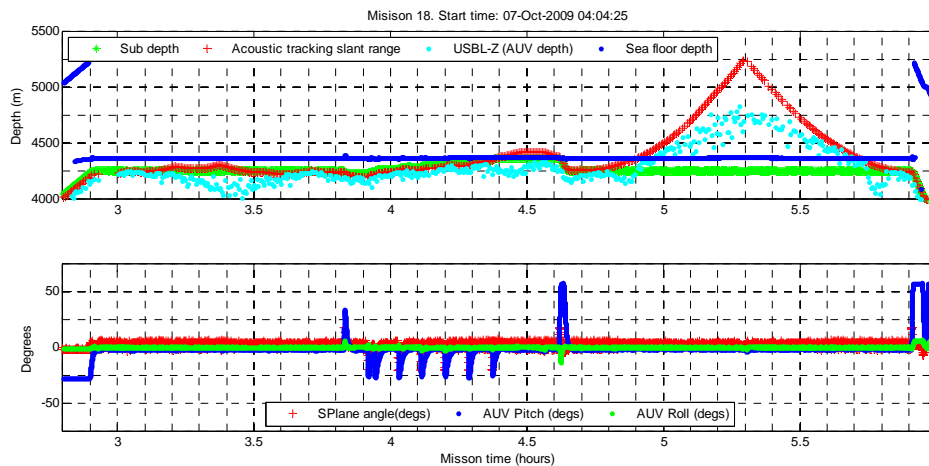
Figure 8. Mission 18 took place in conditions similar to those experienced in the JC027 missions. It can be seen that in this case the Linkquest telemetry worked reliably.

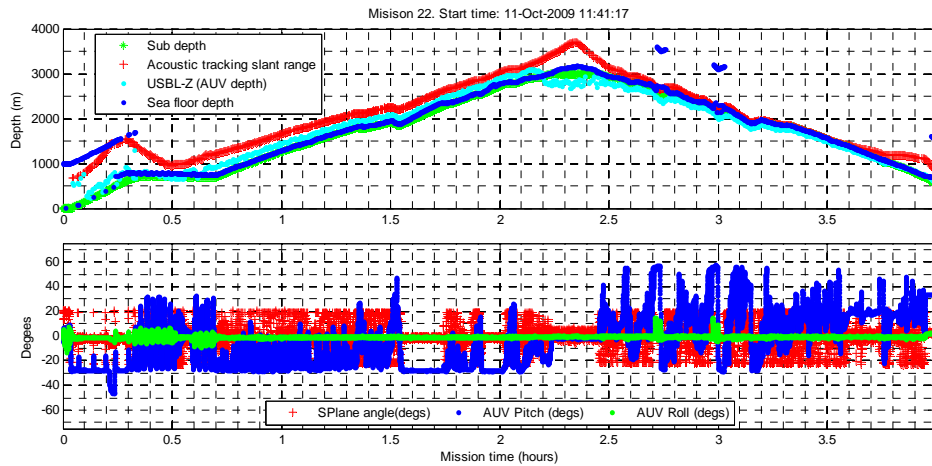
Figure 9. Mission 22. Low altitude (20m and 10m) demand transects across the Casablanca Seamount. Tracking and Telemetry worked reliably.

Mission 22 (Figure 9) was a low altitude, 20m and 10m ascent and descent of the Casablanca seamount. Conditions during this mission were of very rough terrain, including vertical cliffs and overhangs. The Linkquest telemetry system performed well. This performance was also demonstrated in the very low (3m) altitude survey of mission 25 (Figure 10)

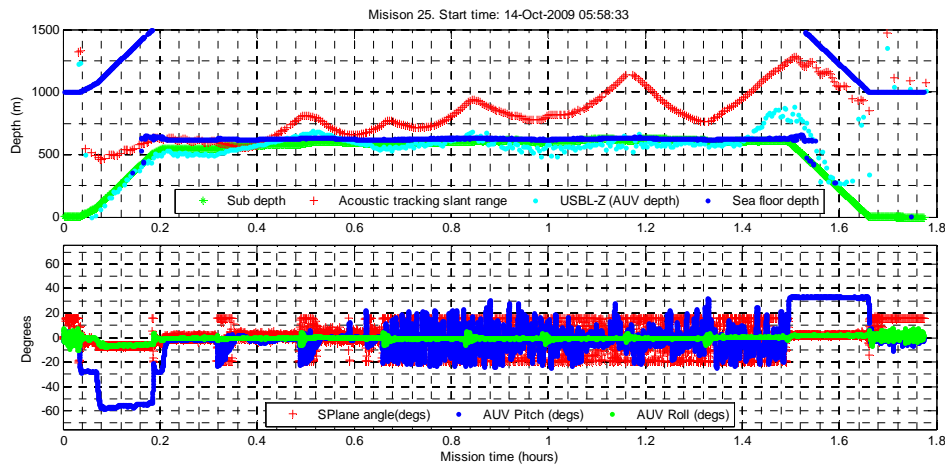
Figure 10. Mission 25, low 3m altitude survey on Casablanca Seamount top, at a depth of approximately 600m. The Tracking and telemetry worked reliably.

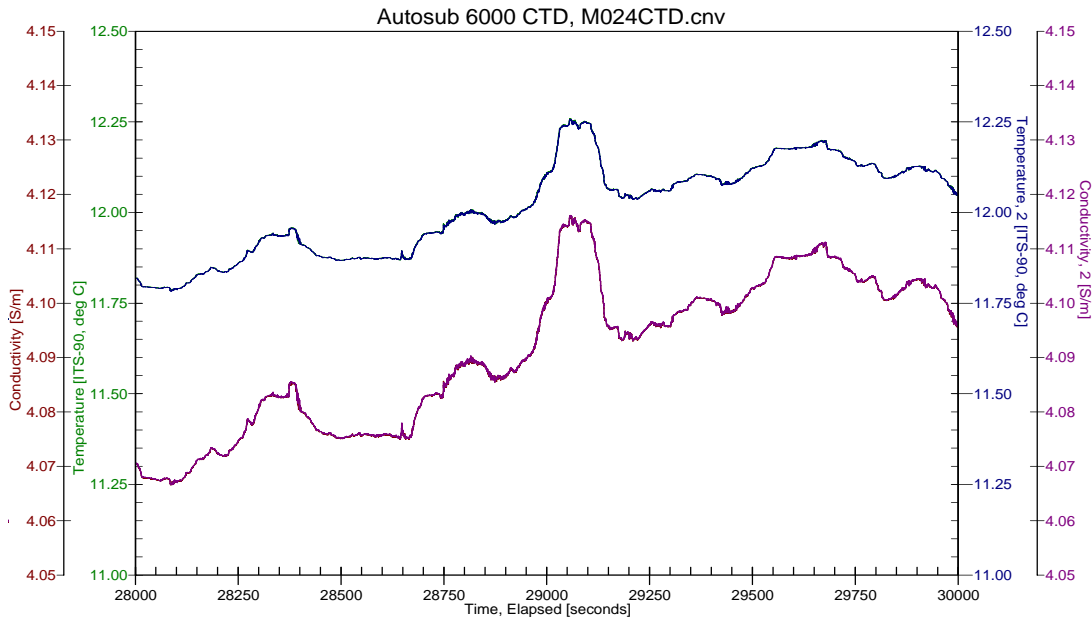
The Conductivity and Temperature sensors appeared stable and well matched as shown in the data excerpt below.

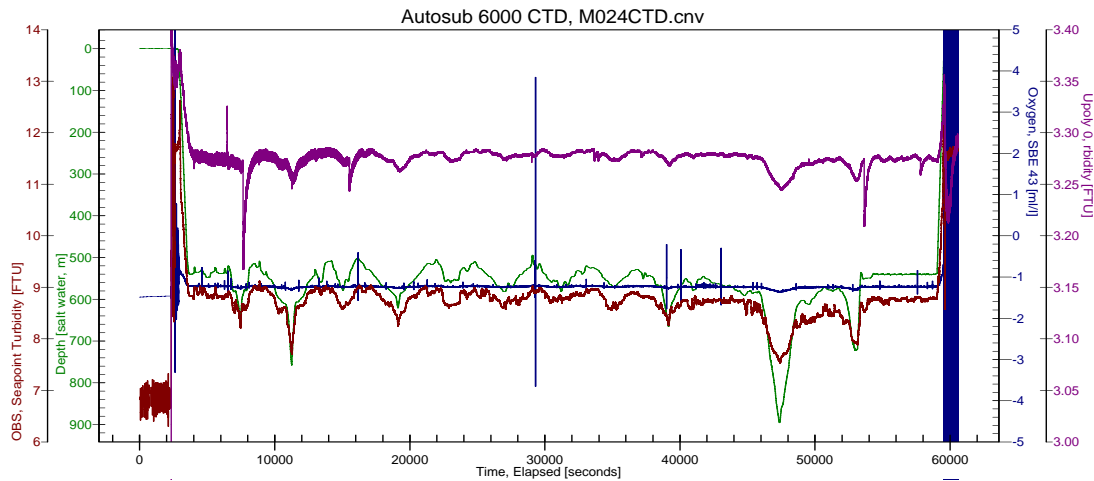
Data from the oxygen, turbidity and EH sensors for the whole mission are shown in the data excerpt below.

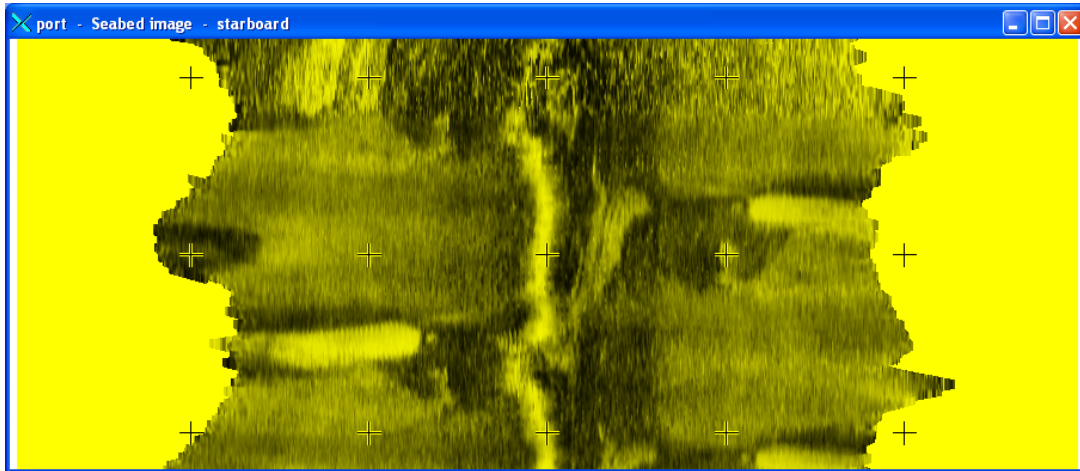
During mission 23 the system was used in free running mode at various altitudes in an attempt to observe any potential interference with other acoustic systems and to give an idea of horizontal coverage at different altitudes. Initial evaluation of the data does not show any obvious interference (as can be seen from the image below) but further evaluation will be necessary.

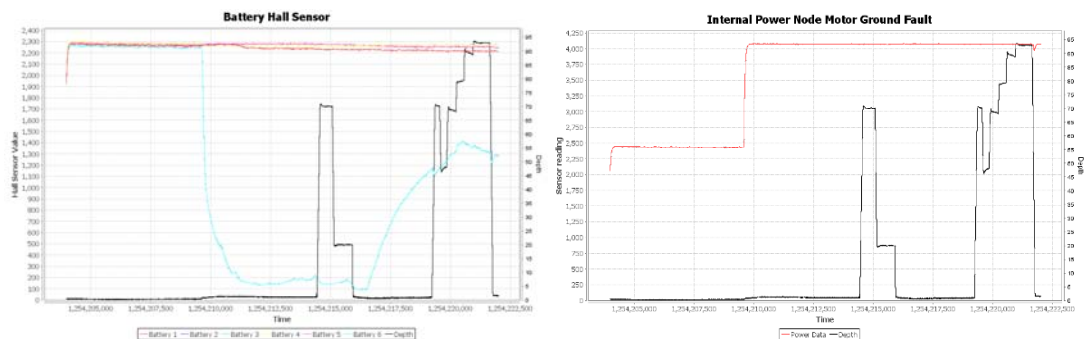
Figure 1 Battery Hall effect sensor readings (left) and Internal Power Node Motor Ground Fault (right) during Mission 14. The motor ground fault reads high and the Hall sensor low as soon as Autosub enters the water. Livingstone correctly detected the faults and localised them as soon as they occur.

fault was detected. The sensor values are shown in Figure 1. The diagnosis system correctly diagnosed that either the Hall sensor failed or that the battery was low on oil, and also correctly inferred there had been a battery short, but was unable to determine which battery it was (in fact, it appeared a number of the batteries had a similar problem).

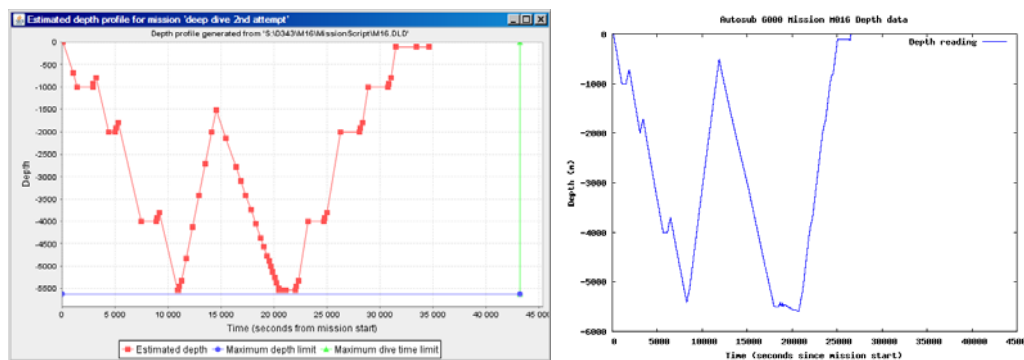
Figure 2 Comparison of predicted (left) and actual depth profile for Mission 16. The central peak of the graph was due to an error in the mission script.

The mission script checking tool, along with a problem with the script for Mission 16 that the tool didn't detect, prompted the observation that checking of depth profiles would be a useful addition to the tool. To that end, a prototype depth profile analyser was developed during the cruise that uses the mission script and a very simple model of Autosub's vertical dynamics to estimate the behaviour that will result from Autosub executing the script. The tool outputs a plot of the expected depth as a function of time. This tool was subsequently run on the mission script from Mission 16 and successfully identified that the script would lead to an unplanned ascent from approximately 4500m to 500m. Figure 2 shows the predicted and actual depth profile of Mission 16.

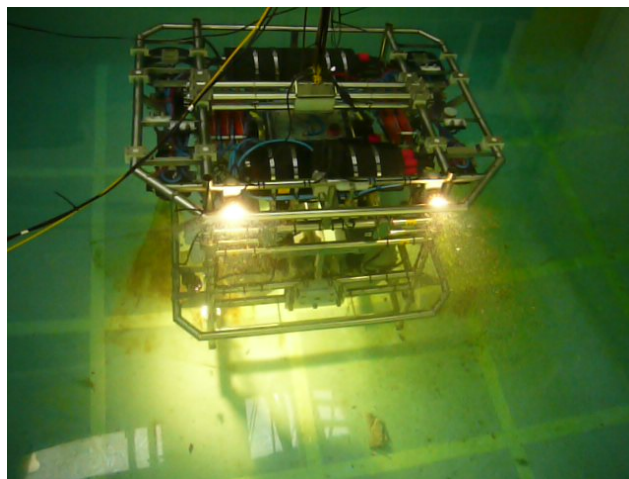
HyBIS is an RO-TVG (Remotely Operated TV-Grab) that is designed to be a versatile, easy-to-use platform for seafloor survey, intervention and instrument package deployment.

The concept was originated by Bramley Murton and Pete Mason to bridge the capability gap between blind sampling and full ROV operations. It was funded through an NOCS technology initiative fund. The vehicle was built in 2007 by Hydro-Lek, an off-shore engineering company that specializes in remotely controlled sub-sea vehicle systems.

HyBIS currently has six serial channels and three colour video channels. It has enough hotel power to supply a CTD, chemical and optical sensors and a variety of sonars. It is powered through the standard NMFD fibre-optic-electrical cable, delivering 7kVA at 1500V ac, with 5 KW available at the vehicle.

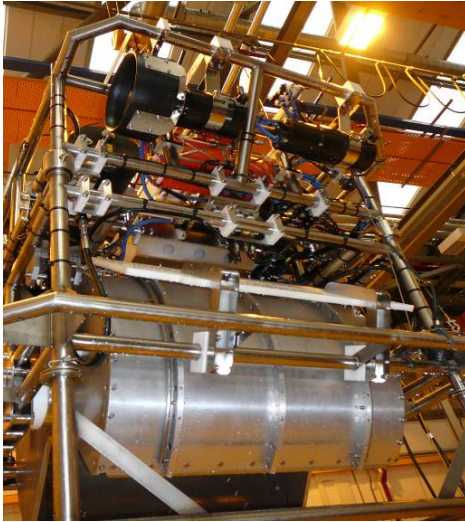
HyBIS has a command module for power, lights, and telemetry, and a swappable tool module for sampling. The command module has twin colour cameras and over 1000W of lights - all rated to 6000m. The command module also has hydraulic power packs, 140Bar water pump and electric thrusters producing 100 kg of thrust. The sampling module currently comprises a 0.3 cubic meter clam-shell grab.

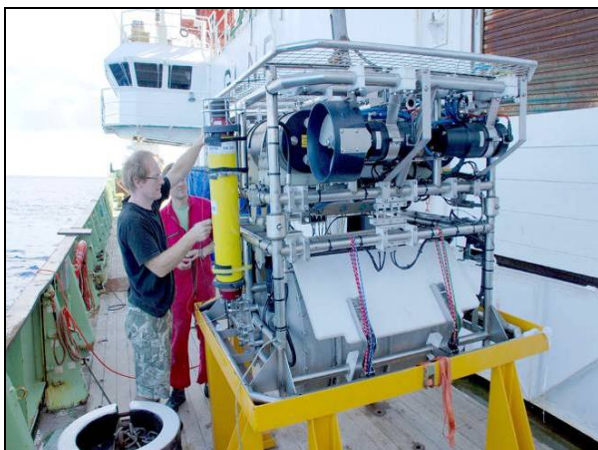
The HyBIS vehicle mounted on its deck stand, on the starboard deck of the RRS Discovery. Dr Bramley Murton (shorts) and Veit Hunnerbach (red wetsuit) mounting the U SBL beacon (yellow tube) on to the vehicle.

The RO-TVG 'HyBIS' was positioned on the starboard side of the RRS Discovery and mounted on its deck frame which, in turn, was mounted to the screw fixture matrix on the ship's deck. The vehicle was attached via a termination bottle to a ~10km length of 17mm electrical fibre-optic umbilical cable wound on the ship's oceanographic winch. All operations of the vehicle were done according to the procedures described in the risk assessment presented to the ship's master and operators prior to the start of the trials cruise.

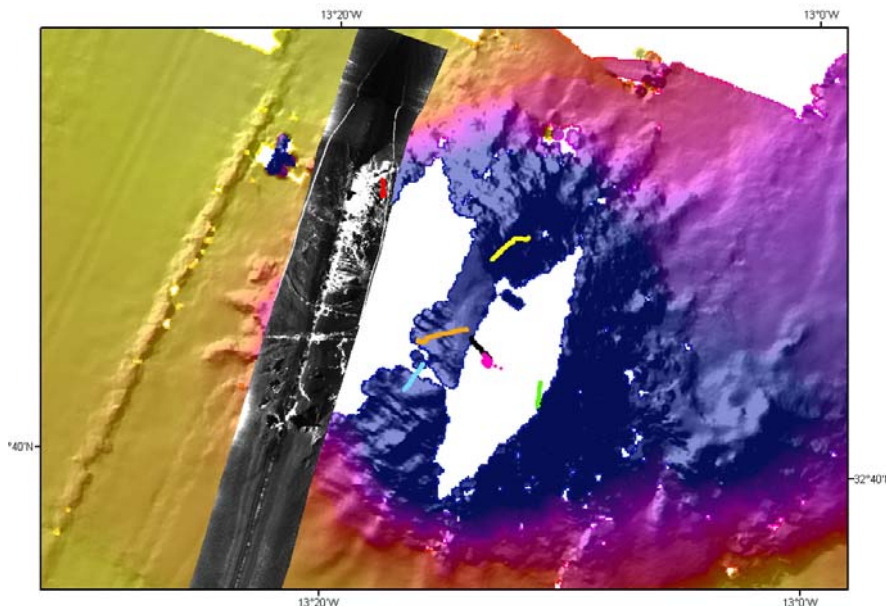
Map showing all dive sites during HyBIS trials on cruise D343. Background data are multibeam bathymetry and TOBI sidescan sonar imagery.

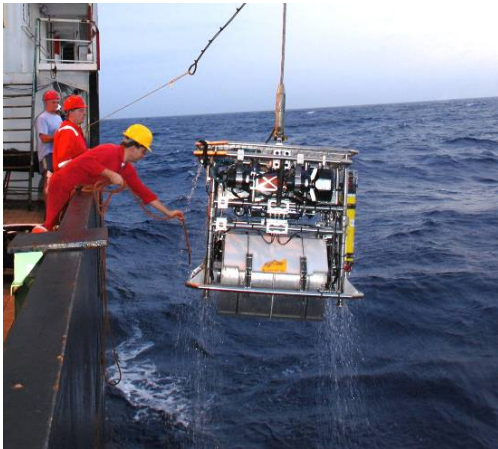
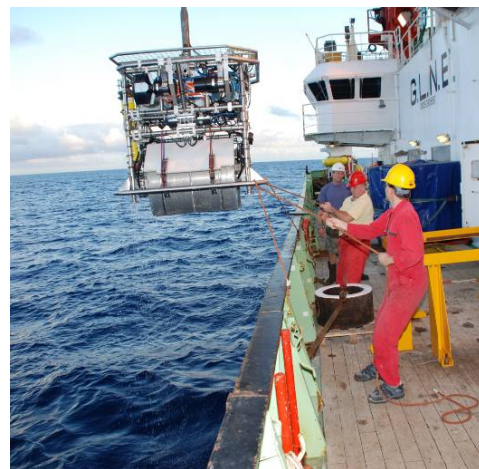
HyBIS launched (left) and recovered (right) over the starboard side of the RRS Discovery.

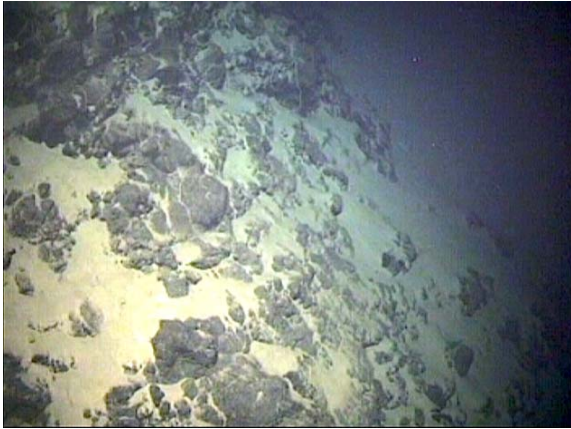
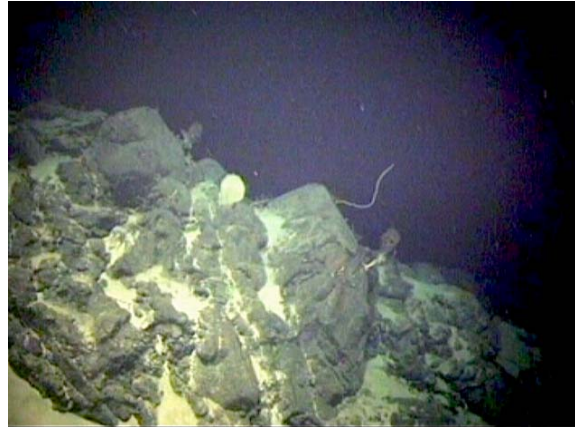
Steep slopes characterise the flanks of the Casablanca Seamount, making it impossible to land the HyBIS vehicle. Surveys MUST be made down slope to avoid dragging the vehicle in to the sea floor.

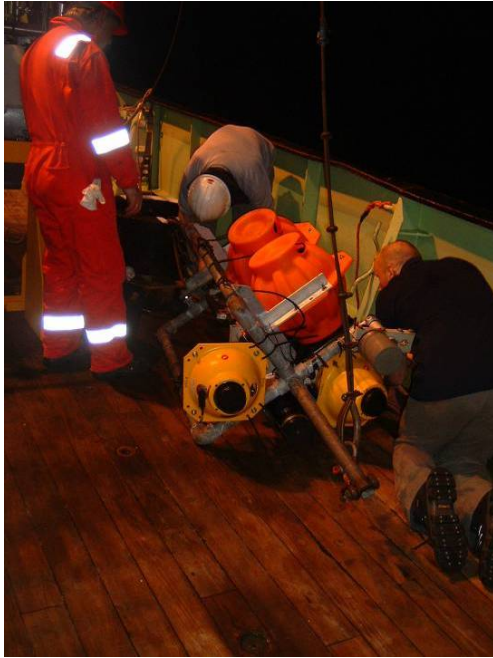
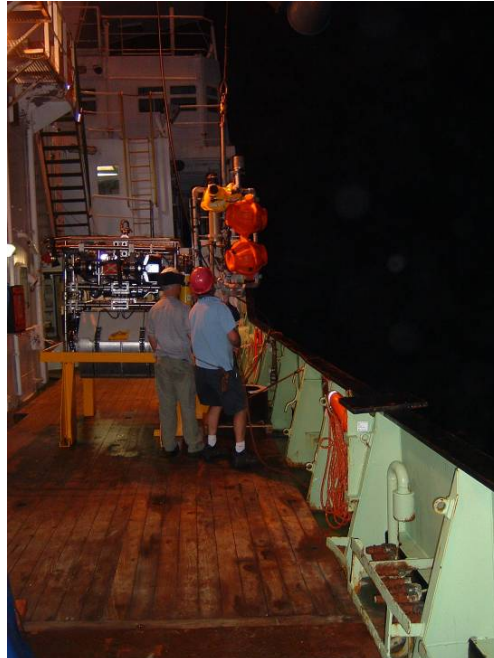
Fig. 1 – POL Wire Test Frame Deployment

a – Preparing the Wire Test Frame for Deployment

b – Deployment of the Wire Test Frame

The wire test location was off the west coast of Portugal at a latitude of 38° 24.01994' N and a longitude of 15° 29.78239' W in a region with a depth of 5500m. Photographs taken during the night time deployment of the wire test frame are shown in Fig. 1. The key features of this test were as follows:

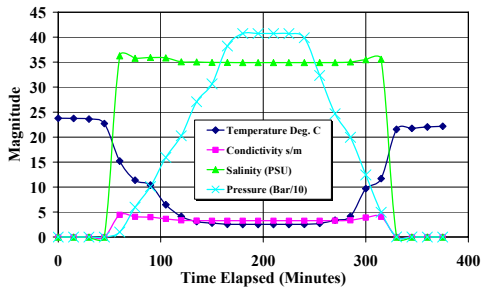
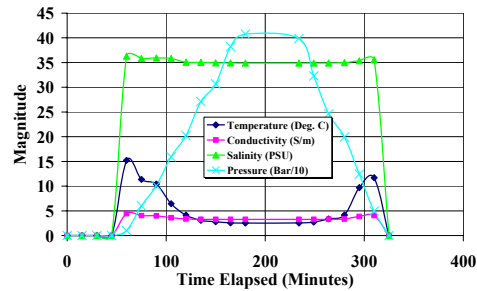
a – Internally Recorded CTD Data

b – Received surface LinkQuest data that has been sampled and sent by the Orbcomm satellite global messaging service

Plots of the data from the seabird Microcat conductivity temperature and depth (CTD) sensor and the received telemetry data are shown in Fig. 2. The chart in Fig. 2a shows the Seabird CTD data recorded at 15 minute intervals with the pressure scaled fit onto the same axes. The pressure record clearly shows the descent of the frame to 4000m, a delay at the ultimate test depth of 4000m for testing of acoustic systems etc before the frame is returned to the surface. The data relayed to the surface by the LinkQuest acoustic data link and then sent by Orbcomm for remote reception is shown in Fig. 2b. This shows good agreement with the CTD data indicating that the acoustic data link and Orbcomm telemetry systems are working reliably.

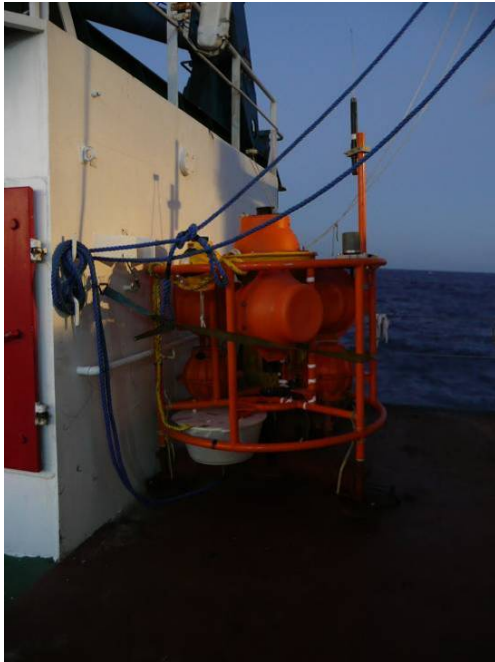
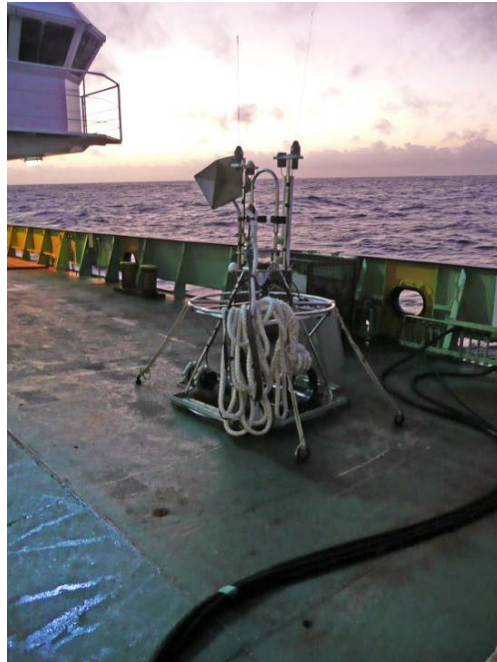
Fig. 3 – PO L Telemetry Buoy and MYRTLE Deep Sea Lander Instrumentation Preparation Photographs

a – MYRTLE Stowed and Ready for Deployment

b – Telemetry Buoy Upper Tower Final Assembly

Preparations for the full system tests were commenced at 08:00 beginning with some final checks before the system was deployed. The deployment sequence commenced at 110:5 at a latitude of 32° 50.6862'N and a longitude of 13° 18.72165'W, at the Casablanca Seamount off the west coast of Morocco. Technical difficulties were then experienced with releasing the MYRTLE data capsule and communicating with the LinkQuest acoustic modem on the sea bed. Concerns about the performance of the acoustic POD release and the sudden loss of communications with the LinkQuest sea bed modem led to the decision to cancel the full deployment and recover the MYRTLE lander as soon as possible. A selection of photographs of the MYRTLE deployment is shown in Figs. 3 and 4.

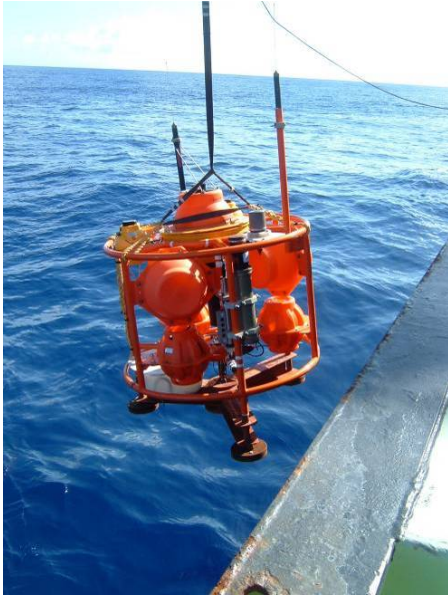
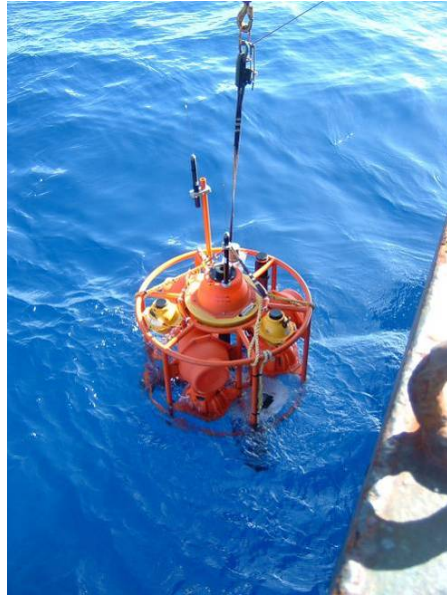
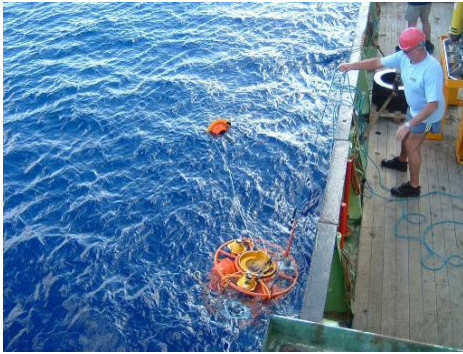
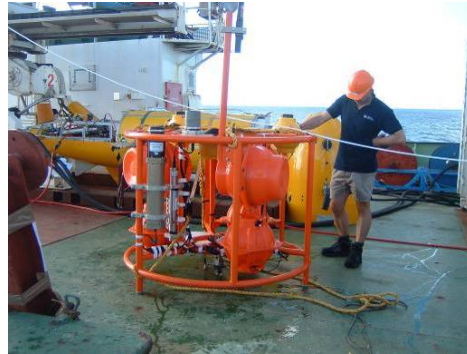
Fig. 4– POL MYRTLE Deployment and Recovery First Full System Deployment Attempt

a– Lowering of the MYRTLE Frame for Deployment

b – MYRTLE Deployment Just Prior to Release

c– MYRTLE Recovery With The Snagged Data Capsule

d – Recovered MYRTLE Frame on the Aft Deck of RRS Discovery

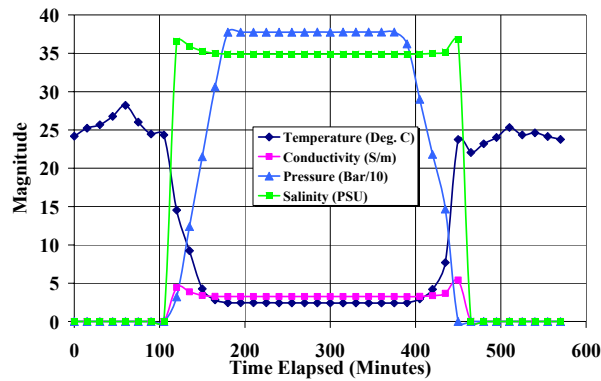
Fig. 5 – Recorded Seabird Microcat CTD Data during the MYRTLE Deployment and Recovery

During the deployment attempt the data recorded by a Seabird deep sea Microcat is plotted in Fig. 5. This shows the descent of the MYRTLE frame to an approximate depth of 3700m, a delay on the sea bed and then the ascent to the surface after the release mechanism is fired before the subsequent frame recovery.

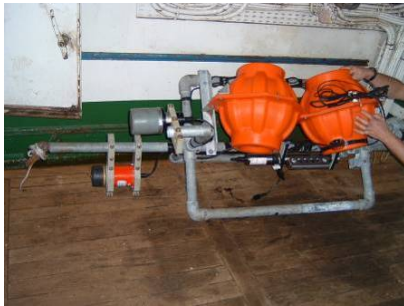
Fig. 6 – POL Preparations for 2000m Wire Test

a – Frame Preparation For Wire Test

The first of the previously described wire tests has been provisionally scheduled for tomorrow (Saturday 10th October). The remainder of the day was then spent preparing the instrumentation and wire test frame for and undertaking the actual deployment as shown in Figs. 6 and 7. This preparation work included testing all the instrumentation, replacing batteries etc. In addition to this, an Orbcomm email based remote control of a CTD using LinkQuest modems set to low power, in air on the deck of the ship was successfully completed.

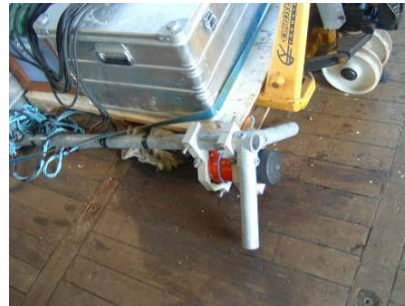
b – LinkQuest UWM3000 Surface Transducer

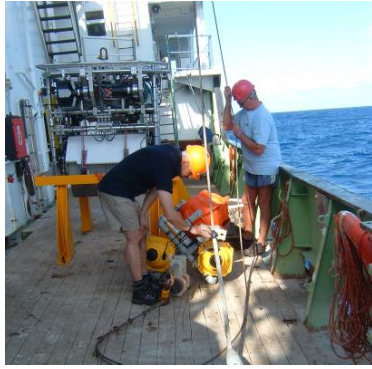
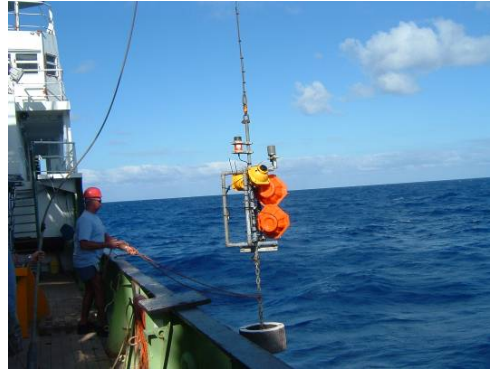
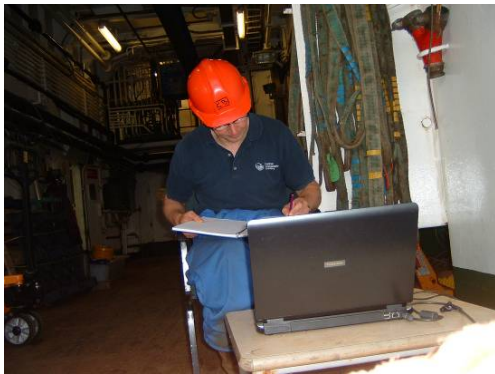
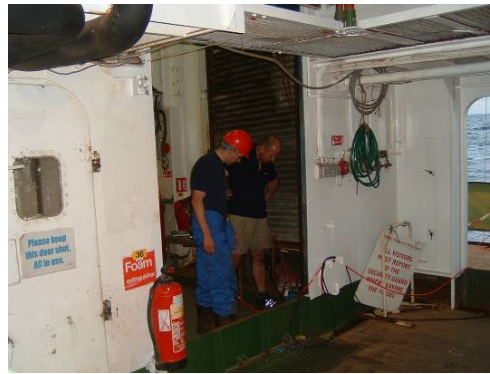
Fig. 7 – POL Wire Test A Photographs

a – Final Preparations for Deployment of the Wire Test Frame

b – Deployment of the Wire Test Frame

c – Monitoring of the Telemetry System Operation

d – Monitoring of the Benthos Smart Modem and Acoustic Release Operation

When the wire test frame reached the maximum test depth of 2000m the Benthos XT6000 based acoustic releases (normally used for MYRTLE frame recovery) were fired. The Benthos Smart Modem release (normally used for MYRTLE data pod recovery) was also fired at 2000m. During this test, one of the XT6000 transponders (serial number 70772) reported that the release mechanism had fired and on recovery of the frame it transpired that this release had not operated correctly. The reason for this needs to be investigated and it has been this problem with release reliability that prompted a halt to any further attempts to deploy the MYRTLE lander during the cruise. The Benthos Smart modem performed well during the trial and it correctly test fired the MYRTLE data pod release mechanism at 2000m.

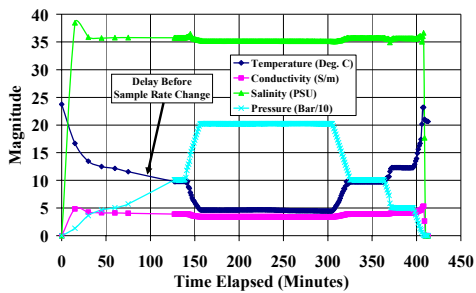
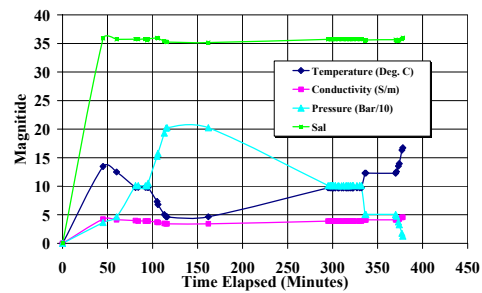
b – Internally recorded CTD Data

b – Received surface LinkQuest data that has been sampled and sent by the Orbcomm satellite global messaging service

A plot of the measured data from the Seabird CTD is shown in fig 8 and the pressure record clearly shows the stop off points at various depths during the test to perform testing and evaluation of acoustic data links and satellite telemetry system performance. A sample rate change request to the CTD from 15 minute to 1 minute sampling was issued during the test by an email command sent via an internet based email client. The performance of the LinkQuest acoustic data modems throughout the trial was poor. A modem software test routine executed at the start of the test reported the communications link performance as being 'Very Demanding', which suggested that the UWM3000 omni-directional data link would be problematic. The exact reason for this poor data link performance is not clear. Bearing in mind that the wire frame modem and the surface modems were almost directly facing each other with only clear water between the two modems it is reasonable to expect the data link to perform well under these conditions. Despite these problems an email based command was scripted to the deployed Seabird CTD to increase the sample rate to one measurement every 60 seconds, as shown in Fig. 20a. The poor performance of LinkQuest UWM3000 acoustic modems resulted in a delay of approximately 50 minutes before the required commands were successfully transferred to the Seabird CTD.

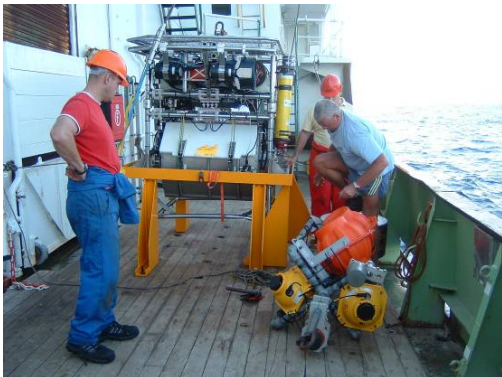
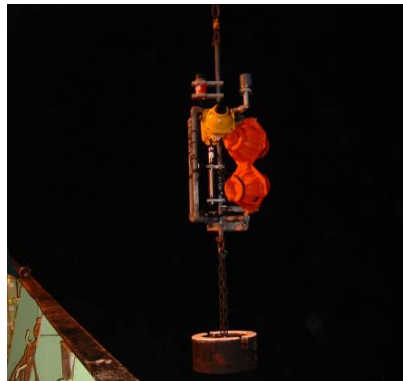
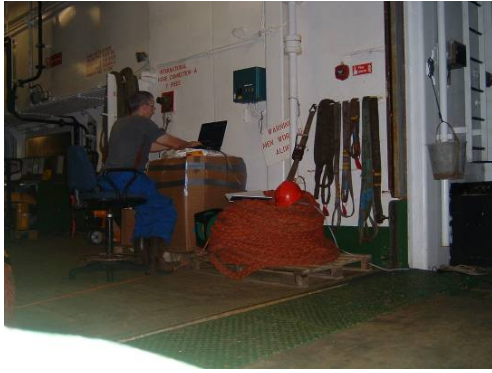
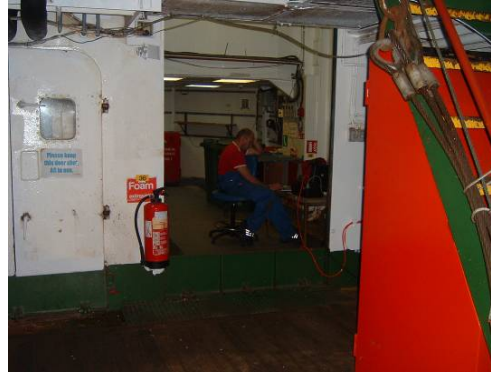
Fig. 9 – POL Wire Test B Photographs

a– Final Preparations for Deployment of the Wire Test Frame

b – Deployment of the Wire Test Frame

c– Telemetry System Monitoring

d – Monitoring of the Benthos Acoustic Data Link and XT6000 Releases

The test started at 20:45 BST at a latitude of 32° 44.9451'N and a longitude of 13° 18.3549'W and continued until 02:45 BST on Tuesday 13th October. The test involved progressively lowering the wire test frame to a series of test depth stop off points of 100m, 500m, 1000m, 1500m 2000m and then back to 1500m, 1000m, 500m and then finally 100m. Following this, the frame was then raised back to the surface for recovery. During these tests a MobiApps m100 Orbcmm modem was used to capture the data transmitted to the surface LinkQuest modem. The Orbcmm constellation of low earth orbit satellites was then used to send this data to a POL hosted email account. An email was then composed and sent to the telemetry system on the deck of the ship to communicate with the deployed Seabird CTD via the LinkQuest acoustic data link. This test was to demonstrate remote control of a deployed CTD using Orbcmm. The key steps in this remote control sequence were as follows:

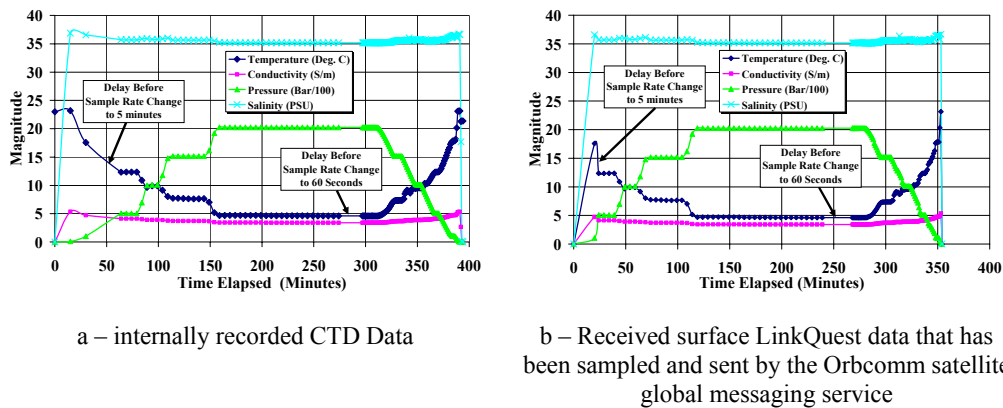
Fig. 10 – Recorded CTD and Telemetry Data from the Second 2000m Wire Test

60m' and then 'Very Demanding' at depths of up to and greater than 100m, which suggested that the UWM3000 omni-directional data link would be problematic. The exact reason for this poor data link performance is not clear. Bearing in mind that the wire frame modem and the surface modems were almost directly facing each other with only clear water between the two modems it is reasonable to expect the data link to perform well under these conditions. Despite these problems an email based command was scripted to the deployed Seabird CTD to increase the sample rate to one measurement every 5 minutes, as shown in Fig. 22a. The sample rate was then further increased at a depth of 2000m to one measurement every 60 seconds. The poor performance of LinkQuest UWM3000 acoustic modems resulted in a delays of approximately 20 minutes before the required commands were successfully transferred to the Seabird CTD. What was noticeable about substituting the UWM3000 surface modem for this test was that measurement data flow from the sea bed (bottom) modem to the surface modem had improved considerably with bursts of data being transferred to the surface within several minutes of being queued to the bottom modem. The data flow from the surface modem to the bottom LinkQuest UWM3000 modem was still poor and very slow. While the commands to script the deployed CTD to a different sample rate were being processed, the software in the Orbcomm modem would regularly time out after 10 minutes and then try once again scripting the commands up to three times to complete the required parameter change sequence. The factors governing the poor performance of the LinkQuest acoustic data link rare not clear. It could be a function of the matching of pairs of surface and bottom modems to each other, or properties of the deployment location that govern the acoustic data link performance. These technical difficulties do however illustrate the need to thoroughly test and evaluate the performance of commercial instrumentation systems before scientific measurement related deployments are attempted. Throughout this test the Benthos Smart data link and release modem performed reliably.

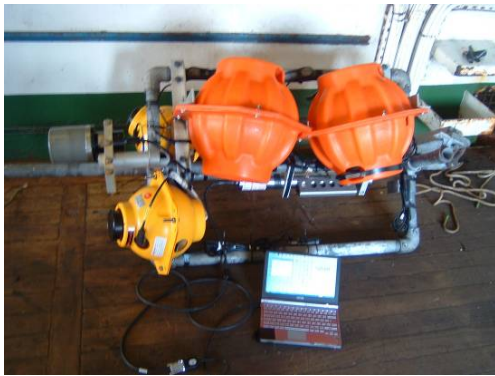
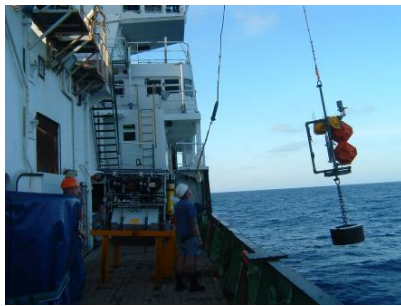
Fig. 11 – Benthos XT6000 Release and Smart Modem 3900m Wire Test

a – Prepared Test Frame Without LinkQuest Modem Fitted

c – 4000m Wire Test Frame Deployment

After an appropriate rest period, the final POL wire test for the D343 cruise was rescheduled and moved forward to occur in the evening due to technical difficulties with Autosub. As previously described the general aim for Wire Test C was to lower the wire test frame without the LinkQuest UWM3000 acoustic modems to a depth of 3900m that is as high as reasonably practicable within the cruise working area around the Casablanca Seamount. When the maximum test depth is reached the plan was to fire all of the release mechanisms to test the performance of the MYRTLE releases at the maximum test depth. Regular performance checks of the Benthos Smart Modem deep water acoustic data link were also undertaken during this test. The test started at 18:30 BST at a latitude of 32° 39.0814' N and a longitude of 13° 23.34504' W and continued until 21:35 BST on Tuesday 13th October. A selection of photographs of the deployment is shown in Fig. 11.

A plot of the internally recorded data from a Seabird Microcat CTD is also shown in Fig. 11d. This CTD data shows the descent of the wire test frame down to a depth of 3900m, a delay while the acoustic release systems are fired and then a return to the surface to end the test. During this test a suspect lead had been fitted to one of the XT6000 transponders and a standard lead and burn wire was used with the other transponder. The result of this test was that both releases failed to operate at 3900m even though both of the XT6000 transponders confirmed activation of the release voltage across the release mechanism for the required length of time. Testing of the release mechanisms at POL in an environmental chamber at 2°C has confirmed that the release mechanism unreliability does not seem to be related to the low temperatures experienced during deep water deployments. Therefore it would appear that the extreme pressures exerted on the release mechanisms during deep water deployments is the most likely cause of problematic release operation. Alternatively, the use of thinner quick operation burn wires during the trials cruises (as used for coastal work) could cause unreliable operation at extreme depths. Perhaps slower dissolving thicker Inconel wires, as normally

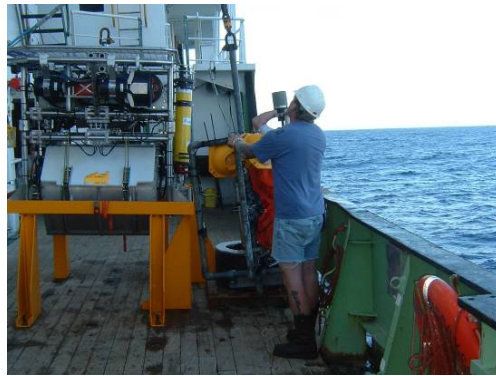
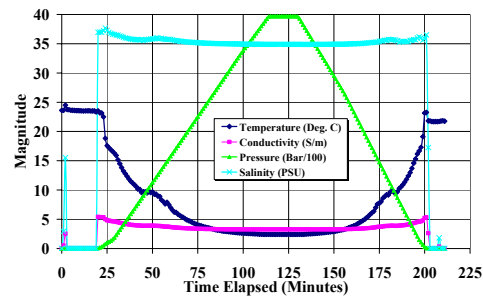
B – Received surface LinkQuest data that has been sampled and sent by the Orbcomm satellite global messaging service

d – Internally Recorded Seabird Microcat CTD Data at 60 second intervals

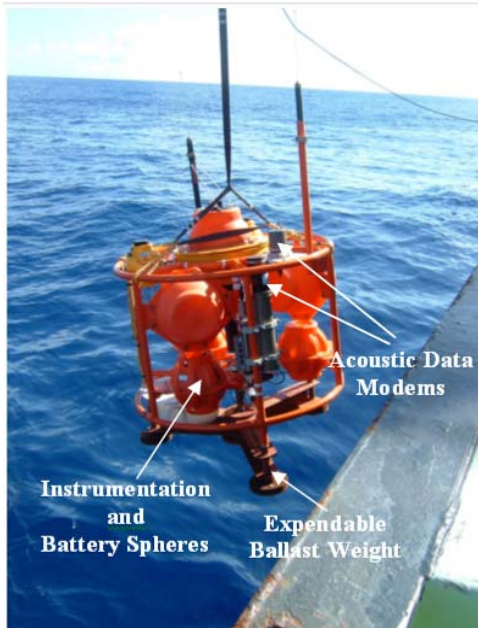
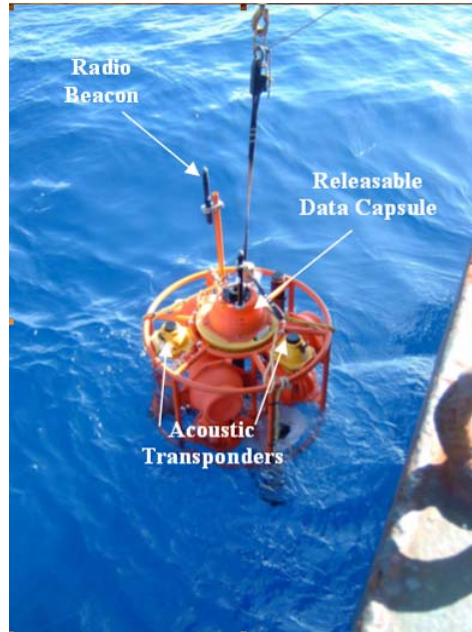
Fig. 24 – The MYRTLE Deep Sea Recoverable Instrumentation Platform

a – MYRTLE Upper View

b – MYRTLE Deployment

This section provides a series of pictures of the MYRTLE lander and POL telemetry buoy with the key components labelled (Fig. 24). The MYRTLE frame basically acts as a platform to mount various deep sea instrumentation spheres, acoustic modems etc. A pair of release mechanisms based around Benthos XT6000 acoustic transponders allows the buoyant frame to detach from the expendable ballast weight for instrumentation recovery. A further release driven by a Benthos Smart Modem combined deep water release and acoustic data link allows the central data capsule to be independently recovered from the frame. Contained within the data capsule is a satellite telemetry transmitter (Iridium or Orbcomm) that allows internally recorded data to be transferred to shore for analysis when the capsule reaches the surface.

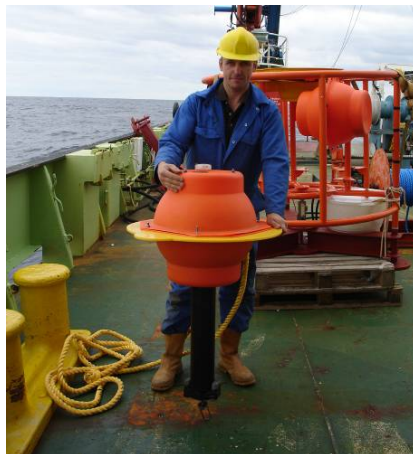
c – MYRTLE Releasable Data Capsule

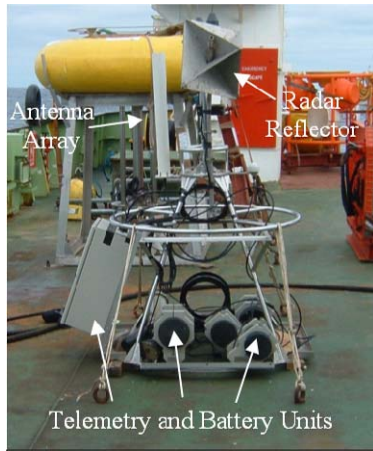
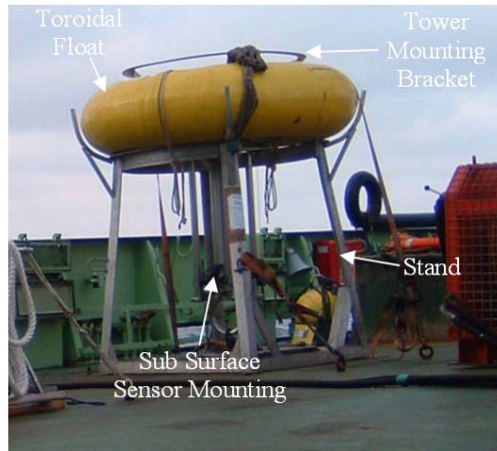
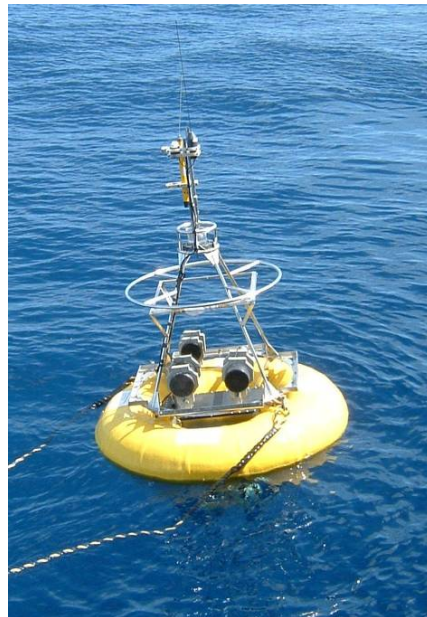
Fig. 25 – The POL Telemetry Buoy

b – Telemetry buoy instrumentation tower

b – Telemetry Buoy Torroid and Stand

c – Telemetry Buoy Deployment

During the D343 cruise the POL telemetry buoy was used to undertake a series of evaluations of marine data telemetry systems. The key components of the system are shown in Fig. 25. Various marine telemetry units and battery housings can be mounted and configured on the upper telemetry tower (Fig. 24a) and then bolted in place on the buoy for deployment. Technical difficulties experienced with the failure of the LinkQuest UWM4000 deep water long range acoustic data modem resulted in the telemetry tower being used for the trials. The basic idea was that the various telemetry systems under evaluation were mounted on the tower and operated from the rear deck of the ship. The ship was therefore being used to simulate the operation of the buoy because an actual buoy deployment was not feasible for most of the cruise work area. Data communications with the instrumentation deployed during the wire tests was achieved by suspending a surface acoustic data modem over the side of the ship just below the waterline. A long deck cable was then connected to the telemetry systems under test on the telemetry tower to simulate a buoy deployment.
