GAS-PATH SEAL TECHNOLOGY

John Zuk
NASA Lewis Research Center

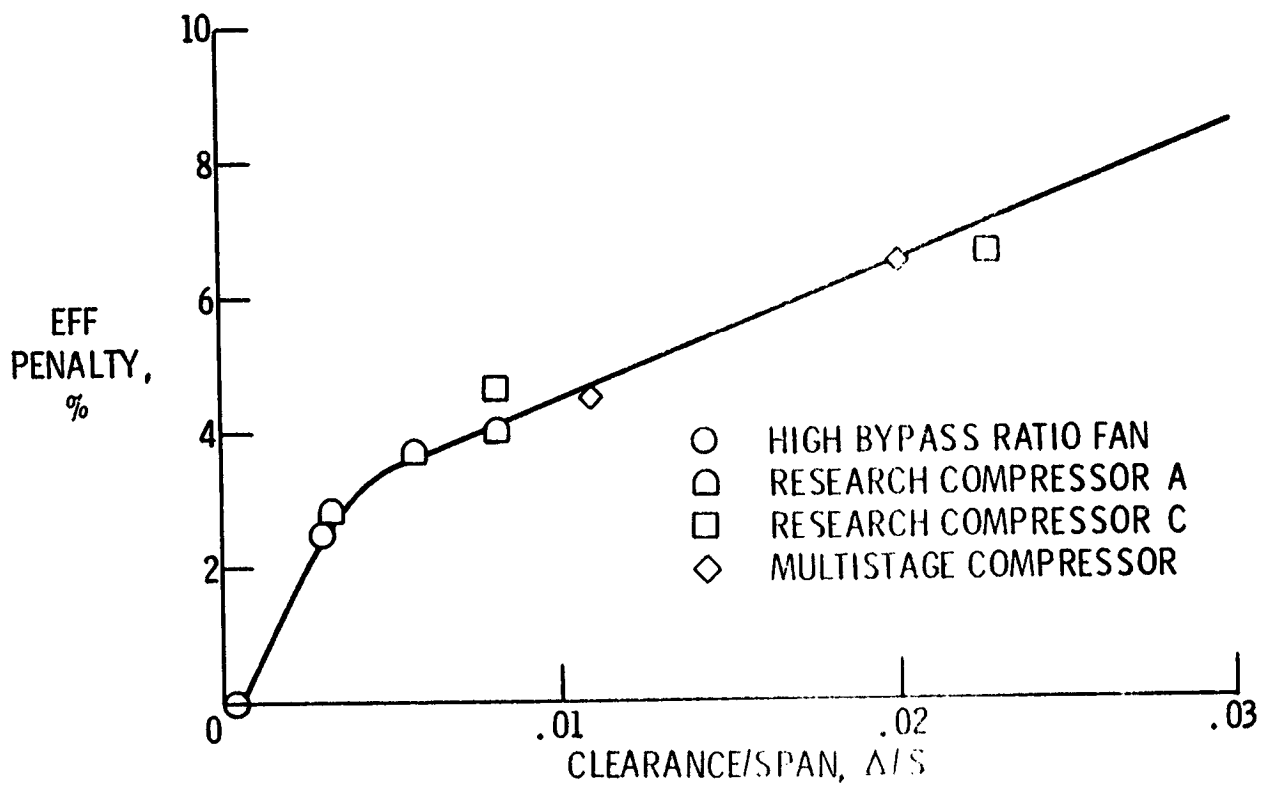
Figure 3.- Compressor performance penalty. (From ref. 3.)

As an example, compressor efficiency, one measure of performance, is greatly affected by the blade-tip clearance. The compressor efficiency penalty as the ratio of blade-tip clearance to blade height is increased is shown in figure 3. These data were obtained from operational and research compressors (ref. 3). Usually, the high-pressure stages of high-performance compressors have short span heights. Hence, the compressor efficiency is very sensitive to blade-tip clearance. Note in figure 3 that doubling the clearance can mean a 2-percent penalty in efficiency. In addition, stall/surge margins also depend greatly on clearance.
