5. Materials and Techniques for Spacecraft*
Static Charge Control

L.J. Amore and A.E. Eagles
General Electric Company
Space Division
Valley Forge, Pennsylvania

An overview of the design, development, fabrication, and testing of transparent conductive coatings and conductive lattices deposited or formed on high resistivity spacecraft dielectric materials to obtain control static charge buildup on spacecraft external surfaces is presented.

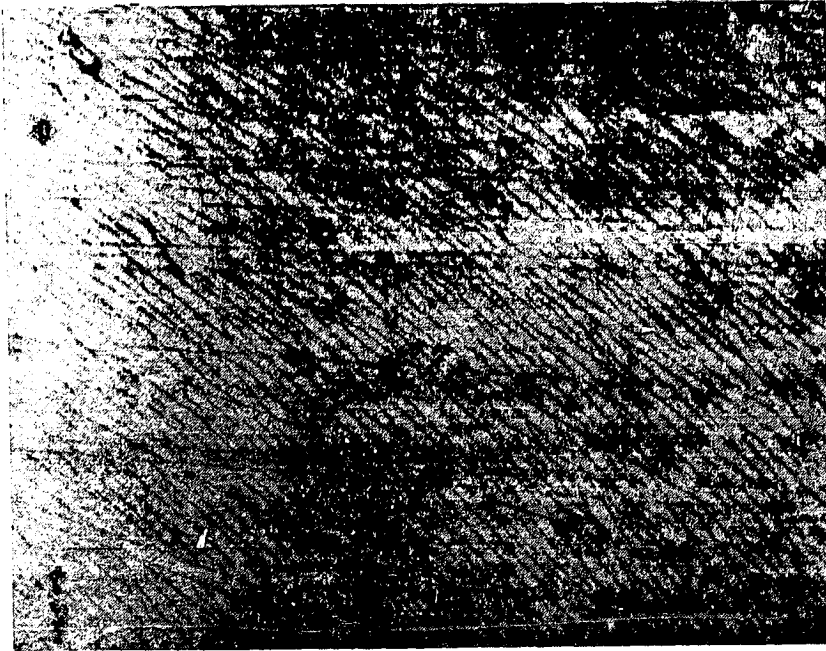
Micrographs of ITO (250 Å) coated FEP Teflon after electron beam irradiation are shown in Figure 18b indicating "electron-etched" cracking and crazing. These craze-cracks (due to large applied anisotropic stress or tensile force) run along parallel direction of stretch lines to which the material was subject (that is, longitudinal drawing or pulling and radial blowing), as is evidence by the micrograph of the unexposed spacecraft material (Figure 18a) and less evident outside the electron beam irradiation area (Figure 18c). The stretch lines correspond to the direction of molecular orientation, preferentially, since the polymer under the coating has less strength perpendicular to the direction of orientation. Crystallization occurs along these oriented molecules.

Figure 18b. FEP/ITO After Electron Irradiation at the Central Region of the Electron Beam. Electron etched craze lines appear on the FEP-Teflon surface, together with fabrication die lines, under the transparent semi-conductor (200X)

Within these imperfections and voids intrapped gas is ionized by electron beam charging. Local temperatures rise, chemical reactions occur and stress is created, as in the case of chemical or vapor etching.
