INSTABILITIES OF GEARED COUPLINGS - THEORY AND PRACTICE

R. Gordon Kirk, Roy E. Mondy, and Richard C. Murphy
Ingersoll-Rand Company
Phillipsburg, New Jersey 08865

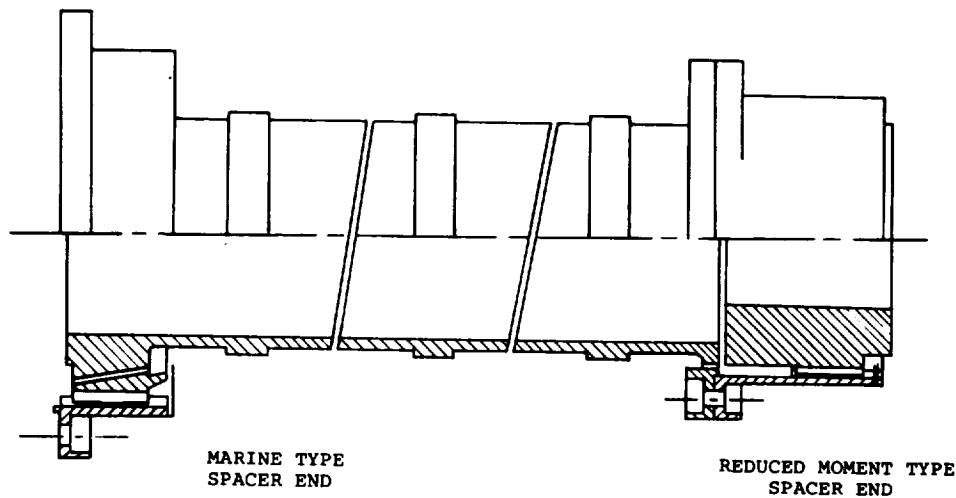
Figure 1. - Expander original coupling design employing both marine and reduced moment spacer design features.

The first coupling to be considered is shown in Figure 1. The shaft end separation is 1727.2 mm (68 inches) and the coupling weight is 79.1 kg (174 pounds). The spacer is 149.2 mm (5-7/8 inches) O.D., 136.5 mm (5-3/8 inches) I.D. This coupling is rated for 11.6 MW (15,500 horsepower) at 95 Hz (5700 RPM) with a maximum continuous operating speed (MCOS) of 100 Hz (6000 RPM). The calculated spacer critical speed is 131 Hz (7860 RPM) or 1.31 times MCOS. In the field this coupling transmits power from an overhung design expander to a center slung design axial flow compressor. The compressor was tested using this coupling and at 100 Hz (6000 RPM), the compressor's bearing vibration adjacent to the coupling was approximately 0.025 mm (1 mil), Figure 2. This same coupling was then used to drive the expander for its mechanical run test.

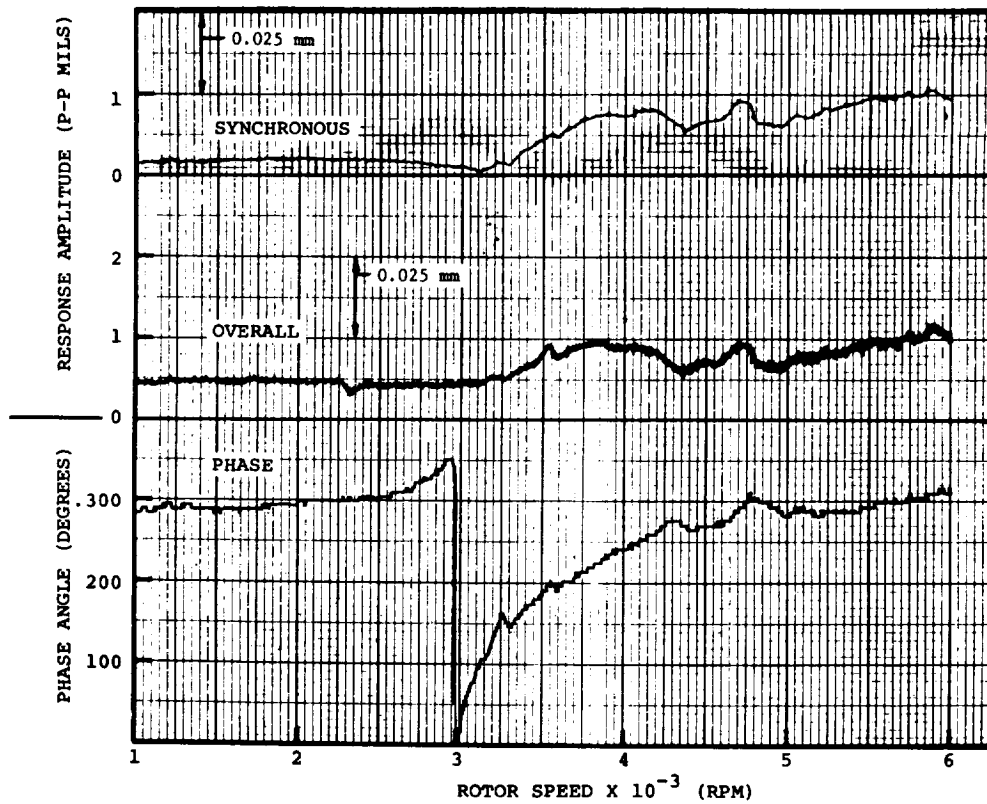
Figure 2. - Acceptable axial compressor vibration (speed vs. amplitude) signature. Four-hour mechanical test run.

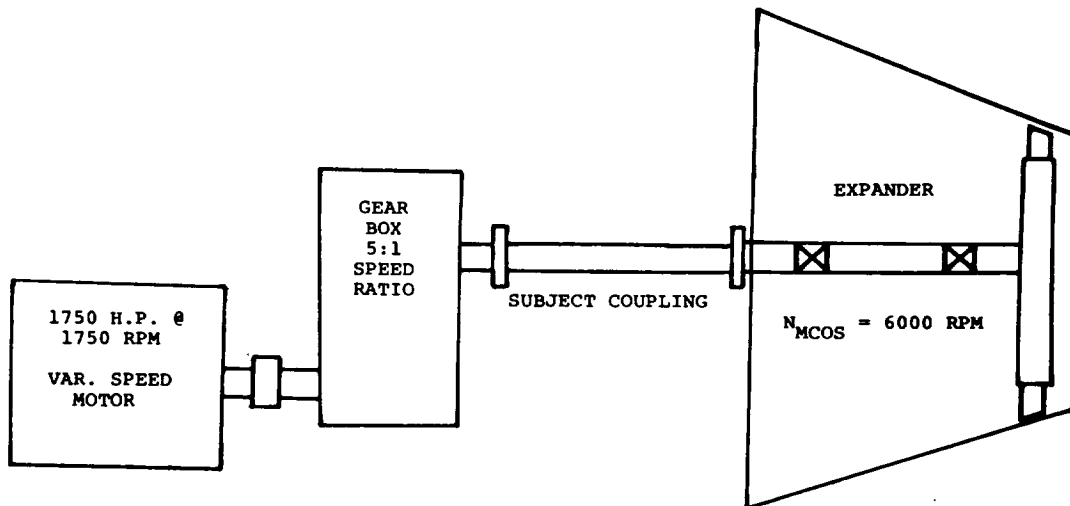
Figure 3. - General configuration of expander test stand assembly.

The set-up for the expander test is shown schematically in Figure 3 where the variable speed motor drives the expander through a 5:1 speed increasing gearbox. The initial results of this test are depicted in Figure 4 which represents the initial run up to speed. As can be seen, vibration levels are acceptable at 83.3 Hz (5000 RPM), approximately 0.010 mm (0.4 mil), but the amplitude rises sharply above 83.3 Hz (5000 RPM) approaching 0.051 mm (2.0 mils) at 91.7 Hz (5500 RPM). The amplitude was nearly all at synchronous frequency. This rapid increase in synchronous response amplitude is usually indicative of a critical speed. A review of the rotor dynamics analysis of the expander, including the coupling half weight, did not indicate a critical speed in this speed range. Upon running an analysis of the test system, the indication was that a system critical existed which was primarily controlled by the coupling. It was necessary to field balance this coupling placing balance weights at the spacer midspan to enable a satisfactory vibration level to be achieved. The field balance required numerous trials due to the sensitive nature of the coupling spacer critical. Figure 5 shows the final balance condition with an acceptable level of 0.038 mm (1.25 mils) being achieved at 100 Hz (6000 RPM). The existence of the critical speed is indicated by the substantial shift in phase angle above 91.7 Hz (5500 RPM).

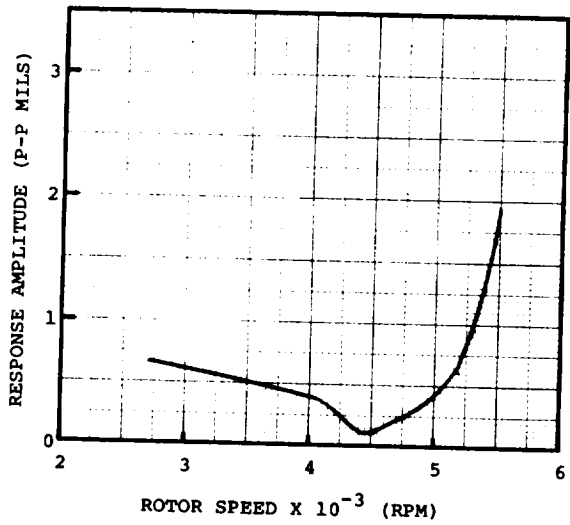
Figure 4. - Expander vibration signature for initial acceleration on test stand.

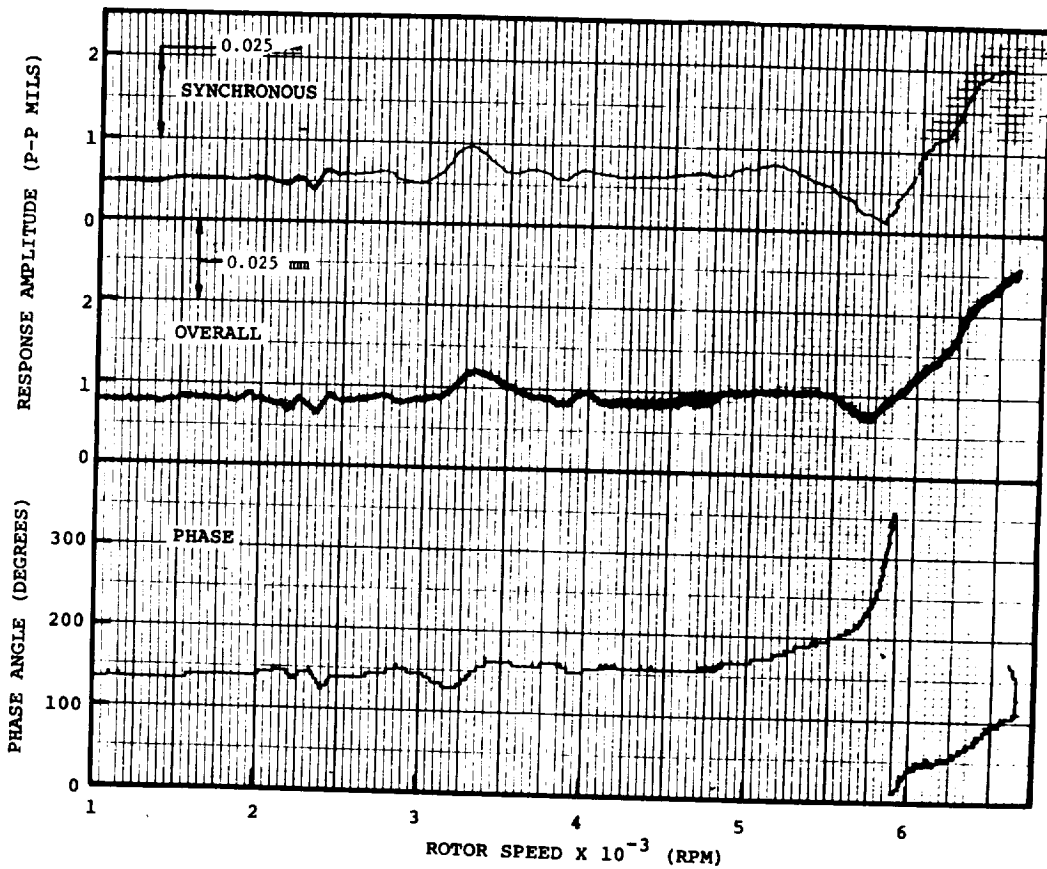
Figure 5. - Expander vibration signature for final balance condition of coupling on test stand during mechanical run.

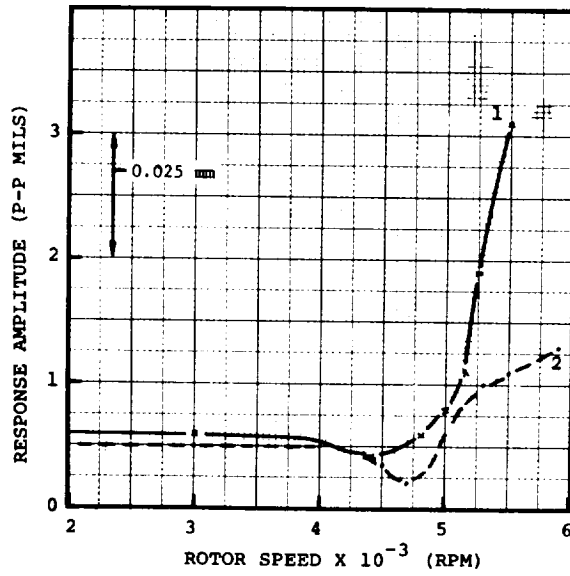
Figure 6. - Test stand vibration signature comparison for balanced spacer with and without polyphenylene tooth coating.

Several proposals were considered to resolve the vibration problems of Case 1. One proposal was to coat the coupling gear teeth with a product which the coupling manufacturer recommends for the running in of new couplings. This coating is a polyphenylene sulfide resin placed on the flanks of the teeth to help the teeth share the load. After a reasonably acceptable level of balance was achieved by field balancing, this coating was applied to the coupling teeth. Figure 6 depicts the results. With the coating on the coupling, the vibration as measured by the expander's coupling end vibration probe reached .076 mm (3.0 mils) at 91.7 Hz (5500 RPM) as seen on Curve 1. The coating was removed by a light sandblasting; the balance of the coupling was considered to be unchanged. Curve 2, showing 0.025 mm (1.0 mil) at 91.7 Hz (5500 RPM), reflects the results upon rerunning the coupling on the test stand. Since the only change between these two runs was the removal of the coating, it was concluded that the difference in response was due to an increase in the coulombic damping in the gear meshes which resulted from the removal of the slippery coating that had been applied to the teeth flanks.

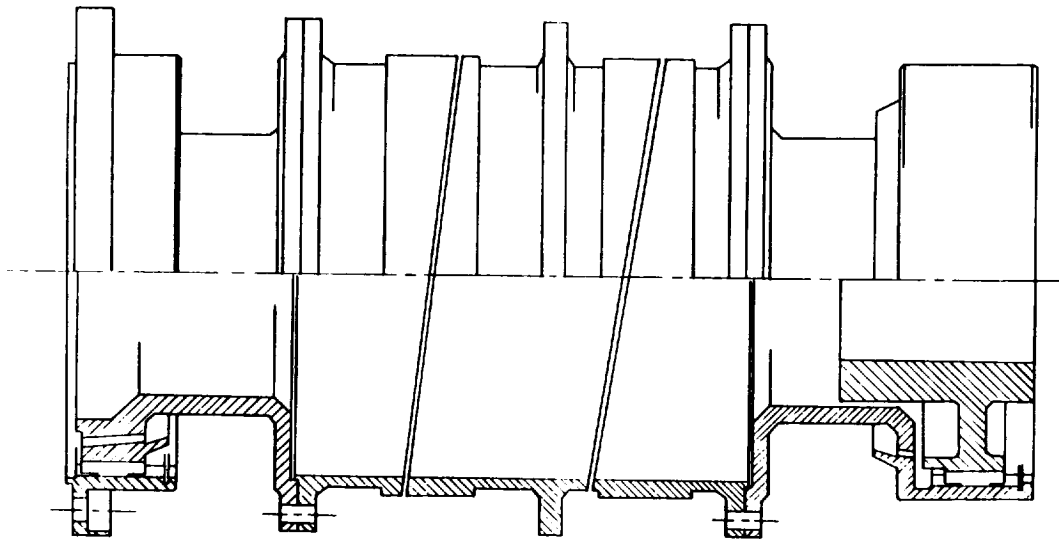
Figure 7. - Expander redesigned coupling with increased spacer tube diameters.

The coupling design resulting from this study is shown in Figure 7. The shaft end separation is still 1727.2 mm (68 inches), but the weight has been increased to 97.7 kg (215 pounds). The main spacer has an O.D. of 235 mm (9.250 inches) and an I.D. of 223.9 mm (8.813 inches). The calculated critical speed is 207.6 Hz (12,457 RPM) or 2.08 times an MCOS of 100 Hz (6000 RPM).

Of necessity, couplings similar to that of Figure 7 consist of a number of pieces which must be assembled. Where possible, rabbet fits are used to maintain consistency in reassembly. However, fits may have clearance and may not be concentric with each other which can result in either constant or variable unbalance being manufactured into the coupling. This same problem can also exist for the fits and pilot diameter of the gear meshes.

The coupling of Figure 7 has a floating member weight of 84.1 kg (185 pounds) which results in an unbalance of 106.7 gm-cm (1.48 ounce inches) for each 0.025 mm

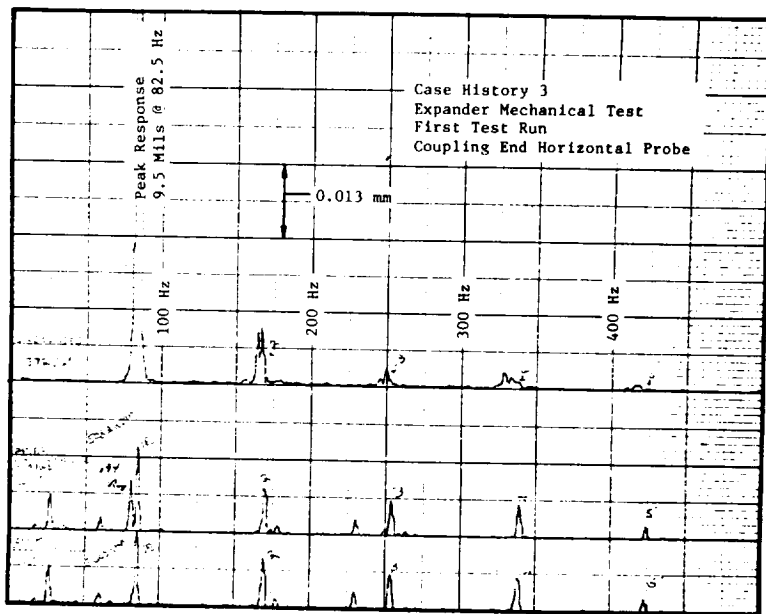
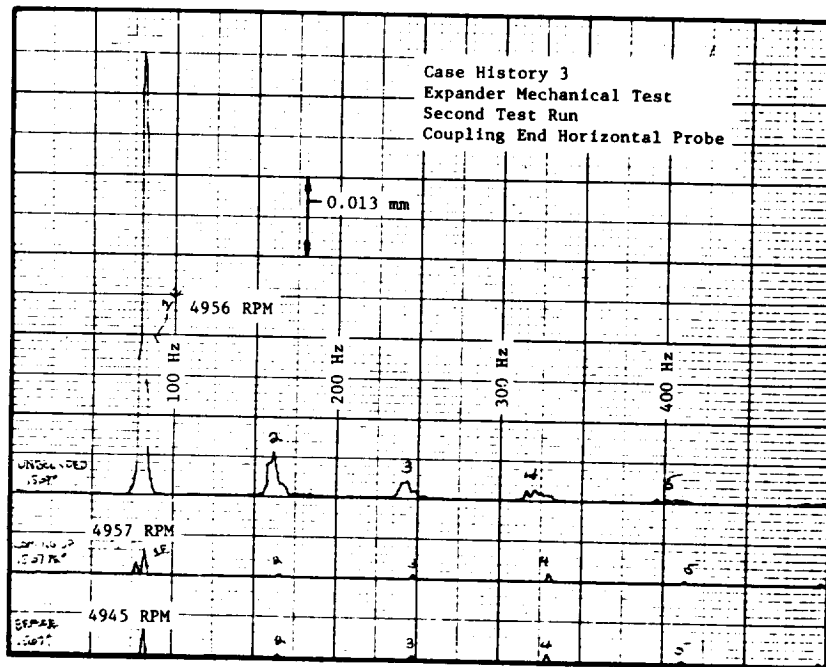
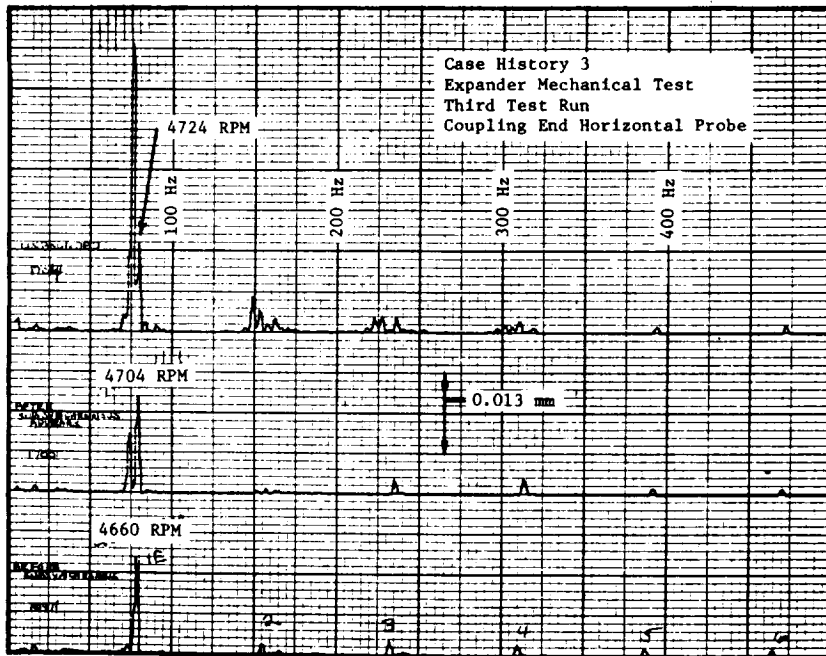
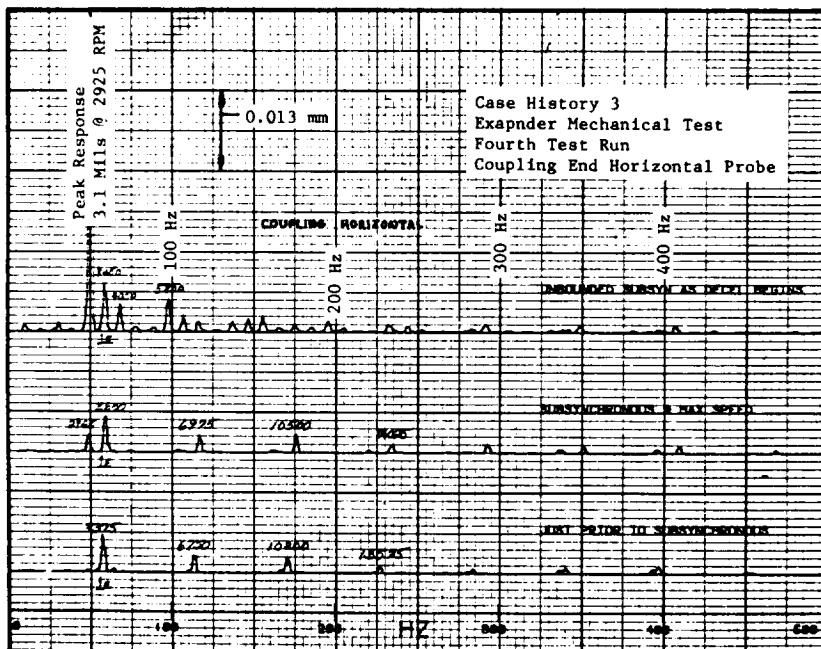
Figure 8. - Test stand vibration spectrum signature.

(a) First acceleration with entrapped oil.

(b) Second acceleration with entrapped oil.

(c) Third acceleration with entrapped oil.

(d) Fourth acceleration with entrapped oil.

In order to confirm the acceptability of this coupling, it was run on the next similar unit to go on the test stand. Figures 8-a through 8-d depict the initial results. An extremely high level of vibration would suddenly occur with a very small increase in speed. As can be seen from a chronological review of the figures, the speed at which this phenomenon would occur was lower with each successive start and the source of the high amplitude was a subsynchronous component varying from .94/rev. on the first start to .83/rev. on the fourth start. Although the amplitude at synchronous frequency was never higher than 0.015 mm (0.6 mil), the subsynchronous component reached levels approximating 0.241 mm (9.5 mils) at 84.8 Hz (5090 RPM) on the first start.

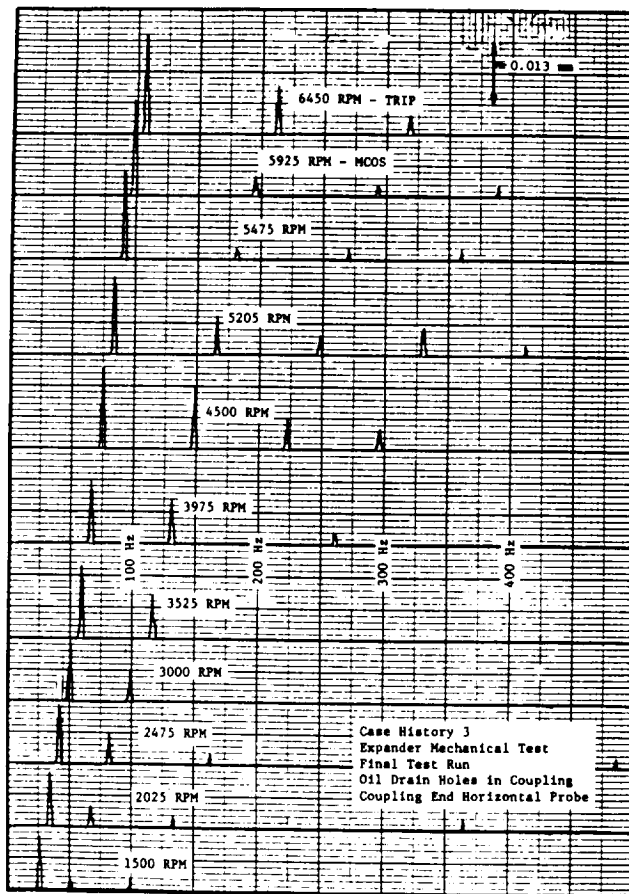
Figure 9. - Test stand vibration spectrum signature after oil drain holes were drilled in spacer.

The first step in disassembly of the unit was the removal of the coupling. Upon breaking the flanges, a substantial quantity of oil was observed to have been entrapped in the spacer tube. In order to permit the oil to escape from the spacer, twelve 6.35 mm (0.250 inch) holes were drilled in the spacer; four at each end and four in the middle. The spacer assembly was check balanced and found to be acceptable. The unit was reassembled. Figures 9 and 10 show the results of the retest run. Figure 9 shows that the subsynchronous component, due to the entrapped oil, has been completely eliminated and Figure 10 indicates that the critical speed, previously seen at about 96.7 Hz (5800 RPM) has been eliminated. An additional modification has since been incorporated into this coupling design to preclude oil from entering the spacer from the gear mesh area. This modification consists of interference fitting dam plates in the ends of the spacer. The oil drain holes are retained.

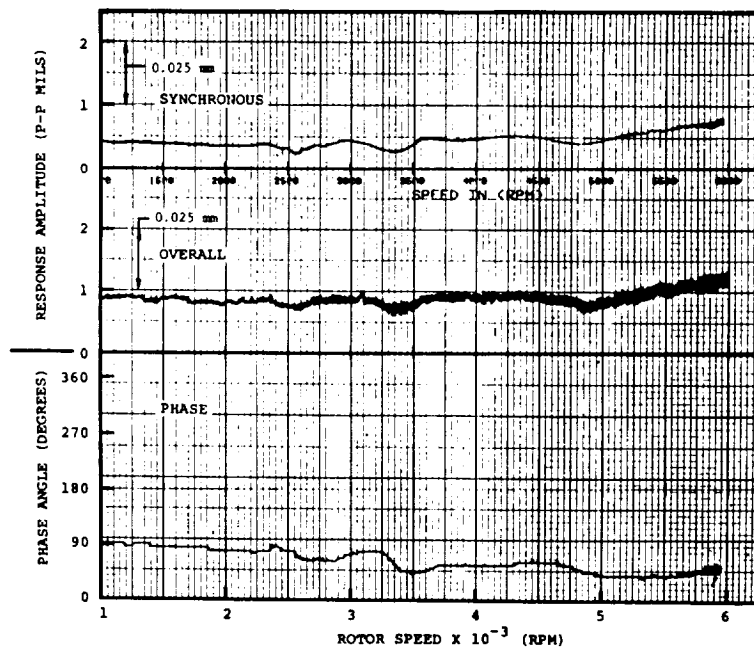
Figure 10. - Test stand vibration signature for retest run with oil drain holes in coupling spacer.

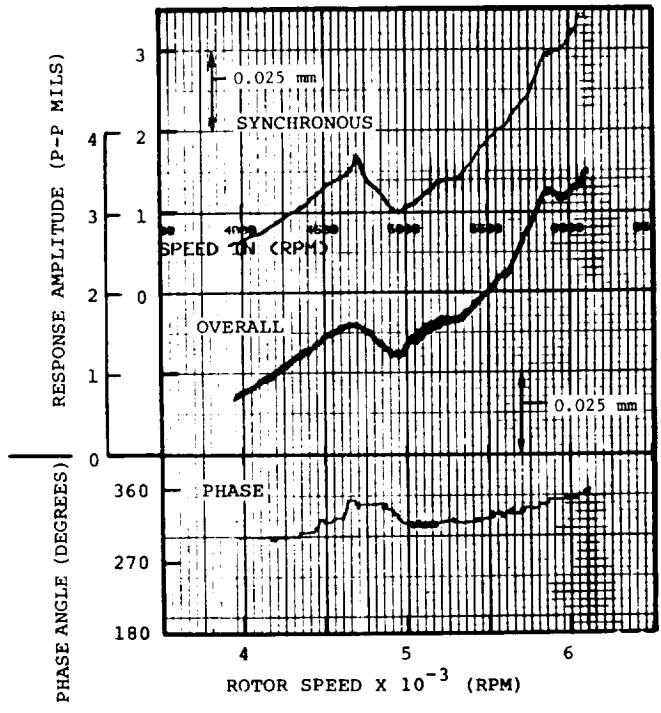
Figure 11. - Test stand vibration signature with coupling assembled using manufacturer's match marks (5-6 mils TIR).

(1 mil) of floating member eccentricity. Figures 11 and 12 graphically depict what can happen as a result of manufacturing tolerances and eccentricities. Figure 11 indicates an overall amplitude of 0.081 mm (3.2 mils) at a speed of 96.7 Hz (5800 RPM). For this test run the coupling was assembled using the manufacturer's match marks. The assembled coupling was indicated with mechanical dial indicators and depending upon axial location, ran out as much as 0.127 - 0.152 mm (5-6 mils). When ignoring the manufacturer's match marks, and rotating components relative to each other, the run out was reduced to under 0.051 mm (2 mils). The test results for this configuration are shown in Figure 12 where the overall vibration level at 96.7 Hz (5800 RPM) is approximately 0.037 mm (1.45 mils).

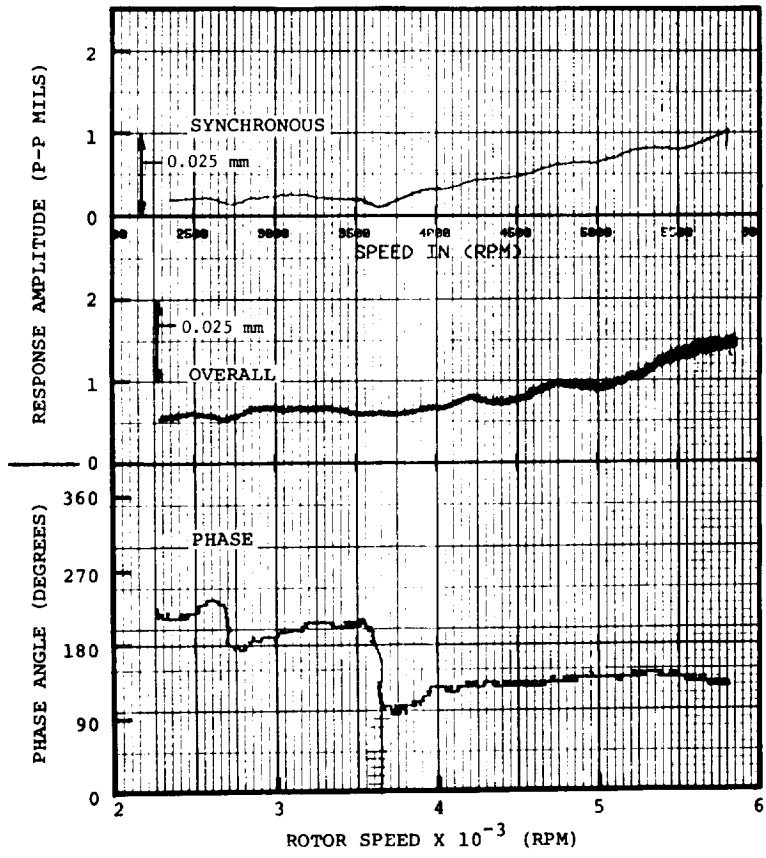
Figure 12. - Test stand vibration signature with coupling assembled to minimize coupling spacer runout imbalance.

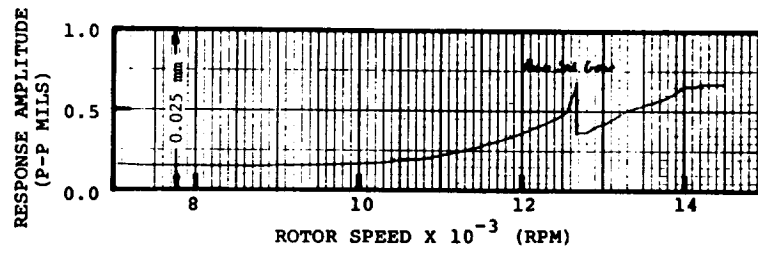
(a) Exemplifying spacer throwout.

Figure 13. - Gas turbine test stand vibration signatures.

This phenomena is graphically displayed in Figure 13a, where a speed reducing gear box is being driven by a gas turbine with the load compressor uncoupled. As long as the accelerating torque is applied, the vibration amplitude gradually increases to a level of 0.013 mm (0.5 mil) at 209.2 Hz (12550 RPM). Since the accelerating torque decreases as the unit approaches idle speed, the vibration quickly increases to 0.018 mm (0.7 mil) at 211.3 Hz (12680 RPM). When torque is reapplied through the coupling during acceleration to MCOS, the vibration amplitude immediately drops to .009 mm (0.36 mil) and gradually increases again as the driving torque decreases while the unit comes up to speed.

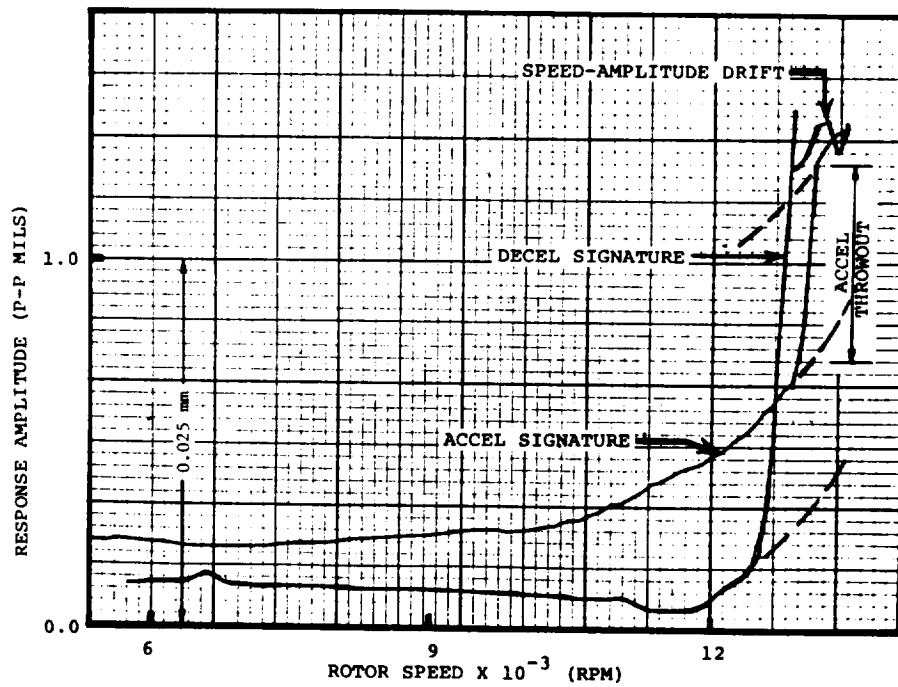
(b) For acceleration and deceleration showing spacer throwout.

Figure 13b shows a separate test run for the subject equipment string. Both accel and decel signatures clearly show the response step increase associated with coupling spacer throwout. The speed-amplitude drift signature is included as additional information to show the absence of a response critical of any kind in this speed range.

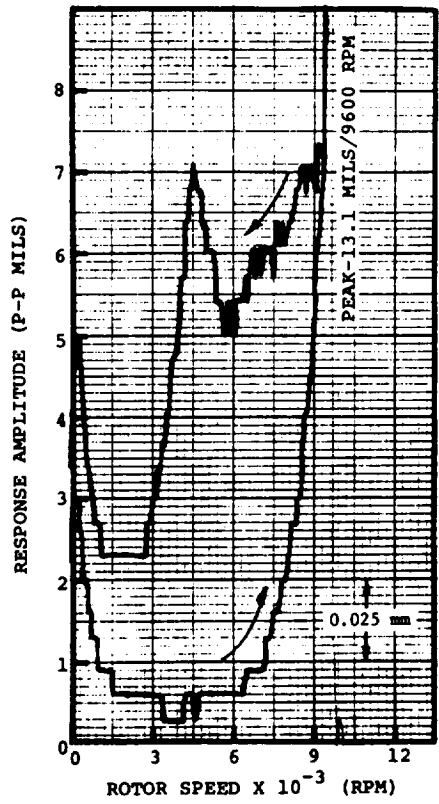
Figure 14. - Gas turbine test stand vibration signature for the condition of a cracked coupling spacer.

Figure 14 depicts a peak hold plot of overall vibration during the startup of a unit similar to the one just described above. As can be seen, the amplitude starts rising rapidly above 120 Hz (7200 RPM) and peaks at about 0.330 mm (13 mils) at 160 Hz (9600 RPM). The unit was tripped and after coast down, the coupling guard was disassembled. Figure 15 shows the condition of the coupling spacer. Three large cracks were evident. The darkened area above the center balancing band was caused by the coupling rubbing the guard. The driven gear box showed no distress and the coupling was not transmitting load as the load compressor was not coupled for this start nor had it been coupled. Metallurgical investigation later determined that the cracks had been formed during the heat treatment cycle of the spacer.

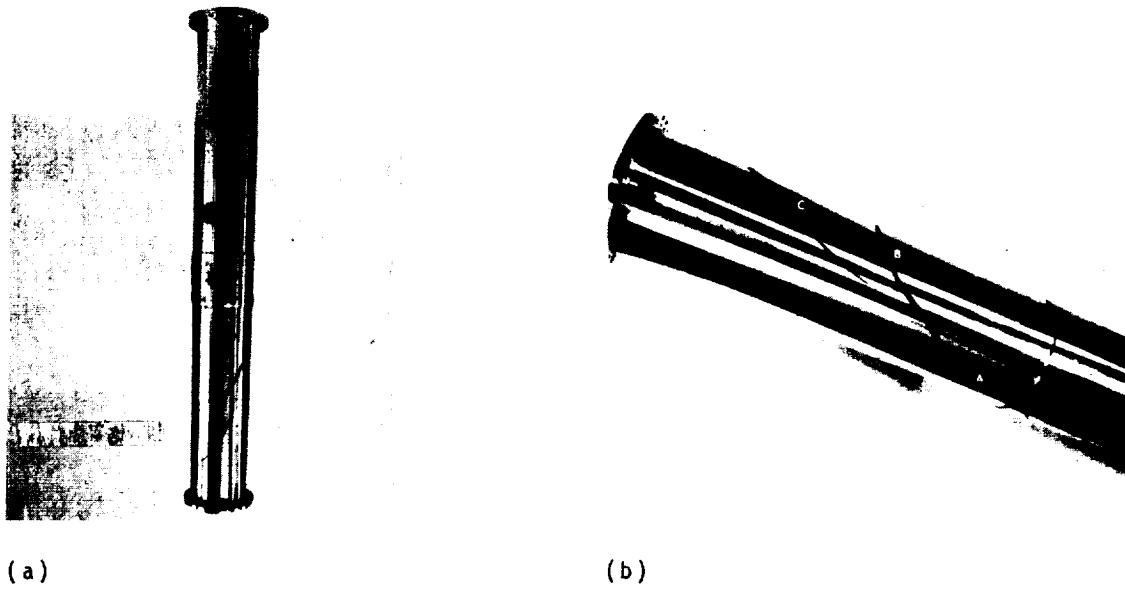
Figure 15. - Failed coupling spacer.

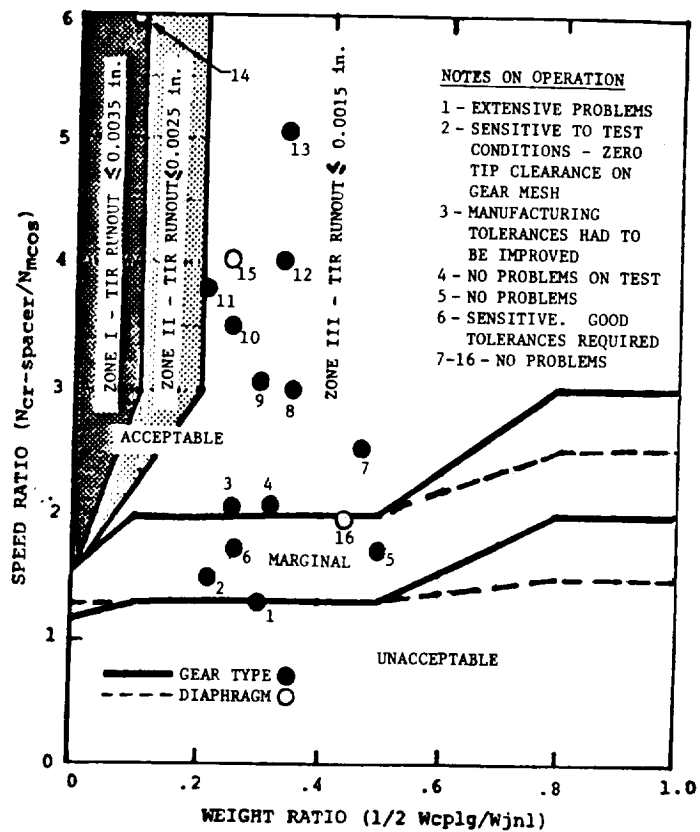
Figure 16. - Chart for coupling selection showing degree of acceptability with overhung turbomachinery. Experience overplotted. Zones indicate runout level of balance bands relative to the mounting bore or rabbet fit.

3. If the spacer is in the satisfactory region given in Figure 16 (Zones I and II, and the upper part of Zone III) for each of the adjoining machines journal reaction ratio, $1/2 W_{cplg}/W_{journal}$, the design specifications need not require a train analysis.
4. If the design falls in the marginal region of Figure 16, a train or partial train analysis should be performed for test stand and field conditions if the spacer cannot be redesigned to move into the satisfactory region.
5. If the design falls in the unacceptable region the coupling spacer should be redesigned to move the calculated critical as far as possible toward the satisfactory zone, analysis being made as noted above.

the floating member is required. The final coupling assembly, as mounted on the turbomachinery, must have a total indicator reading on each of the ground balancing journals on the floating member of less than .051 mm (.002 in). This requirement necessitates that the coupling manufacturer achieve runout levels of less than .038 mm (.0015 in) for each balance journal relative to its mounting bore or rabbet fit. This criteria is relaxed for couplings in Zone I and Zone II as indicated on Figure 16.

1. Coupling designs that are below the marginal zone of Figure 16 should not be accepted for Turbomachinery application.
2. Coupling spacers should be designed to have a critical speed ratio of 2.0 or larger. Smaller ratios may be acceptable if adequate analysis is conducted to assure an insensitive design as outlined in this paper.

8. The balance procedures outlined in this paper could apply to all couplings but are considered essential for those applications in Zone III of Figure 16.
9. Attention to proper material processing and heat treatment is essential in addition to the above considerations.
