# APPLICATION OF EDDY CURRENT TECHNIQUES FOR ORBITER REINFORCED CARBON-CARBON STRUCTURAL HEALTH MONITORING

**ABSTRACT.** The development and application of advanced nondestructive evaluation techniques for the Reinforced Carbon-Carbon (RCC) components of the Space Shuttle Orbiter Leading Edge Structural Subsystem (LESS) was identified as a crucial step toward returning the shuttle fleet to service. In order to help meet this requirement, eddy current techniques have been developed for application to RCC components. Eddy current technology has been found to be particularly useful for measuring the protective coating thickness over the reinforced carbon-carbon and for the identification of near surface cracking and voids in the RCC matrix. Testing has been performed on as manufactured and flown RCC components with both actual and fabricated defects representing impact and oxidation damage. Encouraging initial results have led to the development of two separate eddy current systems for in-situ RCC inspections in the orbiter processing facility. Each of these systems has undergone blind validation testing on a full scale leading edge panel, and recently transitioned to Kennedy Space C

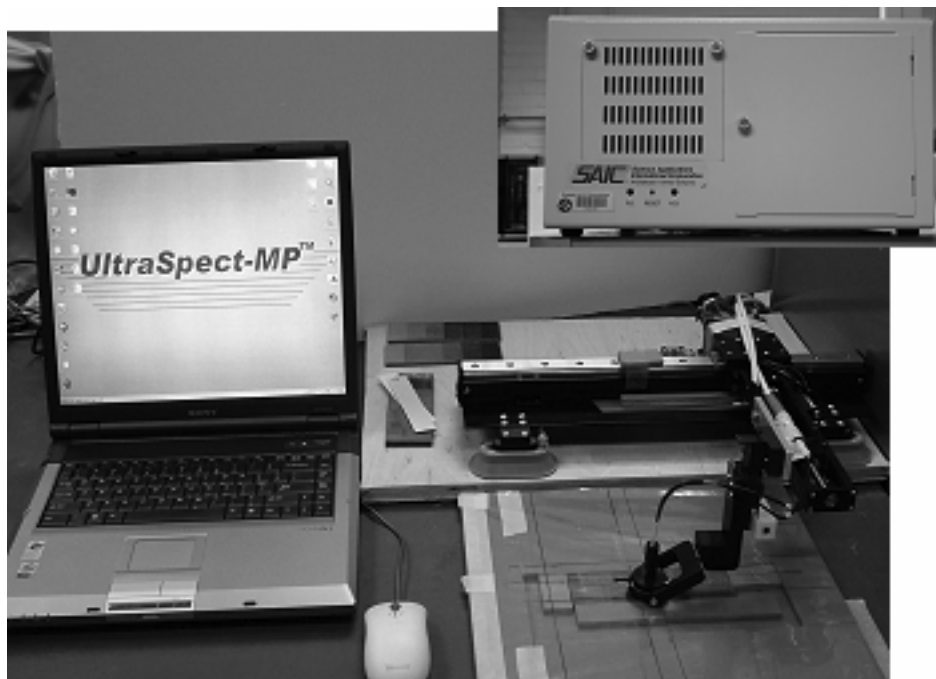
Figure 2. SAIC Ultraspect-MP eddy system for in-situ eddy current inspections of RCC.

In figure 2, the SAIC Ultraspect-MP system with LPS-100 manual scanner is displayed. This system consists of a high frequency eddy current surface probe connected through a spring loaded z-axis gimbal to the manual scanner. The probe is driven by the data acquisition system (DAS), which communicates with the laptop computer for acquisition of normalized probe impedance versus position. Calibration of the system is performed with a test article of nominally matching conductivity and coating thickness to the part under test, and the probe response is rotated such that lift-off is in the horizontal direction. Manual encoded scanning in two dimensions results in horizontal and vertical C-Scan images which are displayed on the laptop computer.

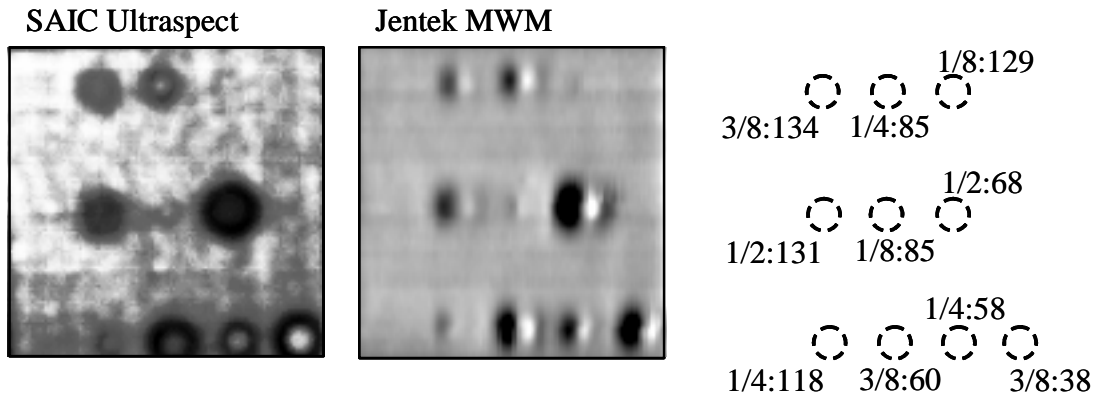
Figure 3. Eddy current inspection results for flat bottom hole standard fabricated from flown RCC material. Schematic diagram on the right displays nominal hole diameter in inches and remaining good material to unflawed front surface in mils. Inspections performed from unflawed surface.

The first sample design contained flat bottom holes milled from the back surface of the RCC to varying distances from the front surface. This general purpose sample could give a rough approximation for buried impact damage within RCC. Holes with diameters ranging from 1/8" to 1/2" were fabricated at various depths into the material. The results in Figure 3 display the 1 MHz SAIC Ultraspect and Jentek MWM data obtained on such a flat bottom hole reference standard. The SAIC C-Scan contains the vertical channel data (perpendicular to lift-off) while the Jentek data is a conductivity C-Scan. A schematic diagram giving the location, diameter, and nominal distance from the outer surface to top of the detectable flat bottom holes is also shown in the figure. Note that the linear induction method of the MWM coil produces a characteristic dipole type pattern when scanned across the flat bottom holes while the circular spot coil attached to the SAIC system shows no angular dependence. Both eddy current techniques are seen to enable detection of flaws as small as 1/8" diameter and as deep as 0.134" into the RCC.
