NASA/TM—2006-214336

Solar Effects on Tensile and Optical Properties of Hubble Space Telescope Silver-Teflon[®] Insulation

Prepared for the
2006 Spring Meeting
sponsored by the Materials Research Society
San Francisco, California, April 17–21, 2006

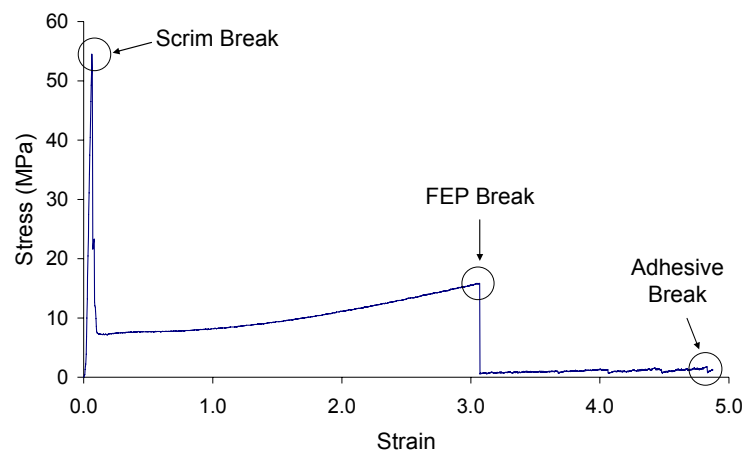
The HST SADA Ag-FEP stress versus strain graphs had three distinct steps indicating breakage of three distinct layers. The scrim layer broke with very little elongation, followed by breakage of the FEP layer, and finally breakage of the ductile adhesive layer. Therefore, the UTS and elongation at failure of the FEP layer was determined based on the location of the second step (break of the FEP) on the stress versus strain graphs. See figure 4 for an example.

Figure 4. Stress-strain curve for Tensile Sample 5 (295.6°) showing three break points.

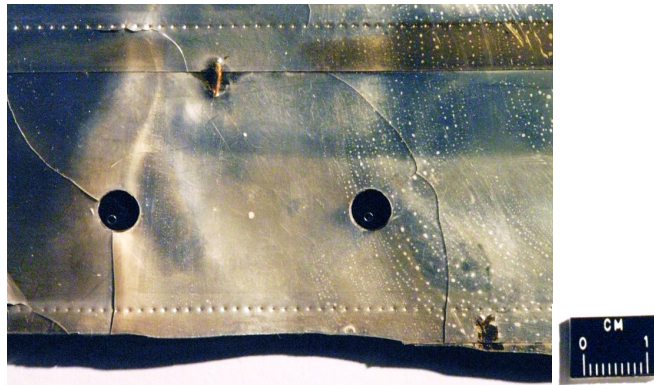
The HST SADA sample had distinct areas with varying discoloration. In general, the solar-facing region had a non-uniform hazy-white, almost milky appearance, and contained numerous through-thickness cracks. Two of these through-thickness cracks are shown in figure 5. Some areas in the solar facing region were discolored brown. There was no observable darkening long the cracks, hence no significant oxidation of the underlying Ag layer was observed. The solar grazing surfaces had clearer appearances, similar to pristine Ag-FEP, and did not contain cracks. The anti-solar facing side was uniformly hazy-white in appearance, but did not contain any observable cracks.

Figure 5. Close-up of the solar facing side of the SADA MLI showing through-thickness cracks and discolored regions.

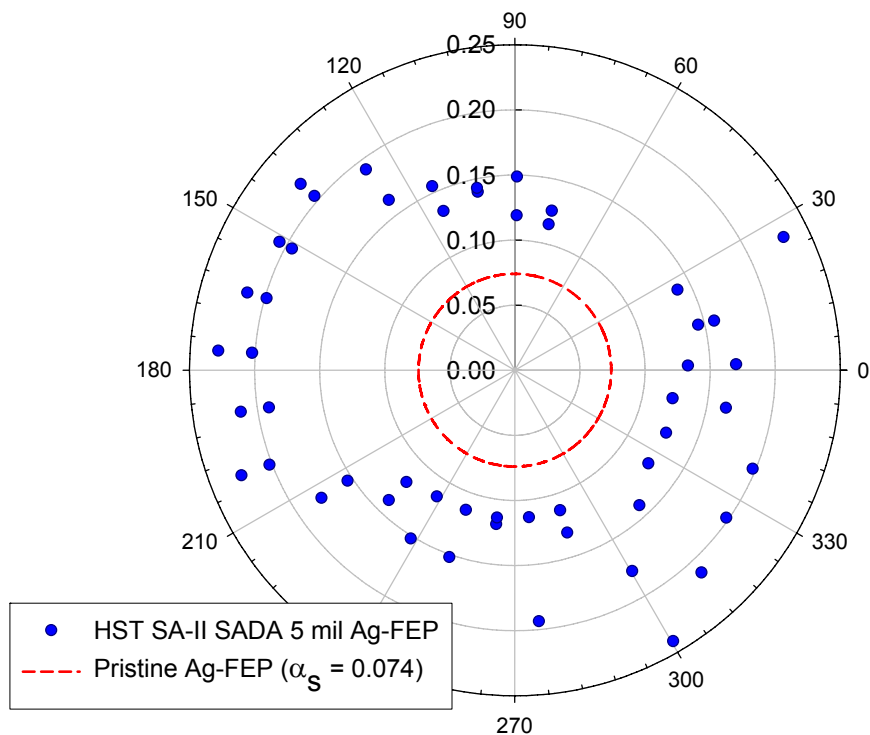
A polar plot of the solar absorptance versus solar angle is provided in figure 9. The solar absorptance for pristine Ag-FEP was 0.074 and is plotted as a dashed line. As can be seen, the solar absorptance for all 61 locations on the HST SADA MLI is higher than the pristine Ag-FEP solar absorptance. The polar plot shows greater increases in absorptance for the solar and anti-solar surfaces and smaller increases at the solar grazing angles (areas likely shielded by cabling and equipment).

The data was averaged based on 60° angular views centered on $0, 90, 180$ and 270° . The solar facing surfaces had an average absorptance of 0.155 ± 0.032 (average of 12 data points between 26.4° and 337.5°) with a large amount of scatter. The scatter in the data corresponds to the variation in haziness and brown discoloration found on the solar facing surfaces. The average solar absorptance values for the two solar grazing surfaces were similar: an average of 0.129 ± 0.027 between 249.6° and 287.9° (average of 10 data points) and 0.134 ± 0.014 between 77° and 114.2° (average of 9 data points). Thus, the overall average for the solar grazing surfaces was 0.131 ± 0.021 (average of 19 data points). Surprisingly, the anti-solar surfaces had high solar absorptance of 0.208 ± 0.012 (average of 11 data points between 151.4° and 201°). The scatter in this data was much smaller than for the solar facing data, which is consistent with the more uniformly hazy appearance of the anti-solar surface.

Figure 9. Polar plot of the solar absorptance versus solar angle for the HST SADA Ag-FEP.
