NASA/TP-2007-214878

# Development of Eddy Current Techniques for the Detection of Cracking In Space Shuttle Primary Reaction Control Thrusters

**ABSTRACT.** A recent identification of cracking in the Space Shuttle Primary Reaction Control System (PRCS) thrusters triggered an extensive nondestructive evaluation effort to develop techniques capable of identifying such damage on installed shuttle hardware. As a part of this effort, specially designed eddy current probes inserted into the acoustic cavity were explored for the detection of such flaws and for evaluation of the remaining material between the crack tip and acoustic cavity. The technique utilizes two orthogonal eddy current probes which are scanned under stepper motor control in the acoustic cavity to identify cracks hidden with as much as 0.060" remaining wall thickness to the cavity. As crack growth rates in this area have been determined to be very slow, such an inspection provides a large safety margin for continued operation of the critical shuttle hardware. Testing has been performed on thruster components with both actual and fabricated defects. This paper will review the design and performance of the developed edd

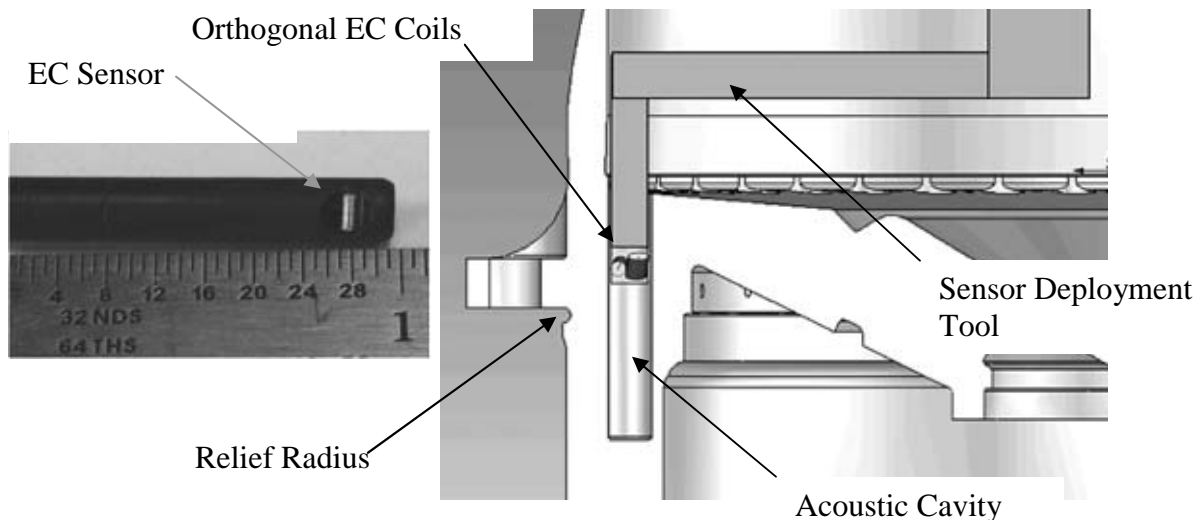
Figure 1 displays a photograph of the prototype eddy current (EC) sensor and a conceptual diagram of the eddy current inspection technique. Matched eddy current coils are arranged orthogonally to each other and scanned into the acoustic cavity of the thruster. In the conceptual diagram in Figure 1, the inspection coil on the left is arranged with its axis along the circumferential direction. This orientation enables a relatively deep field penetration with the small diameter coil required to fit into the acoustic cavity, and induces current in a direction that will have a strong interaction with cracking originating in the relief radius and growing towards the acoustic cavity. The second coil is arranged with its axis parallel with the axis of the acoustic cavity. This second coil is designed to provide a local reference for the inspection coil while minimally interacting with damage originating at the acoustic cavity.

**Figure 1.** Photograph of prototype eddy current sensor and schematic diagram of eddy current thruster inspection tool.

In order to interrogate beneath the surface of the acoustic cavity toward the relief radius, a low frequency excitation is required. An estimate of the required operating frequency can be found using the skin depth equation,

features such as lift-off and roughness of the acoustic cavity wall. Based upon the calculated skin depth and experimental data, 12 kHz and 100 kHz were chosen as standard operating frequencies for the inspection.

Initial testing performed with the sensor design shown in Figure 1 found a good sensitivity to nearly through-wall flaws, but damage that had not progressed to within approximately 0.020" – 0.040" of the acoustic cavity was difficult to detect due to the complex geometry of the part. The presence of varying material thickness, fuel passageways, and a potentially rough surface of the acoustic cavities was further complicated by the need to deploy the probe through the injector nozzle, past a narrow throat, and into the acoustic cavity for inspection. To minimize the combined effects of these attributes, a stepper motor controlled scanning system was incorporated into the inspection system. The stepper motor scanning system, designed in conjunction with NASA White Sands Test Facility, is deployed in the reaction chamber and rests on the face of the thruster. Once positioned, a pre-programmed scan of the sensor through the area of interest is performed. The use of the stepper motor scanning system significantly reduces lift-off effects associated with probe tilt and wobble, which are extremely difficult to control under hand scanning. In addition, the stepper motor scanner provides for indexed scanning such that eddy current response data can be plotted directly against location of the probe within the acoustic cavity. Probe responses associated with edge effects and varying wall thickness throughout the scan region can then be directly accounted for and filtered out, greatly enhancing the flaw detectability of the system.

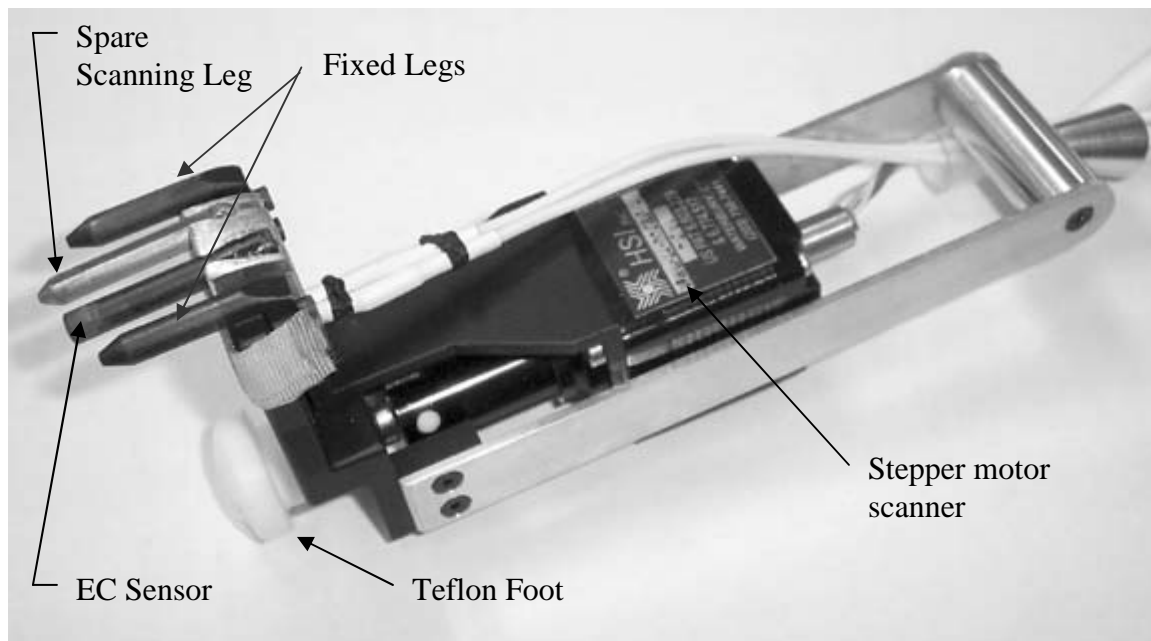
Figure 2 shows a photograph of the eddy current sensor attached to the stepper motor scanner. The eddy current coil pictured in Figure 1 is now mounted in a probe housing that is attached to the stepper motor. In addition to the eddy current sensor, the probe housing holds a second, spare, scanning leg. Two other, fixed legs are attached to the scanning system to provide mechanical stability during scanning. When the scanner is positioned within a thruster, the four legs are spaced to fit into adjacent acoustic cavities. After receiving a trigger signal the stepper motor pulls the probe housing (along with the

**Figure 2.** Stepper motor controlled eddy current PRCS thruster scanner.

eddy current sensor and spare scanning leg) away from the thruster face, moving the eddy current sensor through the region of interest. Immediately after withdrawing the probe the stepper motor reverses, moving the sensor once more through the region of interest and back to its start position.

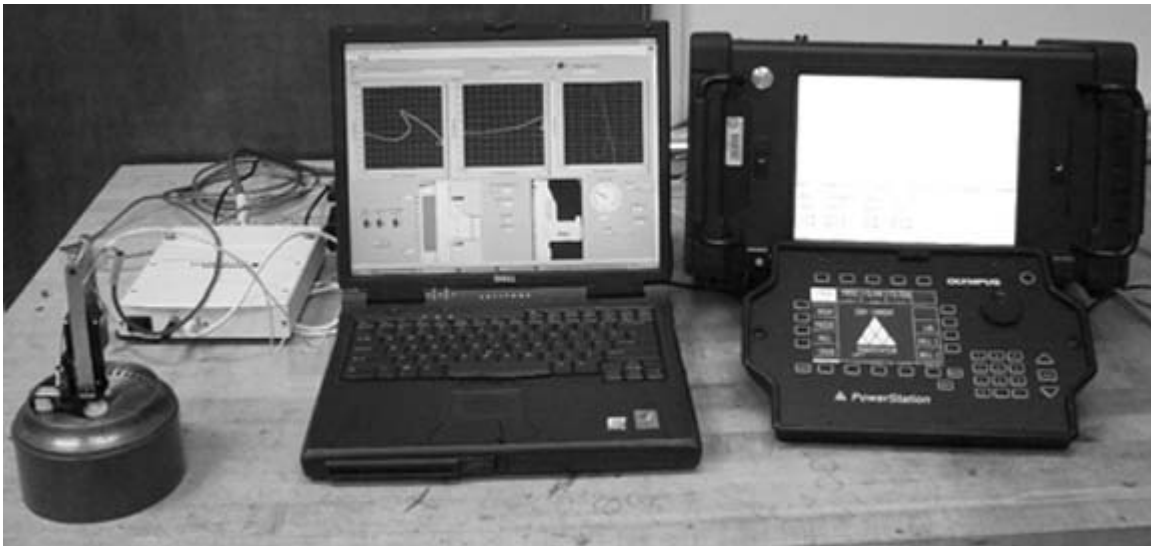
**Figure 3.** Complete eddy current PRCS thruster inspection system.

The complete eddy current PRCS thruster inspection system is pictured in Figure 3. Along with the eddy current sensor and scanner, the system consists of a dual frequency eddy current instrument, laptop computer, A/D converter, and custom software. The scanner is shown inserted into a thruster mock-up used for setup and calibration.

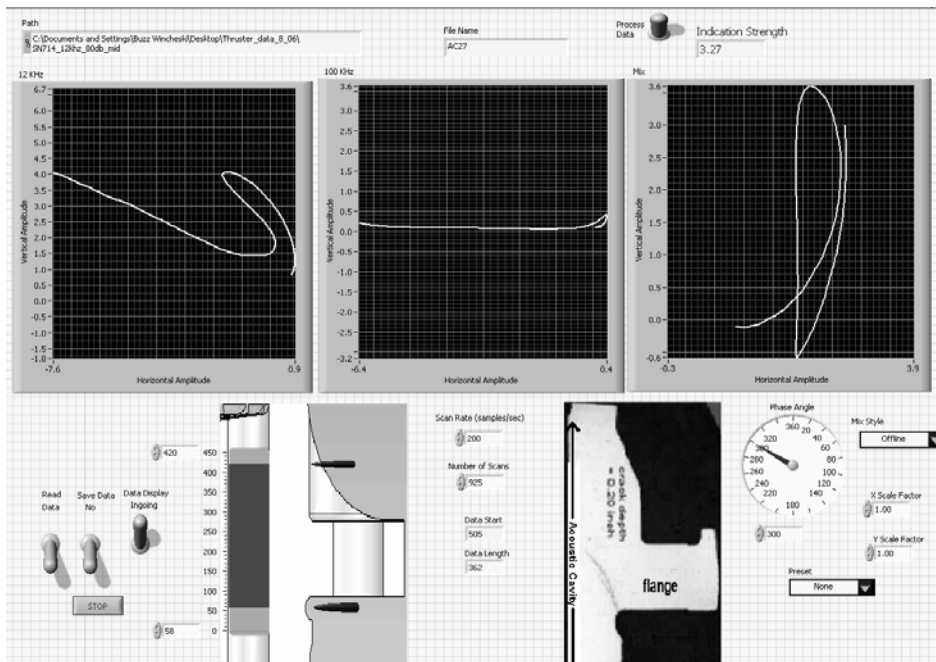
**Figure 4.** Front panel display of system control and data processing software.

kHz, and frequency mix (calculated as the difference between the 12 kHz and 100 kHz responses) are displayed. Figure 4 shows a close up view of the front panel of the system software with data acquired during an inspection of a notched reference standard with 0.020” remaining wall thickness between the notch and the acoustic cavity. The three plots from left to right across the screen display the 12 kHz, 100 kHz, and frequency mix results, respectively. The nearly through-wall flaw is clearly detected in the low frequency and mix signals, with a slight indication of the flaw apparent even at 100 kHz. Toggle and slide switches are incorporated to enable the plotting of data over any region within the complete scan range, as well as of data acquired during the outgoing or ingoing scan of the probe. Controls are also present to adjust the mix signal parameters for data analysis on the selected portion of the scan data. The front panel also contains a micrograph of a cracking site dissected from a PRCS thruster. The typical crack profile displayed in the micrograph is useful for interpreting the eddy current response in relationship to potential damage in the hardware.

A final feature to be noted on the front panel is the calculated “Indication Strength”, given in the upper right hand corner of the display. This value is calculated by fitting the eddy current response to the anticipated profile for the sensor scanned through an unflawed acoustic cavity region. Due to the edge effect as the probe nears the acoustic cavity opening, a sharp increase in the low frequency signal level is seen in this region. As the sensor moves into the cavity, a minimum in the low frequency vertical response is detected, most likely due to increasing wall thickness in this area. As the probe passes deeper into the cavity an increase followed by a final slight decrease in the probe output is detected. Subtracting the high frequency vertical component from low frequency vertical component helps to remove other artifacts, such that subsequent analysis is performed on this difference signal. Analysis of this signal profile has led to a signal processing technique employing curve fitting to a cosine modulated exponential function. The vertical component of the low frequency probe response minus that of the high frequency is fit to a curve of the form

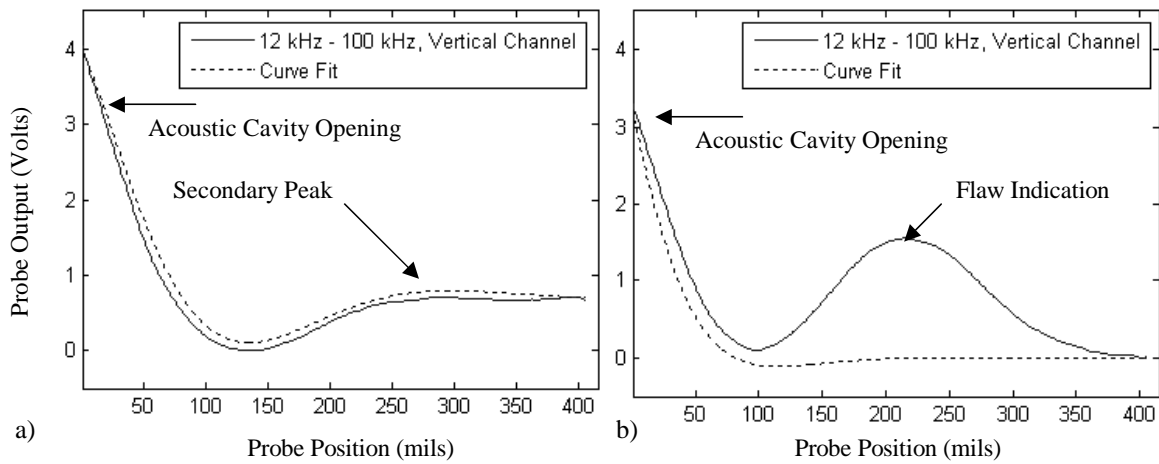
with  $L$  = the secondary peak location,  $x$  = scan position inside the cavity, and  $A$  = the curve fit parameter. The fit is also constrained to match the data at each end of the scan. Figure 5 displays the results of applying this curve fitting procedure to an unflawed acoustic cavity (left plot) as well as a region where a notch approaches an acoustic cavity to within 0.040” remaining wall thickness (right plot). The difference between the raw data and the curve fit highlights the flawed region in the plot on the right. This technique is particularly useful for flaws growing at a steep angle, projecting to an intersection of the acoustic cavity near the cavity opening. It has been found that a calculation of the peak amplitude in the plot of the difference between the curve fit and the raw data correlates well with remaining wall thickness between the acoustic cavity and damage originating in the relief radius area. This calculated peak amplitude is the “Indication Strength” displayed on the system software front panel.

**Figure 5.** Plot of curve fit results for (a) unflawed cavity and (b) cavity with notch approaching to within 0.040” of the acoustic cavity wall. Error between curve fit and raw data highlights flawed regions near the acoustic cavity.

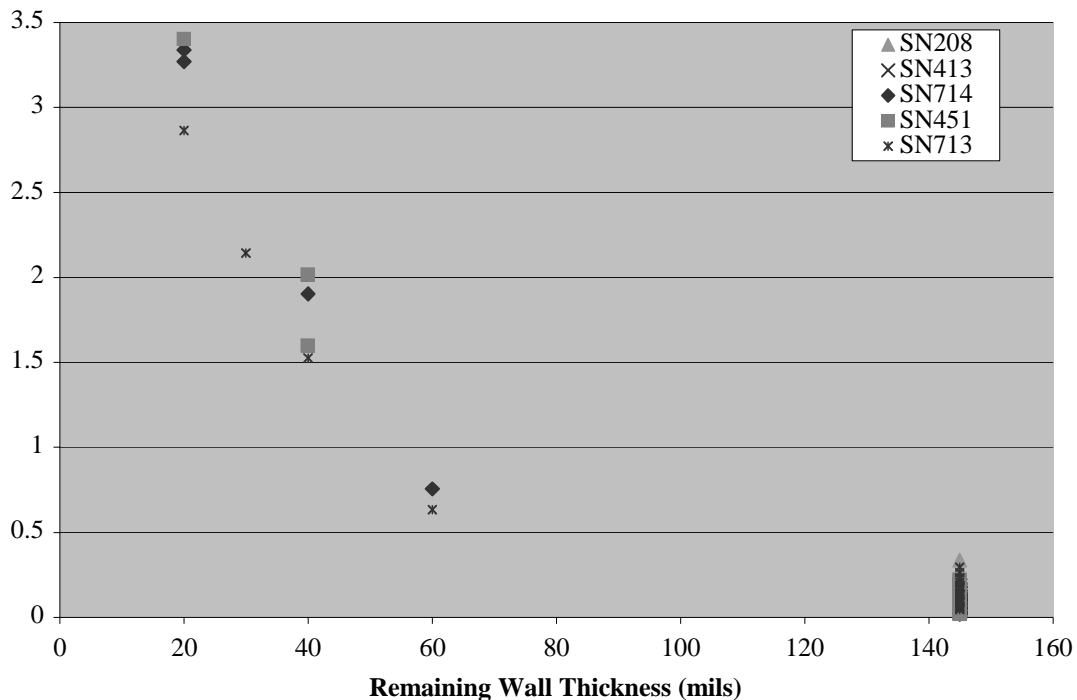
Figure 6 displays a plot of the calculated indication strength, as described above, versus remaining wall thickness between the acoustic cavity and relief radius. The data in Figure 6 was acquired on three thruster reference standards fabricated with electric discharge machine (EDM) notches and two non-flight (Class 3) thrusters. The EDM notch standards contained flaws at angles of 30, 45, and 60 degrees with remaining wall thicknesses of 0.020”, 0.030”, 0.040”, and 0.060”. There are no known flaws in the two

**Figure 6.** Calculated indication strength for all cavities with calibration notches originating across from the acoustic cavity as well as all unflawed cavities in PRCS thruster serial numbers 208, 413, 714, 451, and 713.

Class 3 thrusters. The minimum distance between the relief radius and the acoustic cavity in an unflawed thruster is roughly 145 mils, such that the cluster of points at that value in Figure 6 represents all of the inspected unflawed cavities, 170 sites.

Based upon the data depicted in Figure 6, a clear threshold can be established between unflawed thruster regions and areas with notches approaching to within 0.060” of the acoustic cavity wall. It should be noted that the data shown in Figure 6 corresponds to notches originating directly across from the acoustic cavity. As the eddy current coil is aligned in this direction, the sensor has maximum sensitivity for flaws in this orientation. As a part of the reference standard development, flaws originating at an off angle have also

Naturally occurring cracking in PRCS thrusters has also been studied. A limited number of cracking sites identified in the thruster inventory have been maintained for NDE development and system calibration. The indication levels from this naturally occurring damage have been found to be as high or higher than those for simulated damage using EDM notches. The likely cause for the increased signal levels on naturally occurring damage is the flaw profile. All naturally occurring damage sites identified to date have shown a very high aspect ratio of crack length to crack depth. The notch standards were all fabricated with a two to one aspect ratio, and therefore likely underestimate the crack length at a given remaining wall thickness. The natural crack profile with a long circumferential direction also makes the occurrence of deep cracking between cavities with little damage directly across from the cavity unlikely. It therefore is reasonable to anticipate flaw detection capabilities for naturally occurring cracking to be at least as reliable as those for the calibration data shown in Figure 6.
