NASA/CR-2007-214887

In-Service Evaluation of the Turbulence Auto-PIREP System and Enhanced Turbulence Radar Technologies

*Jason B. Prince, Bill K. Buck, and Paul A. Robinson
AeroTech Research (U.S.A.), Inc., Newport News, Virginia*

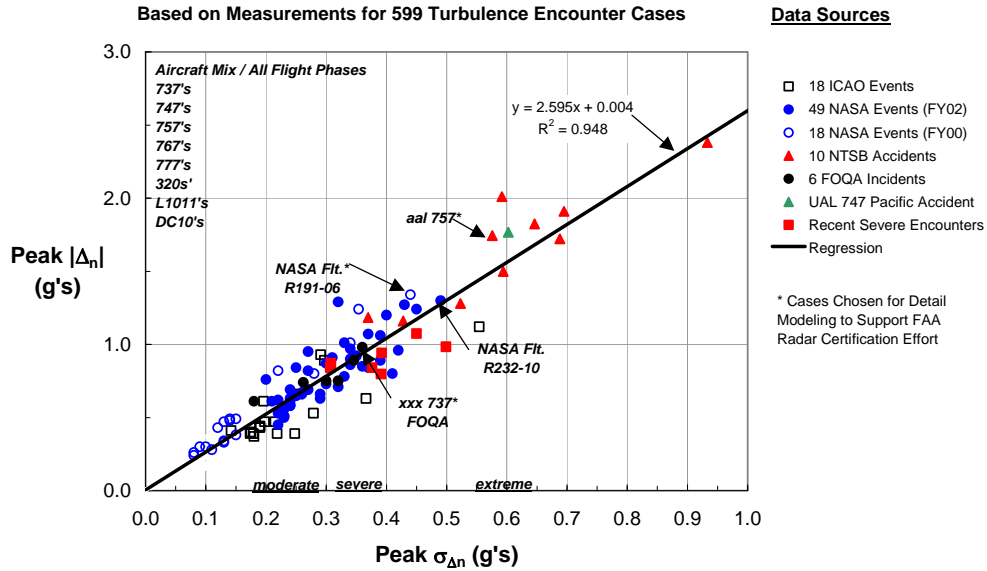
Figure 2: Correlation Between Peak Load and Peak $\sigma_{\Delta n}$ (5 sec. window)

By using the same hazard metric, TAPS and the E-Turb Radar outputs can be directly compared on a one-to-one basis as will be seen in Section 5. The $\sigma_{\Delta n}$ parameter can also be related to the peak accelerations experienced by an aircraft. Figure 2 shows turbulence encounters from historical flight data; including data collected during previous NASA flight tests, National Transportation and Safety Board (NTSB) accident investigations, and several other airline incidents and accidents. A linear regression applied to

this data yields a correlation of 95%. This data clearly demonstrates that the $\sigma_{\Delta n}$ parameter can be used as a surrogate for peak loads.

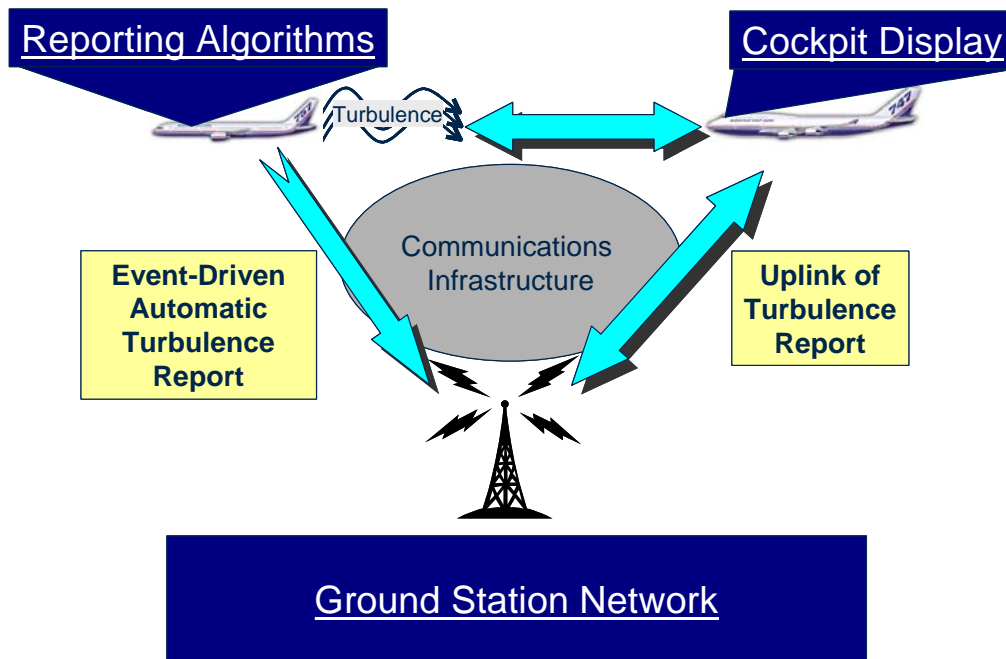
Figure 3: TAPS Architecture

The TAPS reporting algorithms consist of three components: hazard metric (σ_{An}) calculation, reporting logic, and report generation. The hazard metric is continuously calculated during flight. The reporting logic determines when a TAPS report should be generated. When the value of the hazard metric exceeds a particular threshold, a TAPS report is generated containing information on the time, location, aircraft flight conditions, and maximum accelerations experienced during the turbulence encounter. The report also contains a parameter that may be used to scale reports to other aircraft to determine the potential hazard to that aircraft. An additional benefit of TAPS is that the system would report any encounters when the aircraft exceeded the vertical load acceleration limits, defined by the aircraft maintenance manual, that require an airplane structural examination. A graphical depiction of the overall TAPS architecture is shown in Figure 3.

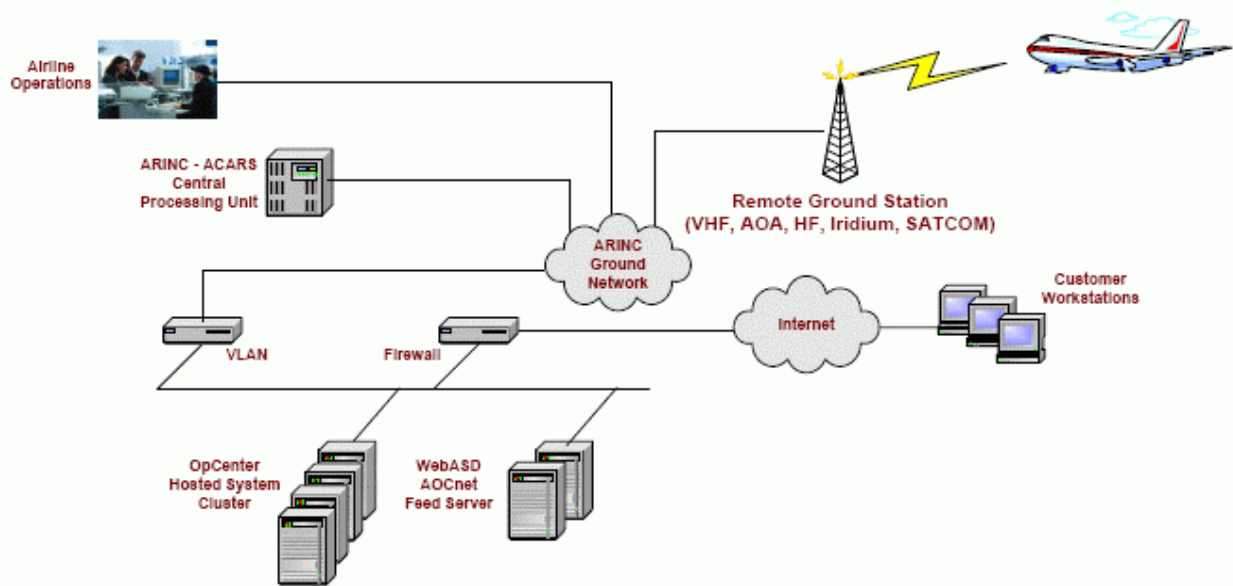
Figure 7: ARINC TAPS Air-Ground Communications System Architecture

Figure 7 provides an illustration of ARINC's TAPS Air-Ground Communications System architecture. Aircraft downlink TAPS reports to ARINC's ground network via one of several media (i.e., Very High Frequency (VHF), ACARS Over Aviation VHF Link Control (AOA), High Frequency (HF), Iridium, or Satellite Communications (SATCOM)). These reports are then forwarded to the ACARS Central Processor, which then routes them to the appropriate ground application. In the case of TAPS, these reports are forwarded to the OpCenterSM Hosted Messaging System, which extracts the TAPS information from the downlink, reformats the message, and forwards it to the WebASDSM application. WebASDSM processes this information into a form that can be displayed to the dispatcher and analyzed by engineering. Both dispatchers and engineers can access the WebASDSM application from the Internet or through dedicated ground circuits.

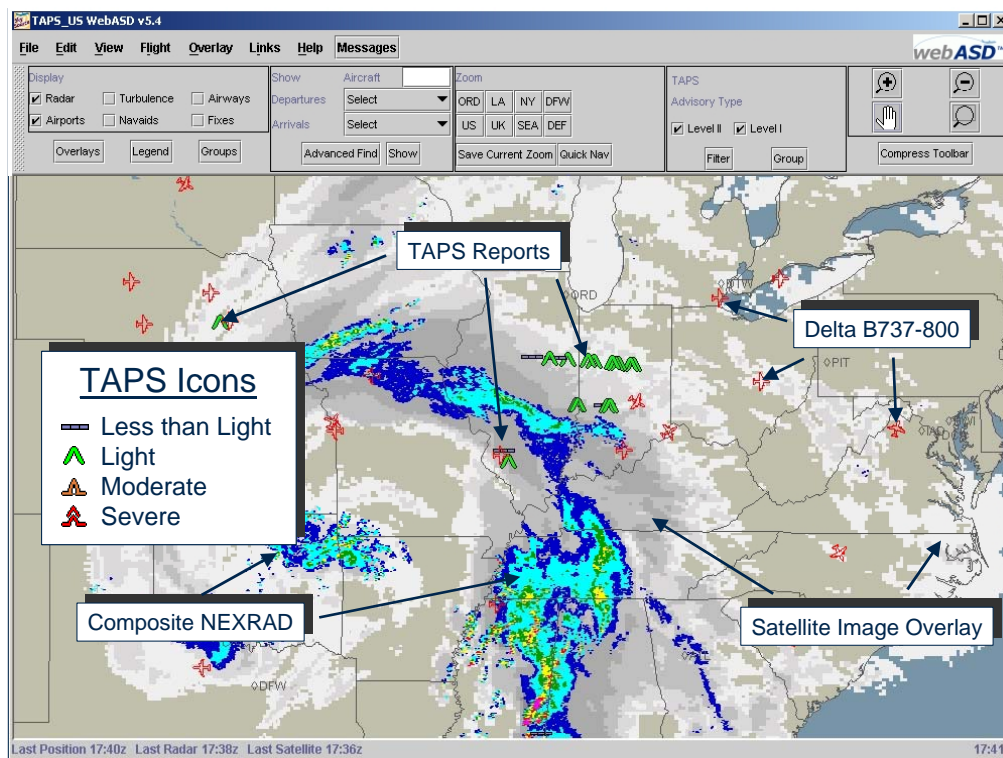
Figure 8: TAPS-WebASDSM Display

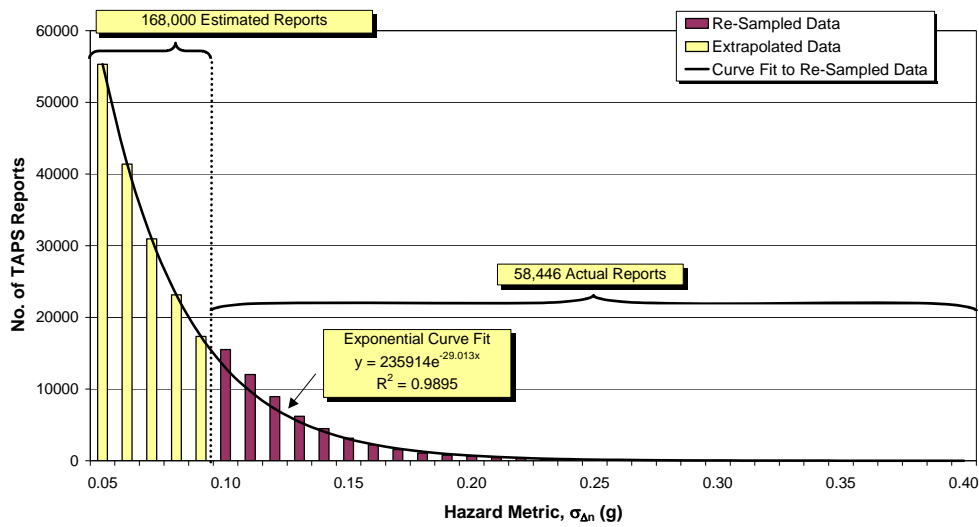
Figure 18: Curve Fit Applied to Re-Sampled TAPS Report Data

Summing the number of reports for each bin from 0.05g to 0.1g, it is estimated that an additional 168,000 TAPS reports may have been generated, which yields a 387% increase in the total number of reports. Using the timeframe of the ISE for which TAPS reports were collected, this averages out to an additional 53 TAPS reports per aircraft per month. Combining the extrapolated data with the ISE results, if the TAPS reporting threshold had been lowered from 0.1g to 0.05g, a TAPS-equipped aircraft may have generated approximately three TAPS reports per day. This volume of TAPS reporting is negligible when compared to the amount of data currently downlinked daily.

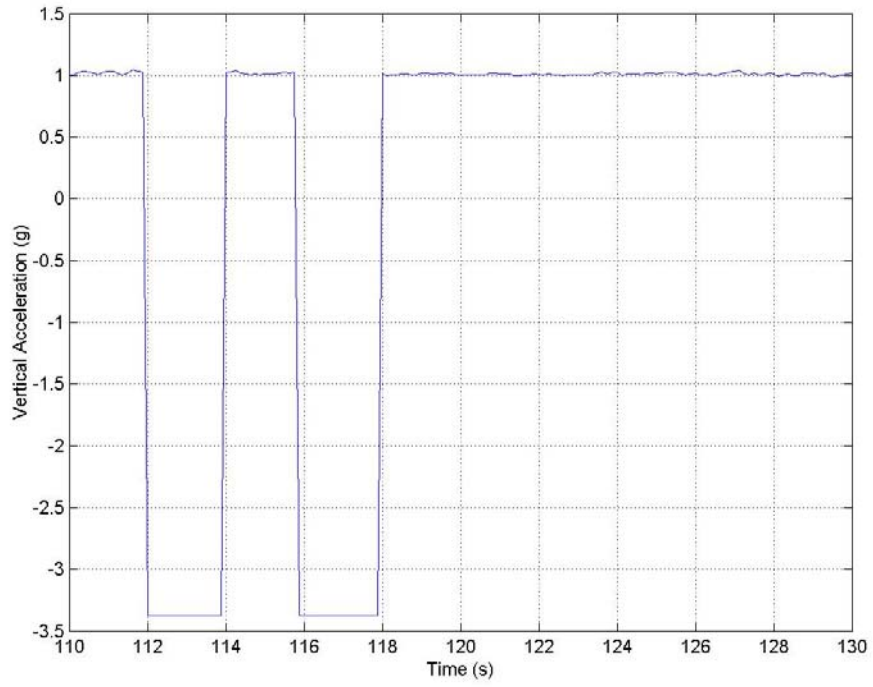
Figure 25: Databus Dropout in Vertical Acceleration

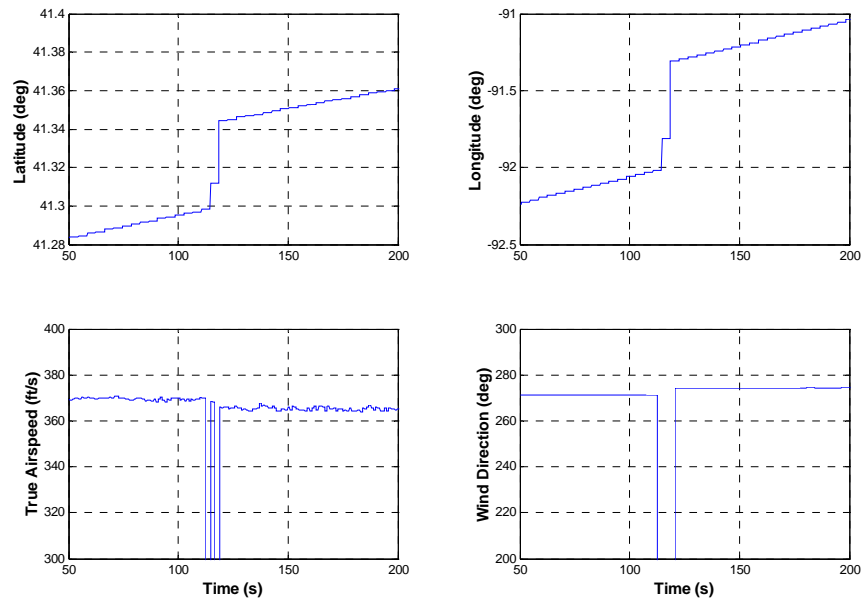
Figure 26: Databus Dropout Examples

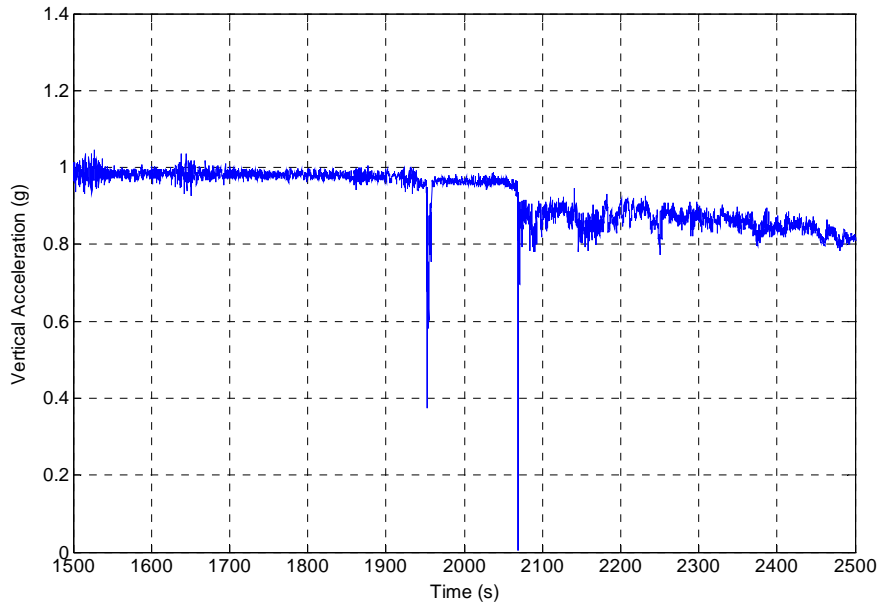
Figure 27: Example of Erroneous Sensor Data (Vertical Acceleration)

Incorrect sensor data also may occur intermittently and ranged from offsets or biases to unreasonable data (e.g., UTC time greater than 23:59:59, true airspeed equal to zero, etc.) to problems attributed to sensor wiring issues. Figure 27 shows an example of the vertical acceleration from a B767-300ER aircraft. From 1500 seconds to 1900 seconds, the accelerometer appeared to be functioning correctly even though the mean acceleration seemed to decrease. Between approximately 1920 seconds and 2075 seconds, the mean acceleration noticeably decreased by 0.02g. Dropouts in the accelerometer measurements could also be seen at 1950 and 2070 seconds. Following the second dropout, the mean acceleration had decreased by almost 0.1g and the signal continued to deteriorate. Eventually, the signal recovered to proper operation but this phenomenon frequently occurred throughout this flight. A clear explanation of the cause of this error was never determined. The identification of these issues resulted in improved awareness of the aircraft system's performance, since many of these sensor and databus problems would possibly have gone unnoticed until the aircraft's next scheduled maintenance.

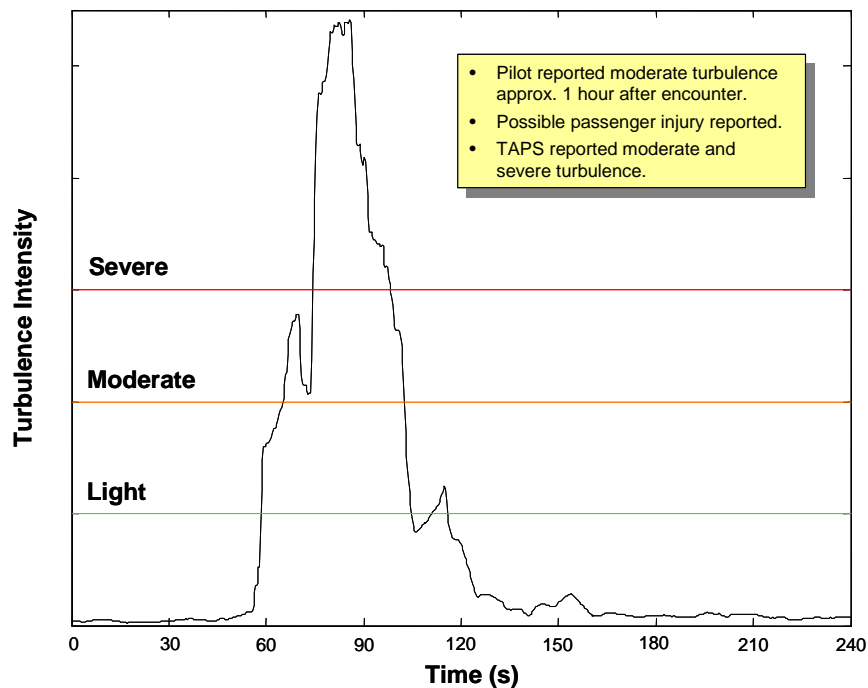
Figure 28: PIREPs vs. TAPS Underestimation

Figure 28 shows data from a flight in which the pilot reported a moderate turbulence encounter. This PIREP was sent approximately one hour after the actual encounter. It was also reported that the flight crew was investigating a possible passenger injury due to the turbulence. TAPS reported moderate and severe turbulence. Since the manual PIREP was made an hour after the encounter, it becomes less useful in improving the situational awareness of other aircraft in the vicinity. These aircraft could have possibly traversed that same region without ever being aware that a flight ahead of them encountered this level of turbulence.

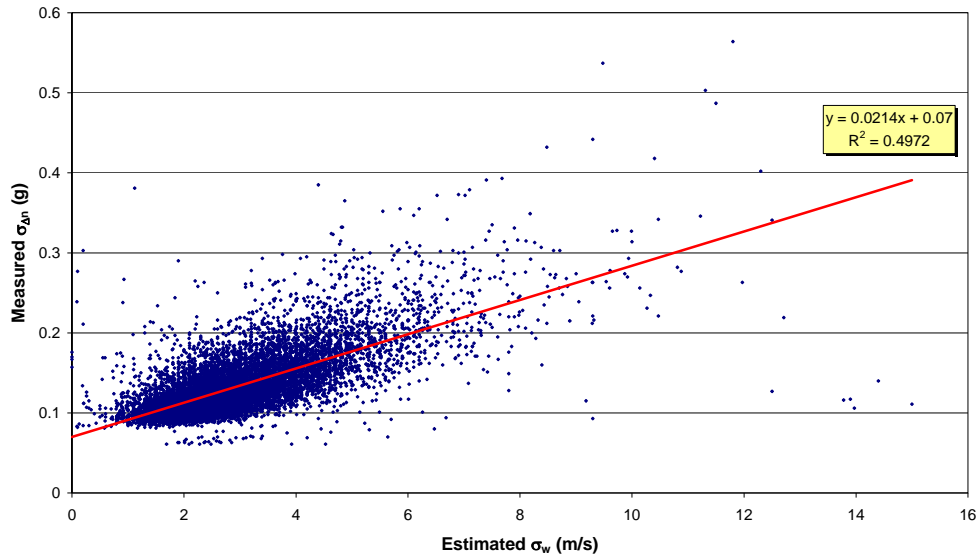
Figure 30: Comparison of Measured $\sigma_{\Delta n}$ to Estimated σ_w

During the B767 evaluation, whenever an aircraft encountered turbulence, a TAPS report was downlinked containing the maximum σ_{An} experienced and maximum σ_w calculated. A total of 12,545 TAPS reports generated from the B767-300ER/400ER aircraft fleets were used for this analysis. All of these reports are shown in Figure 30. A linear regression was applied to the data, and a weak correlation is evident between the measured σ_{An} and estimated σ_w .

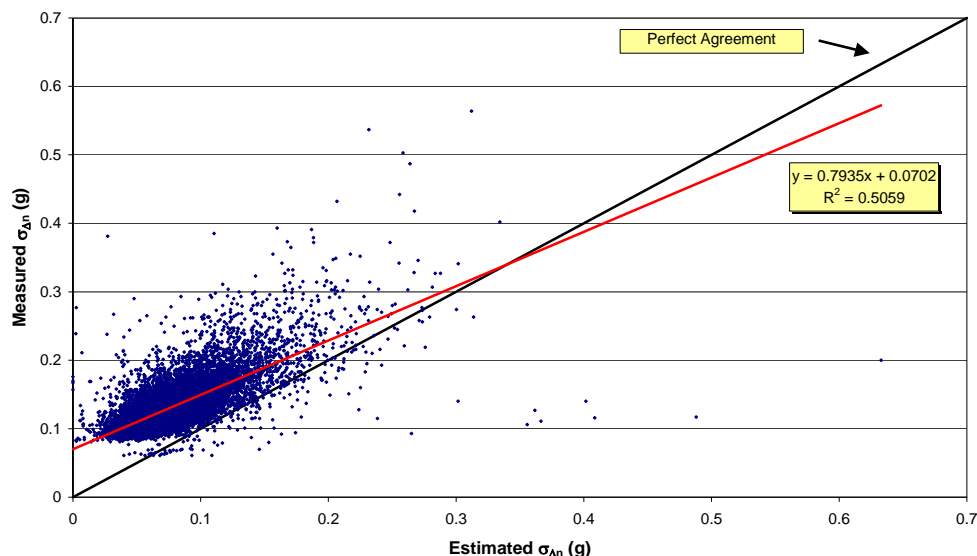
Figure 31: Comparison of Measured $\sigma_{\Delta n}$ to Estimated $\sigma_{\Delta n}$

This analysis suggests that an atmospheric parameter such as σ_w would not suffice as a surrogate for $\sigma_{\Delta n}$. AeroTech did not receive any flight data from Delta to investigate this further, and it was not possible to estimate the magnitude of the error.

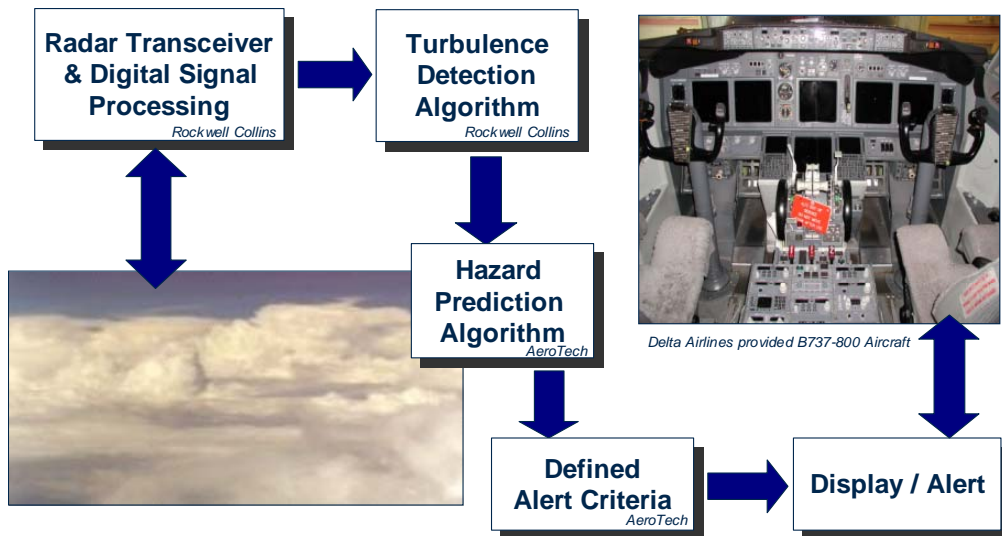
Figure 36: E-Turb Radar System Architecture

The evaluation of the new radar technology involved several new key features. The program saw the insertion of a new, highly automated WXR-2100 Multiscan™ transceiver technology that provides improved performance with many automated features and a 2nd moment detection algorithm with performance characteristics equivalent to the one successfully demonstrated in NASA flight experiments. The ISE is a direct transfer of the NASA hazard prediction algorithm technology and related hazard tables tailored to B737-800 commercial operations. Additionally, real-time estimation of the aircraft’s weight was interfaced with the radar system to support g-load prediction. A graphical depiction of the overall E-Turb Radar system architecture is shown in Figure 36.

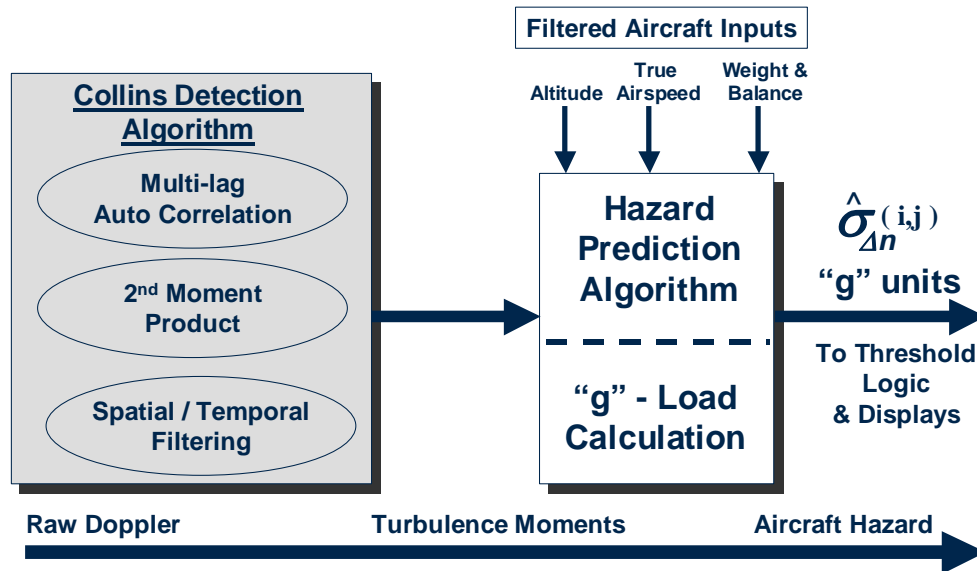
Figure 37: E-Turb Radar Technology System Concept

airspeed, and weight are used in the hazard prediction algorithm to scale the 2nd moment to a predicted $\sigma_{\Delta n}$. The E-Turb Radar features include a presentation of the predicted turbulence impact as a $\sigma_{\Delta n}$ (the same hazard metric used for TAPS).

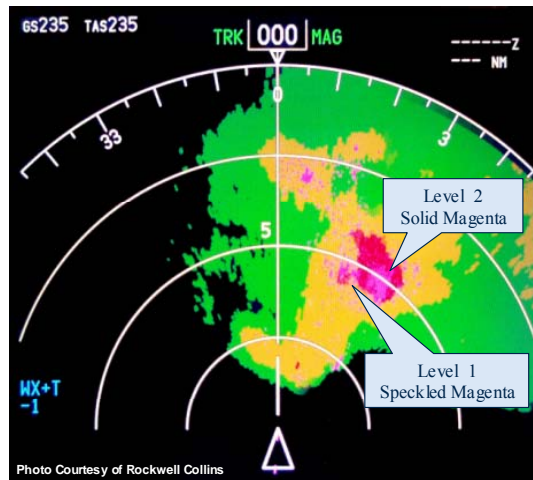
Figure 38: Cockpit Presentation of Turbulence by the E-Turb Radar

Figure 38 illustrates the two-level threshold presentation of the detected turbulence to an aircraft's crew.

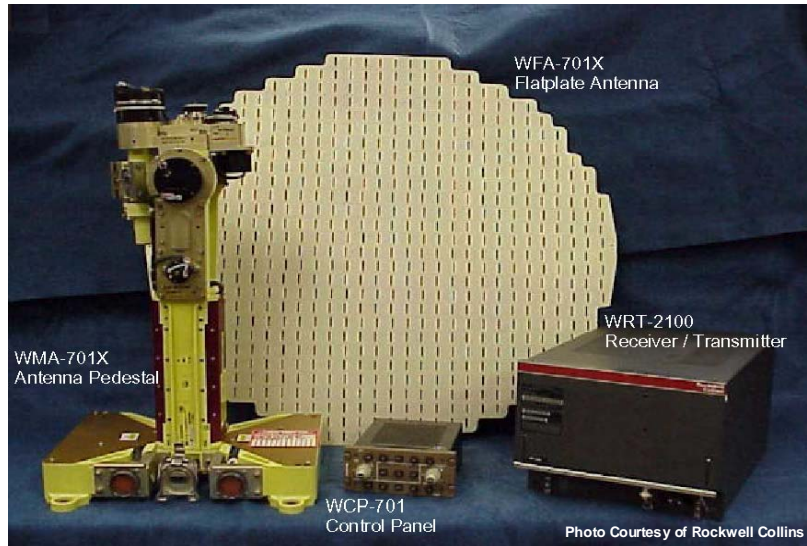
Figure 39: Rockwell Collins WXR-2100 Multiscan™ Radar

As part of the initial feasibility study conducted in August 2003 with Honeywell and Rockwell Collins, the Rockwell Collins WXR-2100 Multiscan™ radar was selected for the E-Turb development and the ISE. The components of the WXR-2100 Multiscan™ radar are presented in Figure 39.

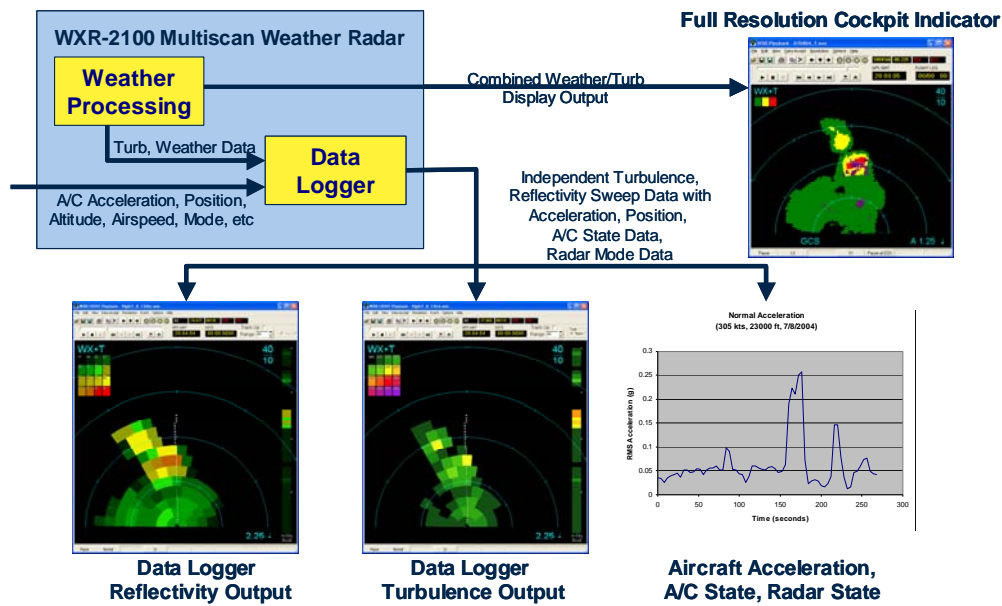
Figure 42: Integrated Radar Data Logger Stores Reflectivity and Turbulence Scan Data

mode data were recorded for accurate data evaluations. The spatial resolution of the radar display information (turbulence and reflectivity) was reduced in comparison to that displayed on the aircraft due to the memory limitations of the data logger hardware.

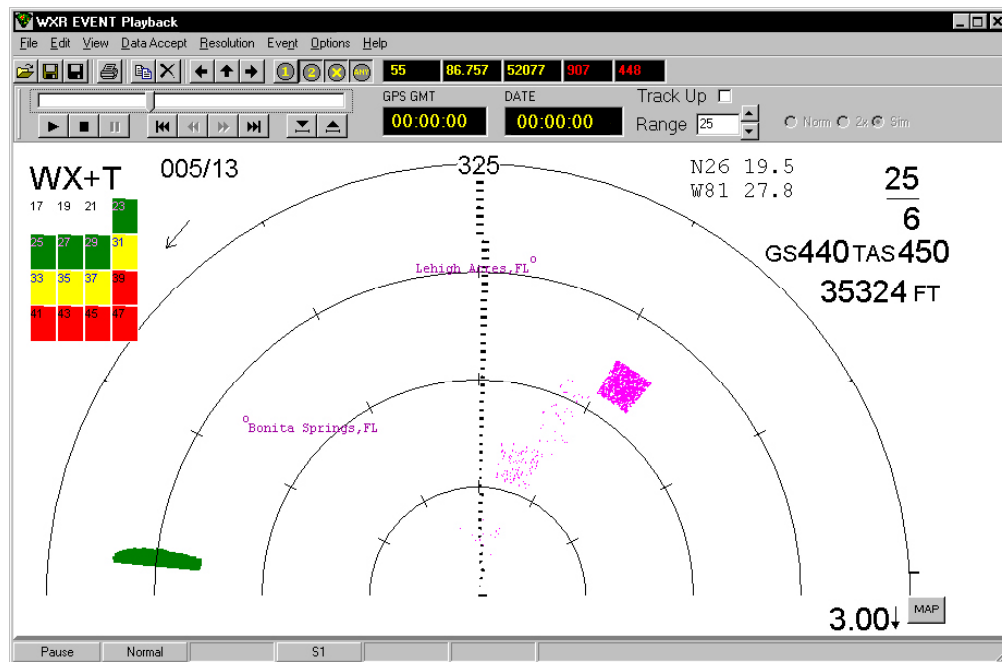
Figure 43: Representative DAL 3708 Encounter, Scan 55

Figure 43 shows the recorded radar display from a DAL 3708 flight. There are convective cells in the vicinity of the aircraft (denoted by the green region in the bottom left). The dotted line is the aircraft's subsequent flight path superimposed on the image. The radar has detected regions of light to moderate turbulence (speckled magenta – Level 1), and a region of greater turbulence intensity (solid magenta – Level 2). These regions were detected in areas of reflectivity less than 20 dBz, which is where normal radars show black or no reflectivity. In fact, in this case the reflectivity in the region of solid magenta was 4 dBz. This event is representative of historical accident cases where the pilot does not see a reflectivity signature on the radar display yet encounters significant turbulence. The E-Turb Radar was capable of detecting these types of hazards. Although the predicted region is not corroborated by the aircraft's penetration of the area, the statistical analysis presented later provides a significant level of confidence in this enunciation.

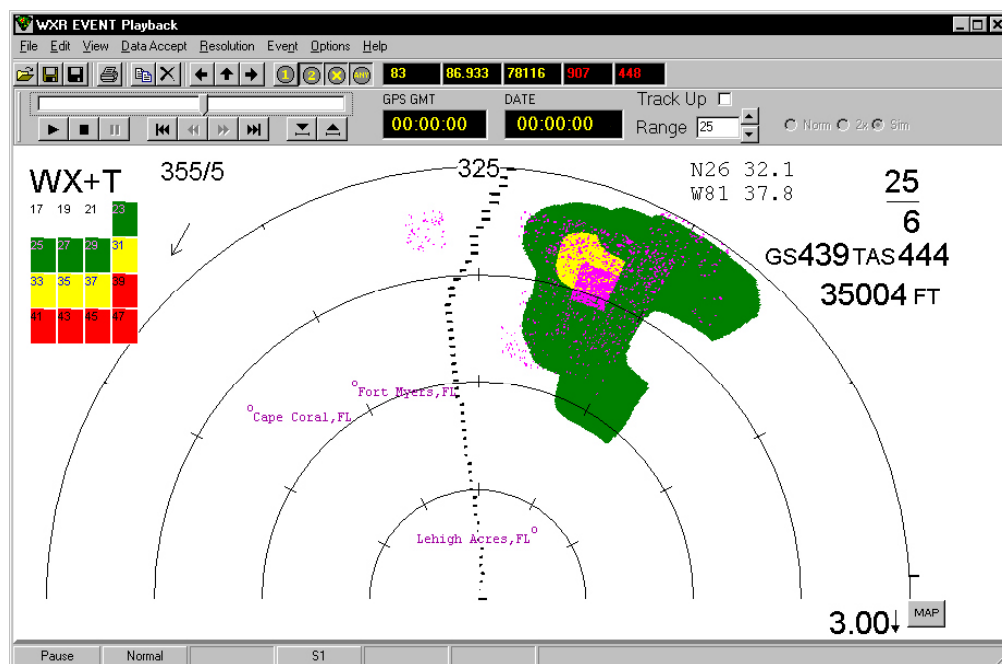
Figure 44: Representative DAL 3708 Encounter, Scan 83

Figure 44 below shows the aircraft's flight path deviating to the left to avoid a convective area clearly depicting turbulence directly ahead. Also depicted are regions of light to moderate turbulence (speckled magenta), one of which lies in the flight path. It was surmised (and supported by pilot feedback) that the pilot deviated around that region to avoid the encounter.

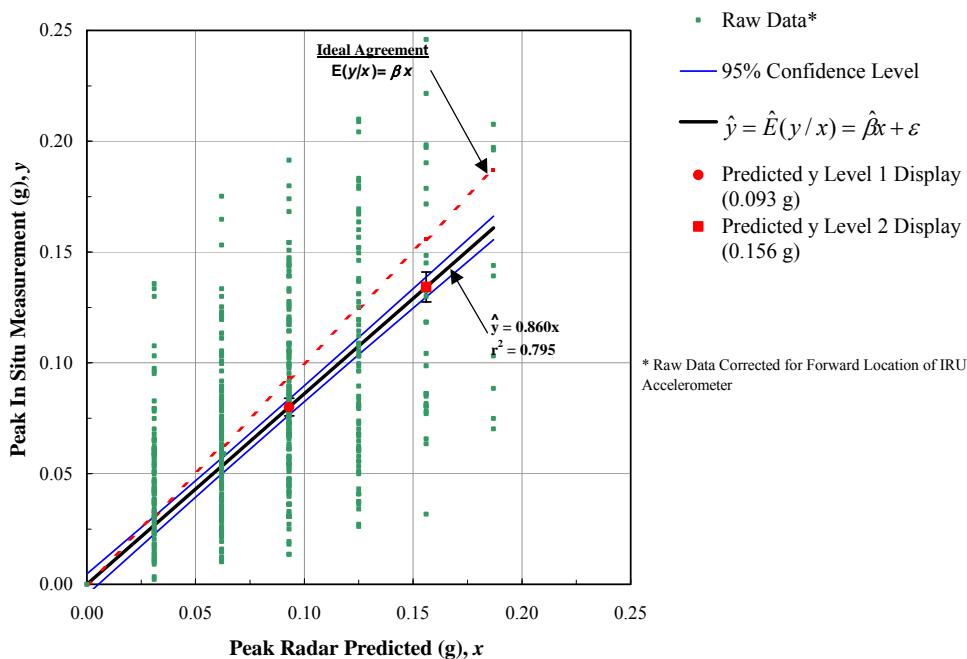
Figure 46: Correlation of Radar Predicted & In Situ Peak $\sigma_{\Delta n}$

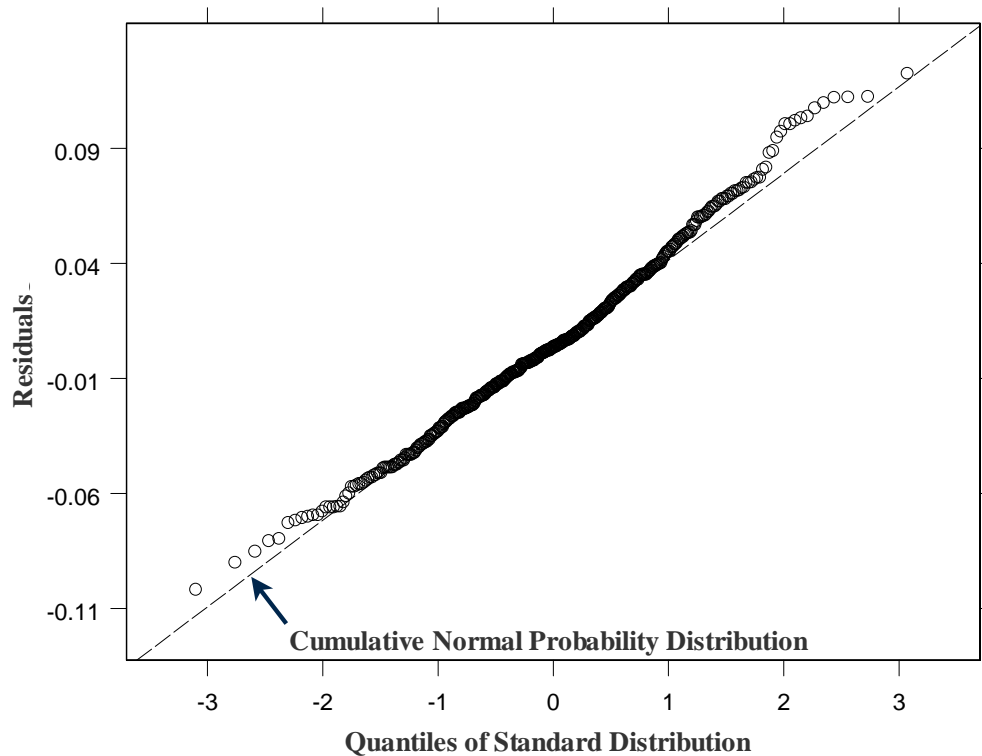
Figure 48: Quantile-Quantile Plot of Residual Errors vs. Standard Normal

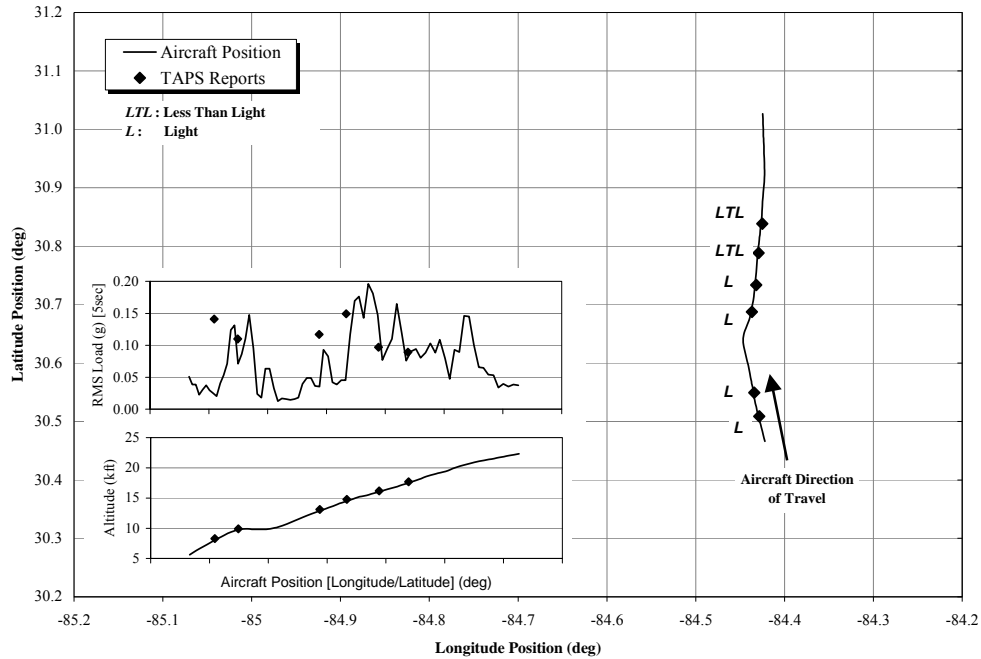
Figure 53: DAL 3708 Turbulence Encounter Day A-11, Event 42 Detailed View

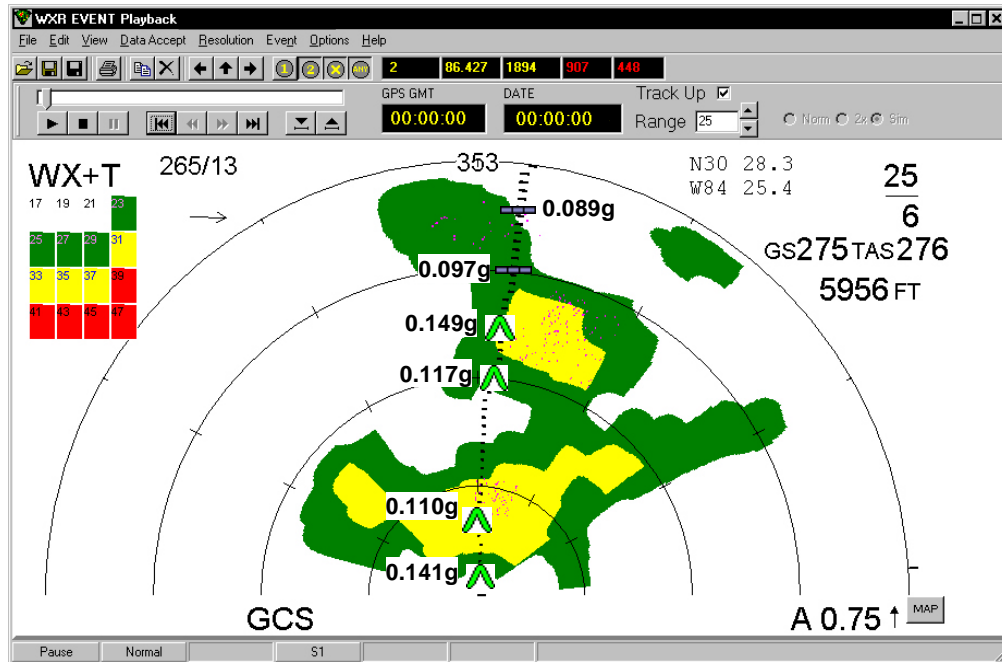
Figure 54: DAL 3708 Turbulence Encounter Day A-11, Event 42, Scan 2
