DYNAMIC MECHANICAL PROPERTIES AND FRACTURE SURFACE MORPHOLOGIES OF CORE-SHELL RUBBER (CSR) TOUGHENED EPOXY AT LIQUID NITROGEN (LN₂) TEMPERATURES

J. Wang, D. Magee, J.A. Schneider
Mechanical Engineering Department
Mississippi State University

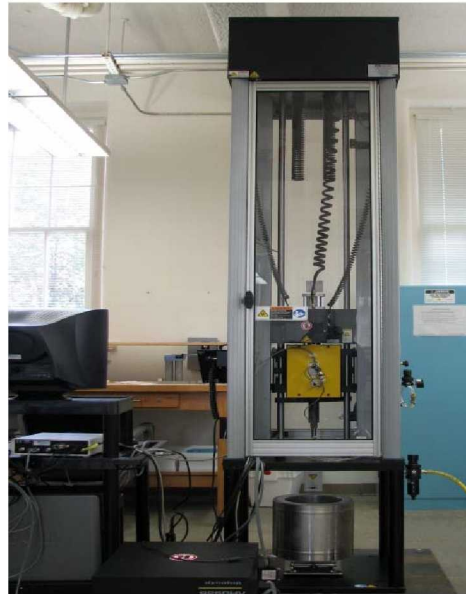
Figure 1. Overview of Instron Dynatup 9250HV Instrumented Drop Tower.

Dynamic impact tests were conducted using a Charpy fixture in an INSTRON Dynatup 9250HV Instrumented Drop Tower as shown in Figure 1. This apparatus is capable of impacting samples at energies of up to 826 J. For this study, all samples were impacted with a 6.9-kg drop weight. The samples were impacted with a 12.7-mm diameter tup, constructed with high-strength steel. Continuous data collection of the loads captured the impact event and allowed calculation of the absorbed energy. Unnotched specimens were machined from the cast 10mm thick sheets into 10mm×10mm×127mm specimen bars. Three to eight specimens were tested for the neat resin and for each CSR concentration to obtain the average R at ambient and LN₂ temperatures (77K). For the cryogenic temperature tests, the specimens were immersed in a LN₂ bath for 10 min to ensure a uniform temperature distribution. The tests were performed at a penetrator impact speed of 216 m/min, and a corresponding energy of 58 N-m. The R values were obtained from maximum absorbed energy divided by the fracture area according to ASTM standard D6110 [19].
