WIND-TUNNEL INVESTIGATION OF THE LOW-SPEED STATIC LONGITUDINAL
CHARACTERISTICS OF THE REPUBLIC RF-84F AIRPLANE

By Lynn W. Hunton, Roy N. Griffin, Jr.,
and Harry A. James

Ames Aeronautical Laboratory
Moffett Field, Calif.

Aug. 4, 1952

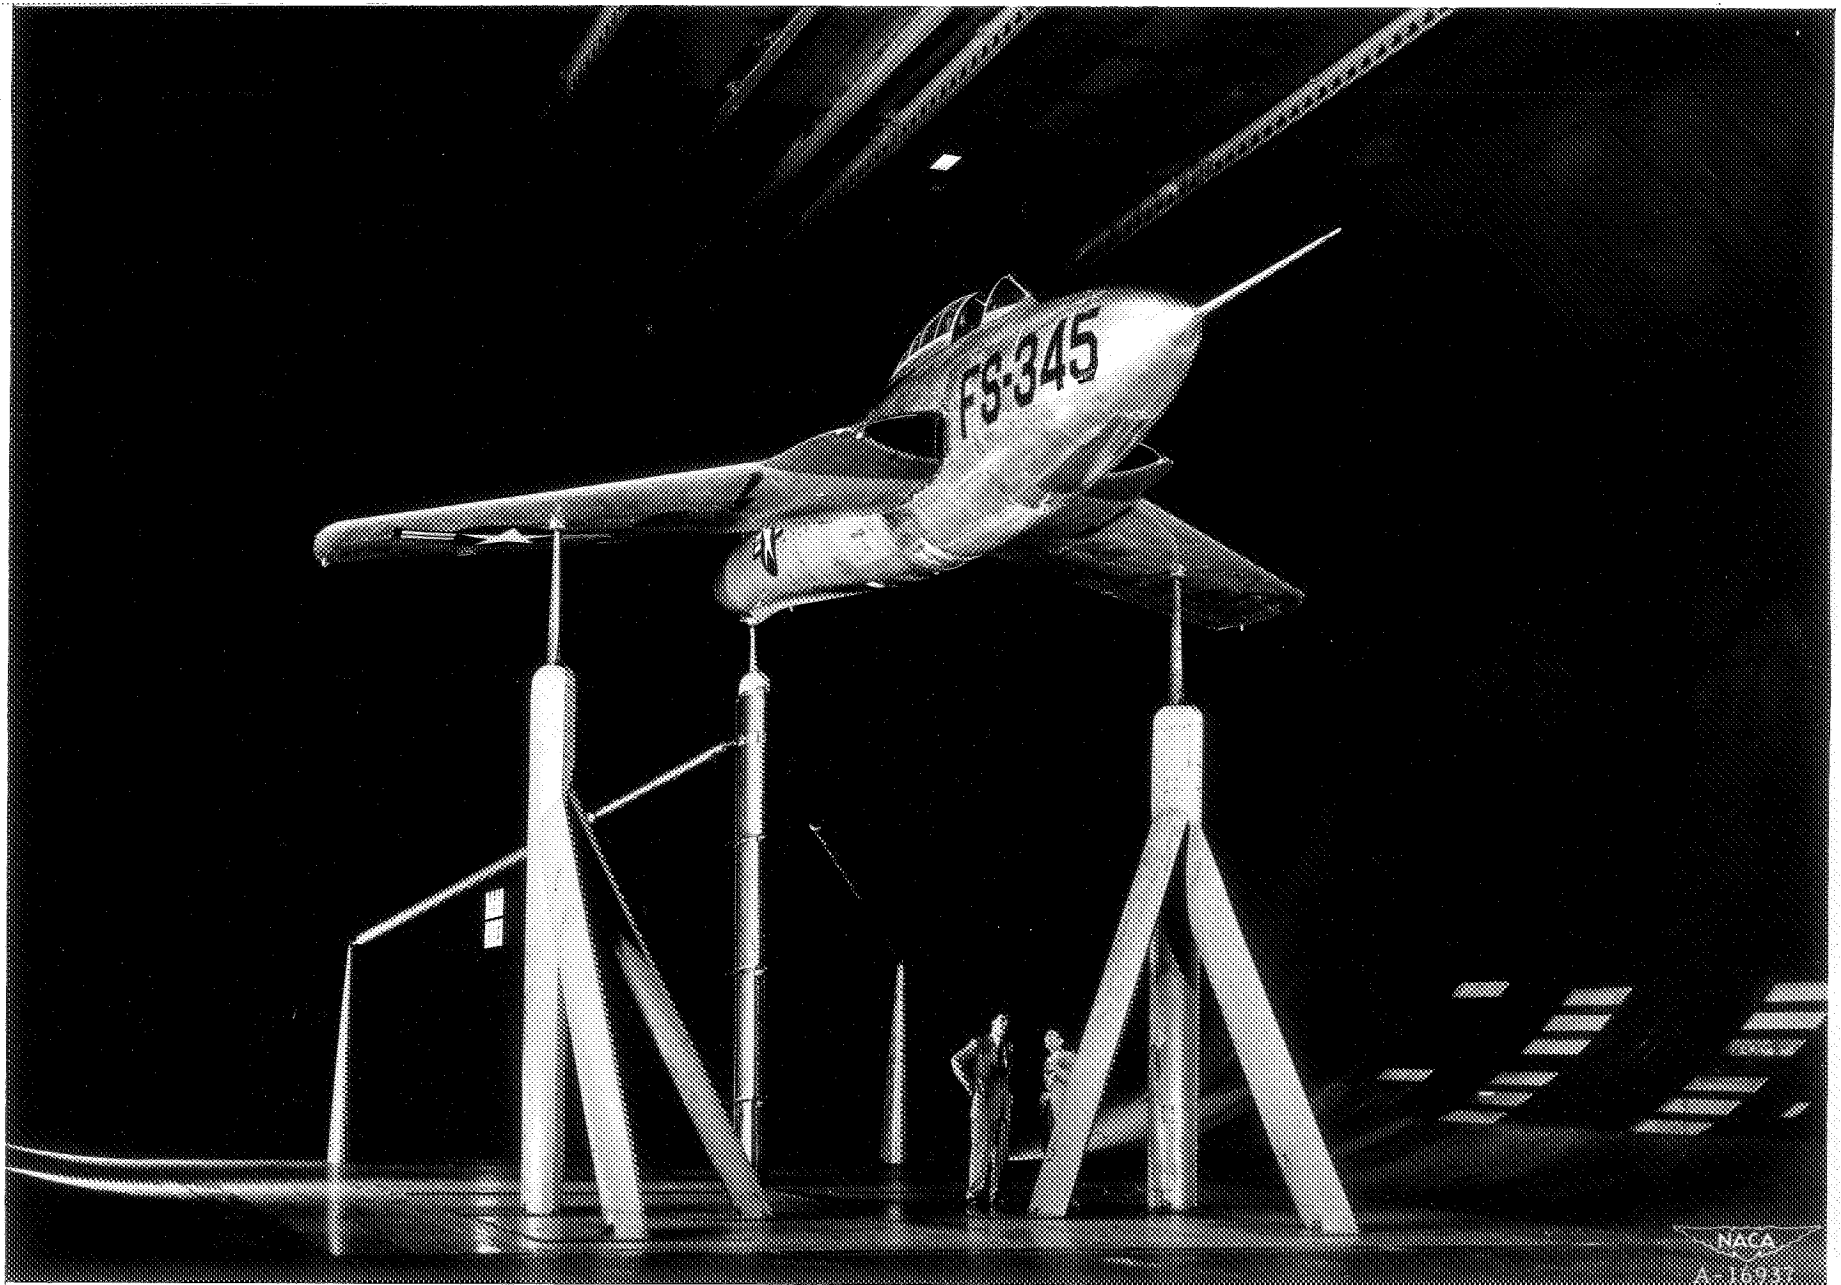
(b) F-84F. Configuration A₁-T.

Figure 2.- Concluded.

Dimensions of the Republic RF-84F prototype photo-reconnaissance airplane (No. 828) are given in table I and in the three-view sketch of figure 1. The airplane actually tested was the F-84F prototype fighter bomber (No. 345) which is identical to the RF-84F with the exception of the fuselage nose shape and the vertical tail size. The former difference is noted in figure 1. For the wind-tunnel investigation, simulation of the RF-84F was effected by modifying the fuselage nose of the F-84F to duplicate that of the RF-84F. In view of the interest in only the longitudinal characteristics of the airplane, the difference in vertical-tail size was ignored. Photographs of the test installations of the simulated RF-84F and the F-84F airplanes in the wind tunnel are shown in figure 2.

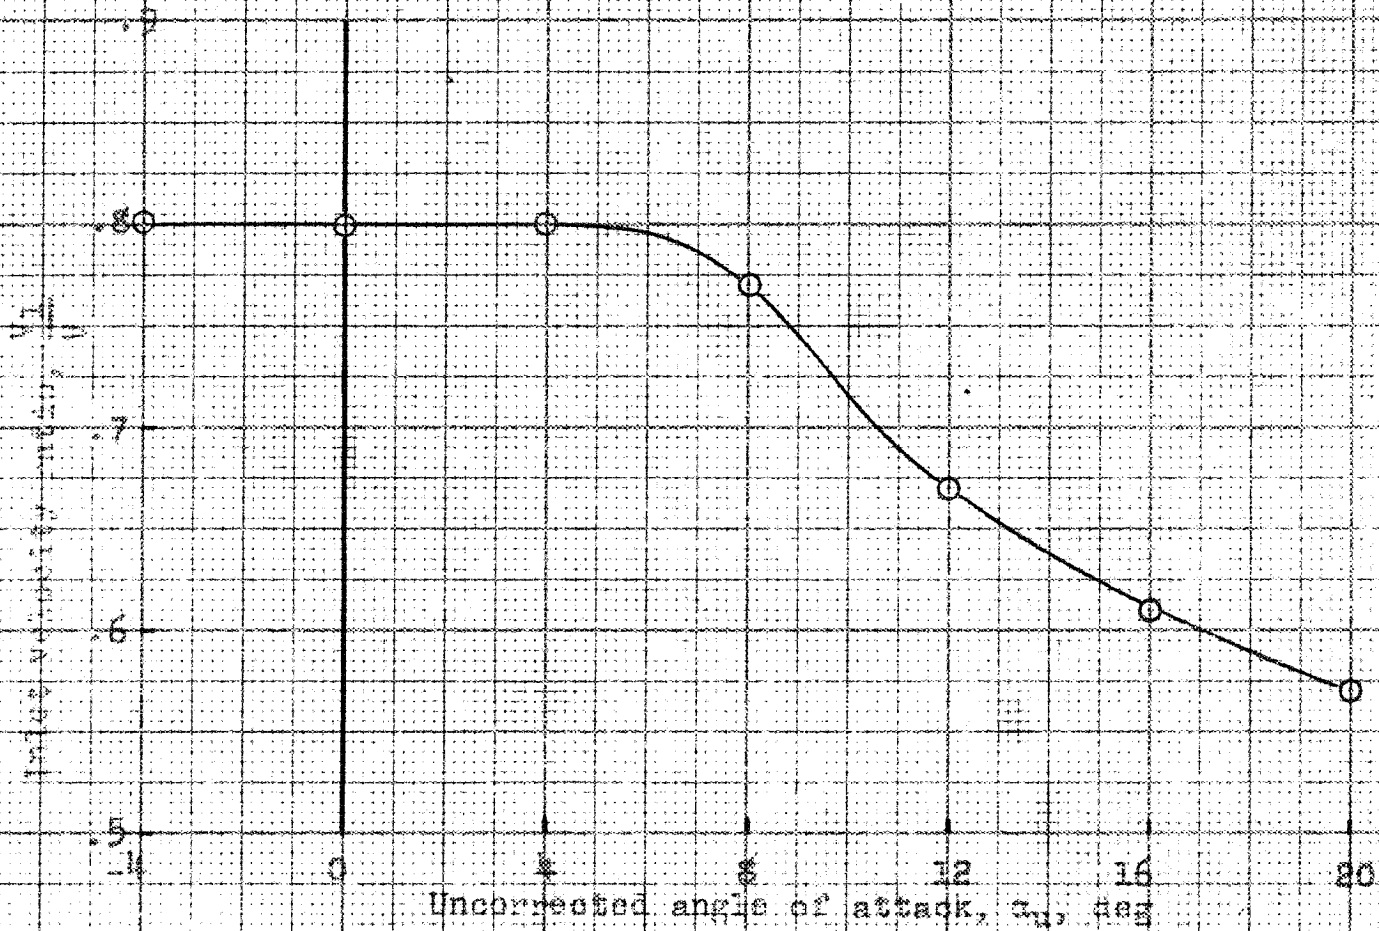
Figure 5. Inlet flow characteristics with engine removed. $V = 126$ mph

The inlet-flow velocity characteristics as a function of angle of attack are given in figure 5 for the airplane with the jet engine removed. Free flow through the air induction system at a test airspeed of 126 mph resulted in a maximum inlet velocity ratio of 0.8.

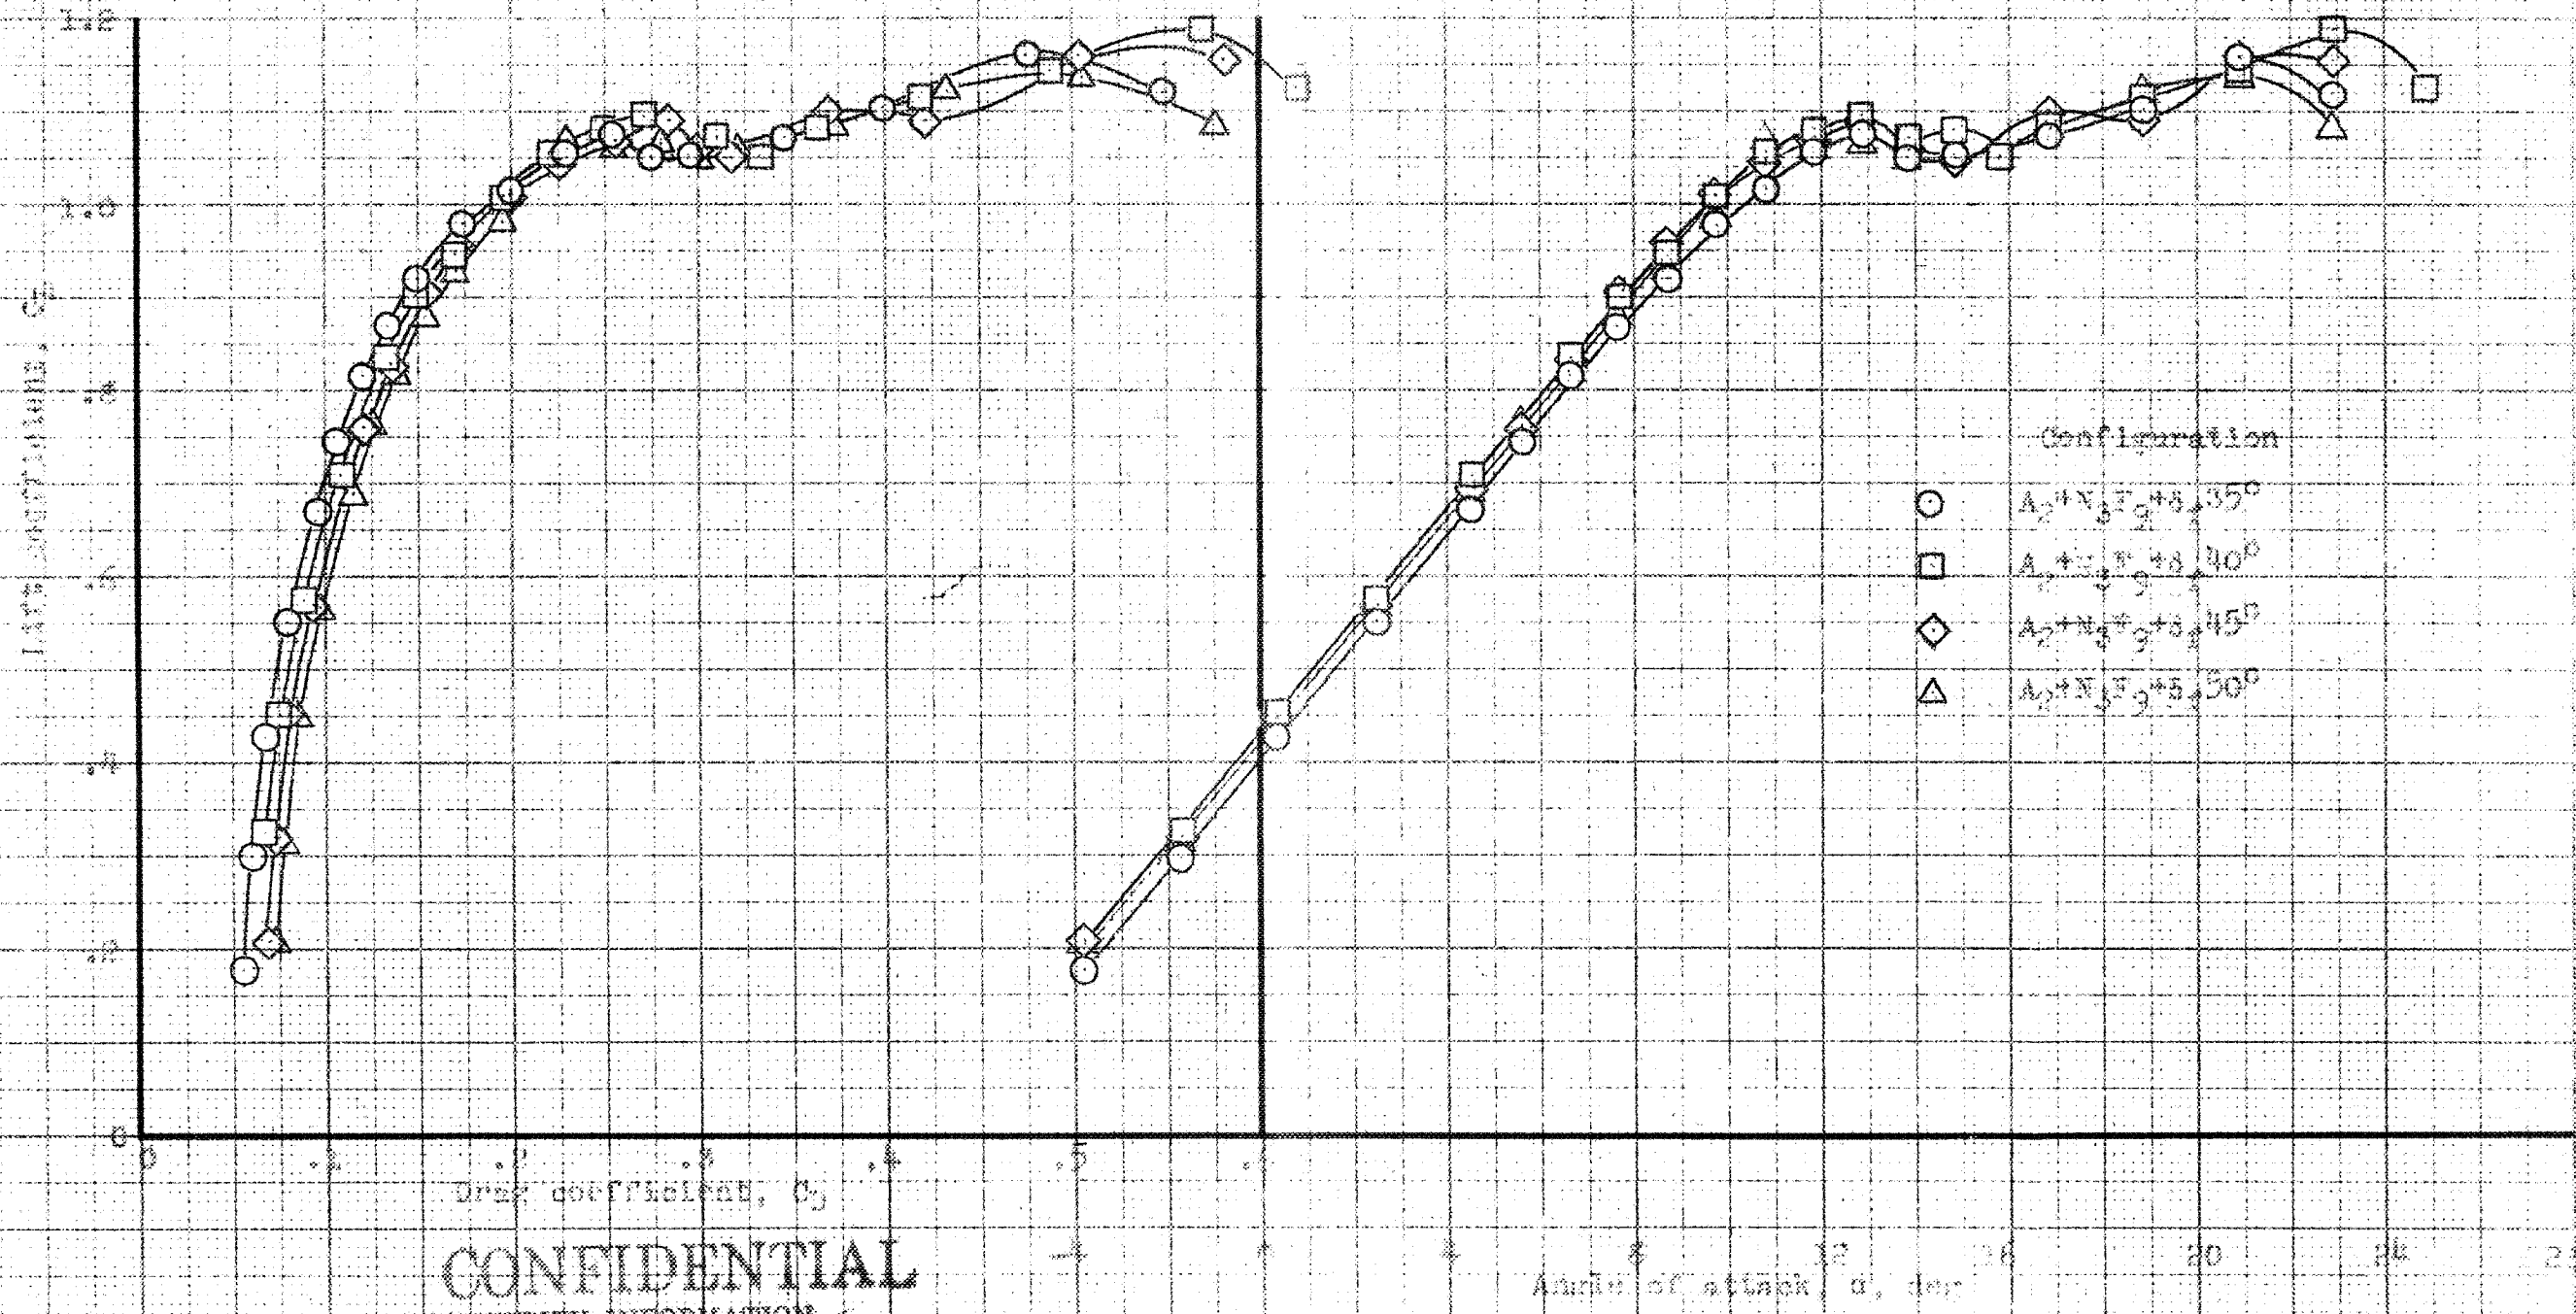
Figure 2. Lift and drag coefficients vs angle of attack for the configurations $\alpha_0 + 35^\circ$, $\alpha_0 + 40^\circ$, $\alpha_0 + 45^\circ$, and $\alpha_0 + 50^\circ$.

(b) q_L vs q_p .
Figure 27. - Concluded.

In figures 21, 22, and 23 are given the longitudinal force and moment characteristics of the airplane with several different flap angles, tail incidences, and elevator deflections, respectively.
