# Manufacturing & Prototyping

## Counterrotating-Shoulder Mechanism for Friction Stir Welding

## Strain Gauges Indicate Differential-CTE-Induced Failures

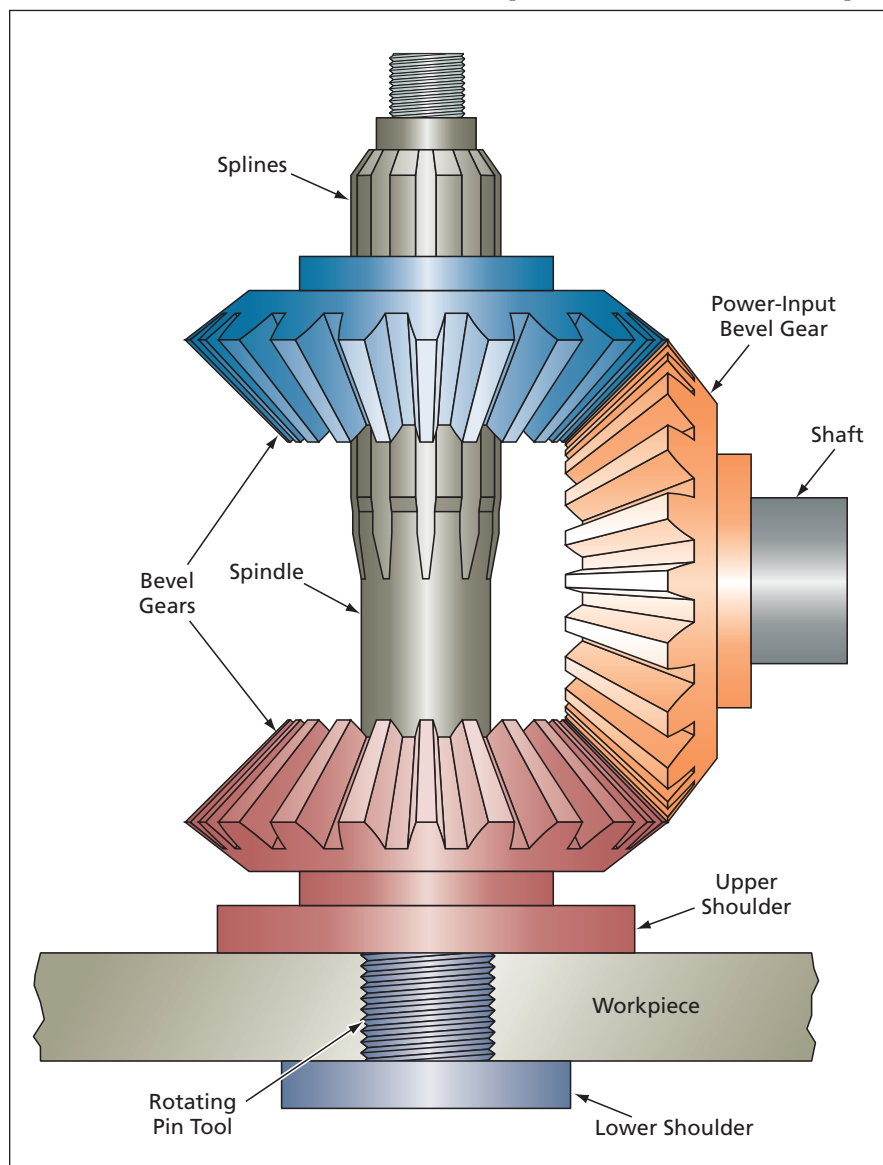
**Counterrotating Shoulders** would press on the workpiece in such a way that most of the large, localized applied welding torques and forces would be reacted within the mechanism rather than through external fixtures.

The proposed mechanism (see figure) would include a spindle attached to a pin tool with a lower shoulder. The spindle would be coupled via splines to the upper one of three bevel gears in a differential drive. The middle bevel gear would be the power-input gear and would be coupled to the upper and lower bevel gears. The lower bevel gear would be attached to the upper shoulder and would slide and rotate freely over the spindle. The spindle would be fastened by its threaded upper end to an external submechanism that would exert axial tension on the spindle to load the workpiece in compression between the shoulders. By reducing or eliminating (relative to the use of a "self reacting" tool) the torque that must be reacted externally, the use of the proposed tool would reduce the tendency toward distortion or slippage of the workpiece.

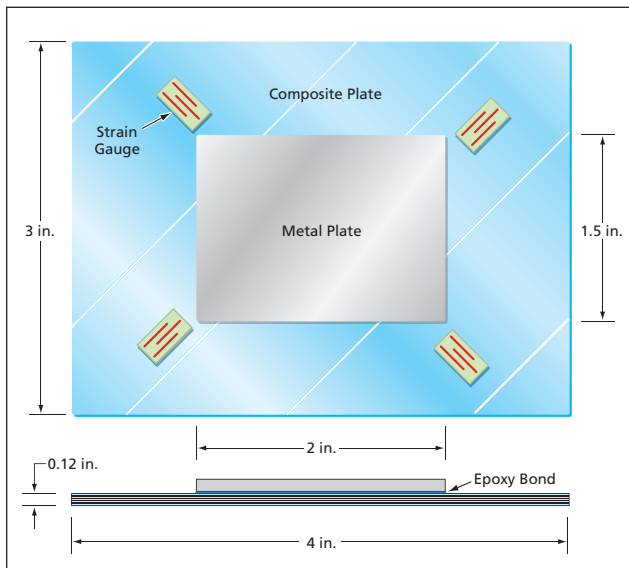
Figure 1. Strain Gauges Were Bonded to the composite plate near the corners of the metal plate because differential-thermal-expansion-induced stresses were expected to be large at these locations.

The method has been demonstrated in experiments on specimens consisting of polyacrylonitrile-fiber/epoxy-matrix laminated composite plates bonded by epoxy to smaller plates made, variously, of aluminum, titanium, and a low-CTE nickel/iron alloy. In preparation for each experiment, strain gauges were bonded, by use of cryogenic-rated adhesives, to the composite plate near the corners of the metal plate (see Figure 1). In each experiment, strain-gauge and temperature read-

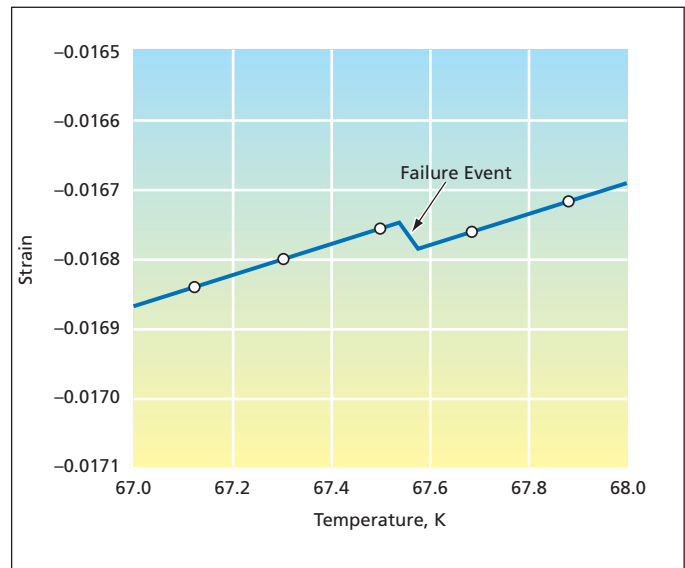
Figure 2. Part of the Strain-Versus Temperature Curve from one specimen includes a slope discontinuity indicative of a failure in the metal/composite bond region.

No failure events were detectable in the strain-gauge readings from the composite/titanium and composite/low-thermal-expansion-alloy specimens, and ultrasonic inspection of these specimens revealed no damage. However, failure events were seen in the strain-gauge readings from the composite/aluminum specimens (see Figure 2), and ultrasonic inspection confirmed that there was damage in the bond regions of these specimens.
