Boundary Layer Transition Protuberance Tests at NASA JSC Arc-Jet Facility

A series of tests conducted recently at the NASA JSC arc-jet test facility demonstrated that a protruding tile material can survive the exposure to the high enthalpy flows characteristic of the Space Shuttle Orbiter re-entry environments. The tests provided temperature data for the protuberance and the surrounding smooth tile surfaces, as well as the tile bond line. The level of heating needed to slump the protuberance material was achieved. Protuberance failure mode was demonstrated.

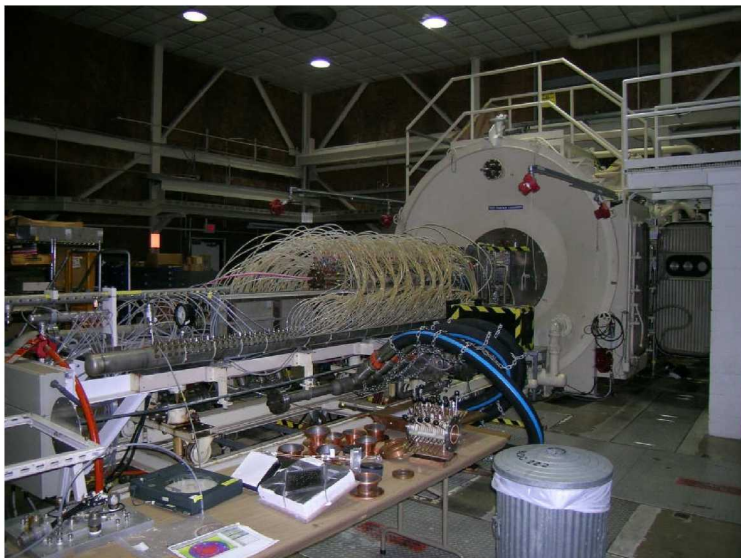
Figure 2. Photograph of TP1 showing components of the arc-jet facility.⁷

An isometric sketch of a typical channel nozzle test technique is presented in Fig. 1, showing the arc heater, nozzle, vacuum chamber, diffuser, and a Reusable Surface Insulation (RSI) test panel installed inside the chamber.⁶ Figure 2 presents a recent photograph of TP1 showing the vacuum chamber and the arc heater with gas and cooling water lines attached.⁷

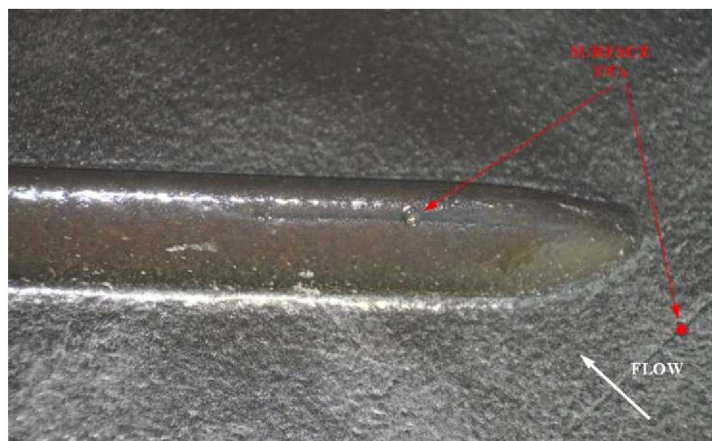
Figure 7. Post-test photograph of the 0.35-inch protuberance showing RCG coating discoloration and partially exposed thermocouple bead.

The test profile run with a 10-pack heater and a polished opposite wall generated just enough heating to the protuberance tip to produce a slumping onset. The post-test inspection revealed discoloration and some melting of RCG coating that partially exposed the protuberance thermocouple bead (Fig. 7). Figure 8 illustrates the amount of flattening of the protuberance tip characterized by the post-test analysis of the test model surface scans.⁸ The pre-test and post-test slices of the model surface scans were taken at an angle most suitable to best illustrate the shape change.

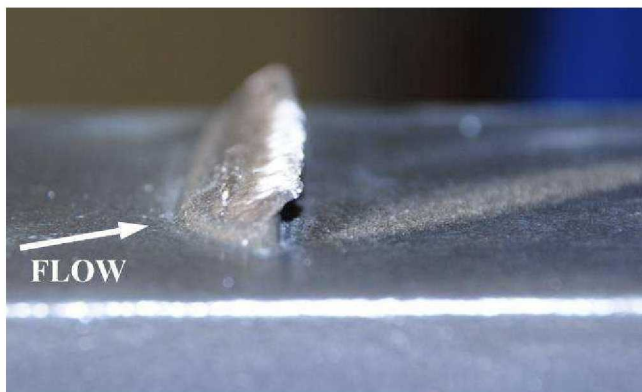
Figure 10. Post-test photograph of the slumped protuberance trip.

Polishing the opposite cold wall for test profile 4 resulted in an approximately 100-150 deg F increase in surface temperature which turned out sufficient enough to effectively demonstrate the protuberance failure mode. The protuberance thermocouple was lost 180 seconds into the test run. Monitoring the temperature difference between the upstream and the downstream smooth OML thermocouple suggested that the run be terminated at 520 seconds in order to prevent the possible overheating damage to the rest of the VCTA. Figure 10 illustrates the post-test condition of the protuberance trip. Along with the deformed protuberance shape, a scorch mark on the RCG coating can be seen downstream of the protuberance.
