(Preprint) AAS 10-085

## LAUNCH AND COMMISSIONING OF THE LUNAR RECONNAISSANCE ORBITER (LRO)

The Lunar Reconnaissance Orbiter (LRO) launched on June 18, 2009 from the Cape Canaveral Air Force Station. LRO, designed, built, and operated by the National Aeronautics and Space Administration (NASA) Goddard Space Flight Center in Greenbelt, MD, is gathering crucial data on the lunar environment that will help astronauts prepare for long-duration lunar expeditions. To date, the Guidance, Navigation and Control (GN&C) subsystem has operated nominally and met all requirements. However, during the early phase of the mission, the GN&C Team encountered some anomalies. For example, during the Solar Array and High Gain Antenna deployments, one of the safing action points tripped, which was not expected. Also, the spacecraft transitioned to its safe hold mode, SunSafe, due to encountering an end of file for an ephemeris table. During the five-day lunar acquisition, one of the star trackers triggered the spacecraft to transition into a safe hold configuration, the cause of which was determined. These events offered invaluable insight to better understand the performance of the system they design

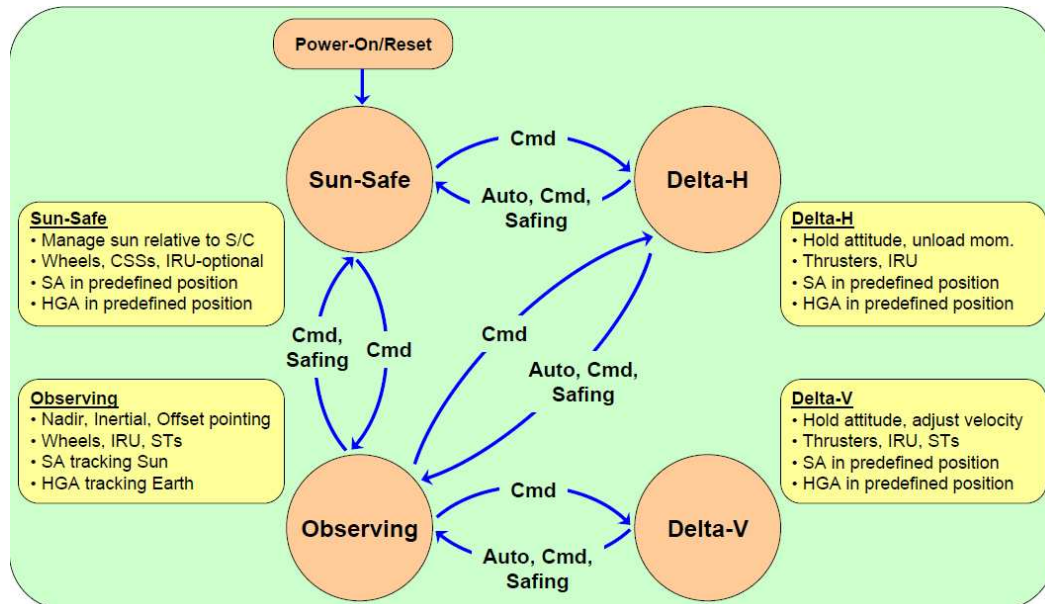
LRO's GN&C subsystem is made up of an onboard attitude control system (ACS), a collection of software algorithms based on high level and derived requirements, and a hardware suite of sensors and actuators. Figure 2 shows the LRO control modes, a brief description of their functions, hardware required and the transitions between each mode. Transitions are defined as automatic based upon defined criteria (Auto), commanded from ground or onboard algorithm (Cmd), or as the result of an anomaly (Safing). A discussion of each control mode and the hardware suite follows.

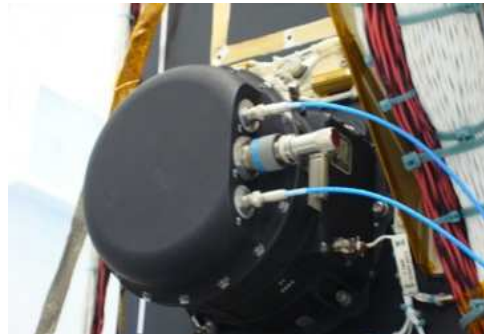
Honeywell's Miniature Inertial Measurement Unit (MIMU) serves as a single IRU. It contains 3 ring-laser gyros (one gyro per axis) that are used to produce spacecraft inertial body rates.

This unit outputs an accumulated angle, which is sampled by the onboard system at 10 Hz and differenced to produce the body rates. These 10 Hz rate estimates are averaged over two samples to provide a rate for use in the feedback loop at the ACS cycle time of 5 Hz. Due to accumulated angle roll-over ambiguity, the MIMU gyros provide only direction of spin but not the magnitude of the attitude rate for rates above a saturation level. For LRO the IRU saturation level is 18 deg/sec. The MIMU was turned on prior to launch and, has performed flawlessly in continuous operation during the LRO mission.

**Figure 4. MIMU mounted on LRO**

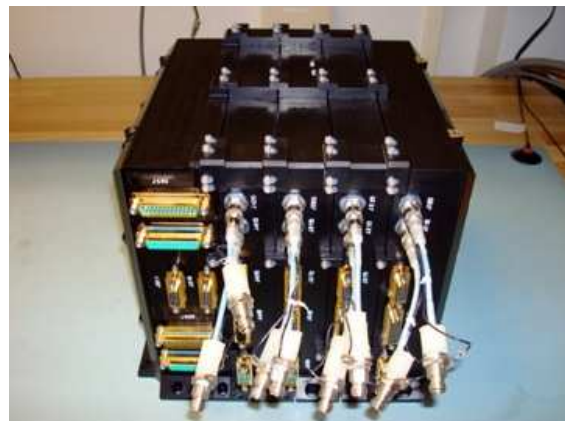
**Figure 6. PDE**

The Propulsion Deployment Electronics (PDE) has a number of functions used to complete the LRO mission. First, the PDE commands the firing of the thrusters when desired as well as firing of the Propulsion NASA Standard Initiators (NSI) for opening of the propulsion pressurization tank. During the Solar Array (SA) and High Gain Antenna (HGA) deployment, the PDE is used to turn on the Non Explosive Actuators (NEA). Additionally, the PDE prevents the radio frequency transmitters from functioning until launch vehicle fairing separation, and provides extra switch capabilities for science payload heaters. This component was designed to allow the propulsion system to have redundant drive electronics to support the redundant set of thrusters. The PDE is designed

to have redundant drive electronics to support the redundant set of thrusters. The PDE is designed

with four identical electronic boards and one module for the prevention of certain spacecraft functions at the desired times.

The design of the four PDE electronic boards allows for the critical Lunar Orbit Insertion (LOI) maneuvers to be completed, even if one of the four identical electronic boards is declared suspect. Each of the four electronic boards has their own 1553 remote terminal address. The thrusters are connected to electronic boards in a manner that allows LRO to complete its desired orbit adjustment despite a thruster failure.

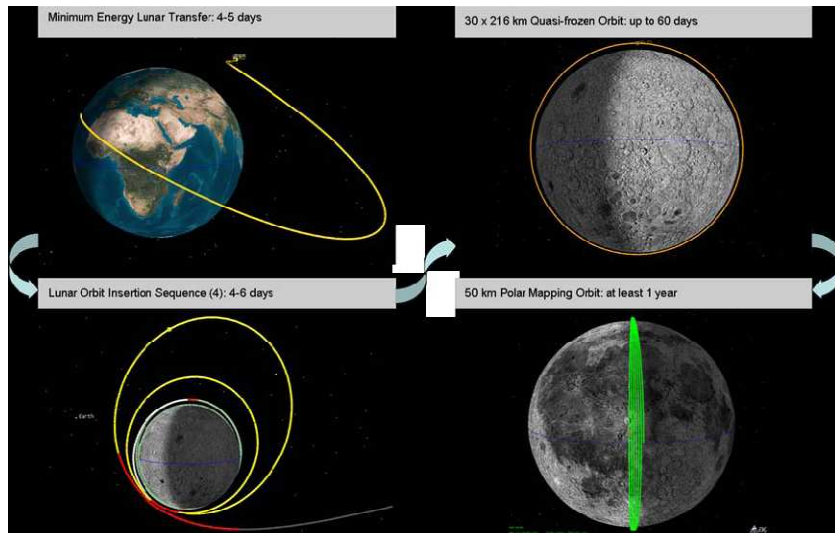
One day after launch, LRO conducted a mid course correction maneuver to adjust the inclination of its orbit. After the mid course correction, LRO cruised towards the moon with little excitement for three days. On the fifth day after launch, June 23, 2009 at 6:26:26am EDT, LRO completed a flawless LOI maneuver to place itself in an elliptical orbit about the Moon (Figure 7 shows the various phases of LRO's orbit during its mission: initial trajectory, LOI, commissioning orbit, and nominal orbit). Over the next five days, four more LOI maneuvers transferred LRO into its commissioning orbit.

Over the next ten weeks, the spacecraft and instrument teams commissioned their respective systems. Commissioning was when the GN&C Team had a chance to test out its primary attitude control mode as well as calibrate all of its systems. Once commissioning was completed, a series of thruster maneuvers, mission orbit insertion (MOI), lowered LRO into its nominal 50 km mean mission orbit where it began collecting meaningful science data.

Figure 7. LRO Orbit Phases

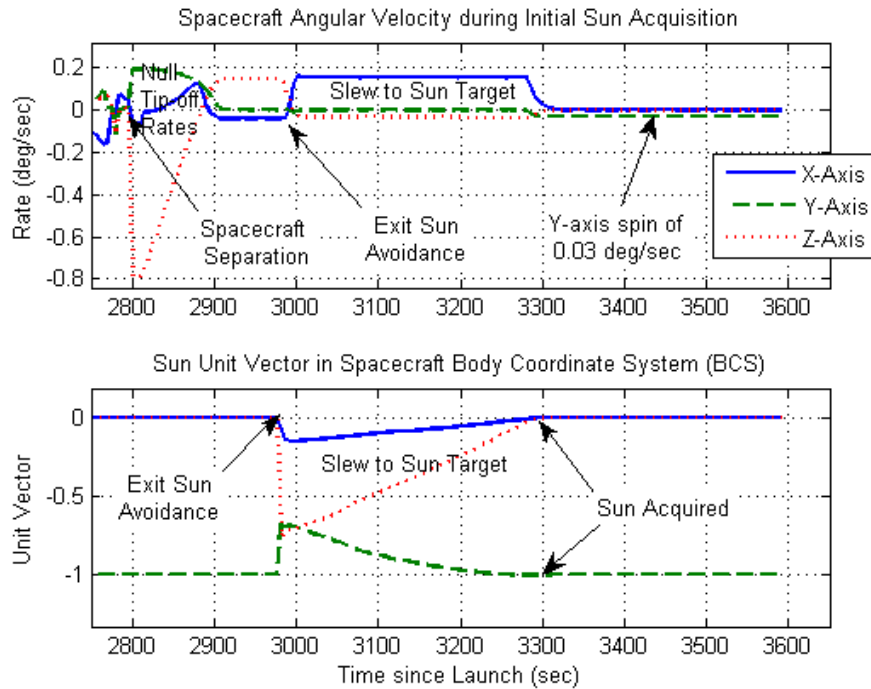
LRO separated from the Atlas V launch vehicle with tip-off rates of approximately [-0.1, 0.2, -0.8] deg/sec in the x,y, and z axes, respectively. Figure 8 shows the autonomous acquisition of the Sun by the SunSafe control mode. Shown are the spacecraft rates and spacecraft body sun vector. During the separation, the spacecraft was in a sun-avoidance state, which seeks to keep the sun off of the spacecraft +Z-axis, to avoid instrument illumination. SunSafe simultaneously removed the tip-off rates, as well as began maneuvering the spacecraft so the Sun is on the -Z-axis. Once sun-avoidance was exited, SunSafe began maneuvering the spacecraft to point the folded SA towards the Sun (SA on the -Y-axis). The presented data shows that it took approximately 8.5 minutes to acquire the Sun after separation.

**Figure 8. Spacecraft Angular Velocity and Sun Vector during Sun Acquisition. The Sun target is the -Y spacecraft axis – i.e. a target vector of [0,-1,0].**

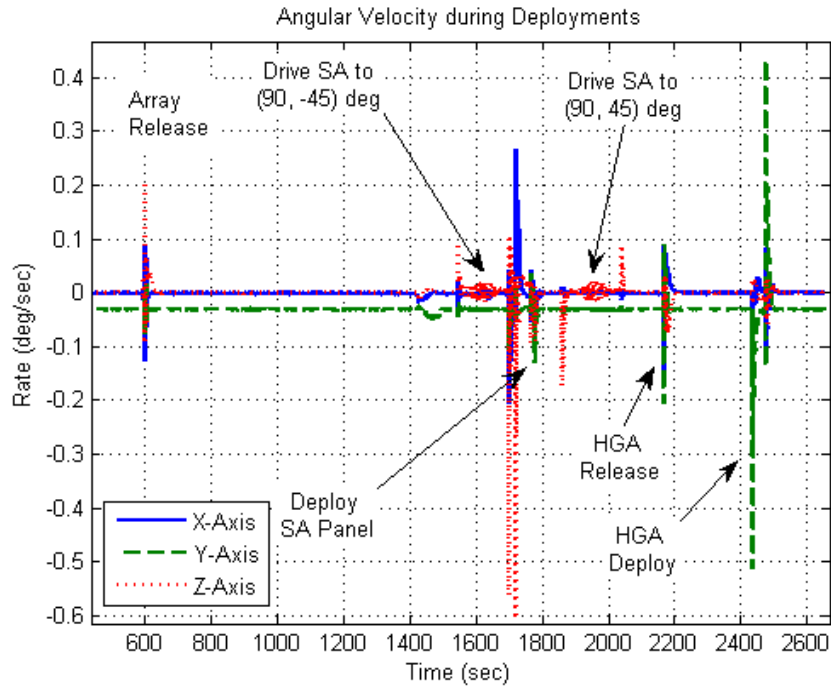
The Mechanical subsystem team requested that the GN&C team monitor the IRU rates in hopes that this data would help to verify proper deployment of the HGA and SA. In particular, they were interested in assessing proper functioning of the deployment latch mechanisms. While it was not possible to absolutely verify proper functioning of the latch mechanisms using IRU data alone, it was thought that careful inspection of the rate data would provide some corroborating evidence of proper deployment. Figure 9 presents the spacecraft angular velocity during the SA and HGA deployments. The deployment process began with the firing of a non-explosive actuator, which released the SA from the spacecraft. To allow the SA panels to unfold, the SA was mechanically driven to an extended position (identified as (90,-45) degrees). During this time, the two panels began to unfold with the assistance of spring mechanisms. The SA panels latched into place when they reached their deployed positions. Afterwards, the SA was driven back to its 'index' position, identified as (90, 45) degrees. A few minutes later, the HGA boom

was released from the spacecraft body and extended to its deployed configuration with the aid of a non-explosive actuator and a spring-loaded mechanism. A latch engaged when the HGA boom arrived at its deployed position.

**Figure 9. Spacecraft Angular Velocity during Deployments**

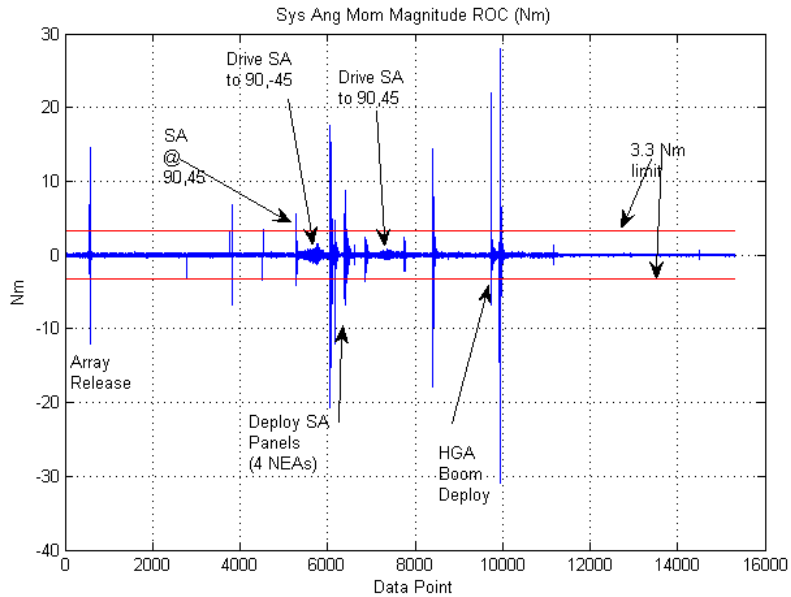
During both deployments, a system momentum rate of change safing action point (AP) was tripped in the Fault Detection and Correction System (FDC). The system momentum rate of change limit was set to 3.3 Nm and the action point trips if the limit is exceeded for more than 3 seconds. As can be seen in Figure 10, the limit is exceeded for more than 3 times on a few occasions during the deployment sequence. The original purpose of this safing action point was to detect and prevent system momentum from growing too fast to handle with wheels, and to prevent fuel loss. When this AP tripped, the FDC commanded the spacecraft to isolate the propulsion system, transition to SunSafe, and stop any activities occurring on the spacecraft. In the deployment situation, there were no issues with the propulsion system because none of the isolation valves were open and the spacecraft was already in the SunSafe control mode.

**Figure 10. Spacecraft System Angular Momentum Rate of Change during Deployments**

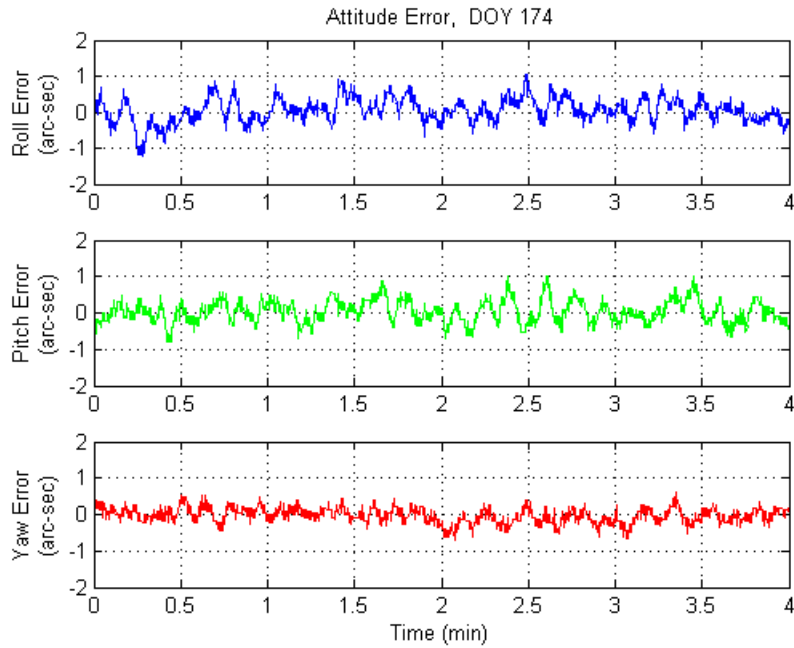
Occasionally, the attitude source was set to IRU propagation. This was primarily done in preparation for Delta-V operations and during ST occultations, which occurred when the spacecraft maintained inertial attitude during initial lunar orbit operations. This gave the team a chance to observe the best controller performance that could be achieved when targeting inertial attitudes with minimal disturbances present. Figure 12 shows typical 1 arc-sec level attitude error performance attained using IRU propagation as attitude feedback, when the SA was fixed, no spacecraft instruments were moving, and the reaction wheels were at low momentum levels. The data from Figure 12 was captured on Day of Year (DOY) 174. Attitude error when the IRU propagation was used as the attitude source, during inertial attitude targeting, demonstrated the best controller performance that was to be expected when the KF was used as the attitude source.

**Figure 12. Best Attitude Performance Using IRU Propagation During Cruise Phase (DOY 174)**

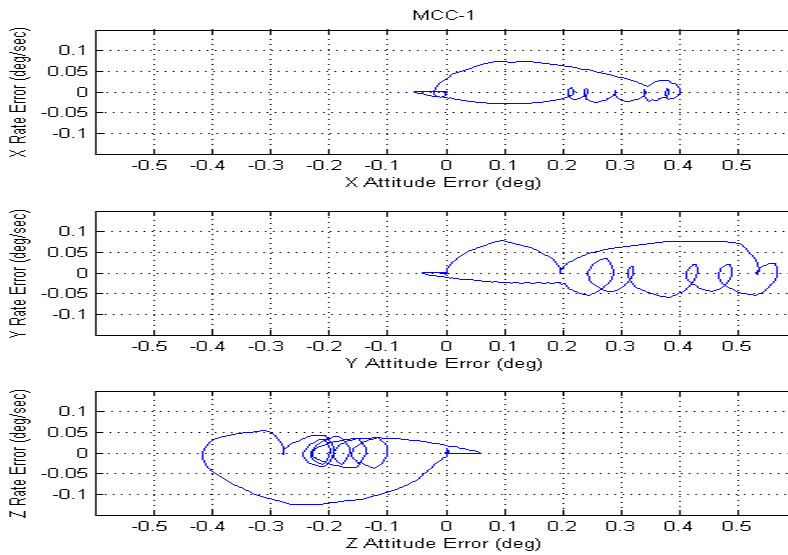
Mid Course Correction 1 (MCC-1) was performed on June 19, 2009, approximately 24 hours after launch and lasted about 48 seconds. MCC-1 used 4 out of the 12 thrusters on-board the spacecraft in an off-pulsing configuration. The maneuver executed flawlessly and phase plane plots of the maneuver are shown in Figure 13. The horizontal axis of each subplot represents the attitude error and the vertical axis of each plot represents the rate error seen by the Delta-V controller. The maximum absolute attitude error was 0.57 deg and the maximum absolute rate error was 0.13 deg/sec.

**Figure 13. Mid Course Correction Maneuver Phase Plane Attitude and Rate Error**

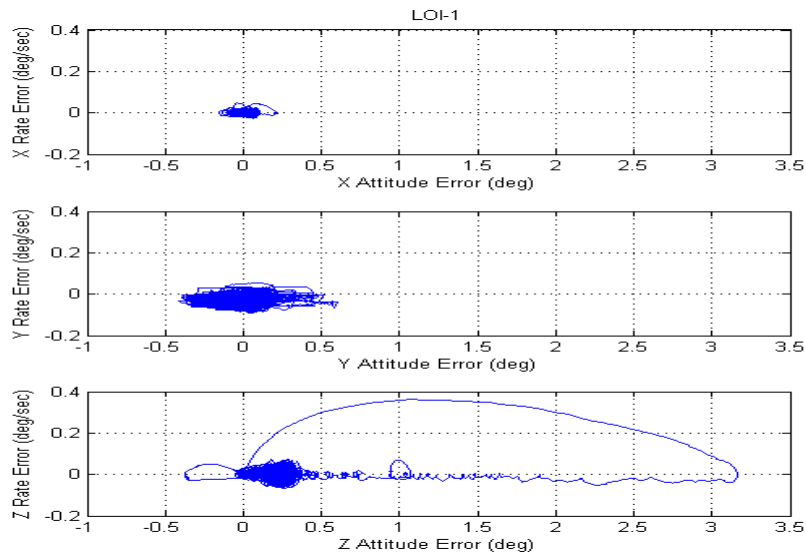
The third Delta-V maneuver performed by the spacecraft was Lunar Orbit Insertion 1 (LOI-1). LOI-1 was the longest thruster maneuver executed by the spacecraft, 40 minutes, and used all 12 of the thrusters on the spacecraft. The 4 NTs were full on, and the 8 ATs were controlled in an On-Pulsed Mode. LOI-1 was used to slow down the spacecraft in order to be captured by the Moon's gravitational field. Any issues with this critical maneuver could have resulted in a degraded science mission or loss of mission. This maneuver executed flawlessly with small attitude and rates errors as shown by the phase plane plots in Figure 14. The maximum absolute attitude error was 3.2 deg and the maximum absolute rate error was 0.36 deg/sec.

**Figure 14. Lunar Orbit Insertion Maneuver Phase Plane**

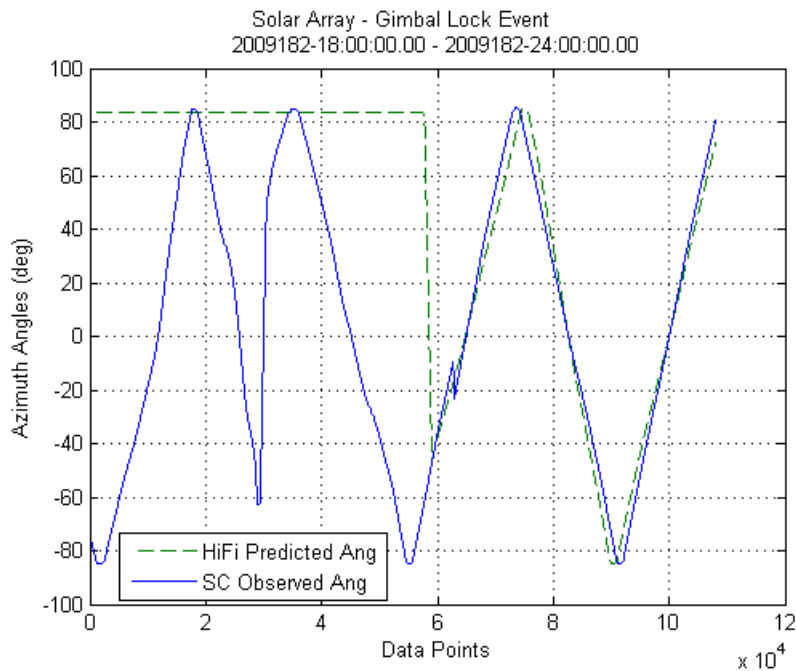
The SA encountered a gimbal lock situation on July 1, 2009 when the sun target vector approached [0,-1,0], i.e., when the sun is directly on the -Y-axis of the spacecraft based on uploaded ephemeris. This happens because there are an infinite number of possible solutions for that particular array orientation. Observed performance showed the commanded SA Gimbal 1 angle swerve, stop, turn around, and continued to swerve for an orbit; refer to Figure 16. Since the spacecraft was flying with a 30 degree offset (for thermal reasons), the SA really was not at the gimbal lock orientation. But, the SA targeting algorithm uses a target sun vector (computed from on-board ephemeris) instead of the measured sun vector. Therefore, when the target sun vector became [0,-1,0], the algorithm detected gimbal lock. However, the observed flight behavior was not seen during testing, which led to a deeper study of the event.

The SA targeting algorithm determines gimbal lock by comparing the target vector to a tolerance value. When that tolerance value is set properly, gimbal lock is identified early and the SA is sent to a pre-defined angle of + 90 deg for gimbal 1. Flight results show that gimbal lock was not detected early. Gimbal 1 was commanded to +90 deg, but then exited gimbal lock and proceeded to follow a swerving command. This means that the tolerance value was not set properly (it's a table value – current value is  $1 \times 10^{-16}$  rad and it should be  $1 \times 10^{-10}$  rad). Figure 16 shows the expected behavior with the correct tolerance setting, “HiFi Predicted Ang”.

**Figure 16. Array Gimbal Lock Event plotted against High Fidelity Simulation Results**

The easiest solution to prevent the observed performance when gimbal lock is encountered again is to change the tolerance value to  $1 \times 10^{-10}$  rad. But this requires the creation, testing and uploading of a new table. Gimbal lock only occurs when the spacecraft is at a high solar beta angle, and since the nominal operational plan is to park the SA at high solar beta angles, this situation should never occur again. The reason it was encountered is because the nominal SA operational plan was not being followed.

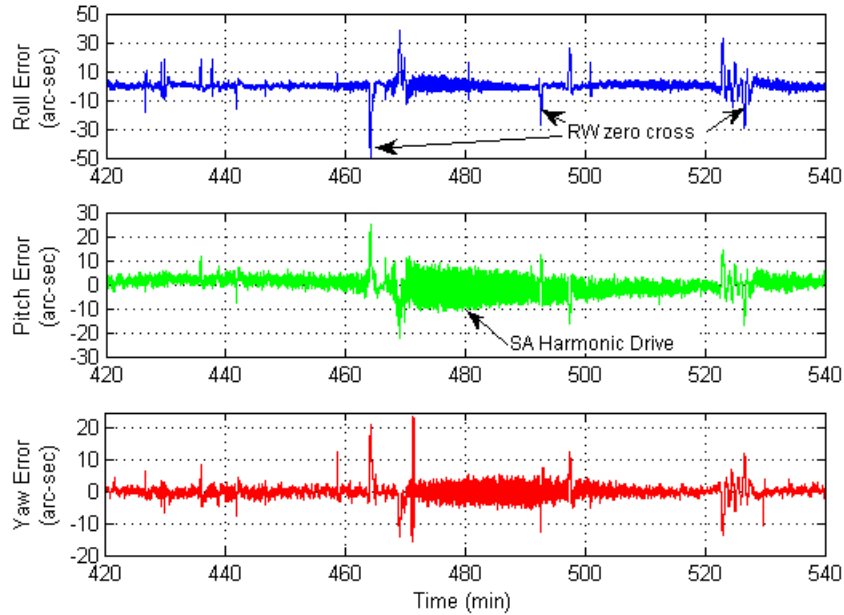
*Reaction Wheel Zero Crossing Disturbance.* Data taken during DOY 220 (Figure 18) shows somewhat increased pointing errors during the times when the SA is tracking the Sun and the RWs are crossing zero speeds. The disturbances at time = 430, 442, 464, 470, 493, 497 minutes, and during period from time = 520 to 530 minutes are all caused by reaction wheel zero crossings. Worst case transients from wheel #3 cause pointing error transients of ~50 arc-sec as shown in Figure 18 at time=465 min. Wheel speed zero crossings continued to occur each orbit as X-Z momentum increased at higher rates than pitch axis momentum. During subsequent Delta-H wheel momentum unloading, pitch momentum biasing was used to minimize low speed wheel operation while maintaining system momentum within 80 Nms over a required two week period. Although using this strategy, it was not always possible to entirely avoid zero crossings within the system momentum constraints.

*Solar Array Elevation Gimbal Step Disturbance.* On DOY 220 attitude transients apparent at time = 427, 437, 480, and 500 min were due to SA elevation angle command step transients, Figure 18. Generally, the SA elevation gimbal is stopped or moving somewhat slowly during nadir

target operations. Integrator wind-up in the SA gimbal controller resulted in instantaneous SA motion of about two cardinal steps (0.015 deg). These disturbances resulted in rate transients of about 30-40 arc-sec/sec about roll axis and 20-30 arc-sec/sec about yaw axis, as shown in Figure 19. These rates were somewhat large, but still within the LRO stability requirements. Options for elimination of this disturbance are to zero out the integrator gain or to reduce the integral limits in the SA elevation controller, neither of which was implemented during the commissioning phase.

**Figure 18. Attitude Error during DOY 220, GMT 07:00**

*Solar Array Harmonic Drive Gear Transmission Error Disturbance.* Figure 18 also shows typical attitude error response due to SA harmonic drive gear transmission error, primarily about the pitch axis. This error is caused by a sustained SA oscillation driven at harmonics of the SA gimbal drive speed. The dominant disturbance occurred at a 2x harmonic of the SA rate, with a period of approximately 15 to 20 sec due to the rather high 200:1 gear ratio of the drive system. This effect resulted in a maximum attitude error of ~11 arc-sec over a typical orbit, shown in Figure 18 on DOY 220. This maximum error coincides with the SA rewind when the SA azimuth gimbal reverses direction at time = 470 min. While this error was predicted prior to flight, it was somewhat surprising that the magnitude of the error seemed to be dependent on the direction of gimbal rotation and perhaps the loading of the gears during the reversal. Note that the error decreases as the SA continues to rewind after time = 480 min. This gear transmission error has been trending somewhat lower as the solar beta angle decreases, as a result of the decreased inertia loading about the +Y gimbal axis.

Transient LRO attitude errors observed during commissioning, shown in Figure 17 and Figure 18, resulted primarily from three sources: Diviner instrument calibrations, RW zero crossings, and SA articulation. A description of each of these disturbances is documented in the subsections below.

Even during times of considerable disturbance, primarily due to RW zero crossings and SA articulation as shown in Figure 18, the attitude errors were maintained below the statistical attitude error requirement level of 15 arc-sec (3 sigma) as documented in Table 3.
