NASA/TM—2010-216751

Experimental Charging Behavior of Orion UltraFlex Array Designs

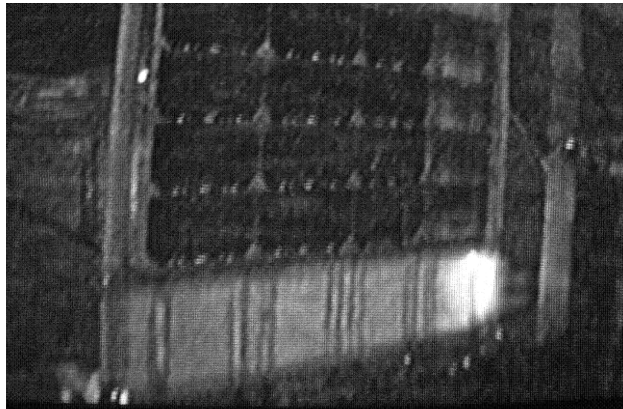
Figure 7.—Snapshot of arc on Tedlar strip triggered with array bias -2.9 kV bias, beam energy 3.5 keV and electron gun current density 7 nA/cm².

All four array strings were shorted together and connected to a High Voltage power supply through the R-C circuit shown in Figure 3(a) (resistor and capacitance values in the R-C circuit were $R = 1 \text{ M}\Omega$, and $C = 50 \text{ nF}$). A problem developed early on in the tests. A number of arcs were registered on the nonflight like areas on the front of the development level array assembly, even at the lowest levels of charging. Discharges were registered in less than 1 min after starting array sample irradiation. Peak current reached 8 A with pulse width of about $10 \mu\text{s}$ (Fig. 5). An electrostatic probe scan of the cell surfaces showed no signs of differential charging; thus, the ITO layer was effectively bleeding off charges. The sample was re-irradiated by energizing the Electron Gun (EG) using the same array bias potential, beam energy and current density settings, and ten more discharges were generated. Arc sites were clearly located: arcs occurred on the exposed thin Teflon sheet and on the Tedlar dielectric coatings. At this point the decision was made to modify the array by covering all exposed Tedlar strips on the front of the array with Kapton tape (Fig. 6). No modifications were made to the back side of the array. These modifications only allowed testing CICs area on the array sample. Even with the Kapton modifications implemented on the Emcore array arcs still struck on the nonflight like array area (see Fig. 7 for details).

No surface charging was found at current densities 1 , 2 , and 5 nA/cm² and beam energy up to 3.5 keV. The array was next biased at -2.9 kV negative and irradiated with electron beam energy 3.5 keV and current density of 7 nA/cm². Kapton tape strips were charged and an arc discharge occurred on the Kapton covered Tedlar strip (Fig. 7). Sample was dismounted from the VF-20 chamber and brought to calibration laboratory. There was no indication of visual damage or burn marks were found on the sample. The Calibration Laboratory recorded a loss of efficiency in each of the four strings. After the sample was returned a last attempt was made at biasing the array sample at -2.9 kV and irradiating the sample with a beam energy of 3.5 keV and beam current density of 7 nA/cm² for a 5 min exposure. Electron gun power supplies were shut down and an electrostatic probe scan was performed directly after e-beam exposure. Horizontal distance between points is 2.2 mm in Figures 8(a) and (b). The electrostatic probe scan clearly demonstrated charging of Kapton tape and a complete absence of charging on any of the CICs array surfaces whatsoever (Fig. 8). The AR-ITO-ZTJM array coupon successively passed all Stage 2 GEO tests. GEO tests were not performed on the back side of the AR-ITO-ZTJM array.

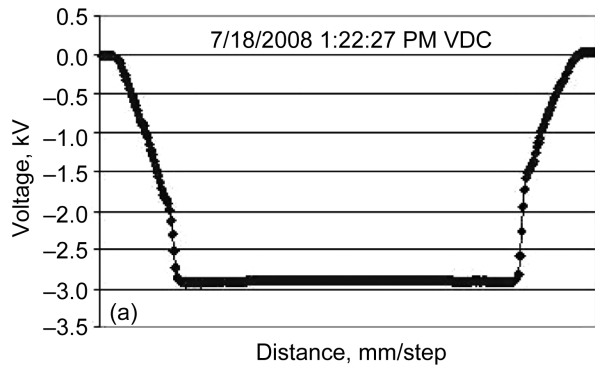
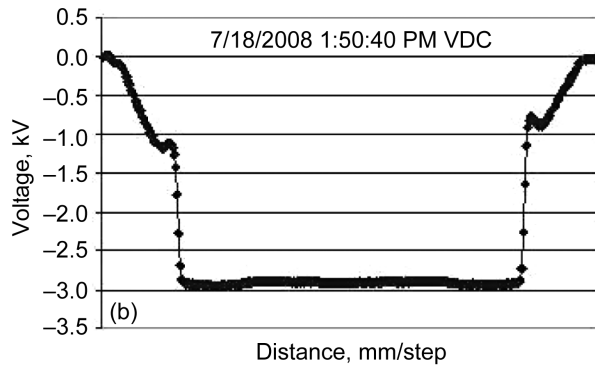
Figure 8.—(a) Electrostatic probe surface scan with array biased at -3 kV but not irradiated. (b) Electrostatic surface potential scan after 5 min irradiation at with $V_B = -3$ kV, $E_B = 3.5$ keV and $I_B = 7$ nA/cm².

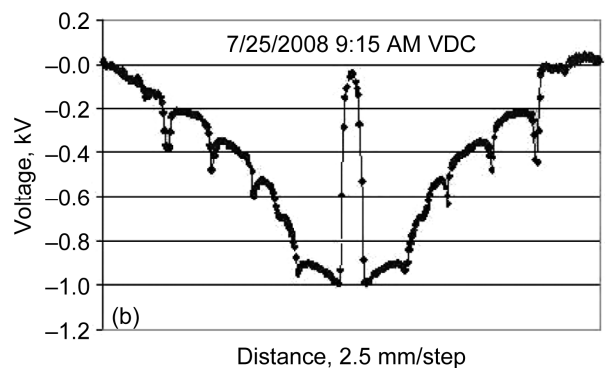
Figure 9.—(a) Surface probe scan of AR-ZTJM coupon indicated a potential of $-1.1 (\pm 0.05)$ kV before irradiation. (b) Differential potential of about 900 V after irradiation.

Initially the Emcore AR array was biased at -1.1 kV. Note that the top cell (cell 1) on the array string U4 was cracked, while trying to remove section of Kapton tape which fell on the cell. Figure 9(a) shows an example of a surface probe scan of potentials for the AR-ZTJM array biased at 1.1 kV, but not irradiated. Figure 9(b) shows a surface scan of potentials after irradiation, with the array still biased at -1.1 kV under an e-beam using a beam energy of 1.8 keV and with beam current density of 2 nA/cm². No arcs were detected but a scan of surface potentials shows the Emcore AR coated array appears to have acquired differential charging of CIC on the order of 900 V, which clearly indicates that no ITO layer is present on the CIC assemblies. Beam current density was increased to 5 nA/cm² and one arc occurred on the cracked cell. String U4 was removed from the circuit. Continued irradiation at the previous beam current density showed no arcing occurred. Array bias level was increased to -2 kV with the beam energy was raised to 2.8 keV and the sample was tested at beam current densities 1 , 2 , 5 , and 10 nA/cm² with no arcs detected on the flight like cell surfaces. However, three arcs were triggered on the nonflight like array (first two arcs occurred on the Teflon sheet and the third arc was detected on the Kapton covered Tedlar strip). Resumed testing with the array biased at -3 kV, beam energy 3.5 keV and a beam current density of 2 , 3 , and 5 nA/cm² with no arcs detected on the flight like areas of the AR-ZTJM array. Beam current density was increased to 10 nA/cm² and a discharge occurred in the area covered by Kapton tape after 10 min of irradiation (Fig. 10). Note: four lighted CICs above arc site in Figure 10 appear to be due to current flowing through the array string CICs.

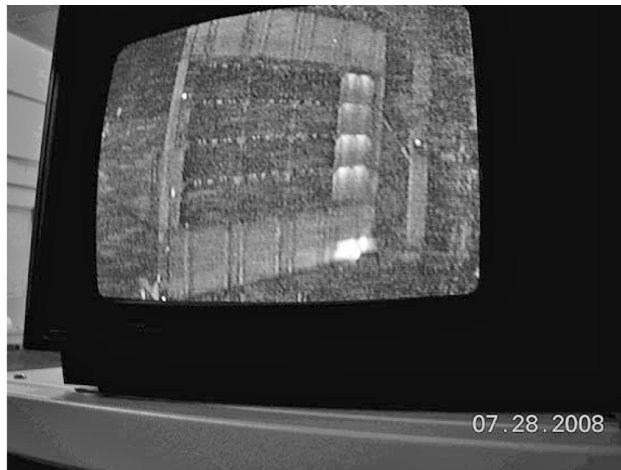
Figure 10.—Discharge on Teflon at -2 kV bias voltage with beam energy at 2.8 keV and with a beam current density of 10 nA/cm².

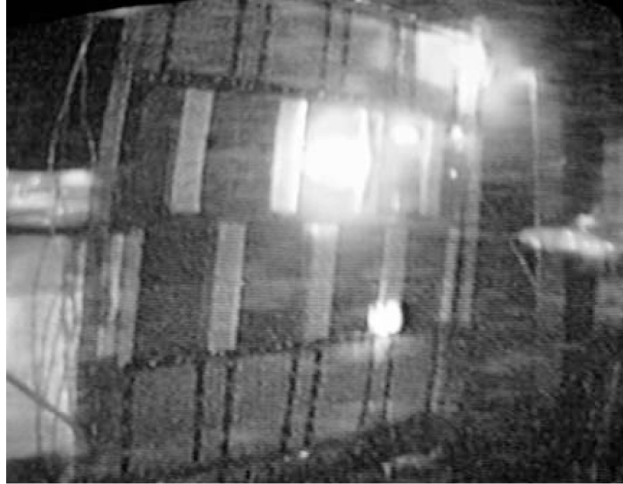
Figure 11.—Snapshot of AR-ZTJM coated array showing multiple discharges under -9.5 kV bias and irradiated with 10 keV beam energy and 5 nA/cm² beam current density.

The chamber was opened and the ZTJM array was reinstalled with the electron guns pointed directly at the back side of the array. Back side testing started the -2 kV array bias. No arcs were detected in a 17 min test under irradiation with beam energy of 2.8 keV and beam current density of 5 nA/cm². Bias level of the array was increased to -3 kV with beam energy set to 3.5 keV and a beam current density of 1 nA/cm². One arc occurred near the top left side of the Kapton cover. Two more arcs were detected on the back side of the array in the area on the conducting strip near the edge of the composite frame. Array bias voltage was increased to -5 kV and the back side of the array was irradiated with e-beam energies of 5.7 keV with a current density of 5 nA/cm². Three more arcs were recorded: one arc occurred near the top middle region of the array on the Kapton cover applied over the composite frame and the other two arcs on the Vectran gore mesh near to the string conducting strips. A final attempt was made to see the effects of charging the back side of the array at extreme GEO levels well beyond those expected during flight. For this test the array sample was biased at 9.5 kV and the back side of the array was irradiated with a beam energy of 10 keV and a current density of 10 nA/cm². This extreme charging test resulted in multiple number of very intensive arc discharges scattered over face of the back side of the array (Fig. 11).

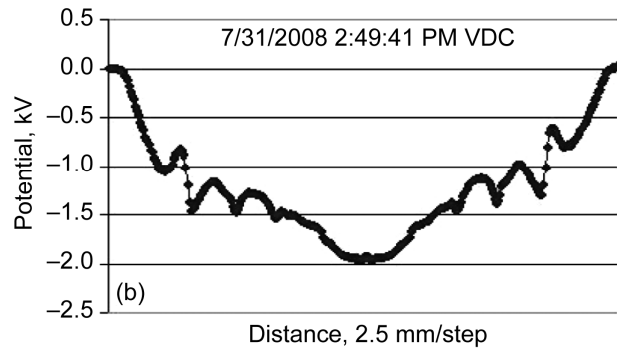
Figure 15.—(a) Surface potential scan with array biased at -2 kV. (b) After 10 min of irradiation with beam energy of 2.8 keV and beam flux 3 nA/cm².

Output leads of all the four strings of the AR-XTJ array was connected to the negative terminal of the high voltage power supply through the R-C network (Fig. 3). All four array strings were biased at -2 kV and a surface potential scan was performed before irradiating the array assemblies (Fig. 15(a)). The array was then irradiated with 2.8 keV and 1 nA/cm² beam. First arc occurred on the top right corner of array string U1 and a second arc occurred at the same site after 2 min of irradiation. A third arc was recorded at the same position as the first two arcs some 7 min later. Beam current was increased to 3 nA/cm². One arc was registered on the bus bar at the top of string U3. After total of 10 min under irradiation, an electrostatic probe scan indicated differential charging of approximately 800 V (Fig. 15(b)).

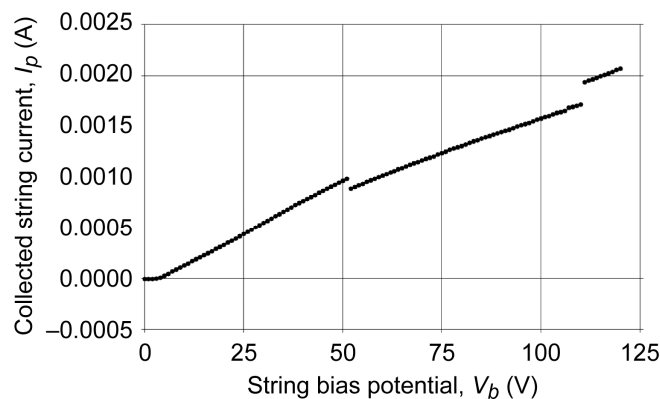
Figure 18.—Collected current plot for ZTJM AR-ITO string U1.

If the floating potential, V_f is now assumed to be 50 percent of the operating potential, $V_{op} = 120$ V then $V_f = (0.5)(120) = 60$ V and the positive peak voltage, $V_{pv} = (120 - 60) = 60$ V. The collected current, I_c computed from the curve is then specified in Equation (3):

The value of the collected current I_c now becomes

$$I_c = 5.5 \cdot 10^{-4} A$$

The parasitic current loss, I_p from string U1 can then be similarly computed from the ratio in Equation (4):

$$I_p = \frac{I_c}{I_{pv}} = \frac{5.5 \times 10^{-4}}{0.5} = 1.1 \cdot 10^{-3} = 0.11\% \quad (4)$$
