NASA/TM—2010-216743

Propulsion Health Monitoring of a Turbine Engine Disk Using Spin Test Data

Prepared for the Smart Structures and Materials and Nondestructive Evaluation and Health Monitoring 2010 sponsored by the International Society for Optical Engineering (SPIE) San Diego, California, March 7–11, 2010

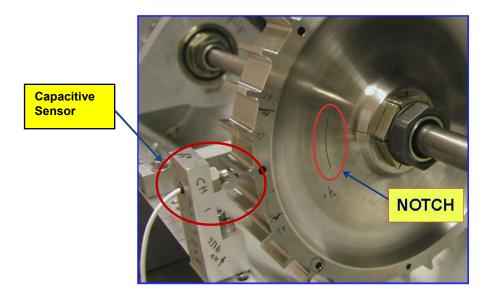
Figure 1 shows the disk specimen and the induced crack-notch along with the tip clearance probes. The test specimen disk has an outside diameter of 23.495 cm (9.25 in.) respectively; a bore and an outside rim thickness of 2.54 cm (1 in.) and 3.175 cm (1.25 in.); the thickness of the web is 0.254 cm (0.10 in.), and the cross section and height of the blades are 3.175- by 0.330-cm (1.25- by 0.13 in.) and 0.838 cm (0.33 in.), respectively. It has rotor like blades, total of 32, evenly spaced around the circumference. Eight holes, 0.508 cm (0.20 in.) diameter each, were drilled through the disk half-way in the rim. The holes were spaced every 45° and they were designed for future studies as possible mass add-on points or notch initiation sites.

Figure 1.—Test disk with a notch.

The materials used to manufacture the disk specimen were nickel base alloy Haynes X-750 and Grade 2-Titanium. This paper focuses on the Haynes X-750 material disk which weighs approximately 10.75 lb (4.88 kg). For blade tip clearance measurements, a capacitive sensor system was installed, see Figure 1. These types of sensors are based on a DC offset rather than a modulation technique. The DC voltage, in conjunction with the motion of the rotor, allowed the current system to record three channels at a rate of 1 MHz each. The experimental testing included running tests under transients and steady state conditions such as ramp-up, ramp-down and cruise conditions.

The controlled speed applied during the current testing ranged from a minimum of 1,000 up to a maximum of 10,000 rpm with acceleration-deceleration rates of 60 rpm/second. This insured surpassing the critical speed of 2,610 rpm and leading to post critical state. Experiments covered base line runs with undamaged disk and with damaged disk via artificially induced notch, shown in Figure 1.

The notch had a width of 0.381 mm (0.015 in.) as per wire thickness and burn area of the electric discharge machining (EDM) process. The notch region was intentionally selected to be in the rim area due to the fact that the finite element results revealed that this section encounters the highest stress level in the disk during the spin operation (Refs. 1 and 2). Systemic considerations were emphasized to preserve consistency of the operating parameters and other experimental conditions during the removal-reinstallation process of the disk specimen in both situations, baseline no-notch and notch state.

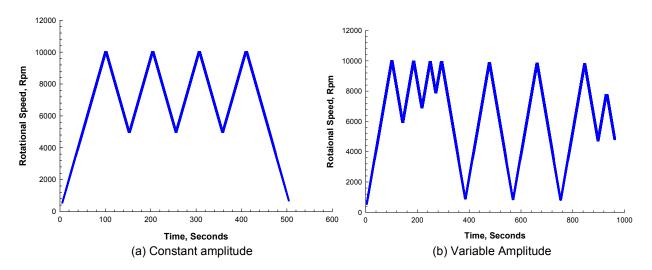
Figure 2.—Simulated engine mission history profiles.

Figure 2 shows the mission history profiles applied in this experimental work for the disks, the baseline unnotched and the notched disk. These profiles were derived on the basis of revolutions per minute data obtained on different flights comprising different flight maneuvers (Ref. 15). Figure 2(a) shows the constant amplitude portion which is one of the test mission profiles applied in the experiment. It clearly demonstrated less aggressive and smoother profile compared to the variable amplitude profile shown in Figure 2 (b), starting with a minimum of 200 rpm up to a maximum of 10,000 and a shutdown to 0 rpm. Meanwhile, Figure 2(b) represents the variable amplitude engine history which reflects steep and sharp changes in the rotational speed across the entire cycle, subjecting the disk to high and complex loading conditions in an attempt to fatigue the disk with the expectation that all existing anomalies would appear in the test data. The speed was varied sharply from a minimum of 200 rpm up to 10,000 rpm at various intervals. Testing the rotor under these conditions provided a good simulation to collect data under various loading conditions which the disk may experience during nontypical operating environment. Furthermore, these experiments supplied valuable assessments for both, the crack detection scheme and the structural durability of the disk materials.

For the constant amplitude cycle (Fig. 2(a)) data analysis, the data was recorded in two sets: "normal" and "notched". The rotational speed for the disk continuously varied from 5,000 to 10,000 rpm for both normal and notched runs. In this analysis, only the 32 gap measurements were considered. Orca, Inductive Monitoring System (IMS) and One-Class Support Vector Machines (OCSVM) were chosen to evaluate this data. The normal run's data was randomly divided in half. One half was used for training and the remainder half was used for validation. The means and standard deviations for all 32 channels are calculated for the training data and used to z-score normalize (normalize each channel to have zero mean and unit standard deviation) both the training and testing data sets. The plots, Figures 5 to 8, are the global anomaly scores for each of the algorithms on both the validation normal and the notched runs over time.

An additional data set had rotational speed varying from 1,000 to 10,000 rpm; Figure 2(b) was evaluated using all three algorithms. For the analysis of 1,000 to 10,000 rpm data, the algorithms performed comparably to the 5,000 to 10,000 rpm analysis. However, in the category of false alarm rates when fixing the correct detection at 90 percent IMS appears to have trouble, with a false alarm rate of 100 percent. It also appears that Orca has an edge in this category with a false alarm rate of 1.99 percent where OCSVM is slightly higher at 4.57 percent.

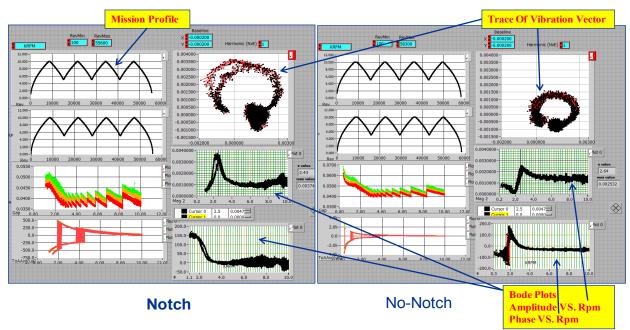
Experimental data under both applied mission profiles are represented in Figures 3 and 4. The data in Figure 3 are produced under the constant amplitude mission for both the baseline no-notch and the notched disks. The mission history is shown along with the trace vibration vector and bode plots for the phase and amplitude response. A clear observation is noted for both, the baseline and the notched disk; a closed loop representation for the trace of vibration vector is seen for the baseline disk while a gap in the loop is present for the notched disk. This behavior offers the first hint that we have a difference in the vibration response for the two structures indicating the presence of some type of anomaly. Such observation has been reported in Reference 7, where a crack in the rotor disk is documented via the presence of distorted trace of the vibration vector distribution and a rise in the phase and amplitude response upon surpassing the critical speed stage.

Figure 3.—Bode Plots—9 minutes comparison test for the disk with and without notch, constant amplitude mission profile.

This conduct is obvious in Figure 3 for the notched disk. A rise in the phase and amplitude response is clearly noted. While a flat and steady decrease in these parameters is shown for the baseline rotor which implies that it is a healthy rotor. Again, similar remarks for the variable amplitude mission history profile are seen in Figure 4. A rise is reported in the phase and amplitude response as soon as the disk crosses the 5,000 rpm level up to the 9,000 rpm where a notable no changes response is apparent. The difference between the data reported for the variable and the constant amplitude profile is confined to a higher blade tip clearance for the variable amplitude (nearly about 22 percent higher). Therefore, examination of the above data verified that the detection scheme applied in the experiment seemed to deliver a reasonable set of results indicating the presence of a defect in the rotor disk. However, this confirmation has to be further documented by conducting more tests for different rotors under similar operating conditions to authenticate that this behavior in the data is strictly due to existing structural defects in the rotor and not due to a system related unbalance.

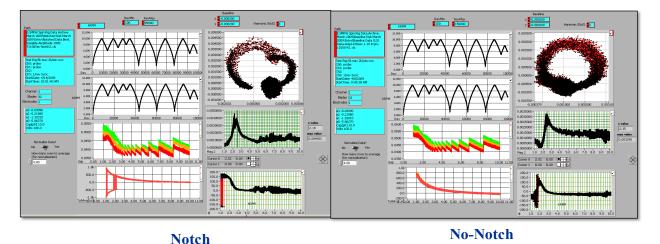
Figure 4.—Bode Plots—9 minutes comparison test for the disk with and without notch, variable amplitude mission profile.

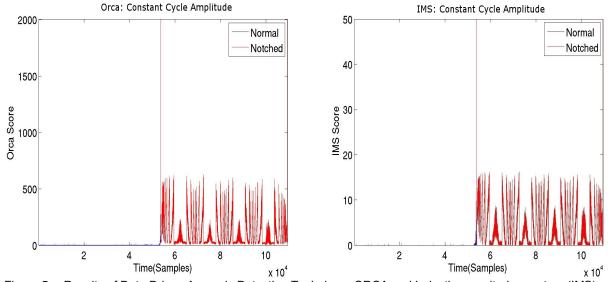
Figure 5 through 8 provides the scores for the three different techniques. In Figures 6 and 8 the anomaly scores are portrayed as positive values and any nominal points are represented as zero. This was done to allow for similar comparison across the algorithms. It is important to note that OCSVM allows some nominal sample points in the training set to be classified as anomalous. This percentage is governed by the Nu parameter, which is set by the user, but for which we set currently at the default value of 10 percent. Due to this characteristic of the algorithm, 10 percent of all nominal data tested may result in anomalous classification. In Tables 1 and 2 the choice for fixing correct classification to 90 percent was to make the comparisons fair between all three algorithms, since OCSVM, in this case, was optimized for a correct classification of 90 percent.

Figure 5.—Results of Data Driven Anomaly Detection Technique; ORCA and Inductive monitoring system (IMS).

Therefore, based on the information reported in Figures 5 to 8, it can be concluded that the detection techniques performed as expected and indications of malfunctions are seen in the scored representations of highly spiked distributions for the notched disk, while no spikes are noted for the baseline no notch disk. This applies to the data reported in Figures 5 to 8. The evaluation of the data reported from these techniques is also tied to the scores produced as a result of the simulation. For instance, the higher the score, the more anomalous is the structure.

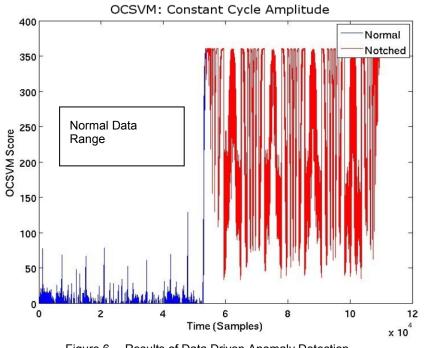
Figure 6.—Results of Data Driven Anomaly Detection Technique; OCSVM Algorithm.

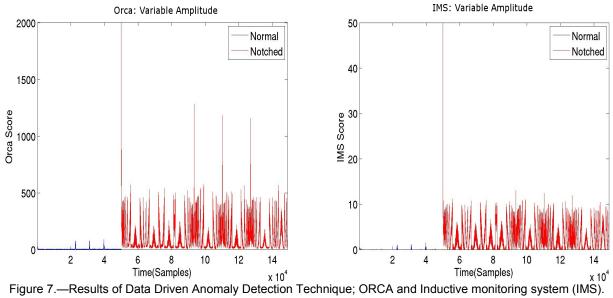
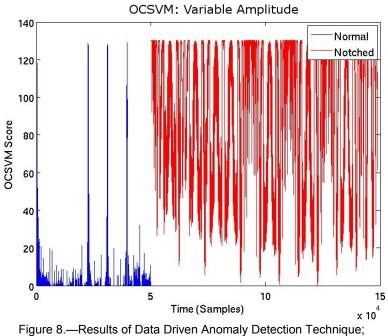
One-Class Support Vector Machines (OCSVM).
