Response of Honeycomb Core Sandwich Panel with Minimum Gage GFRP Face-sheets to Compression Loading after Impact

Thomas D. McQuigg*^a, Rakesh K. Kapania^a, Stephen J. Scotti^b, Sandra P. Walker^b

ABSTRACT

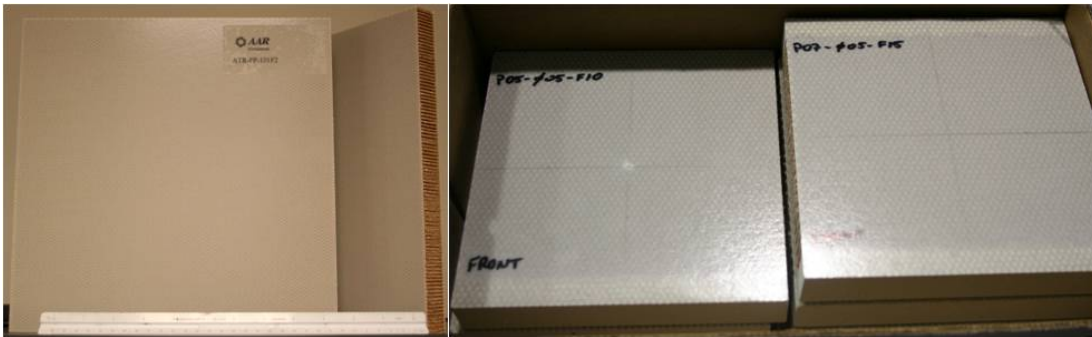
Figure 1. PXX sandwich panel material (left) and PXX material coupons (right).

Test coupons were prepared from PXX material at the nominal size of 6 in. by 6 in. The test coupons are shown in Fig. 1. These coupons were used in all of the tests described in the next section. To avoid premature coupon failure for the uniaxial compression tests, special considerations for load introduction were made. At the top and bottom (the load bearing ends of each coupon) a section of core material was removed from between the face-sheets. This section had dimensions of the width (6 in.) and thickness (1 in.) of the coupon and it extended in the loading direction approximately 0.5 in. A clay “potting” material was used to fill this void. The purpose of this was to increase the surface area for load transfer between the compression test frame and the coupon. In addition, the potting limited the out of plane bending (or “brooming”) of the coupon face-sheets’ load direction edges, due to the applied compression load. The potting on the ends of each coupon was ground to straight and level to a tolerance of 0.001 in.

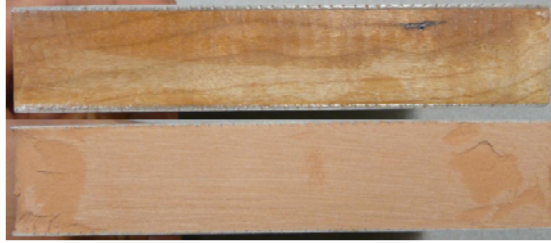
Figure 2. Comparison of wood filled (top) and potting material filled (bottom) coupon ends.

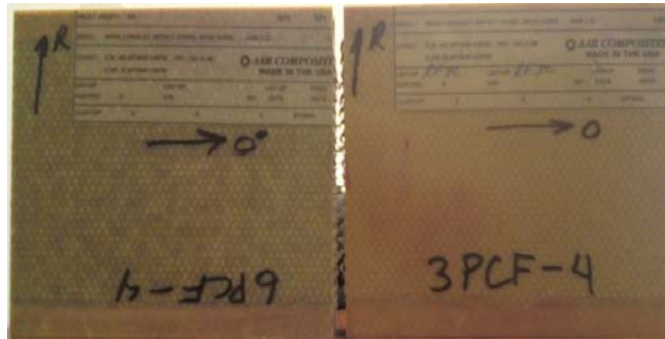
Figure 3. 6PCF (left) and 3PCF material coupons.

Coupon attributes of the 3PCF and 6PCF sandwich constructions were changed slightly based on source material limitations and lessons learned from potting of the PXX material. The coupon size was still nominally 6 in. by 6 in. but the actual dimensions of each coupon are slightly smaller due to the size of the received source material panels. The potting approach was slightly different as well. It was found that the potting clay used in the PXX test series shrunk when cured which introduced bending stresses in the face-sheets. A study was conducted to evaluate two alternative approaches. A clay potting material having less contraction during cure was considered. In addition, a block of wood inserted with close clearances between the face-sheets and fastened with an epoxy resin was examined. A comparison of samples using the two approaches is shown in Fig. 2. It was determined that the wooden insert could be specifically sized to allow little or no introduction of out of plane displacement of the face-sheet edges; this method was thus used in the 3PCF and 6PCF compression coupons shown in Fig. 3.

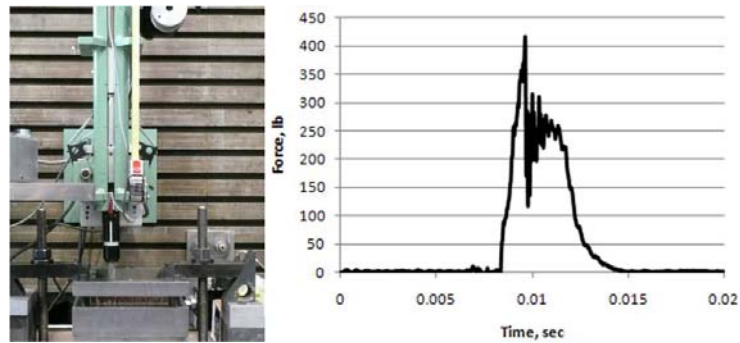
Figure 5. Impact survey test fixture and apparatus (left) and sample results for a 5 ft-lb. impact (right).

The drop impact survey was the second of two preliminary tests run to determine the impact energy levels of interest for CAI testing. The purpose of the impact survey was to determine the characteristic damage at various impact energy levels. A material coupon was clamped on all four edges in a special test fixture with no support under the opposite face-sheet; this boundary condition is considered to be characteristic of a real world structural impact. The test fixture was then mounted to a robust steel table using heavy bolts. A 0.5 in. diameter hemispherical tipped impactor was measured to determine its mass. The drop height for a given impact energy level could then be calculated. During an impact event, reaction force vs. time information was recorded. The impact survey test fixture and apparatus is shown in Fig. 5 with example force vs. time results for a 5 ft-lb. impact energy level. At this energy level, the impact resulted in considerable face-sheet cracking, which absorbs substantial energy. Note the sudden drop in force at 0.01 sec. and the subsequent rapidly oscillating force level prior to tailing off.

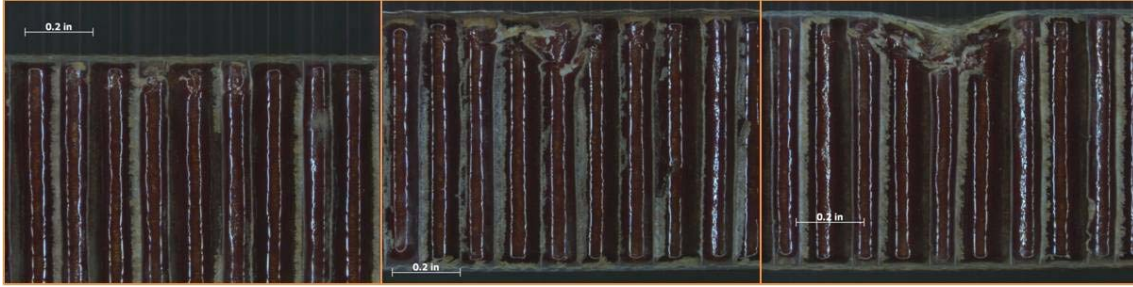
Figure 6. Examples of interior damage images at 1.0 (left), 3.0 (center), and 5.0 (right) ft-lbs. for 6PCF type sandwich panel construction.

Once the impact survey was complete, each residual dent that resulted from a given impact was measured to determine its diameter and maximum depth as a general characterization of the damage. In addition, measured and visual qualitative observations were made about the location and characteristics of other types of damage present, including cracking or penetration of the impacted face-sheet. A few panels were also carefully dissected at the midpoint of the residual dent. Observations were then made to determine the extent and level of core damage that resulted from each impact. In addition, measurements could be accurately made to determine the profile of the core damage and the residual dent in the face-sheets. Example images of the interior of dissected impact dents are shown in Fig. 6.

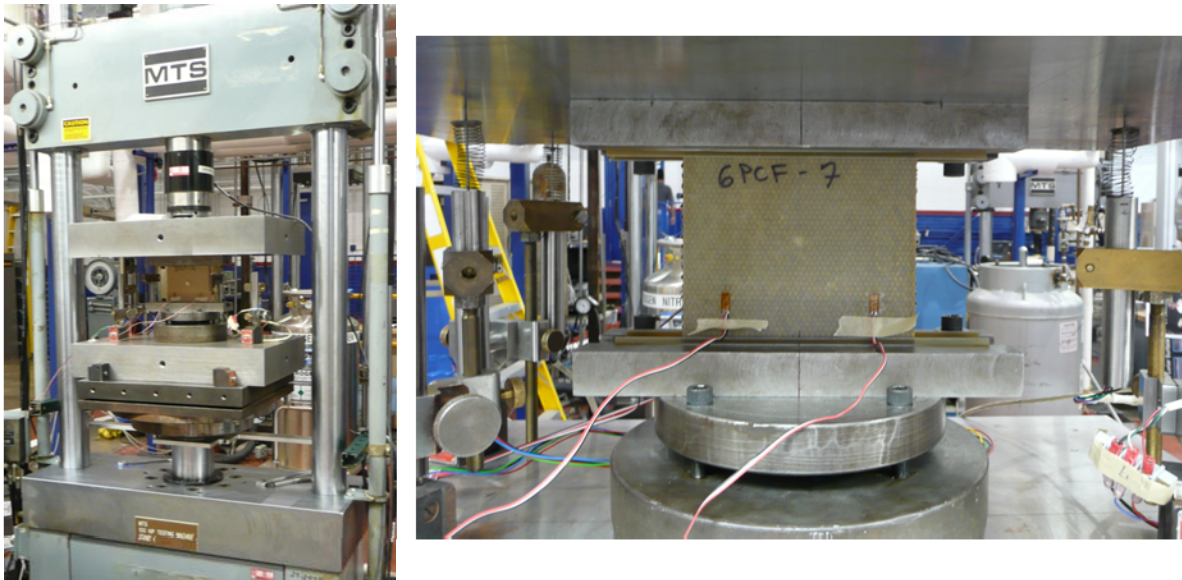
Figure 7. Compression after impact test apparatus.

A servo-hydraulically actuated MTS load frame with a 100-kip maximum load was used for the CAI tests. The sandwich panel coupons were clamped at the top and bottom and mounted between two square loading platens. Loading was displacement controlled and applied through the upper platen at a rate of 0.02 in. per minute for the PXX sandwich constructions and at a rate of 0.01 in. per minute for the 3PCF and 6PCF sandwich constructions. Coupon alignment was adjustable through the lower platen as well as a smaller circular platform placed in between the lower coupon clamp and the lower platen. The CAI apparatus is shown in Fig. 7.

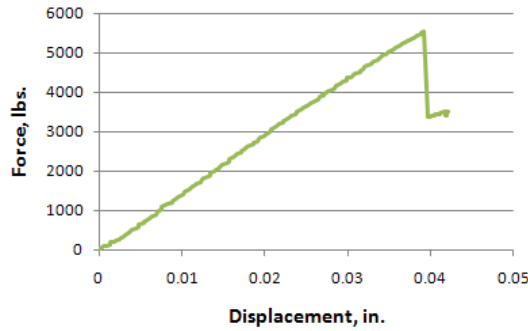
Figure 8. Typical force vs. displacement results for CAI tests.

Coupons of PXX sandwich construction materials were tested with a centrally located impact of energy level 0.5, 1.0, 1.5, or 2.0 ft-lb. Two panels were tested at each damage level and two additional panels were tested without impact damage for reference. The typical force vs. displacement response for a CAI test is shown in Fig. 8. The force-displacement behavior is linear until panel failure is observed, at which time there is then a sudden drop in the reaction force. Nominal failure stress and average far-field failure strain were reported for each test case and the results are shown in Fig. 9.
