Full-Scale Test and Analysis of a PRSEUS Fuselage Panel to Assess Damage-Containment Features

Andrew Bergan¹, John G. Bakuckas, Jr.², Andrew Lovejoy³, Dawn Jegley³, Kim Linton⁴, Gregory Korkosz⁵, Jonathan Awerbuch⁶, and Tein-Min Tan⁶.

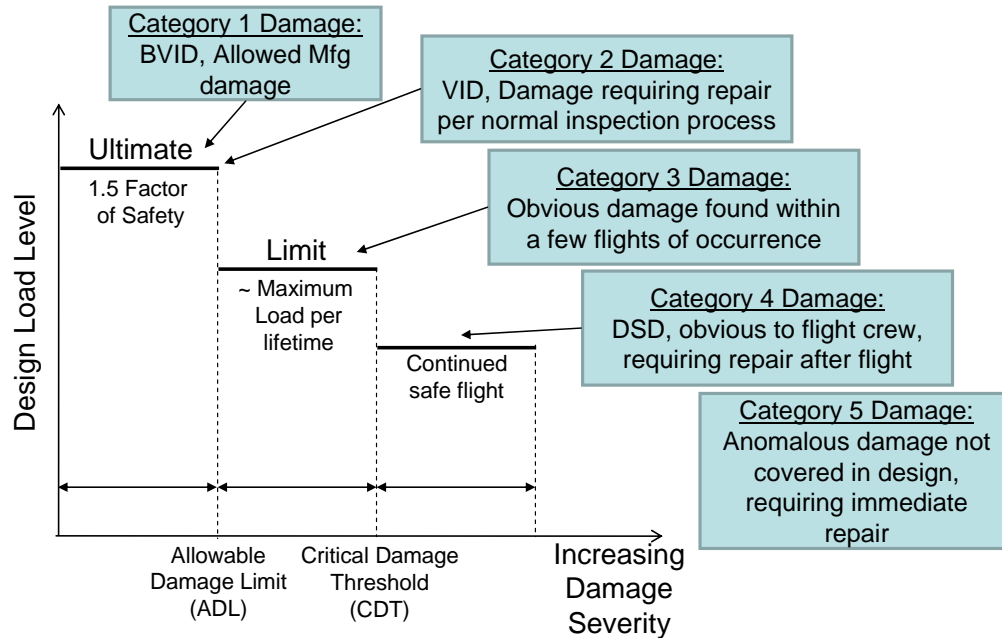
Figure 1: Increasing damage severity requires lower sustained loads.

In this study, the load requirements to sustain categories 1, 2, and 4, damage severity, shown in Figure 1, will be demonstrated.

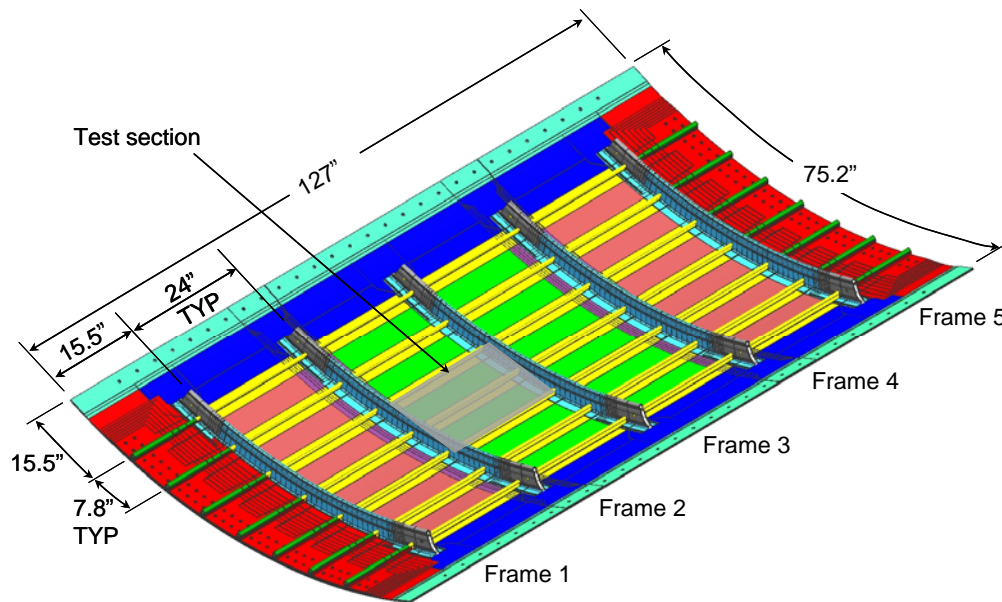
The fuselage test panel has a 90-inch radius, 127-inch length and 75-inch width with seven full-length rod-stiffened stringers and five frames as shown in Figure 2. The nominal skin thickness in the test section, the 2-bay region identified in Figure 2, is 0.052 inches, which is a minimum gauge thickness for a 55 ksi operating stress level. The interior and exterior surface of the panel are termed the inner mold line (IML) and the outer mold line (OML), respectively.

Figure 2: Overall panel geometry showing the inner mold line (IML) surface.

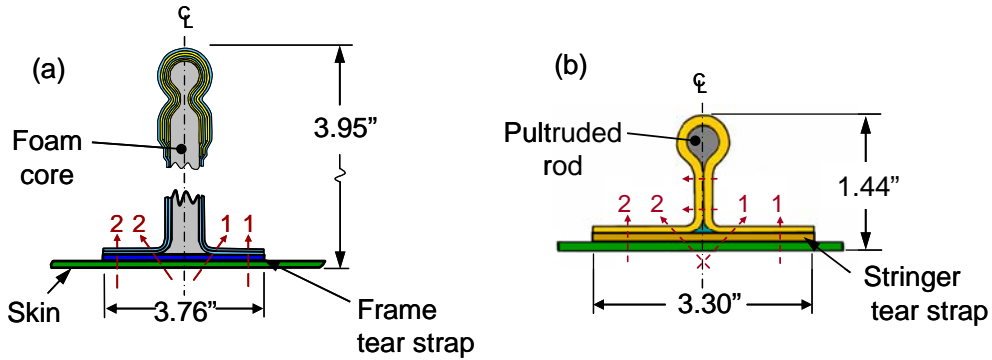
The panel substructure comprises integrally stitched frames and stringers. The frames were formed around a half-inch thick foam core support with a 3.8-inch wide tear strap at the base. The top of the frame was reinforced with a frame cap. The detailed frame cross-section geometry, including the single-sided frame stitching denoted by dashed red arrows labeled 1 and 2, is shown in Figure 3a. The stringers are formed with a pultruded rod for high structural efficiency [1]. The stringer web is stitched using a two-sided stitching machine before pre-assembly to the panel. The detailed stringer cross section geometry, including the single-sided stringer stitching denoted by dashed red arrows labeled 1 and 2, is shown in Figure 3b.

Figure 3: Frame and stringer cross section.

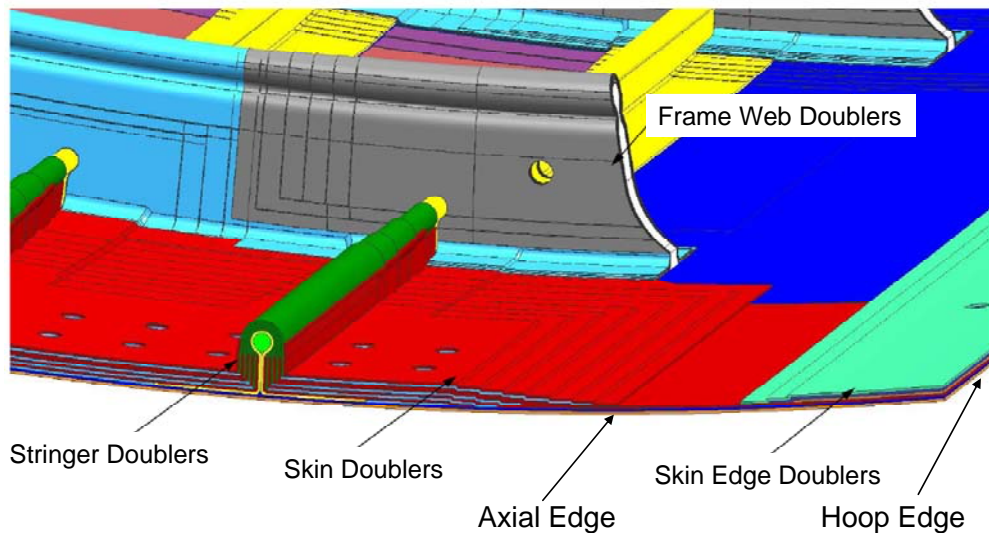
Doublers were co-cured with the panel to reinforce the load introduction areas at the axial and hoop edges as well as frame and stringer terminations as shown in Figure 4. Transitions between the doubler regions and the test section were tapered to maintain a constant neutral axis from the load introduction region to the test section. The axial edge skin doublers were interleaved with four stringer doublers to aid in transferring load into the pultruded rod. Doublers were added to the frame ends. Bolted radius blocks were also added locally at each frame end to tie the frame flange to the skin because high peel stresses were anticipated in this region due to the test setup.

Figure 4: Load introduction doublers.

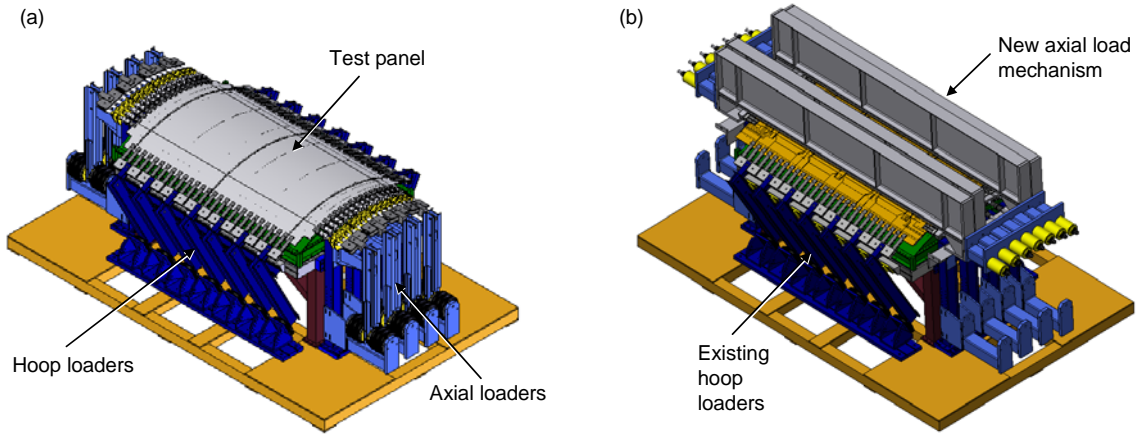
The FASTER fixture modifications include accommodations for a larger panel radius, a modular seal for full-length stringers, a frame loader slide system for large axial displacements, and an increased axial load capacity. A comparison of the existing fixture and modified fixture is shown in Figure 5, highlighting the new axial load mechanism. The axial loading features of the modification are discussed in the following subsections.

Figure 5: Comparison of (a) existing FASTER fixture and (b) modified fixture.

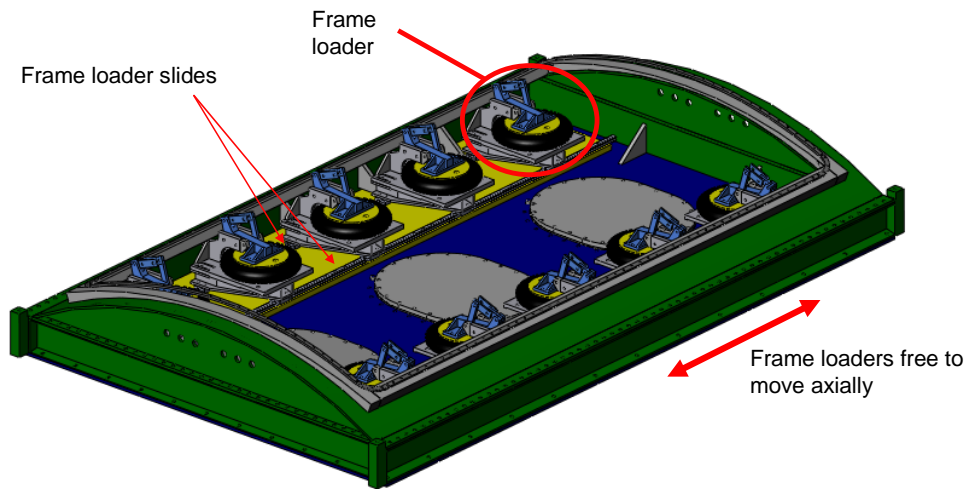
Initial test predictions show an overall axial displacement of up to 0.25 inches between the outer frames. This displacement would have induced large reaction forces into the frames with the existing rigid frame loader design that are not characteristic of flight loads. A frame loader slide-system was designed that allows the frame loaders to move freely in the axial direction avoiding non-flight loads, as shown in Figure 6.

Figure 6: Frame loader slide-system.

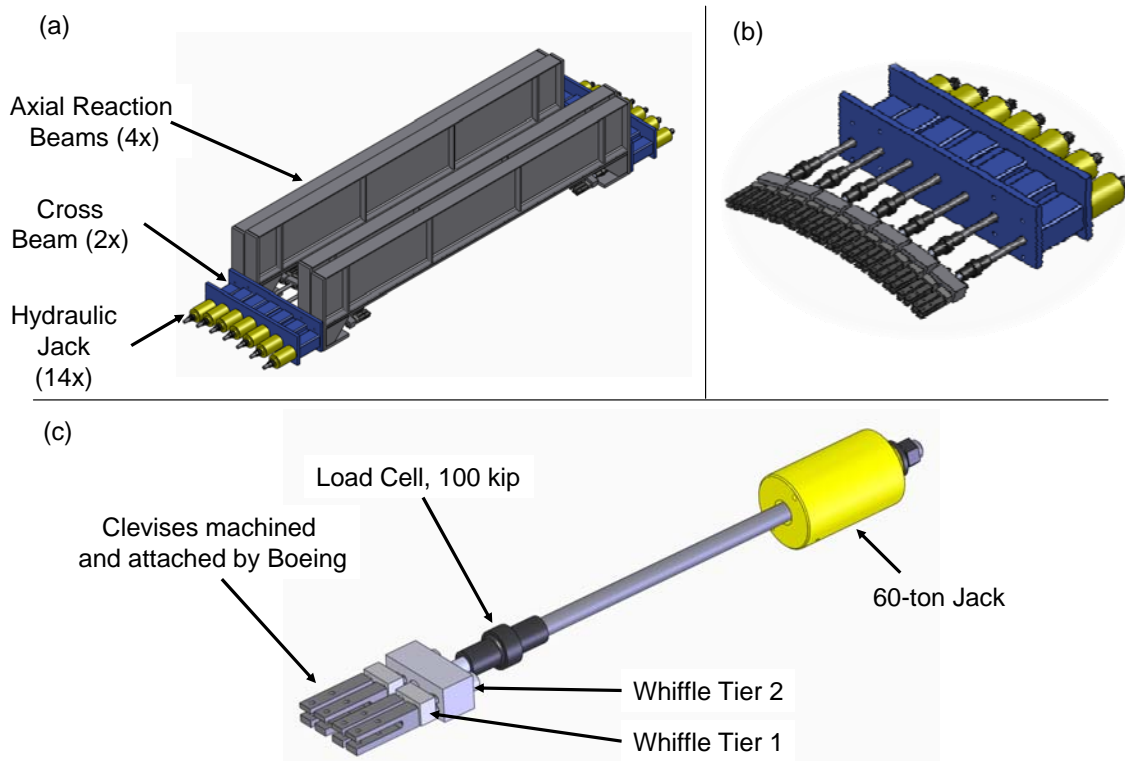
Failure loads for the PRSEUS panel were predicted to exceed the existing FASTER fixture axial load capacity of 100 kips. Based on previous PRSEUS testing, a new axial load mechanism was designed with a capacity of 840 kips to catastrophically fail the PRSEUS test panel. The significant increase in axial load capacity was accomplished using fourteen 60-ton hydraulic jacks connected to each end of the panel with a whiffletree assembly as shown in Figures 7a and 7b. The axial loading is reacted by four built-up beam columns, which measure 178 inches long and 24 inches tall, each weighing approximately one ton. A detail view of a single axial load whiffle tree assembly is shown in Figure 7c.

Figure 7: Axial load mechanism assembly (a). A cross beam with seven whiffletrees is shown in (b). A detail view of an axial whiffle tree is shown in (c).

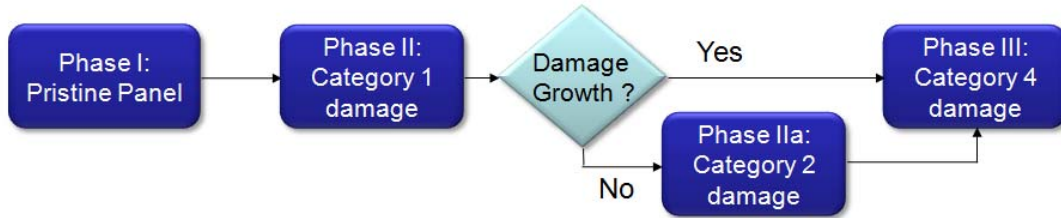
Testing will be performed in three phases with increasing damage severity in order to show compliance with CFR 25 requirements for structure. The three phases of testing follow the flow chart illustration in Figure 8. In the following subsections, each phase is described in detail including the objective, damage case, applied loads, and inspection and monitoring methods.

Figure 8: Test phase flow chart.

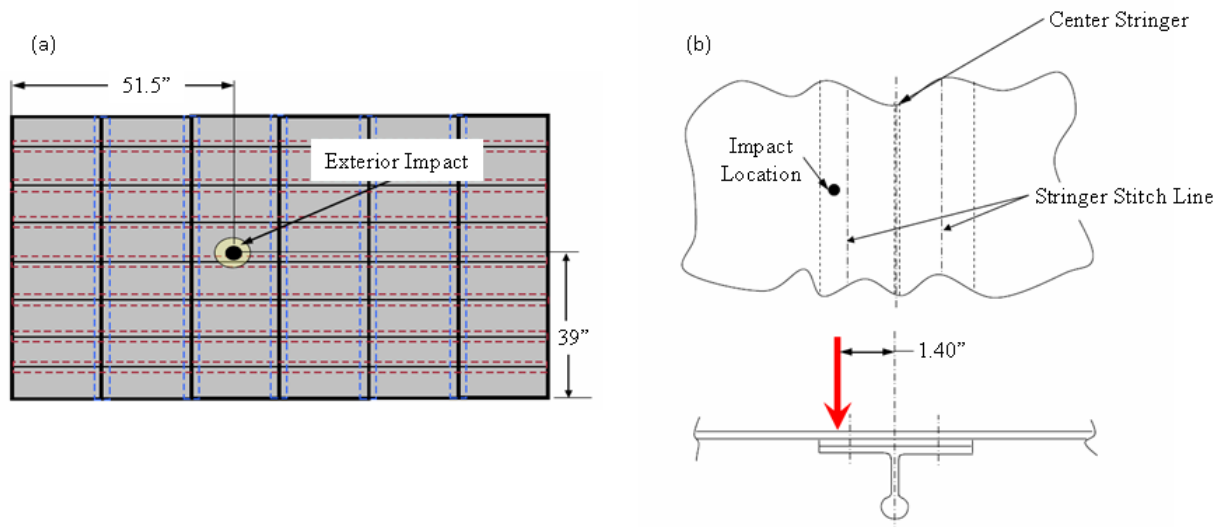
The objective of phase II is to demonstrate that the panel with Category 1 damage in the form of BVID, meets the strength and deformation requirement of CFR 25.305. Category 1 damage is defined as damage that may go undetected by scheduled or direct field inspection or allowable manufacturing defects by AC 20-107B. The Category 1 damage will be created using a portable impactor with a 1" diameter hemispherical tup on a cylindrical weight and impact energy of 40 ft-lbs. The damage location is shown in Figure 9a in reference to the panel OML and in Figure 9b in reference to the central stringer. During phase II, testing damage growth will be monitored and quantified using NDI techniques.

Figure 9: Phase II damage location with respect to (a) the panel OML and (b) the central stringer.

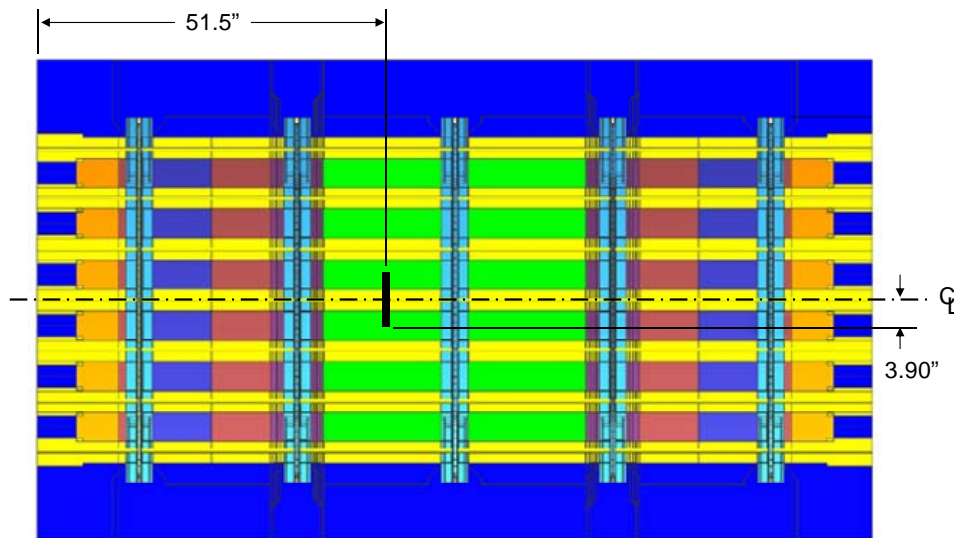
The objective of phase III is to demonstrate damage tolerance for DSD, in the form of a 2-bay saw-cut notch severing the central stringer, as shown in Figure 10. Compliance with CFR 25.571 is demonstrated by withstanding limit loads with discrete source damage. Then loading will be increased to catastrophic failure. During phase III testing damage growth and ultimate failure load will be monitored and quantified.

Figure 10: Discrete source damage saw cut position and dimensions.

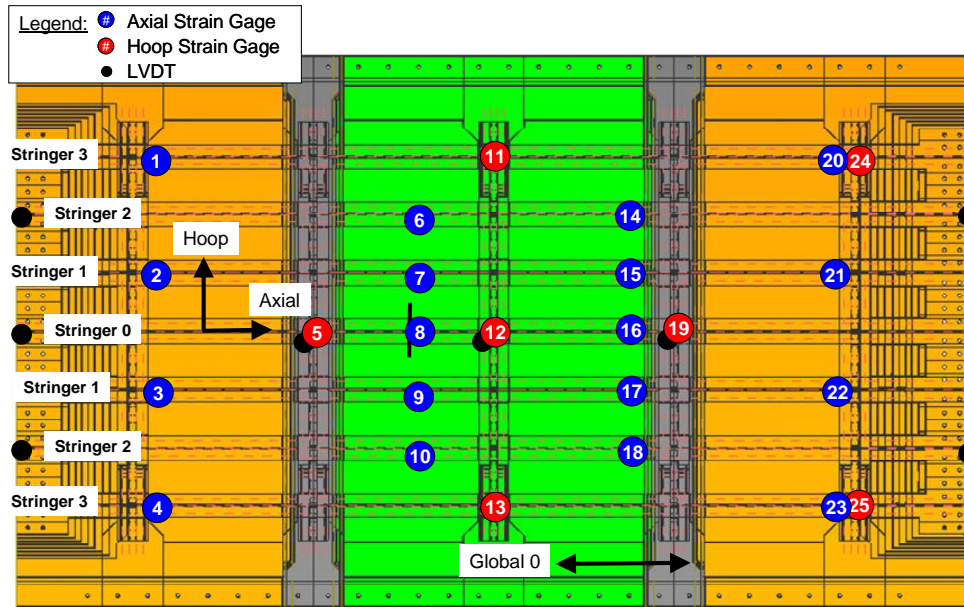
Strain gages, linear variable displacement transducers (LVDTs), and an ARAMIS Photogrammetry system will be used to record strain, displacements, and deformation. The test panel will be instrumented with strain gages to monitor real-time strain distribution to ensure proper load introduction from the load application points. Strain gages will be installed in

proximity to the skin, frames, and stringers, on the OML and IML as shown in Figures 11 and 12.

Figure 11: OML strain gage and LVDT locations.

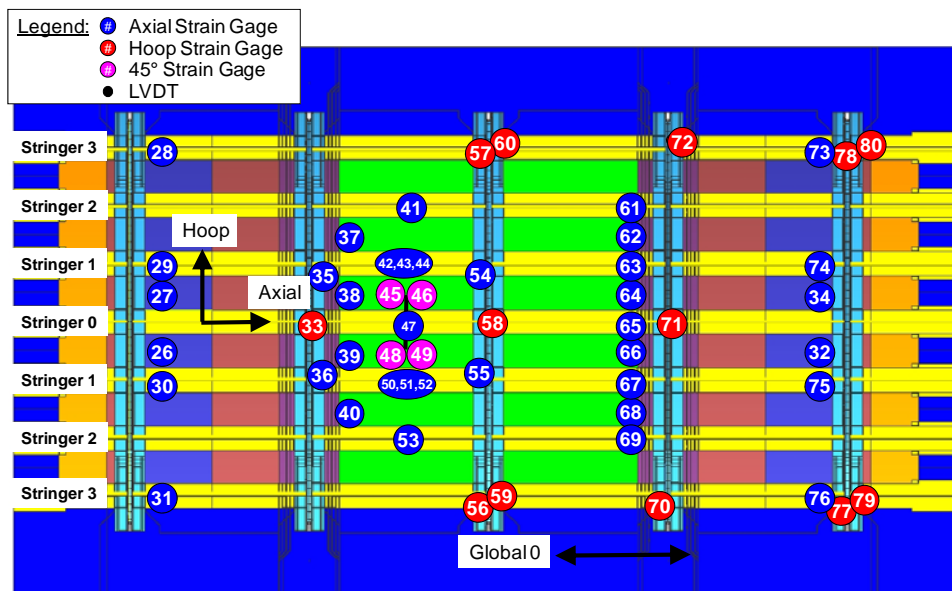
Figure 12: IML strain gage locations.

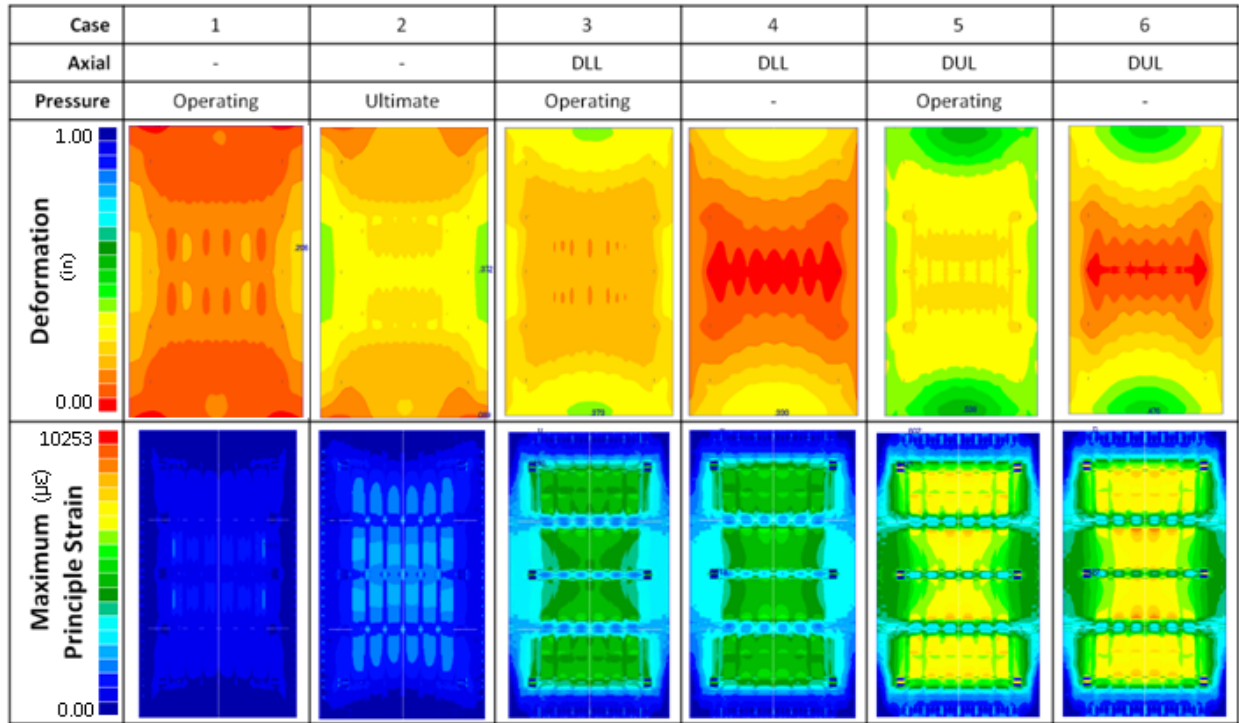
The FEM was used to predict displacements and strains, and to calculate margins of safety. The test sequence was written with loads applied in increasing severity based on FEM results. As shown in Table 4, fringe plots were generated to illustrate the deformed shapes and the maximum principle strain distribution for six loading cases. All deformation fringe plots are consistent with the applied symmetric loading. The plots predict that the load introduction edge-effects are minimized in the test section where damage will be introduced.

Table 4: Deformation and maximum principle strain fringe plots for six loading cases.

Predicted maximum principle strains, $\epsilon_{p,max}$, in the skin, stringer wrap, stringer tear strap, and frame tear strap were compared to allowable strain, $\epsilon_{allowable}$, from the ACT program tests and previous PRSEUS tests [4]. The stringer rod was also included in the comparison; however, maximum principle stresses, $\sigma_{p,max}$, were compared to allowable stress, $\sigma_{allowable}$, because allowable strain was not available. Table 5 shows a summary of the margin of safety comparison, where margin of safety is defined as $\epsilon_{allowable}/\epsilon_{p,max}-1$ and, in the case of the stringer rod, as $\sigma_{allowable}/\sigma_{p,max}-1$. As expected, the margin of safety for the skin approaches zero under ultimate axial load.
