PROCEEDINGS

5th International Congress

DIAGNOSTICS AND RESTORATION (1st Part)

SUSTAINABILITY AND ENVIRONMENTAL CARE IN THE ANASTYLOSIS AND RESTORATION PROJECT OF THE FIRST ORDER OF THE SEVERIAN MARBLE *SCAENAEFRONS* OF THE THEATER OF HIERAPOLIS OF PHRYGIA

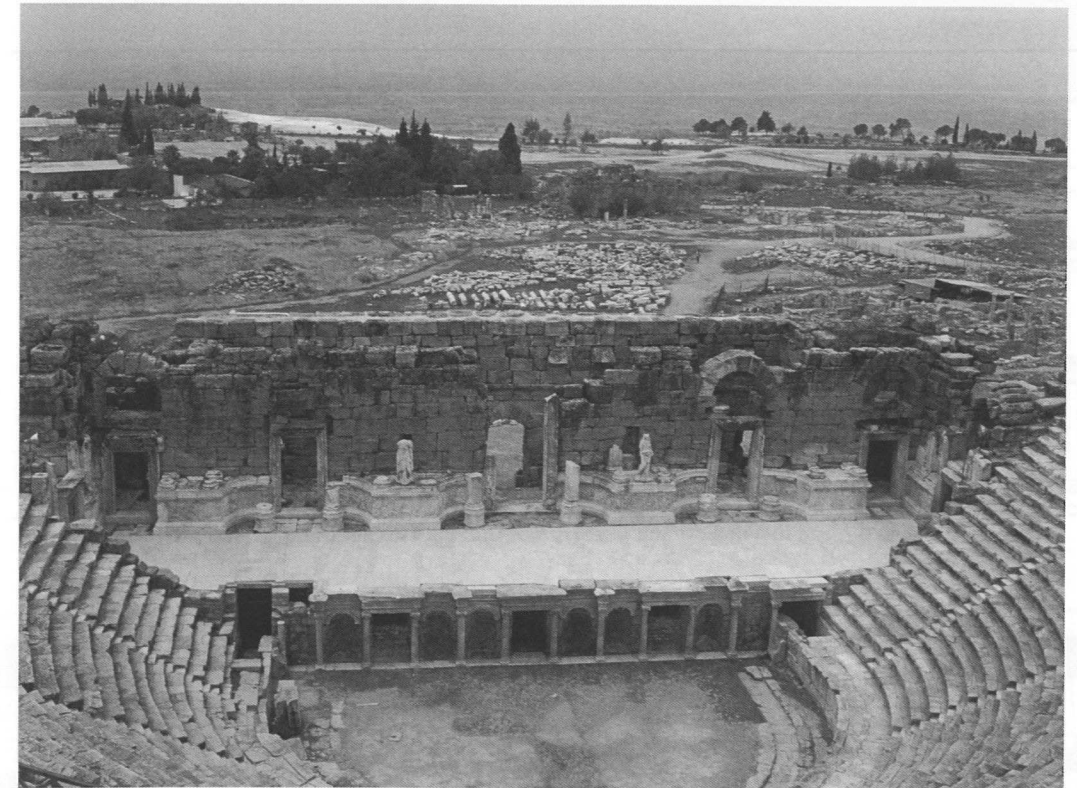
Fig. 2 – The theatre of Hierapolis in 2007, after the restoration of the stage and the hypocaust. Behind the theatre, the square of the reconstructions (Paolo Mighetto)

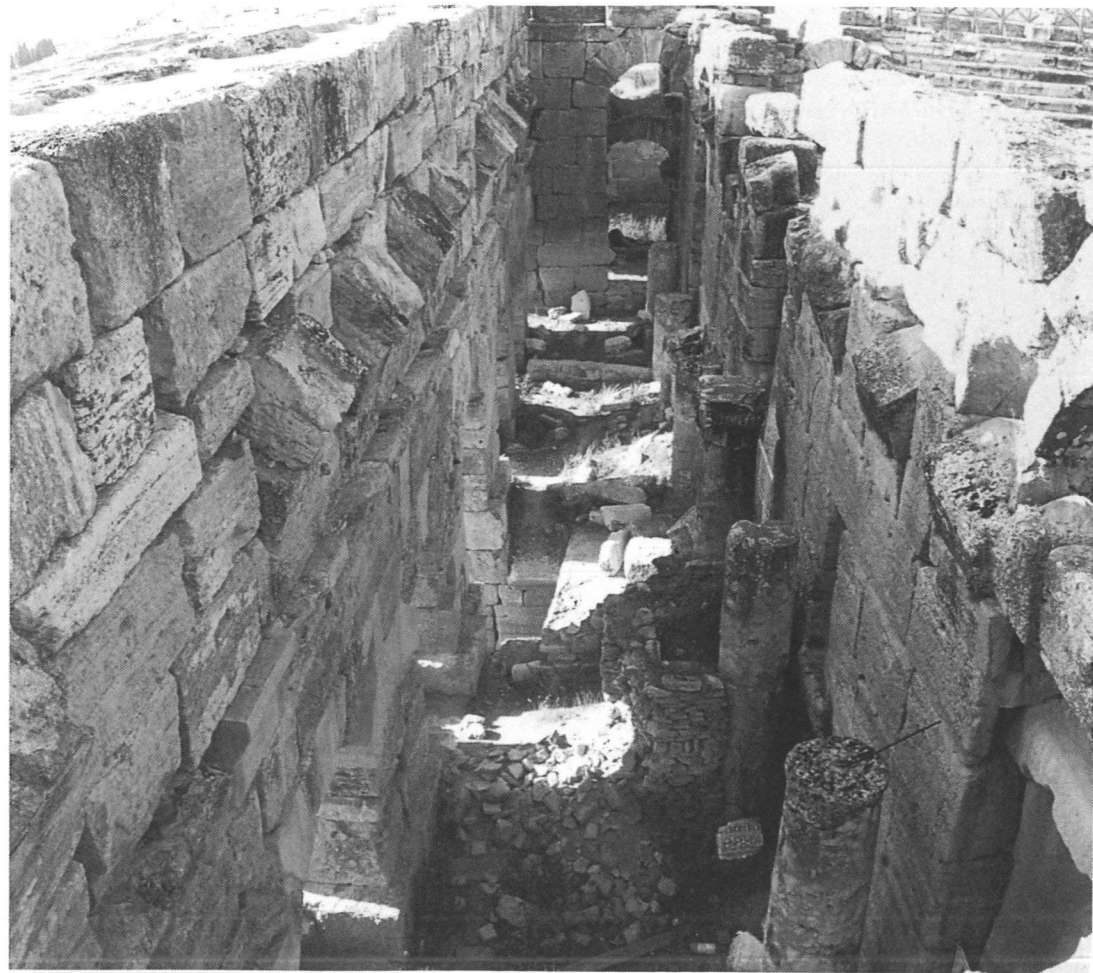
Fig. 3 – The *scaenae* building of the theatre with the sets of transverse arches (Paolo Mighetto)

The same choice of using ties between the opposite walls of frontescena and retoscena, but with a fully contemporary language and materials -this means metal arches that reconstitute the interior volume of the scaenae building- concern the attention to the original geometry -product of the history of the building- to the specific mechanical history of the building that allow us to understand and evaluate the reliability and effectiveness of the technical solutions provided. It 'should be emphasized that the new consolidation facilities and related stairs will ensure the chance for a maintenance over time in the structure and-to those parts of the building that are now inaccessible.
