A new experimental snow avalanche test site at Seehore peak in Aosta Valley (NW Italian Alps) – Part II: engineering aspects

M. Barbero¹, F. Barpi¹, M. Borri-Brunetto¹, E. Bovet¹, B. Chiaia¹, V. De Biagi¹, B. Frigo¹, O. Pallara¹, M. Maggioni², M. Freppaz², E. Ceaglio^{2,4}, D. Godone³, D. Viglietti², E. Zanini²

Keywords Avalanches dynamics; small and medium avalanches; experimental site; NW Italian Alps

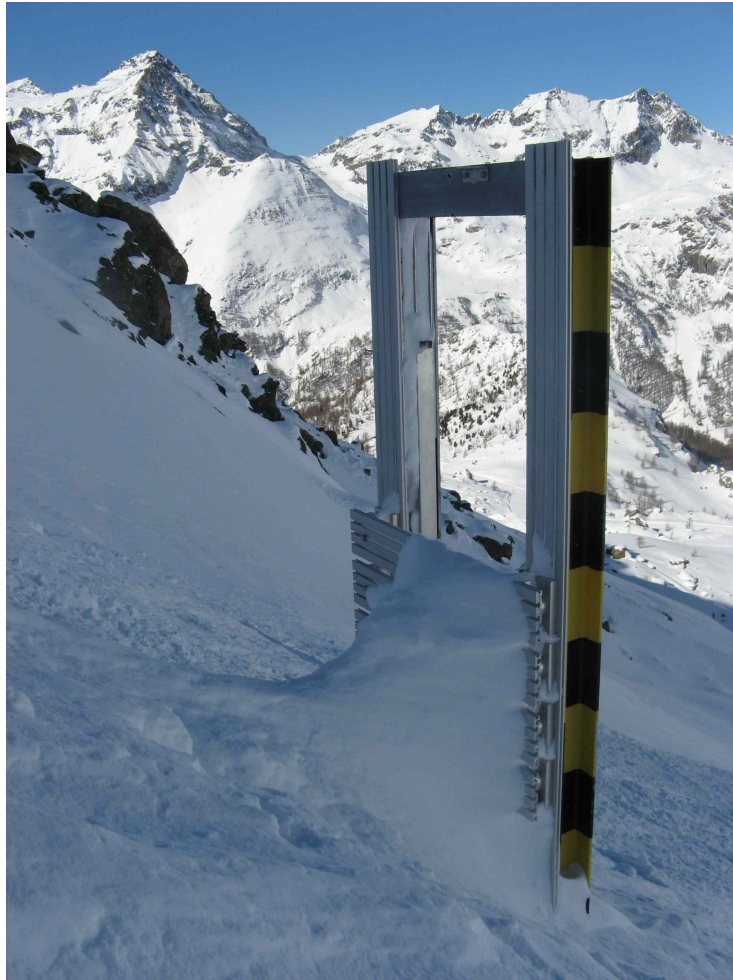
Figure 4: View of the obstacle after an avalanche event. Only the upper part of the steel structure emerges from the snowpack.

The following main parts were assembled (Figure 4):

1. a vertical obstacle made of galvanized steel profiles (4.0 m high, protruding 2.8 m from the natural slope profile), consisting of a lower section bolted to the concrete foundation, serving as a support for the upper part which carries the sensors, directly exposed to the avalanche impact;
2. a sealed electric cabinet that hosts the acquisition and control systems, terminal of the power supply line and of the optical fiber of the data transmission line, connected to the upper station of the Staffal-Gabiet cableway;
3. a galvanized steel shed that protects the cabinet from the direct impact of the avalanches and provides also a walking surface to reach the upper part of the obstacle for inspection and maintenance works.

The impact surface is made of an array of 5 aluminum grooved plates placed at different heights, each one supported by two load transducers, which are connected to the structure. The load transducers are, in turn, mounted on slides that can be easily moved along vertical guides: this design permits their positioning at the desired height above the ground level. The total area of the impact plates is 1 m² (Figure 4).

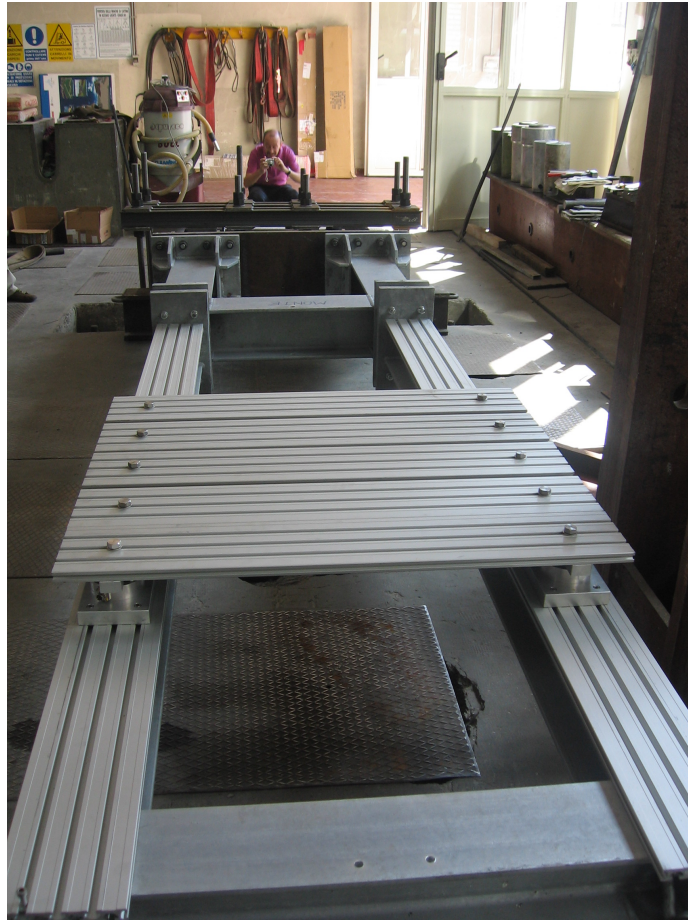
Figure 6: The obstacle mounted in horizontal position as tested in the laboratory.

In order to validate the design assumptions, a number of tests have been carried out at the laboratory of structural mechanics of the Department of Structural, Geotechnical and Building Engineering of the Politecnico di Torino. The complete structure had been assembled within a specially built testing frame in order to place the obstacle in a horizontal position (Figure 6).

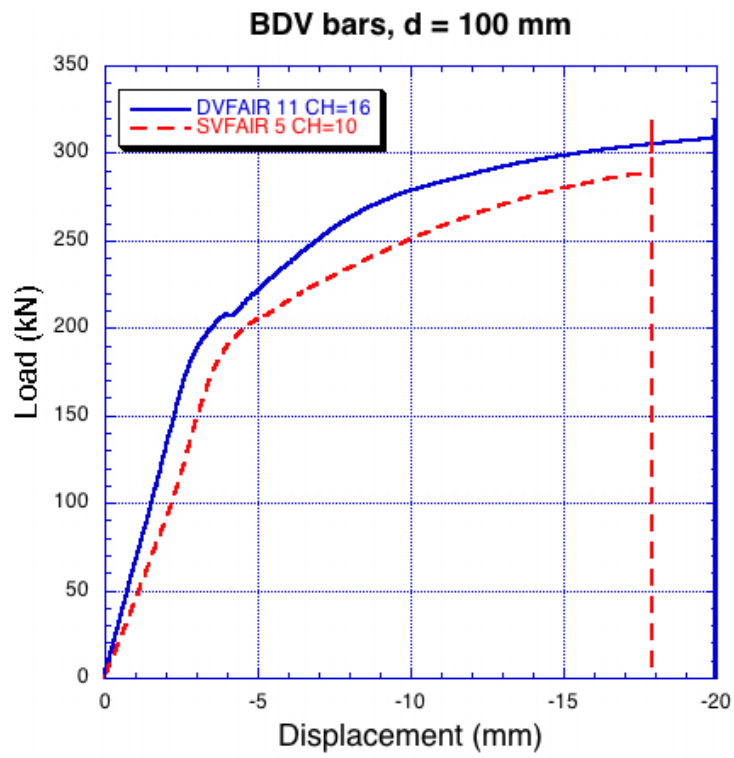
Figure 8: Total load vs. relative displacement for left (dashed) and right (solid) load limiter device (distance of load limiter plates equal to 100 mm).

In addition, static tests leading to failure of the load limiter device have been conducted, simulating different real loading conditions. Some results are presented in Figure 8, where the total load applied by the testing machine on the obstacle is plotted against the relative displacement of the load limiter plates. Such tests have been carried out for different distances of the load limiter plates, i.e., for different length of the steel bars linking the lower and the upper

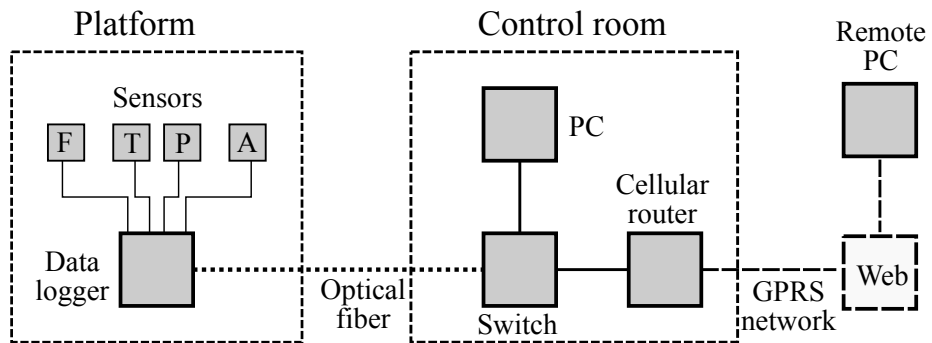
Figure 9: Block diagram of the communication network of the system. F, T, P, A denote the physical quantities measured by the groups of sensors: force, temperature, atmospheric pressure, acceleration, respectively.

The system conceived to fulfill the design tasks were divided logically into two main parts, namely, 1) the measuring and data logging part, located on the platform, near or onto the obstacle; 2) the data storage and control in a remote room, safe and easily accessible. The two parts are physically connected by a power line and an optical fiber for data transmission, both lying in a buried PVC duct, which ensures a permanent and reliable link. The control room is also connected, via cellular network, to the Internet, providing the possibility of remote operations. A scheme with the connections between the parts of the system is shown in Figure 9.

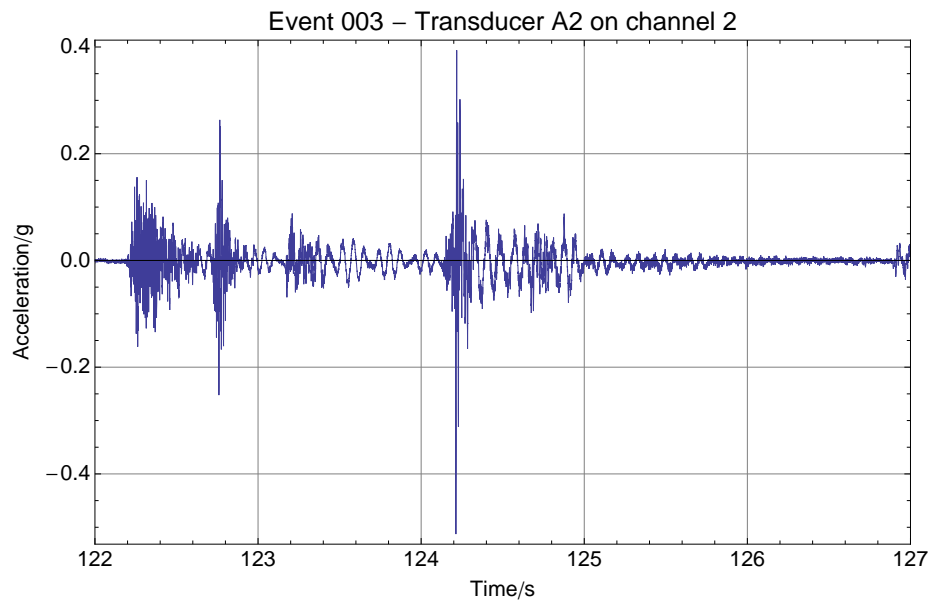
Figure 11: Example of measurements of acceleration plotted vs. elapsed time for an artificially triggered avalanche.

An example of the recorded data is shown in Figures 11 and 12, where the signals obtained from two sensors (an accelerometer and a load transducer), converted to engineering variables, are plotted for a time interval of 5 s beginning about 0.2 s before the impact of an avalanche.

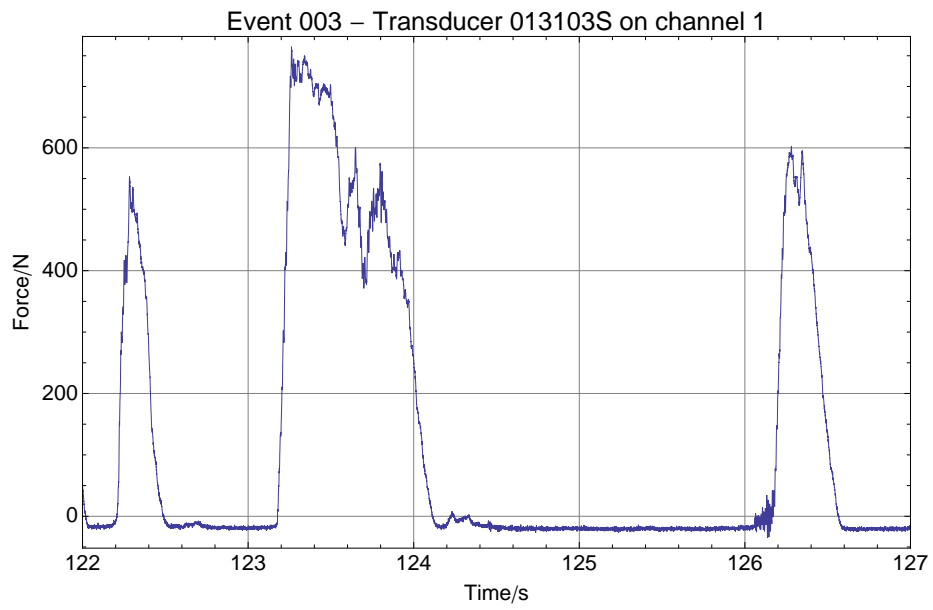
Figure 12: Example of measured force plotted vs. elapsed time for an artificially triggered avalanche.
