[Proceeding] Rutting Behaviour of Wearing Course Mixtures in Severe Temperature and Loading Conditions

## **RUTTING BEHAVIOUR OF WEARING COURSE MIXTURES IN SEVERE TEMPERATURE AND LOADING CONDITIONS**

In such a context, the Authors recently addressed the subject of rutting in wearing courses as part of a forensic investigation which was performed on a section of the East-West Motorway in Algeria. As illustrated in the following paragraphs, following the observation of significant rutting in the early phases of the service life of the pavement, laboratory tests were carried out to understand the origin of permanent deformation phenomena and to validate the adoption of a specific rehabilitation solution.

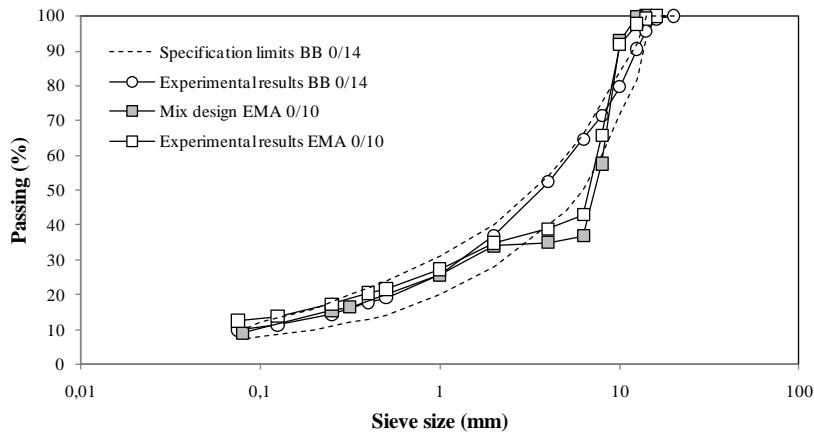
Figure 1 Aggregate size distribution of the bituminous mixtures

Composition tests showed that average binder content of the mixture (EN 12697-39), equal to 5.64%, was very close to the design value (5.60%) and to values recorded during quality control operations. Aggregate gradation (EN 933-1), of the continuous type, satisfied specification limits (Figure 1).

Results of composition tests showed that the EMA 0/10 had a slightly lower binder content (5.46%) and a finer and more discontinuous aggregate gradation than BB 0/14 (Figure 1).

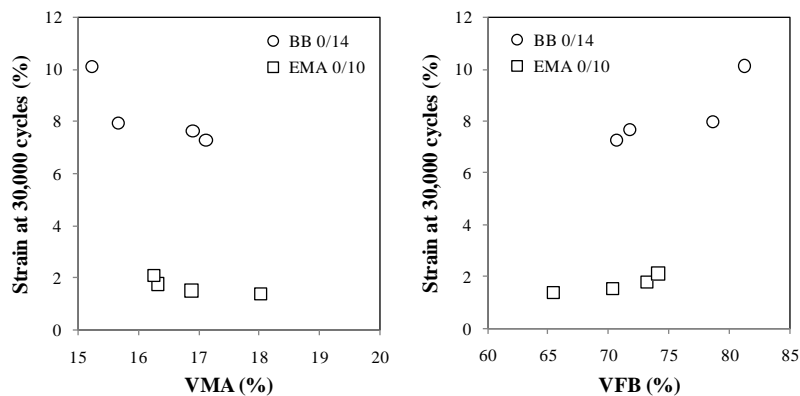
Figure 3 Correlations between volumetric and mechanical properties

Figure 3 provides a synthetic illustration of the correlations between volumetric and mechanical properties of the slabs subjected to testing.

For both bituminous mixtures, vertical strain at 30,000 cycles increases as the VFB is increased (i.e. as the bituminous binding mastic absorbs increasing portions of the applied loads), regardless of the fact that VMA is correspondingly reduced (i.e. as a closer aggregate packing is achieved). However, the strain level achieved by the two mixtures is clearly different because of their different aggregate structure and binder rheology.

These observations clearly indicate that in both cases permanent deformation is associated to viscous flow of the binding mastic rather than to post-compaction phenomena. Accordingly, it is convenient to adopt a binder characterized by enhanced stiffness properties at high temperatures in order to reduce the severity of rutting.
