# Thermal and Chemical Analysis of Fouling Phenomenon in Condensers for Cooling Tower Applications

Wu, Xiaoxiao and Cremaschi, Lorenzo, "Thermal and Chemical Analysis of Fouling Phenomenon in Condensers for Cooling Tower Applications" (2012). *International Refrigeration and Air Conditioning Conference*. Paper 1212.  
<http://docs.lib.purdue.edu/iracc/1212>

Xiaoxiao Wu<sup>1\*</sup>, and Lorenzo Cremaschi<sup>1</sup>

<sup>1</sup>Oklahoma State University, School of Mechanical and Aerospace Engineering,  
Stillwater, OK, USA

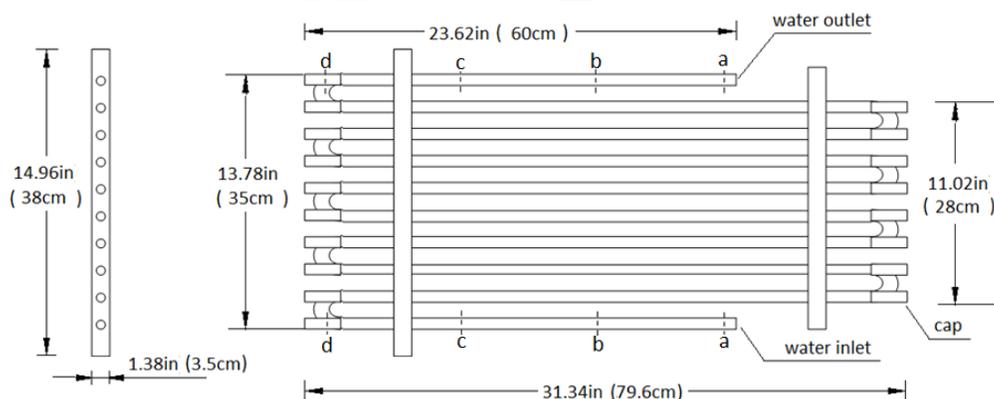
From authors previous work, BPHEs with different geometries were tested with different water quality. In order to provide some comparison of the fouling characteristics between BPHEs and tube-in-tube heat exchangers (TTHE), a smooth TTHE with the same heat transfer area as the BPHEs was investigated in this work. A schematic of the test TTHE is shown in Figure 1 and detail specifications are given in Table 1.

**Figure 1:** Schematic and dimensions of tube-in-tube heat exchanger<sup>#</sup>

The bore-scope of the CCD camera was inserted inside the water inlet and outlet tubes of the TTHE and digital images were taken at various locations indicated as “a”, “b”, “c”, and “d” in Figure 1. The corresponding images of the fouling deposit layers are shown in Figure 4; the top images are for the tube at the water inlet section while the

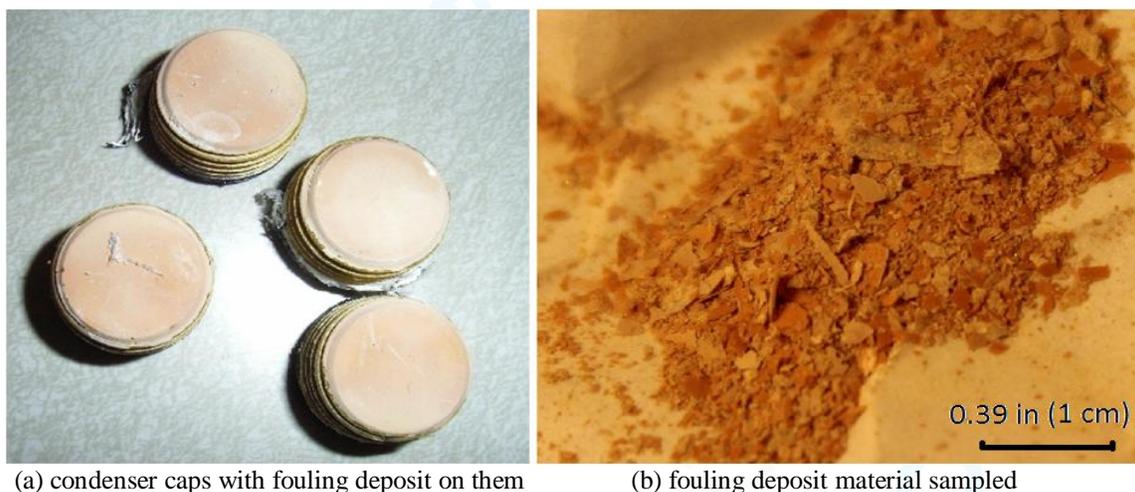
After two months of testing, the condenser was opened from the caps located at the end of each tube and a layer of light yellowish fouling deposit on the caps surface was visually observed, as shown in Figure 2(a). These images were taken by a conventional digital camera. It is evident that mineral precipitation occurred and the heat exchanger experienced fouling. The fouling deposit material was sampled, as shown in Figure 2(b), and composition analysis was conducted by chemical digestion at Soil, Water and Forage Analytical Laboratory (SWFAL) at Oklahoma State University. Chemical analysis showed that more than 85% of the fouling deposit was  $\text{CaCO}_3$ ; the amount of Mg was less than 0.5%; the amount of Fe, Cu, Zn were within 5%. During the fouling test, fouling deposited on every component throughout the entire water loop, including water tank, electric heater, cooling tower, water pumps, heat exchangers, and water pipes. In particular, the amount of fouling on the test TTHE was about 4 to 5% of the total amount in the water loop. When considering the area of the entire test set up without the TTHE, it was estimated that the mineral precipitation mass flux was about  $4.4 \times 10^{-5} \text{ lb}/\text{in}^2$  ( $3 \text{ mg}/\text{cm}^2$ ) and the precipitation mass flux in the TTHE was about  $3.7 \times 10^{-5} \text{ lb}/\text{in}^2$  ( $2.6 \text{ mg}/\text{cm}^2$ ). Considering the measurement uncertainty in the fouling deposit mass sampled from the TTHE and the approximation for the effective area exposed to fouling in the batch tank and in the cooling tower tank, the two precipitation mass flux were similar. In the TTHE the water had the highest bulk temperature but in the water tank, water reached the highest local temperature near the heating elements. In the

**Figure 2:** Fouling samples from TTHE condenser

In the process of sampling fouling deposit material from the tube caps, an observation was made that, the thickness of fouling varies according to the location of the cap. Thicker deposition appeared at the water outlet, where the water temperature was almost  $10^\circ\text{F}$  ( $5.56^\circ\text{C}$ ) higher than the water inlet. This phenomenon can be explained by the solubility of minerals in water since the solubility of  $\text{CaCO}_3$  decrease with increasing temperature as shown in Figure 3. More minerals tend to precipitate at higher temperature resulting in a larger amount of fouling deposit at the outlet of water tube than the inlet. In order to verify this assumption, a CCD camera with an extended bore-scope probe was used to take digital images inside the smooth tube-in-tube heat exchanger, as shown in Figure 4. The CCD camera had a high resolution short focus charge-coupled device camera and included a motorized 1 meter extended mini probe head, which was inserted in the condenser tubes.

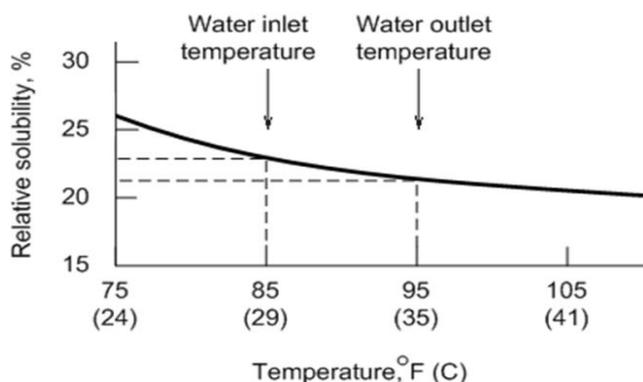
**Figure 3:** Solubility of  $\text{CaCO}_3$  with temperature change (adapted from (Flynn & Nalco, 2009) )

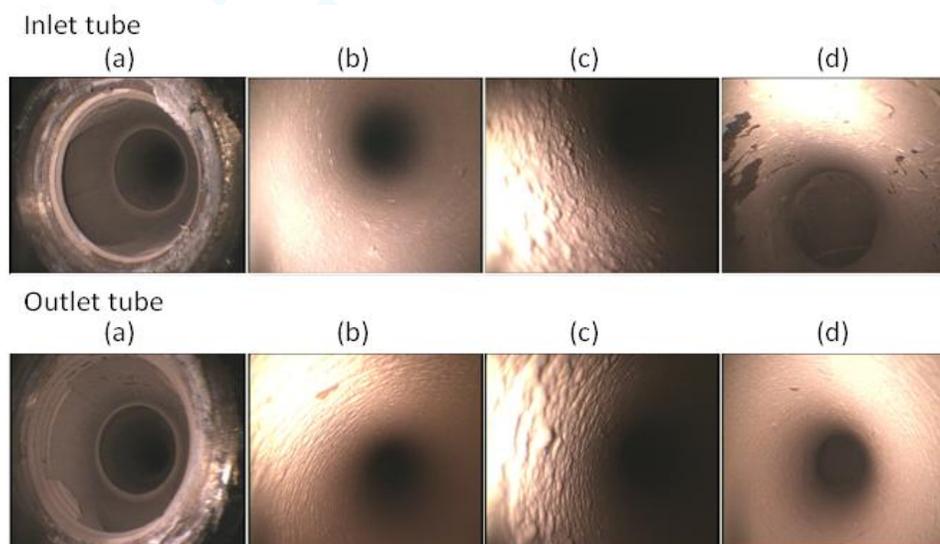
bottom images are for the water outlet section. The four images are labeled (a), (b), (c) and (d) and they represent the fouling conditions at the entrance, in the first half, in the second half and at the end of each tube. In order to make a comparison of fouling appearance, the photos were taken at the same axial location inside the inlet and outlet tubes. Thicker layer of fouling was visually observed inside the outlet tube than the inlet tube and photo (d) in Figure 4 supports this observation.

**Figure 4:** Images of fouling deposit inside smooth tubes of a tube-in-tube heat refrigerant condenser

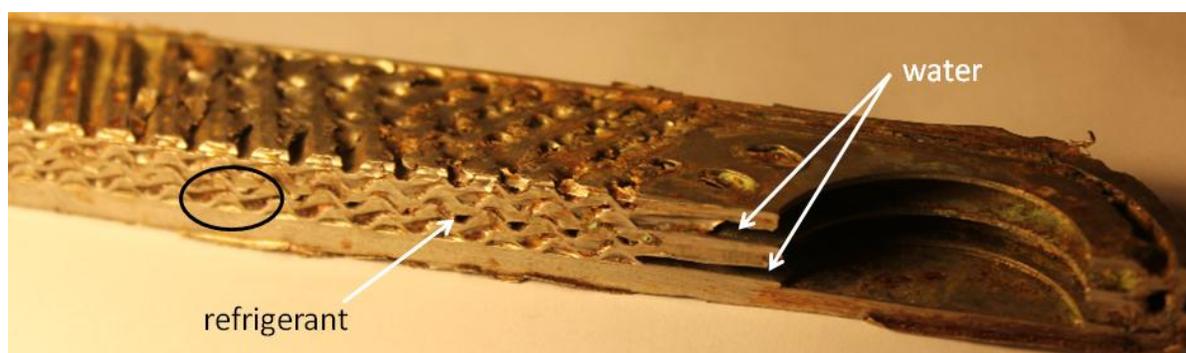
Attempts were also made to take fouling pictures inside the BPHEs, as shown in Figure 5. The authors cut the plate heat exchanger with a bench saw. It was observed that the thin metal plates plastically deformed due to the heat generated during the cutting process and the surfaces were contaminated by the cooling fluid of the saw. Inevitably some of the fouling deposit material was destroyed and removed. However, some fouling deposit was still visible inside the mini channels as shown in the circled region in Figure 5.

**Figure 5:** Images of fouling deposit inside a BPHE

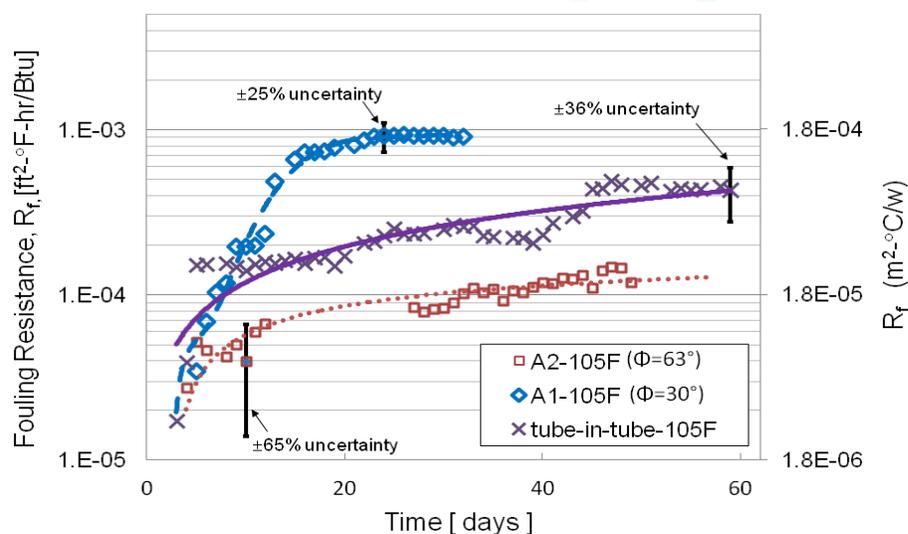
Figure 6 shows a comparison of measured fouling resistance between TTHE in the current work and BPHEs of authors previous work with same test condition and same quality of water. A1 indicates BPHE with soft corrugation angles of  $30^\circ$ , and A2 indicates BPHE with hard corrugation angle of  $63^\circ$ . The TTHE tested in the current work had the same nominal heat transfer area as A1 and A2 plates. Detail information of BPHEs geometry and experiments on A1 and A2 plate was given in Cremaschi *et al.* (2011, 2012)

In Figure 6, the A1 plate achieved a fouling resistance of about  $1.0 \times 10^{-3} \text{ ft}^2 \cdot ^\circ\text{F} \cdot \text{hr} / \text{Btu}$  ( $1.8 \times 10^{-4} \text{ m}^2 \cdot ^\circ\text{C} / \text{w}$ ) in 30 days, as shown in diamond points. A2 plate reached a fouling resistance of  $1.3 \times 10^{-4} \text{ ft}^2 \cdot ^\circ\text{F} \cdot \text{hr} / \text{Btu}$  ( $2.4 \times 10^{-5} \text{ m}^2 \cdot$

$^{\circ}\text{C}/\text{w}$ ) in 55 days, shown as square points. A1 and A2 plates had identical geometry; the only difference was that A1 had a soft corrugation angle while A2 had a hard angle. The experimental results clearly showed that the fouling resistance for A1 plate was almost one order of magnitude higher than A2 plate. Water in between the plates flows from the inlet to the outlet mainly in the mini-channels created by the corrugations on the plates, which are stacked on each other and rotated by  $180^{\circ}$ . Water also crosses the ridges from one mini-channel to the adjacent one, thus moving in a zig-zag pattern. The extension of the angle of the zig-zag pattern depends on the chevron angle and depth of the corrugations. Different local velocities and local turbulence intensity in between the plates are expected between the A1 plate and the A2 plate. The authors speculate that higher local velocity and higher degree of zig-zag were the A2 plate with respect to the A1 plate. Thus higher convective heat transfer coefficients and higher water side pressure drop in between the plates in A2 plate could be expected. This high level of local velocity and turbulence seems to promote the removal mechanism of the fouling deposit, resulting in a lower overall fouling resistance. Stasiak *et al.* (1996) investigated the influence of corrugation angles on flow and heat transfer phenomenon in plate heat exchangers. Their research revealed that the increase of corrugation angle would promote local Nusselt number, which is proportional to  $\text{Re}^{2/3}$ , which supported our speculation that higher local turbulence occurred in the A2 plate with hard corrugation angles. For the smooth tube-in-tube heat exchanger with same heat transfer area and operating conditions, its measured fouling resistance data was shown as cross points in Figure 6. Since the TTHE had larger water flow cross-section area than the BPHEs, the local velocity was expected to be fairly low. The measured fouling resistance was in between A1 and A2 plate; after 60 days of operation, a fouling resistance of  $4.8 \times 10^{-4} \text{ ft}^2 \cdot ^{\circ}\text{F}\text{-hr}/\text{Btu}$  ( $8.6 \times 10^{-5} \text{ m}^2 \cdot ^{\circ}\text{C}/\text{w}$ ) was obtained. The effects of geometry and local velocity were combined in this test, leading to a fouling behavior in between the A1 and A2 plate; similar phenomenon was reported by Bansal *et al.* (2001). However, more tests at different velocities and various tube diameters would be necessary for further investigation of the fouling behavior on tube and tube type condensers.

**Figure 6:** Comparison of measured fouling factor between TTHE (tube-in-tube) and BPHEs (A1&A2)

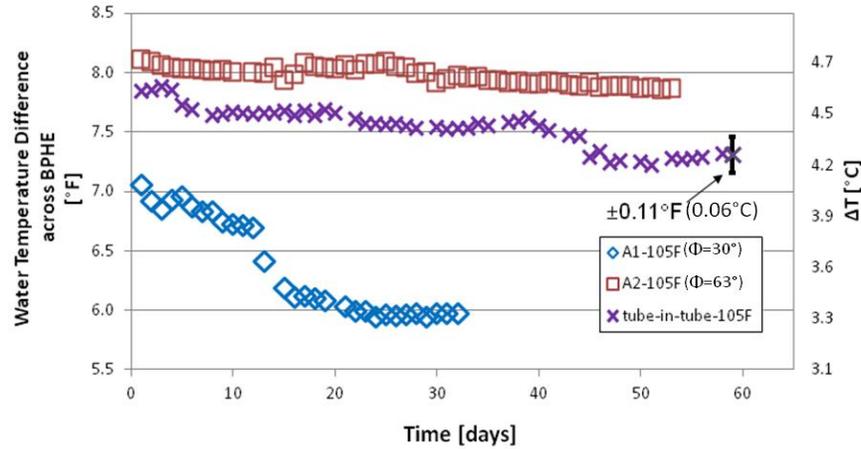
Figure 7 shows the water temperature difference between inlet and outlet of the test condenser. Three heat exchangers, A1, A2 and TTHE were compared. All of them were tested with same operating conditions. Since entering water temperature and the water flow rate were controlled to be constant for all the tests, the decrease of leaving water temperature has similar trend of the heat flux. A1 plate, shown as diamond points, had a sharp temperature drop of  $1^{\circ}\text{F}$  ( $0.56^{\circ}\text{C}$ ). The heat fluxes in clean conditions were about  $3,424 \text{ Btu/hr} \cdot \text{ft}^2$  ( $\sim 11 \text{ KW}/\text{m}^2$ ), and after 30 days of fouling test, the heat fluxes decreased by 28%. The A2 plate, with a hard corrugation angle of  $63^{\circ}$ , experienced a small decrease in the heat flux across the plate; the heat flux degradation was within 5% in 55 days with respect to heat flux in clean conditions. The trend of heat transfer degradation in TTHE was quite similar to the A2 plate. During 60 days of operation, a decrease of 8% in heat flux was observed, the water temperature difference across the test condenser for A2 plate and the TTHE had similar slope during first 40 days of operation. By the end of the fouling test, the temperature difference for the TTHE decreased by as much as  $0.7^{\circ}\text{F}$  ( $\sim 0.4^{\circ}\text{C}$ ).

**Figure 7:** Comparison of measured water temperature difference between TTHE (tube-in-tube) and BPHEs (A1&A2)

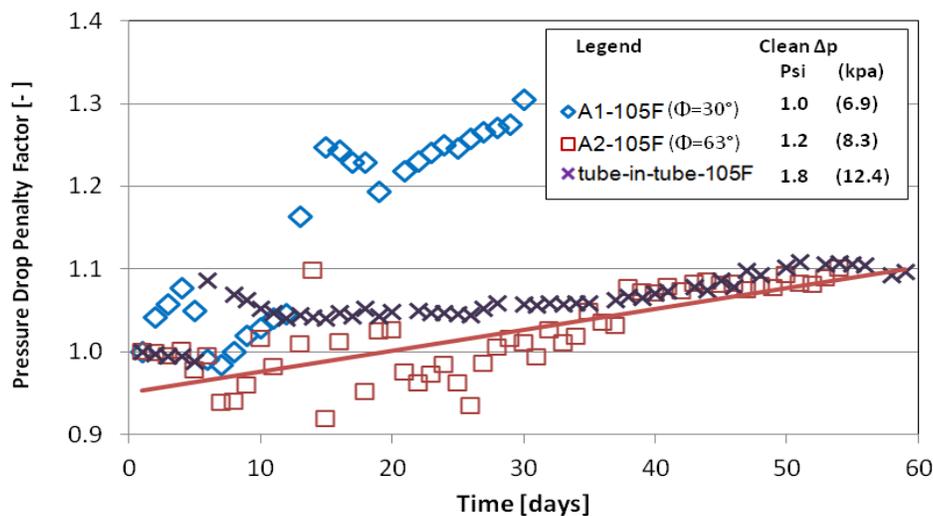
The hydraulic performance of the test heat exchangers is presented in the form of pressure drop penalty factors (PDPF) in Figure 8. Pressure drop across the test condenser in clean conditions are also given in the legend. PDPF values for each test were calculated according to Equation (2) and they represented the ratio of water side pressure drops measured in fouled conditions and the corresponding ones measured in clean conditions. For instance, the A2 plate had a PDPF of 1.1 after 55 days of fouling tests, which means a 10% of increase of pressure drop in fouled conditions was observed by the end of the test with respect to clean conditions. A1 plate experienced a localized blockage of the mini-channels and as a result, the pressure drop increased by 30%.

The cross points in Figure 8 indicate the pressure drop across the TTHE tested in the current work. Since the TTHE had larger free flow cross sectional area than the plate-type heat exchangers, it was not subjected to severe clogging due to fouling. As shown in Figure 8, at about day 5, the tube PDPF increased suddenly. This phenomenon is generally due to localized flow blockage from particulate fouling, in which particles attached on the surface and created a significant resistance to the water stream. After day 5, the increase of the PDPF for the TTHE was minor and the pressure losses were about 10% higher than the initial pressure drop in clean conditions.

**Figure 8:** Comparison of measured pressure drop penalty factor between TTHE (tube-in-tube) and BPHEs (A1&A2)

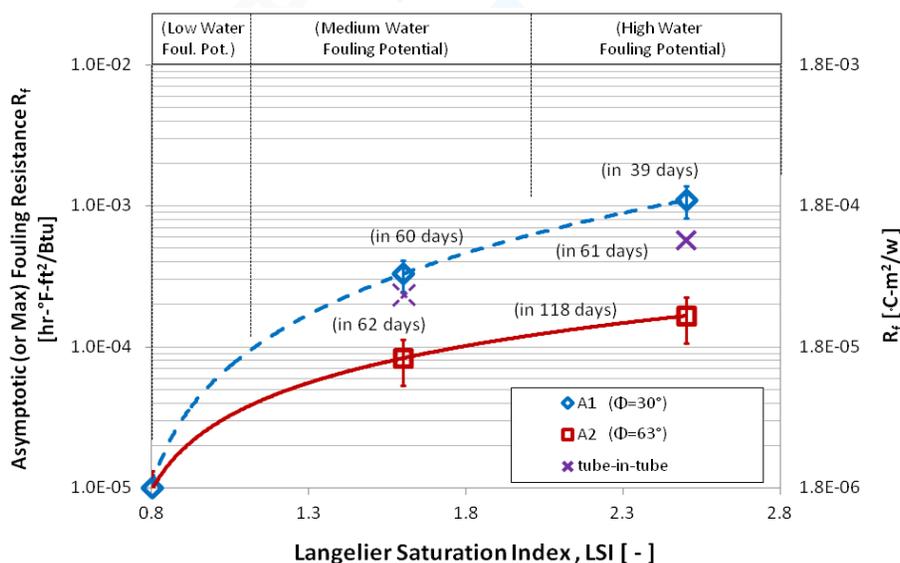
It should be noted that, high fouling potential water (very aggressive water in terms of precipitation) represent severe scaling conditions that should be avoided by proper water treatment of the cooling tower water. Figure 9 shows the effect of water quality on asymptotic fouling resistance. In this figure, both BPHEs and tubular heat exchangers are compared. For A1 plate with soft corrugation angles of  $30^\circ$ , shown as diamond points, the increase of water fouling potential from medium to high, would lead to threefold increase in fouling resistance, that is from  $3.3 \times 10^{-4} \text{ ft}^2 \cdot ^\circ\text{F} \cdot \text{hr}/\text{Btu}$  ( $5.8 \times 10^{-5} \text{ m}^2 \cdot ^\circ\text{C}/\text{w}$ ) to  $1.1 \times 10^{-3} \text{ ft}^2 \cdot ^\circ\text{F} \cdot \text{hr}/\text{Btu}$  ( $1.9 \times 10^{-4} \text{ m}^2 \cdot ^\circ\text{C}/\text{w}$ ) for medium and high fouling potential, respectively. For A2 plate with hard corrugation angle of  $63^\circ$ , an increase of fouling potential augmented the fouling resistance by about 50%. The trends indicate that water fouling potential has a measureable effect on the fouling performance of the heat exchangers. In the current work, the authors experimentally measured the TTHE performance at high fouling potential water while the fouling resistance at medium fouling potential was extrapolated from the data based on the results with A1 and A2 plates. This extrapolation point of the fouling resistance for the TTHE condenser at medium fouling potential is shown as the dashed cross in Figure 9.

**Figure 9:** Effect of water quality on asymptotic fouling resistance between TTHE (tube-in-tube) and BPHEs (A1&A2)
