NASA/TM—2017–219431

# **Hypersonic Inflatable Aerodynamic Decelerator (HIAD) Torus Mechanical Testing**

*Tony Chen, Matthew R. Moholt, and Larry D. Hudson  
Armstrong Flight Research Center, Edwards, California*

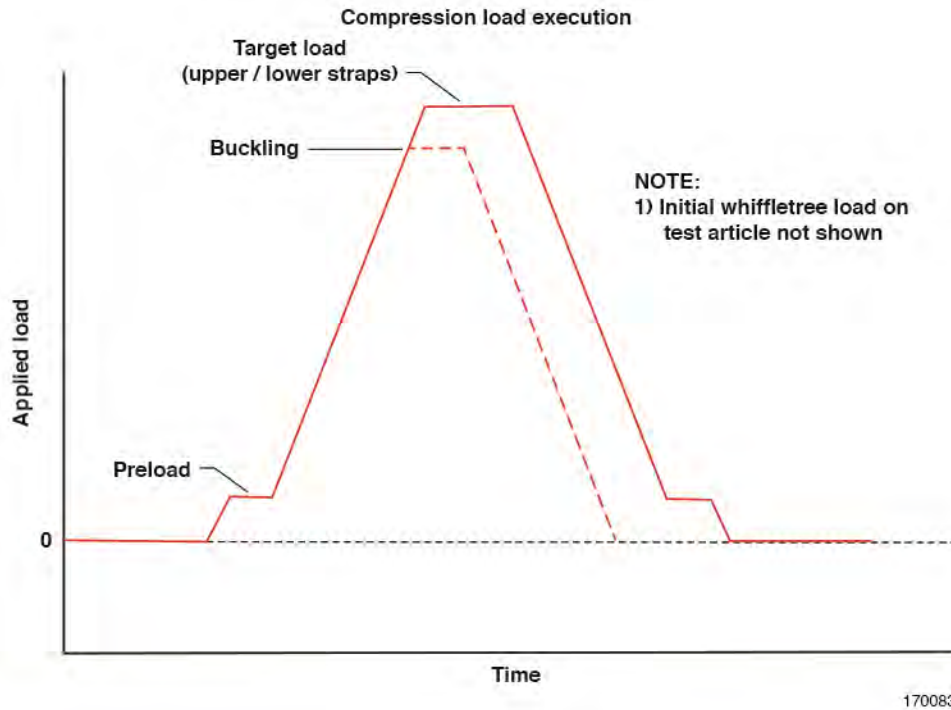
Figure 7. Representative load profile for the compression load cases.

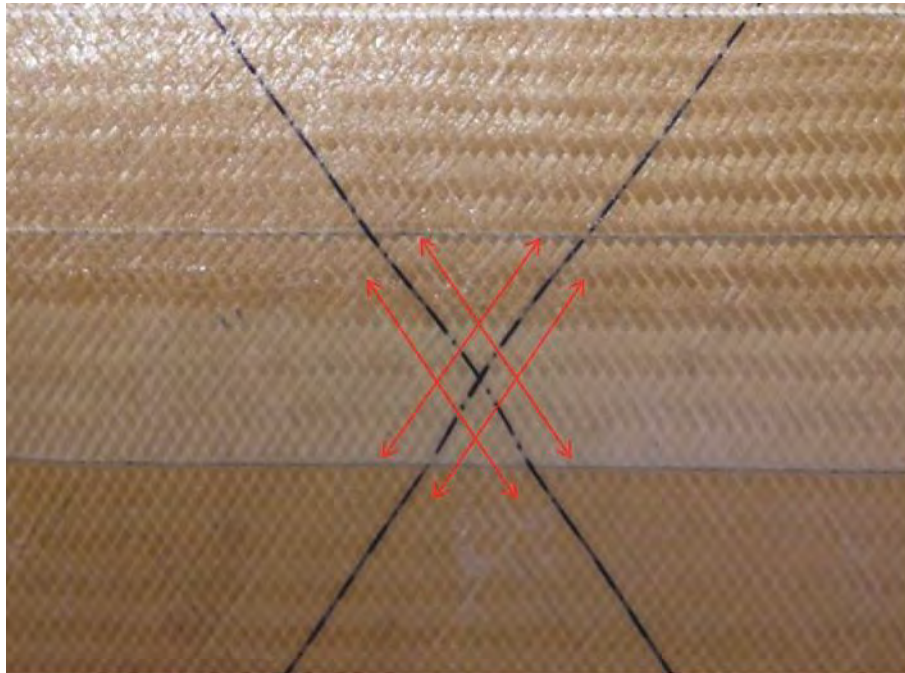
170085

**Figure 9. Braid fabric directions.**

After the completion of testing of the first two test articles, NASA LaRC requested that pre-test and post-test measurements of the test articles be performed to calculate the braid angles (figure 9).

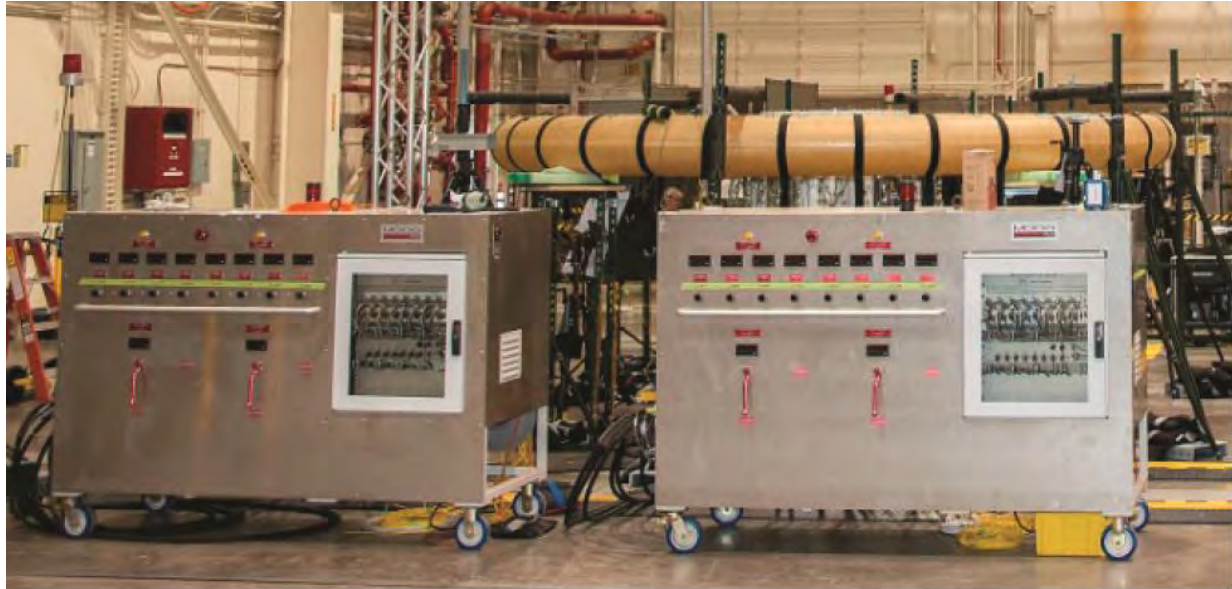
170098

**Figure 22. The hydraulic carts used for hydraulic actuator control.**

The FLL 80-channel mechanical load control system (MLCS) was used to support mechanical loading of the test articles. Two hydraulic carts (figure 22) with eight channels per cart were used to control 16 load control channels. Control was performed with force feedback from the load cells. Given the rather unconstrained nature of the test it was originally expected that stroke control would be required because the

test article could deform abruptly. Stroke control was not necessary, however, because the MLCS was able to control each jack using force control with minimum load error throughout the load profile.

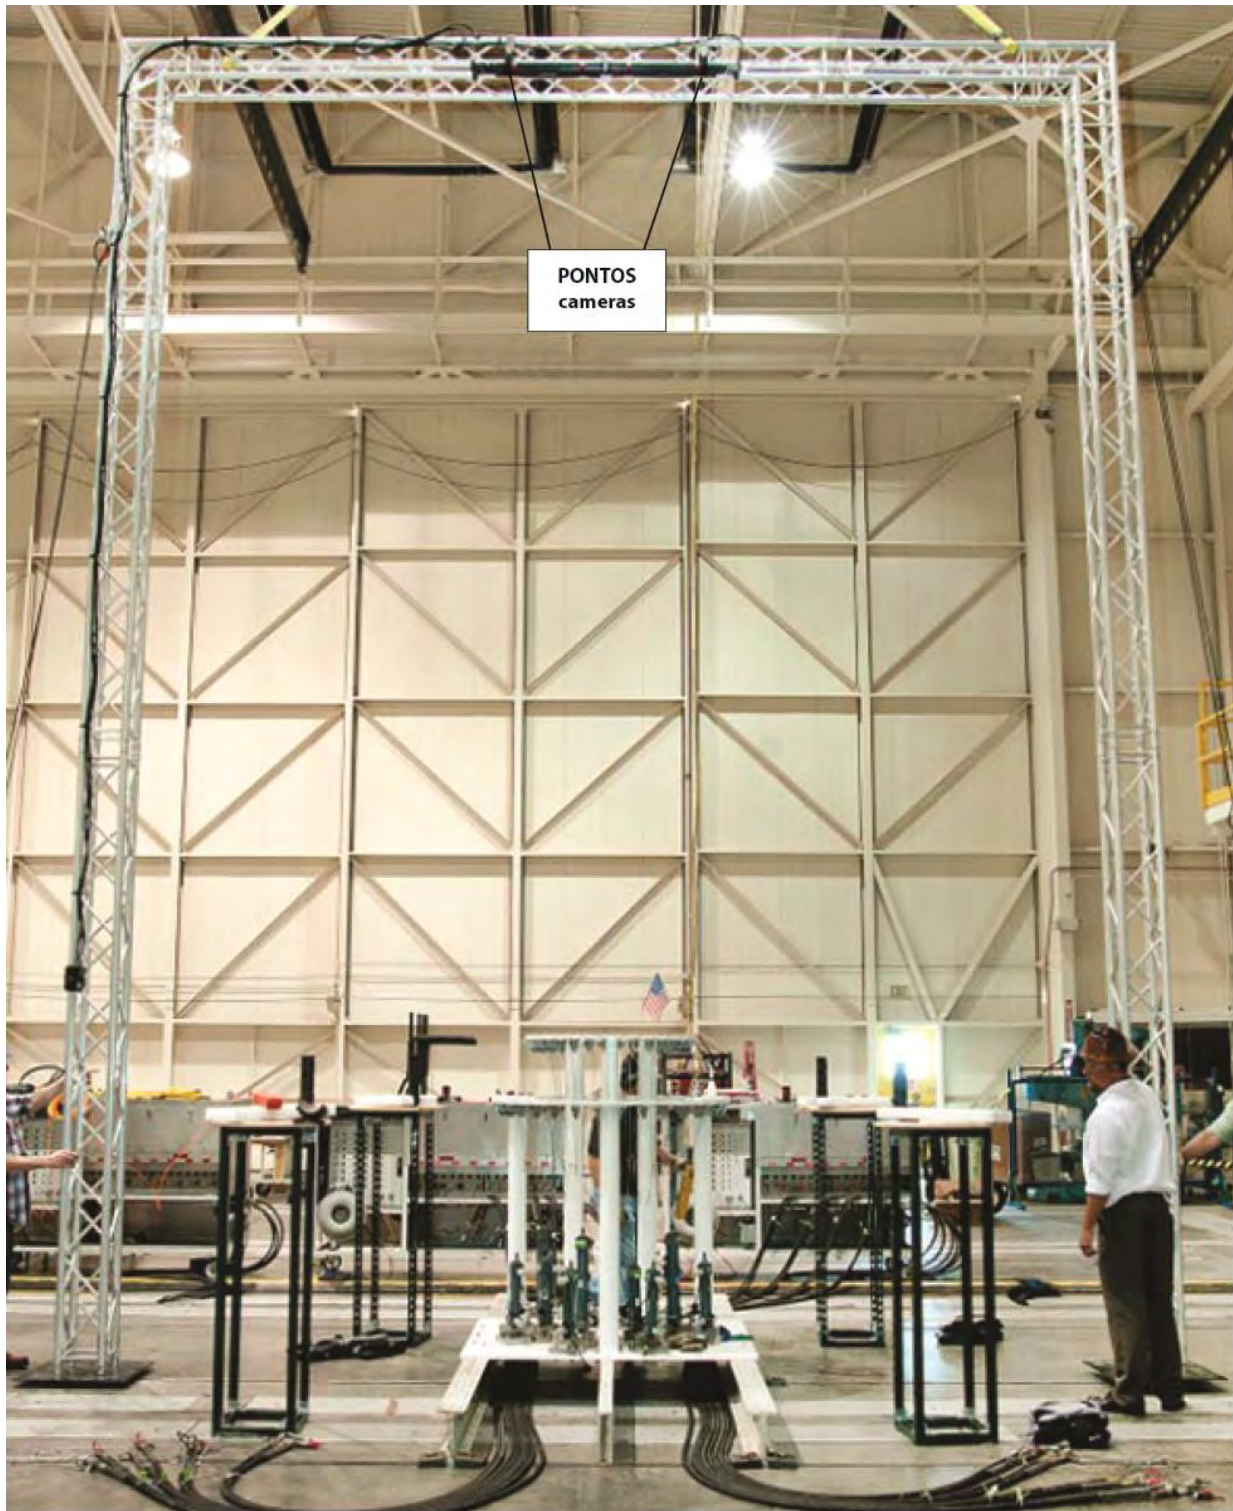
A PONTOS photogrammetry system was used to measure the global spatial displacement of each test article during load testing. The PONTOS system model #TXG50-K06 (GOM Optical Measuring Techniques, Braunschweig, Germany) was used, which is a non-contact, optical, 3-D point-tracking measurement system. The purpose of this system was to capture global movement of the test article during test by measuring the spatial position of targets located on the surface of each test article (figure 27), using two cameras looking down onto the test article from a height of approximately 20 ft (figure 28 and figure 29). Depending on the size of the test article, 80 to 120 targets were placed on the upper surface of the test article. There were also additional targets placed on stationary structures serving as reference points. The PONTOS data was taken at a rate of 1 image per second.

**Figure 28. The setup of the PONTOS cameras.**

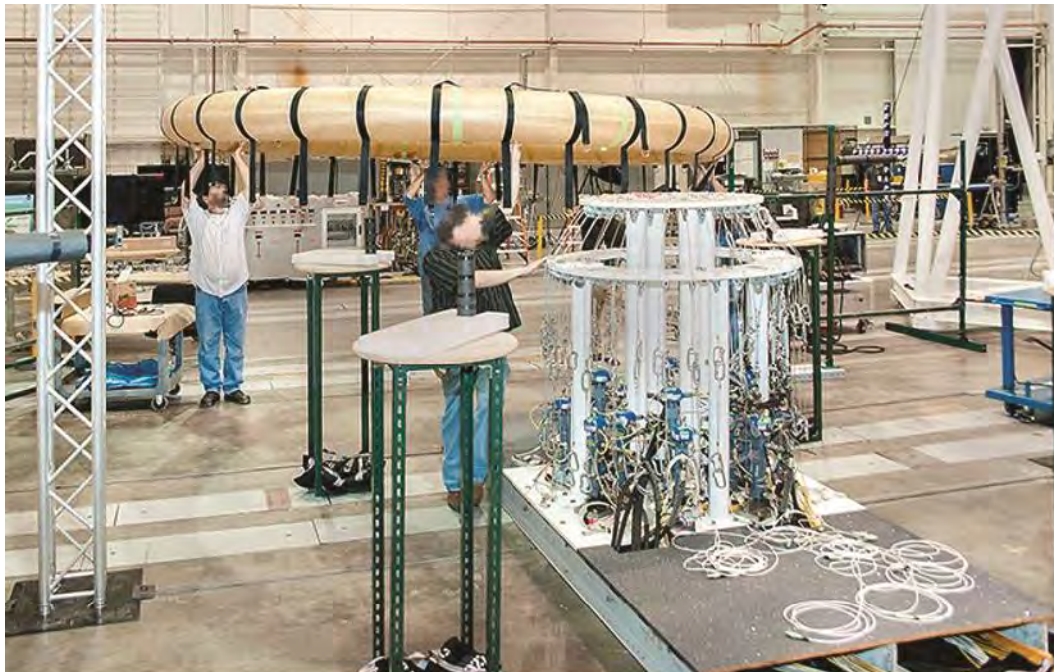
After completion of the installation process described above, the test article was ready to be placed in the test setup (figure 38). Once the test article was placed on the test stands and centered to the hub stand, all of the load train lengths and the string pot lengths could be fine-tuned to ensure there would be enough length to accommodate test article deformation. The photogrammetry PONTOS targets were also placed on the test article at this time. After the PONTOS targets were in place and the PONTOS system calibrated, the test article was then inflated to 15 psi for pre-test braid angle measurements. The ARAMIS system was then put in place and the calibration was performed. Figure 39 shows the test article in test configuration (placed on the test stands and connected to the load trains).

**Figure 38. Flight Loads Laboratory technicians placing the test article in the test setup.**

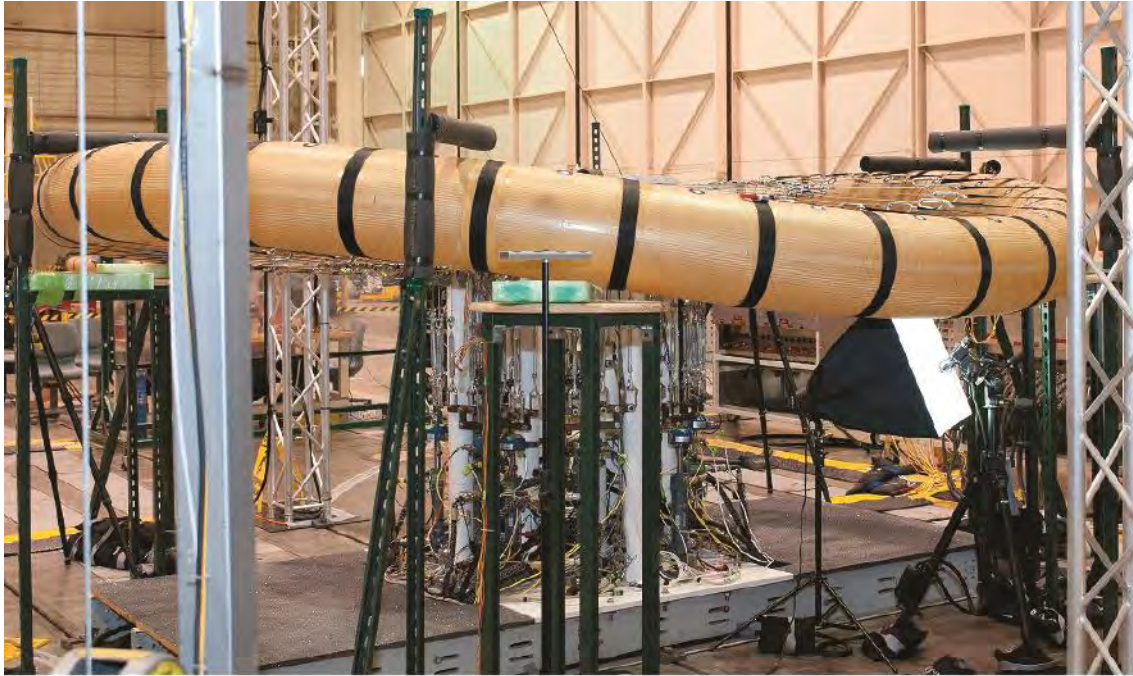
170119

**Figure 43. Out-of-plane buckling (test run #1 / T5C-1 / 20 psi / compression).**

**8.3.1.5 Visual Observation** - The buckled shape of the test articles were either in-plane or out-of-plane. During out-of-plane buckling, the test article could deflect several inches vertically in both directions, as shown in figure 43. In this case, test article buckling was easily detected by visual observation.

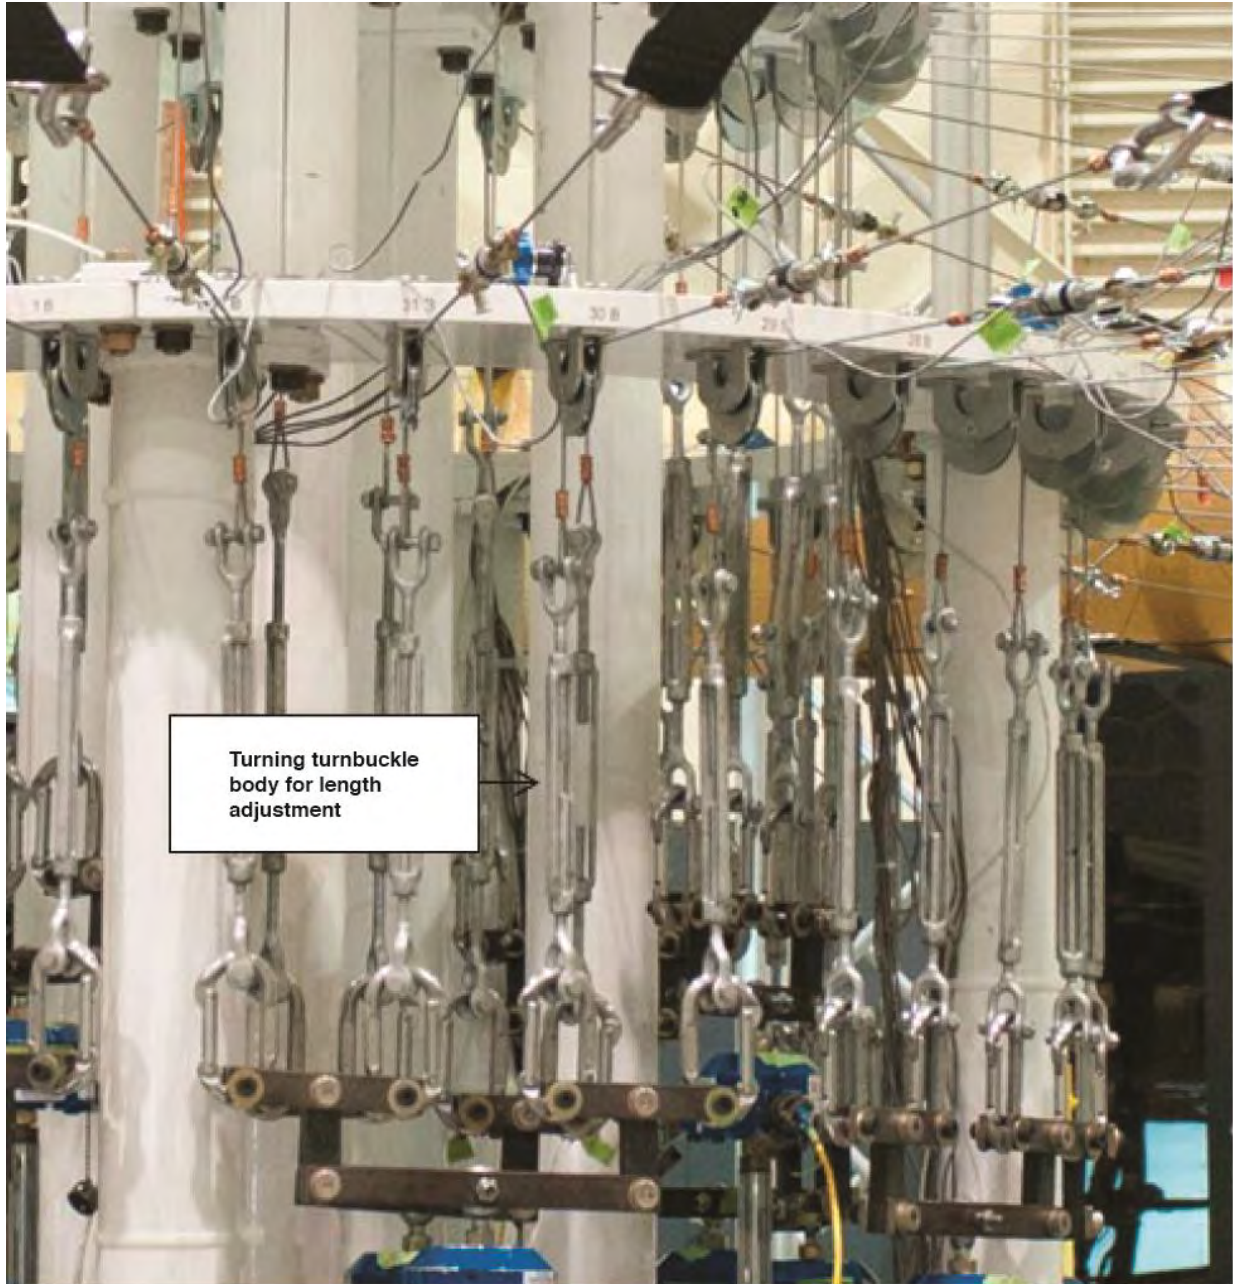
Due to the frequent turnbuckle adjustments required to maximize the available jack stroke for loading, the load train cable connection became loose and eventually disconnected during the loading of test article T5B-2 during test run number 127. Once pre-load had been applied, turnbuckles, as needed, were adjusted to maximize the jack travel in the direction of loading. It is very likely that turning the turnbuckle body (figure 55) also rotated the cable that routed through the pulley. It is believed that this rotation unscrewed the threaded connection between the clevis rod end and the in-line load cell (figure 56).

**Figure 55.** Turnbuckle adjustments were made to provide more available jack stroke.
