UNIVERSITY OF NOVA GORICA  
GRADUATE SCHOOL

**FEASIBILITY ANALYSIS OF A RESTORATION IN  
VENICE: CASE STUDY OF CA' ZENOBIO PALACE**

II. LEVEL MASTER'S THESIS

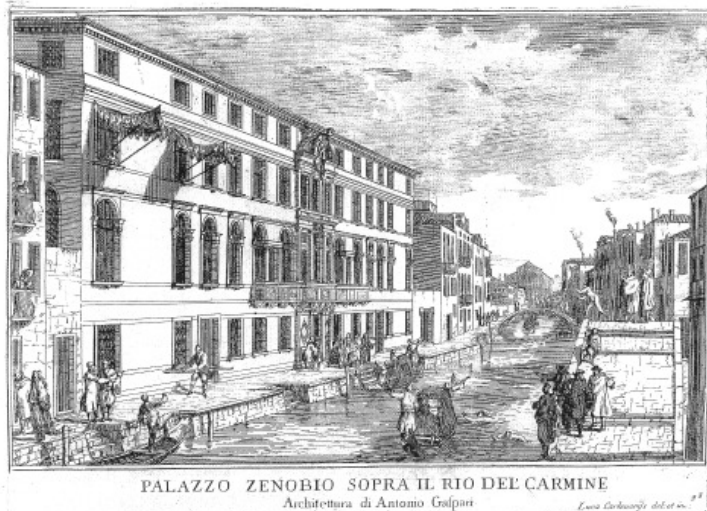
Image 9: Luca Carlevarijs, *Le Fabriche, e Vedute di Venetia* (1703)

the Palace both from the canal (image 9) and from the rear garden (image 10). There are some very interesting drawings of Antonio Gaspari, kept in the archive of Museo Correr in Venice that can help not to date but to understand how the building was conceived.

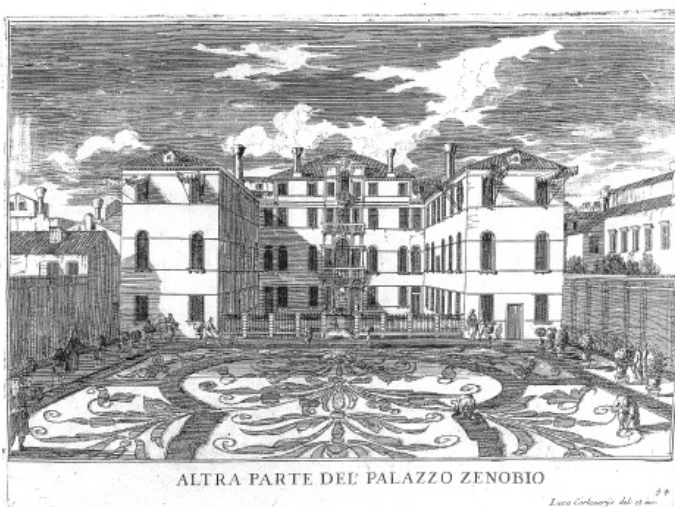
Image 10: Luca Carlevarijs, *Le Fabriche, e Vedute di Venetia* (1703)

part of the Palace. As one can see from the Carlevarjis etching (image 10) the two parts between the Palace and the two wings were present only in the area of principal façade<sup>38</sup>. Anyway this floor was surely used by servants.

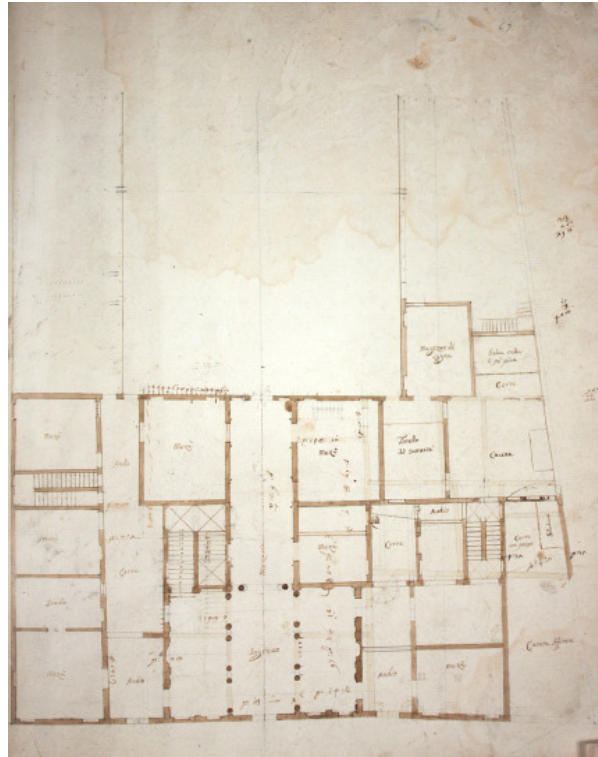
Image 15: Antonio Gaspari, final project for Ca' Zenobio - ground floor (XVII century)

There are also two drawings showing what should be the final solution for ground floor (image 15) and first noble floor<sup>33</sup> (image 16), since they are very similar to the present status of the building, at least in its central part. The most important information given by these drawings is that Gaspari maintains some of the principal walls, such as that of the main façade and of the *portego*. At the ground floor these two walls are transformed into pairs of columns supporting the wooden beam floor of the ballroom. The maintenance of some of the existing walls and beams for the new Palace is directly visible nowadays in the last floor, over the ballroom (see chapter III, paragraphs 2.5 and 3.1).

At the ground floor the main staircase is shown on the left of the principal entrance, as it still is, but the start was in the northern side and not directly from the *androne* as it is today. The

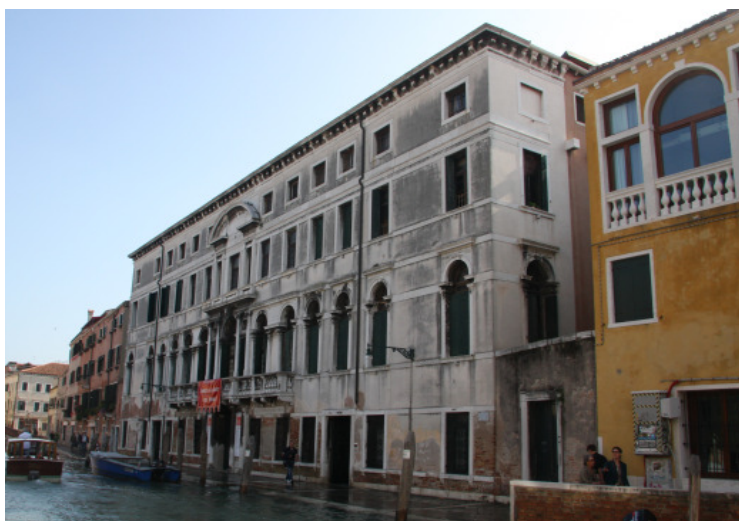
Image 17: Ca' Zenobio, principal façade

The main façade (image 17), entirely plastered with *marmorino*, is characterized by the regularity of the windows that doesn't suggest the double height of the ballroom of the first noble floor; anyway, the central important room is stressed by the presence of a balcony and large arched windows, studied in detail by Antonio Gaspari (image 18). The main entrance is also in the middle of the elevation, with an important portal, under the balcony (image 19); at the last floor a quite rare arched gable crowned the great stone coat-of-arms of the Zenobio family (now positioned on the eastern wing, facing the internal courtyard).

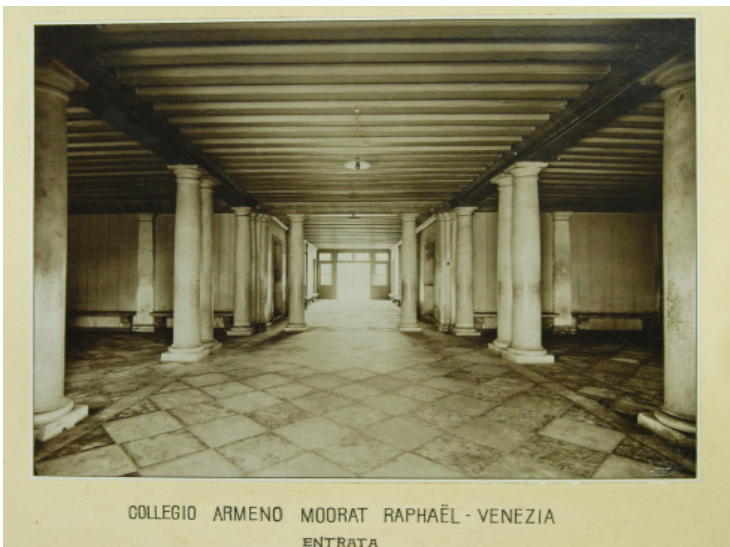
Image 20: Main entrance of Ca' Zenobio (20<sup>th</sup> century)

mainly marked by the entrance with a “T” shape (image 20), pairs of columns and a classical pavement with white and red stone-tiles (Istrian stone and *Rosso Verona* marble). Probably the wooden beams were decorated and the walls plastered with some nice decorative effect. The narrow *androne* has at his rear a large glass door as a passage to the courtyard, where at least two well heads and cisterns were located. From the paved courtyard a large wrought iron gate introduced to the rich garden, probably ornamented by baroque decorations, as portrayed in one of the Carlevarjis etchings (image 10), that “fills the whole width of the gardens with curvilinear forms, perhaps laid out in coloured earths (gardeners who are working on them seem to be tidying the material within each arabesque) while potted plants are ranged around the

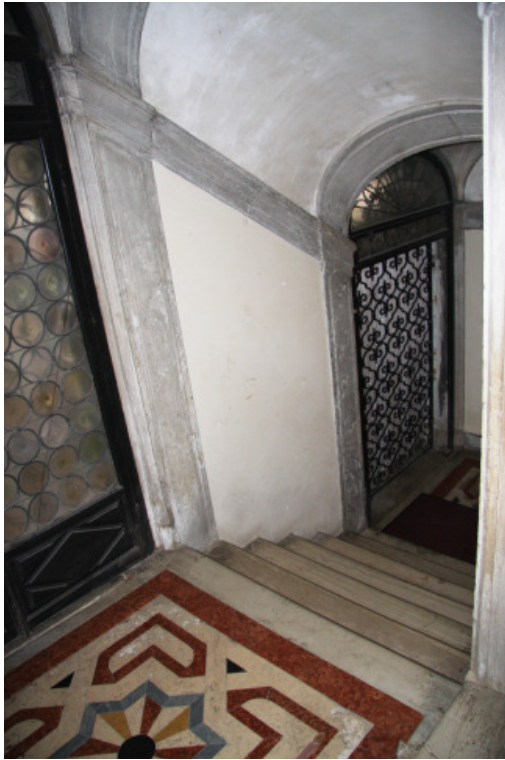
Image 23: Principal staircase

The main staircase starts from the eastern side of the *androne*: it was surely decorated both with coloured and precious marbles in the landings and coloured glasses on doors and windows; the steps are in Istrian stone and probably the walls were plastered with *marmorino*, maybe decorated; even vaults were surely painted or decorated (image 23).

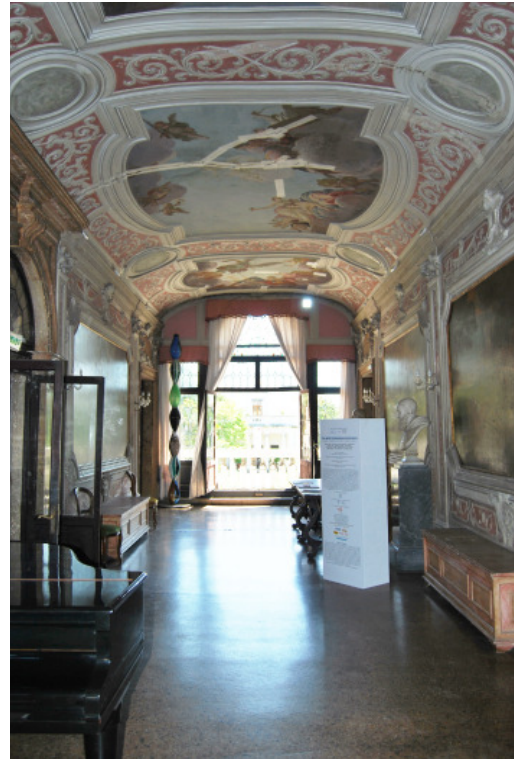
Image 24: *Portego*

reaches the *portego* of the first noble floor, through a magnificent walnut door. The narrow *portego* overlooks the garden with a balcony and a large arched window (image 24); on the north side a stone portal topped by a Serliana introduces to the great ballroom (image 25), a spectacular room, set in parallel to the principal façade.

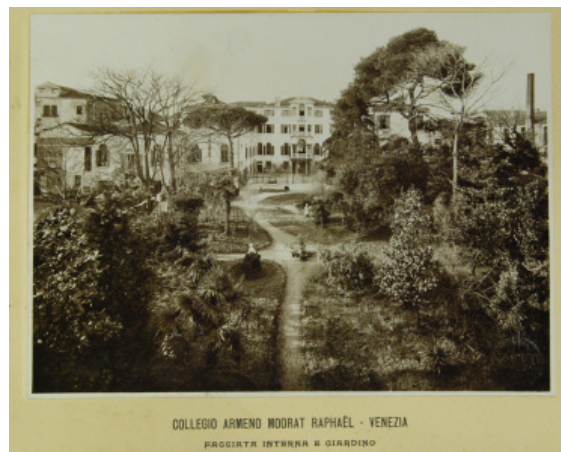
Image 55: Garden designed by architect Negrin

In 1848-49 the architect Antonio Caregaro Negrin (1821-1898)<sup>54</sup>, famous landscape gardener, created a new garden in romantic style (image 55) : two little hills and a bridge are still evident on the western side of the garden. In many photographs one can see the new look with many tall trees and winding paths.

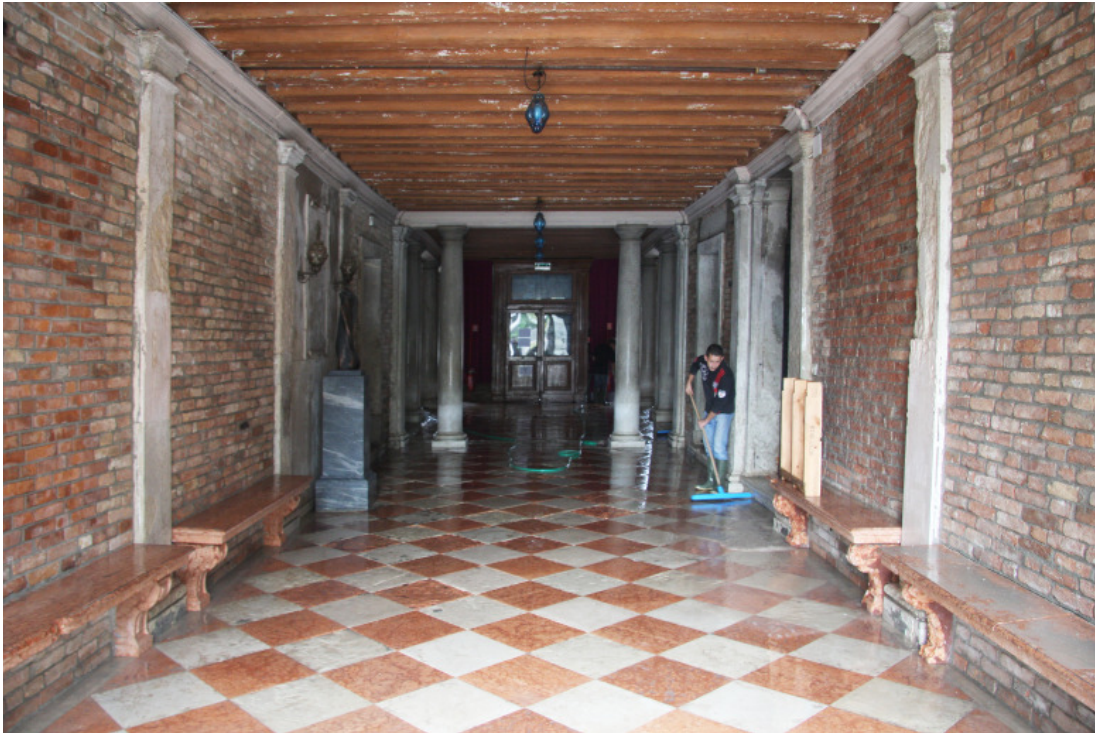
Image 68: Ordinary maintenance after flood tides

In case of *acqua alta*, the humidity “climbs up” the walls, carrying the salts inside them. At a certain level water starts to evaporate and salts crystallize causing tensions to the materials that often break<sup>1</sup>.

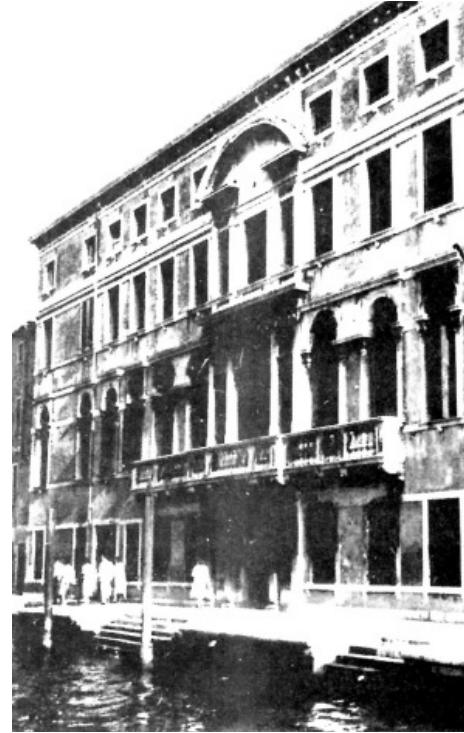
Image 69: Main elevation, 1962

For the principal façade, it is interesting to compare some photographs published in different times. In 1962 Elena Bassi published her *Architettura del Sei e Settecento a Venezia*<sup>3</sup>, with some pictures of the palace (image 69). The main façade presents spread lack of plaster and both deposits and black crusts. In a following book, dated 1976<sup>4</sup>, the façade is perfectly plastered with a white *marmorino* (image 70); some leakages under the windows are visible: this can suggest that new plasters had been made some years earlier. The same type of decay is evident in a later photograph of 1979 by Aikema<sup>5</sup> (image 71). In all these pictures stones are aggressed by a very thick black crust.

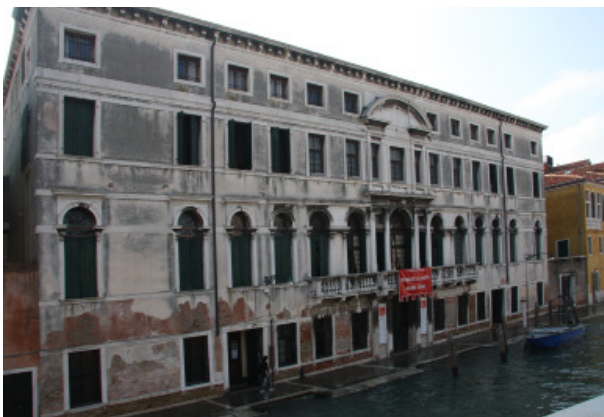
Image 72: Main elevation, 2011

Today the elevation main decay is loss of plaster in the lower part of the wall,

corresponding to the first floor; it is interesting to notice that the left side of the façade shows a larger loss than the right one (image 72). Probably this is due to the presence of the canal flowing just opposite of the left side of the palace. From this, a great amount of marine spray comes and causes a major decay, compared to that of raising dampness. All the external bricks of the lower part of the masonry of the façade have been already substituted by new ones and a dampness barrier has been inserted, maybe during the last restoration works. Another evident problem of the plaster, but of easier solution, is a spread biopatina that gives a gray colour to the surface.

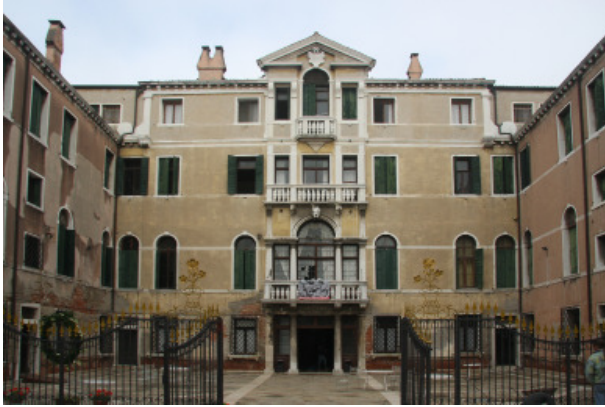
Image 74: Rear façade

Also the rear façades have been restored, probably together with the main elevation. Here walls were plastered with “*cocciopesto*”, a yellow (for the principal block) or red (for the two wings) lime plaster made with brick powder (image 74). In the lower part of masonries a raising dampness barrier has been inserted, but also in these elevations humidity caused the falling down of the lower part

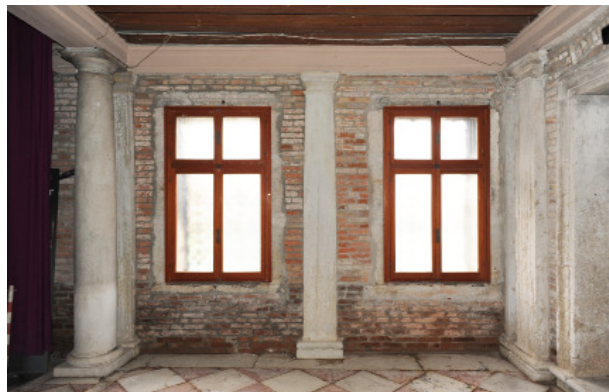
Image 75: Internal wall at ground floor

Several rooms of the ground floor, such as porter's lodge or rooms used for temporary exhibitions, have been raised of one, two or three steps (from 15 to 45 cm) to avoid "*acqua alta*". This raising is impossible for the main entrance that has the original floor made of stone tiles (Istrian Stone and *Rosso Verona* marble) and 12 columns that prop up the wooden beam floor of the ballroom. So this room and the next *androne* have problems of erosion and humidity both of the floor and of the walls.

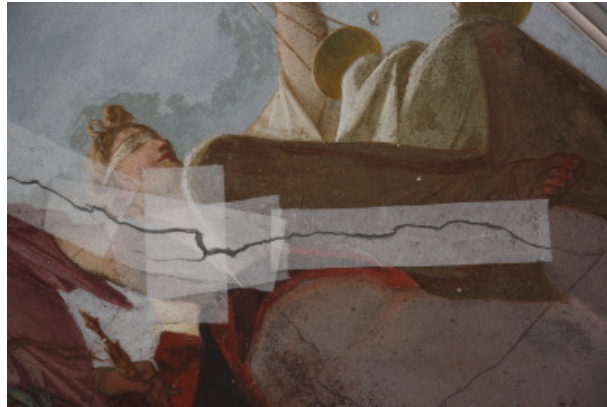
Image 76: Crack of false ceiling in the *portego*

seepages from upstairs damaged some stuccoes-decorated false ceiling, such as that of room PT.17: this is another worrying problem.

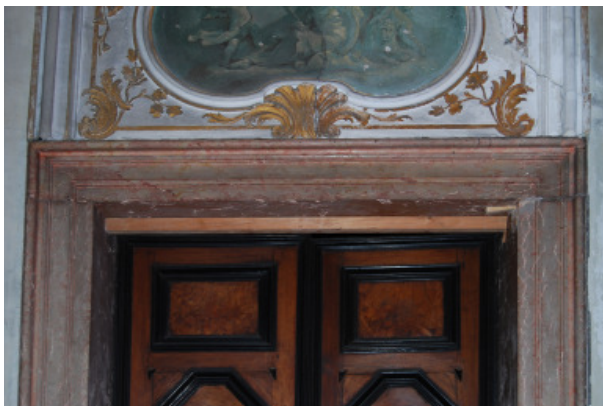
Image 88: Door jamb detached

In the same room there is also an other problem in the north western corner of western wall: a crosswise fracture is above the door nest to the principal elevation and the right door jamb is completely detached from the wall (image 88). On the principal façade there is a vertical crack next to this wall that cross

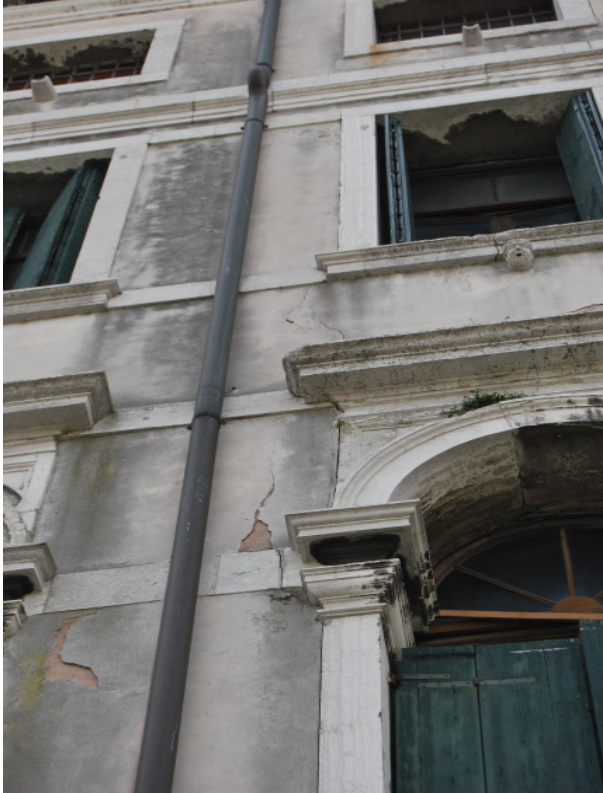
Image 89: Cracks of principal elevation

all the masonry from the bottom to the top (image 89). This means that the structural decay that is visible in room A.19 is strictly linked to a general mechanical behaviour of the building. We can just suppose that a foundations sagging had occurred: in Venice the soil is very poor and weak and it is quite normal that a building

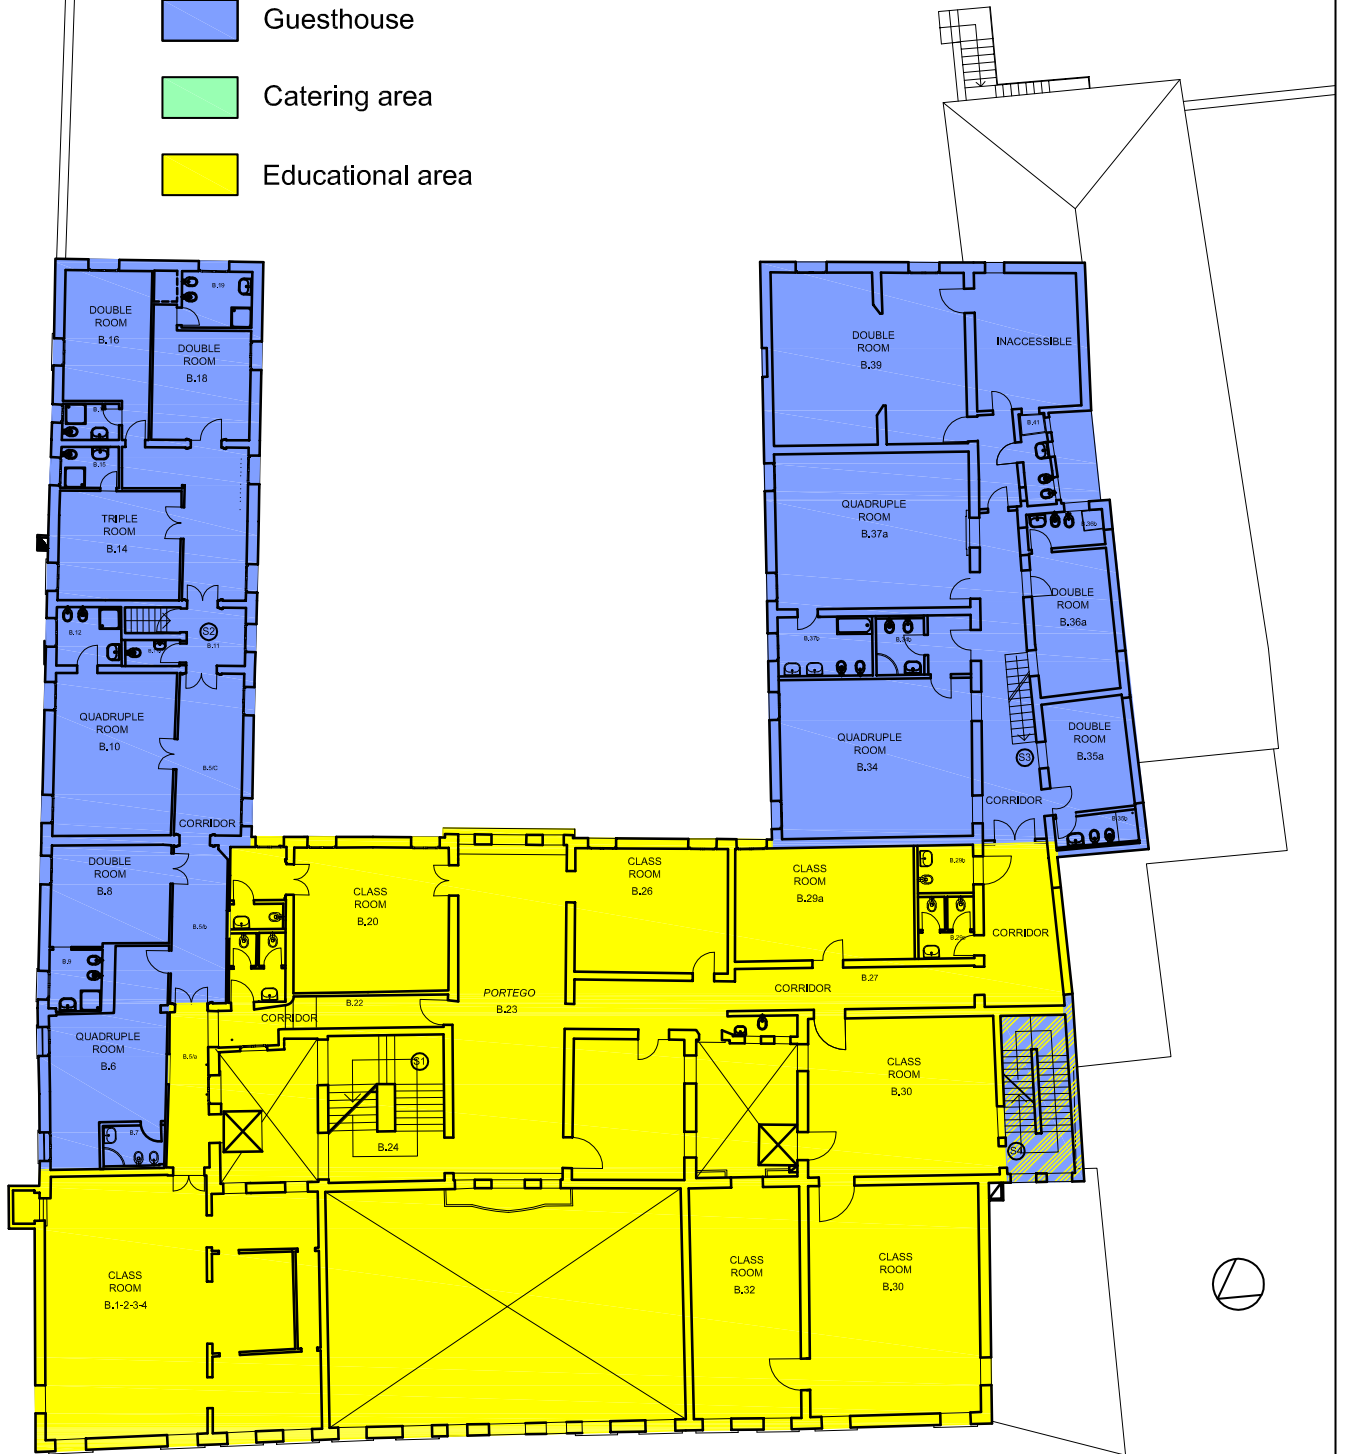
**USES OF THE PALACE**

-   Main public access
-   Exhibition area
-   Guesthouse
-   Catering area
-   Educational area

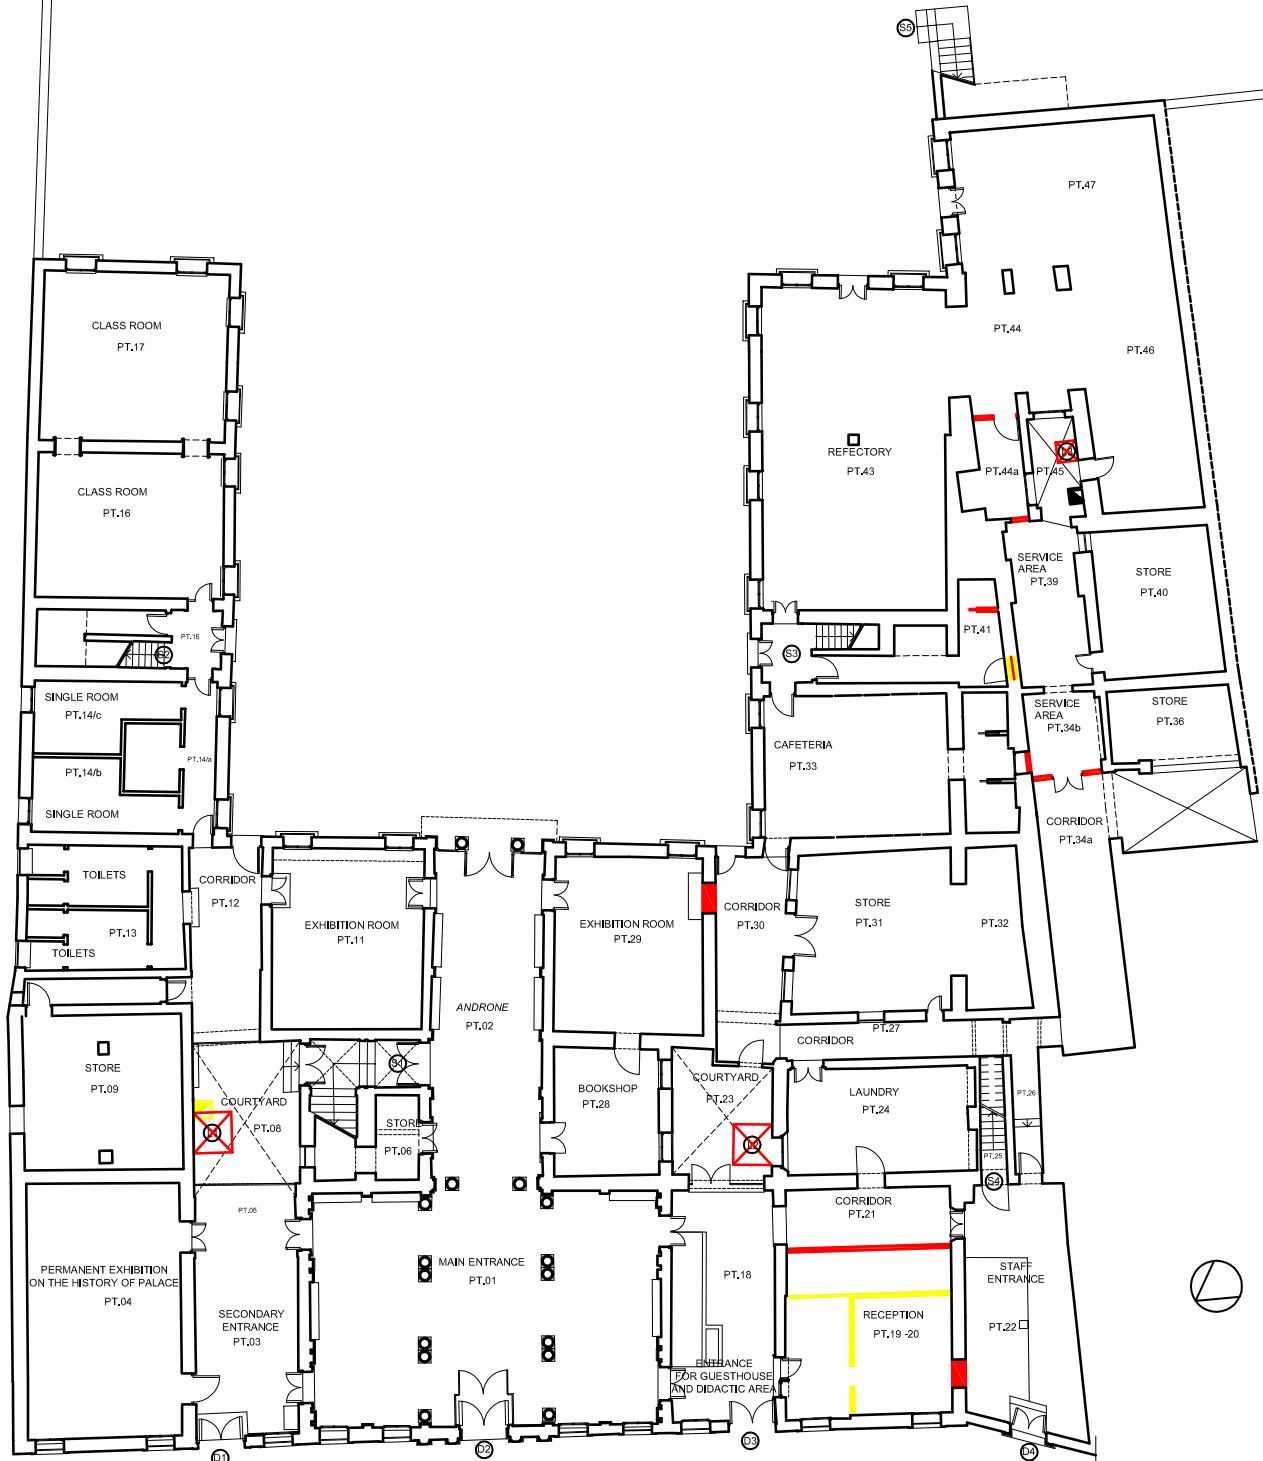
## COMPARATIVE DRAWING

- Demolition
- New elements

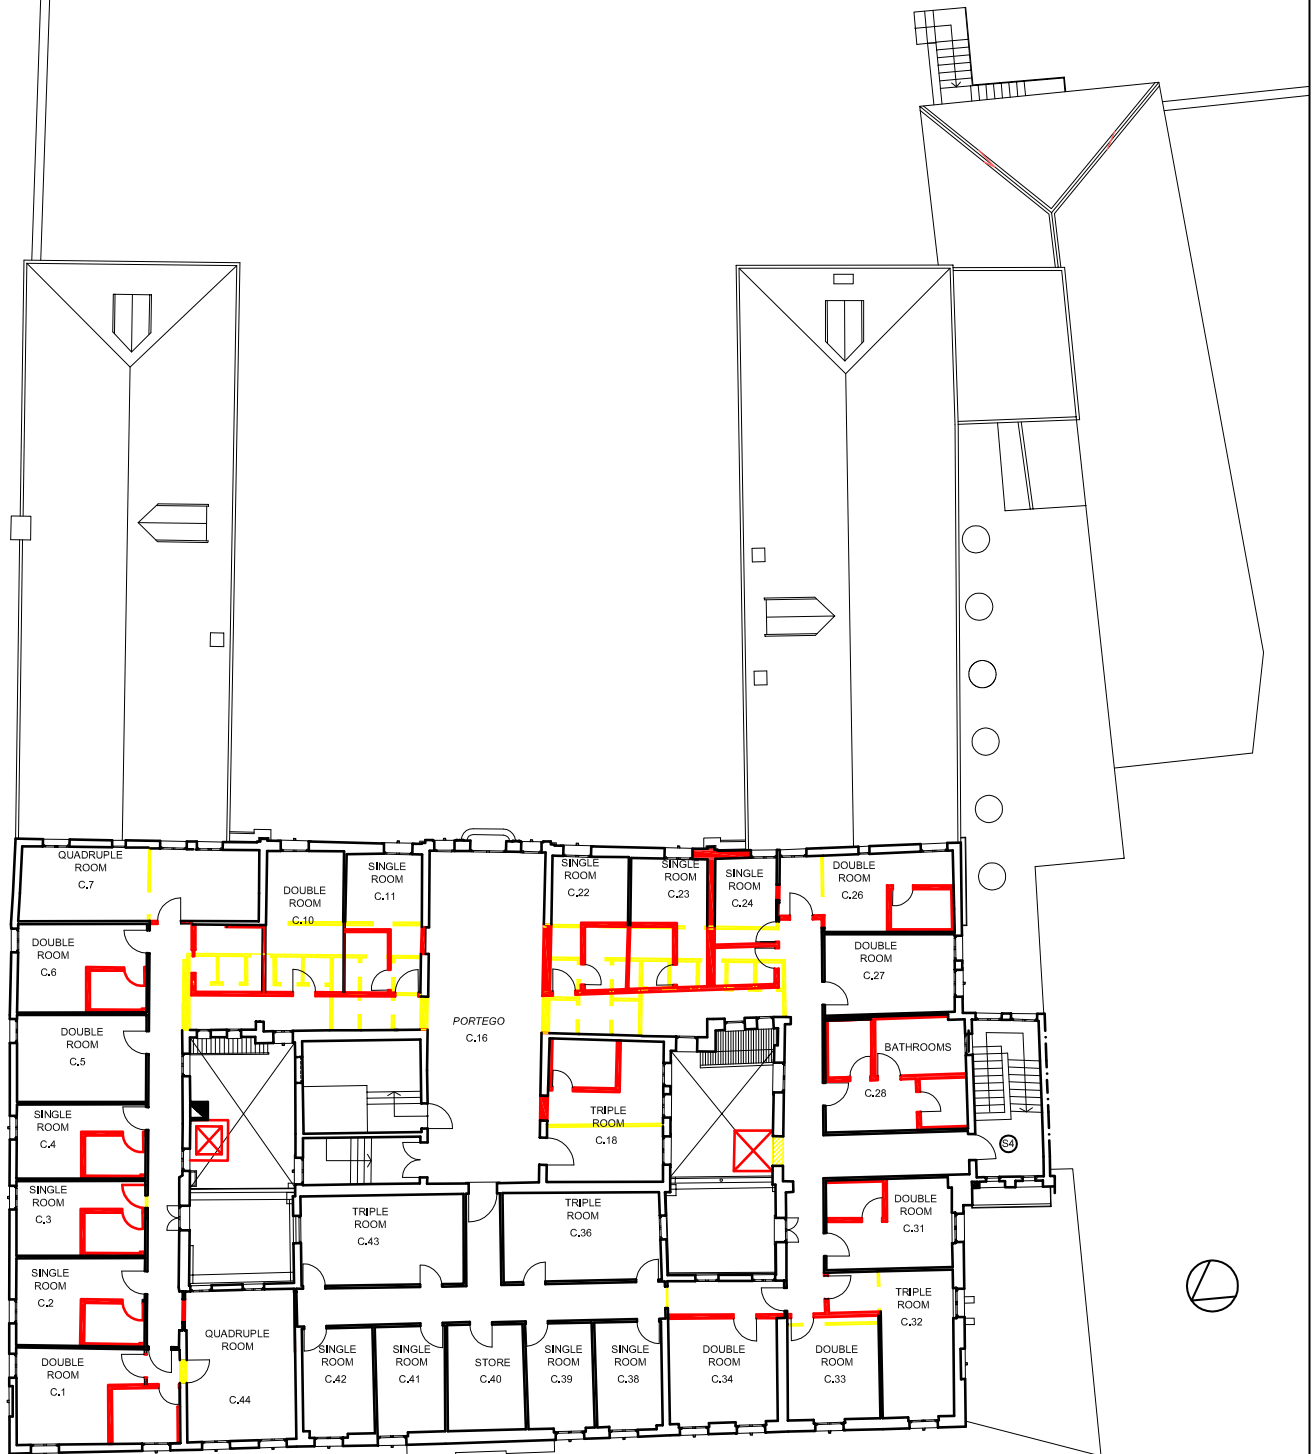
COMPARATIVE DRAWING

- Demolition
- New elements

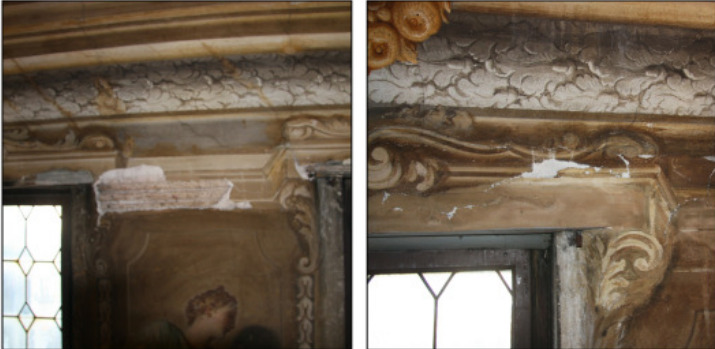
Image 102: Sample of conservation files

<p>Codice Intervento:</p> <p><b>IN.01</b></p>	<p>Definizione Intervento: <b>RISARCIMENTO DELLE LACUNE</b></p> <p>Risarcimento delle lacune di intonaco mediante integrazioni con impasto a base di calce aerea</p>	<p>Scheda n.:</p> <p><b>i10.1</b></p>
<p>Riferimento tavole:</p> <p>- TAVOLE DI PROGETTO P.01 e P.02</p>	<p>Documentazione fotografica:</p>

<p>Materiali:</p> <ul style="list-style-type: none"> <li>- Intonaco a calce affrescato</li> <li>- Cantinelle lignee</li> </ul>	<p>Protocolli operativi:</p> <p>Tutte le lacune di intonaco, comprese le fessurazioni, andranno riprese con rappezzi di malta, di composizione simile a quella esistente. Le esistenti stuccature non compatibili con il supporto andranno accuratamente rimosse mediante scalpelli di piccole dimensioni.</p> <p>Il rappezzo dovrà essere realizzato con un intonaco compatibile con il supporto e similare a quello esistente per spessore (numero di strati), composizione e traspirabilità; i coefficienti di dilatazione termica e di resistenza meccanica dovranno essere simili a quelli dei materiali esistenti così da poter garantire lo stesso comportamento alle diverse sollecitazioni.</p> <p>La formulazione della malta per realizzare il nuovo intonaco dovrà presentare le caratteristiche tecnologiche dell'intonaco rimasto sulla superficie, ovvero dall'analisi della rimanenza si dovranno dedurre le varie stratificazioni, i diversi componenti e in che modo sono stati combinati tra loro: rapporto aggregato-legante, granulometria inerte e il tipo di legante. Per questa operazione saranno di supporto le analisi chimiche già realizzate e quelle che verranno ulteriormente effettuate.</p> <p>Prima di procedere con il rappezzo la superficie dovrà essere preparata, essendo sufficientemente asciutta (esente da fenomeni d'umidità) e pulita (priva di sali e/o patine) in modo da consentire la totale aderenza della nuova malta sul supporto; dopodiché, si eseguirà l'inumidimento della muratura o delle cantinelle tramite pennello imbevuto d'acqua o mediante l'uso di un semplice nebulizzatore manuale. Al fine di garantire la corretta realizzazione dell'impasto dovranno essere presi degli accorgimenti sul modo di dosare e amalgamare i diversi componenti.</p> <p>La preparazione della malta in cantiere dovrà essere fatta in contenitori puliti privi di residui di sostanze che potrebbero alterare la natura dell'impasto, avendo cura di dosare sapientemente la quantità d'acqua, onde evitare la formazione di impasti o troppo fluidi o poco lavorabili; lo scopo dovrà essere quello di ottenere una consistenza tale da garantire la capacità di adesione fino all'avvenuta presa sul supporto; il dosaggio degli ingredienti dovrà essere fatto con estrema cura e precisione, evitando metodi di misurazione troppo approssimativi, in modo da riuscire ad ottenere formulati aventi sempre le caratteristiche richieste; la quantificazione in cantiere potrà avvenire prendendo come riferimento un'unità di volume identificata in un contenitore facilmente reperibile in sito.</p> <p>Compiuta la pulitura, e se necessario il consolidamento, dei margini del vecchio intonaco si procederà all'applicazione del rappezzo, seguendo i diversi strati: previa bagnatura del supporto, verrà applicato il rinzaffo (in malta morbida a base di grassello di calce, sabbie scelte e cocchiopesto con aggregati a grana medio-fine 0,125 - 0,5 mm) in modo tale da penetrare bene negli interstizi dell'apparecchio; a presa avvenuta, previa bagnatura della superficie, si procederà alla stesura del secondo strato, tramite cazzuola, e se necessario degli strati successivi fino a raggiungere lo spessore totale dell'intonaco; l'impasto, a base di grassello di calce lungamente stagionato e sabbie scelte, avrà una granulometria degli inerti medio-fine e verrà, nell'ultimo strato, lisciato con una spugna.</p>

<p>Degradati:</p> <ul style="list-style-type: none"> <li>- FF: Fessurazione</li> <li>- Fratturazione</li> <li>- LC: Lacuna</li> </ul>	<p>Lavorazioni precedenti:</p> <ul style="list-style-type: none"> <li>- PL.01: Pulitura a secco</li> <li>- PL.02: Pulitura a umido</li> </ul>	
<p>Lavorazioni successive:</p> <ul style="list-style-type: none"> <li>- IN.02: Integrazione pittorica</li> </ul>		
<p>Materiali e attrezzature impiegati:</p> <ul style="list-style-type: none"> <li>- Cazzuola</li> <li>- Spugna</li> <li>- Malta prodotta in cantiere</li> </ul>

All works have been described in detail in specific files which give the technical specifications of works (image 102).

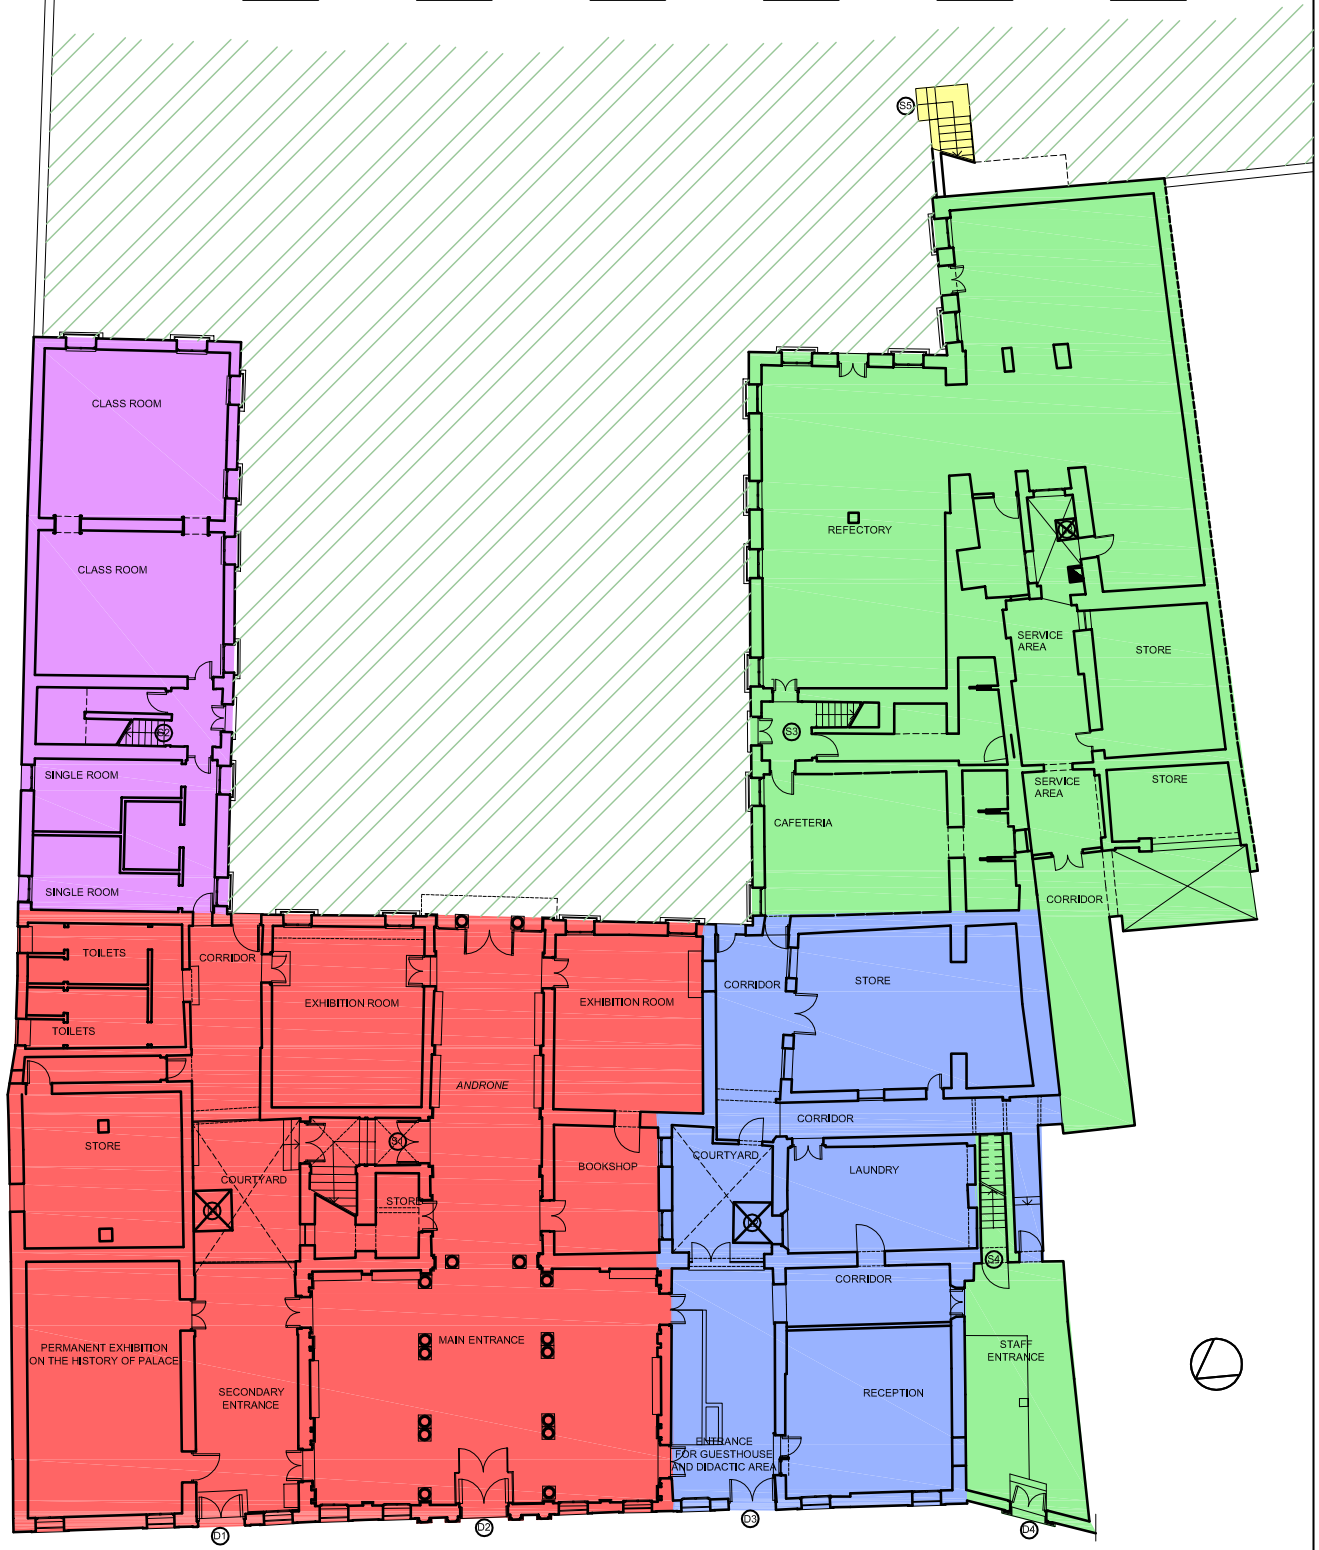
## ZONING OF WORKS

AREAS:  1  2  3  4  5  6

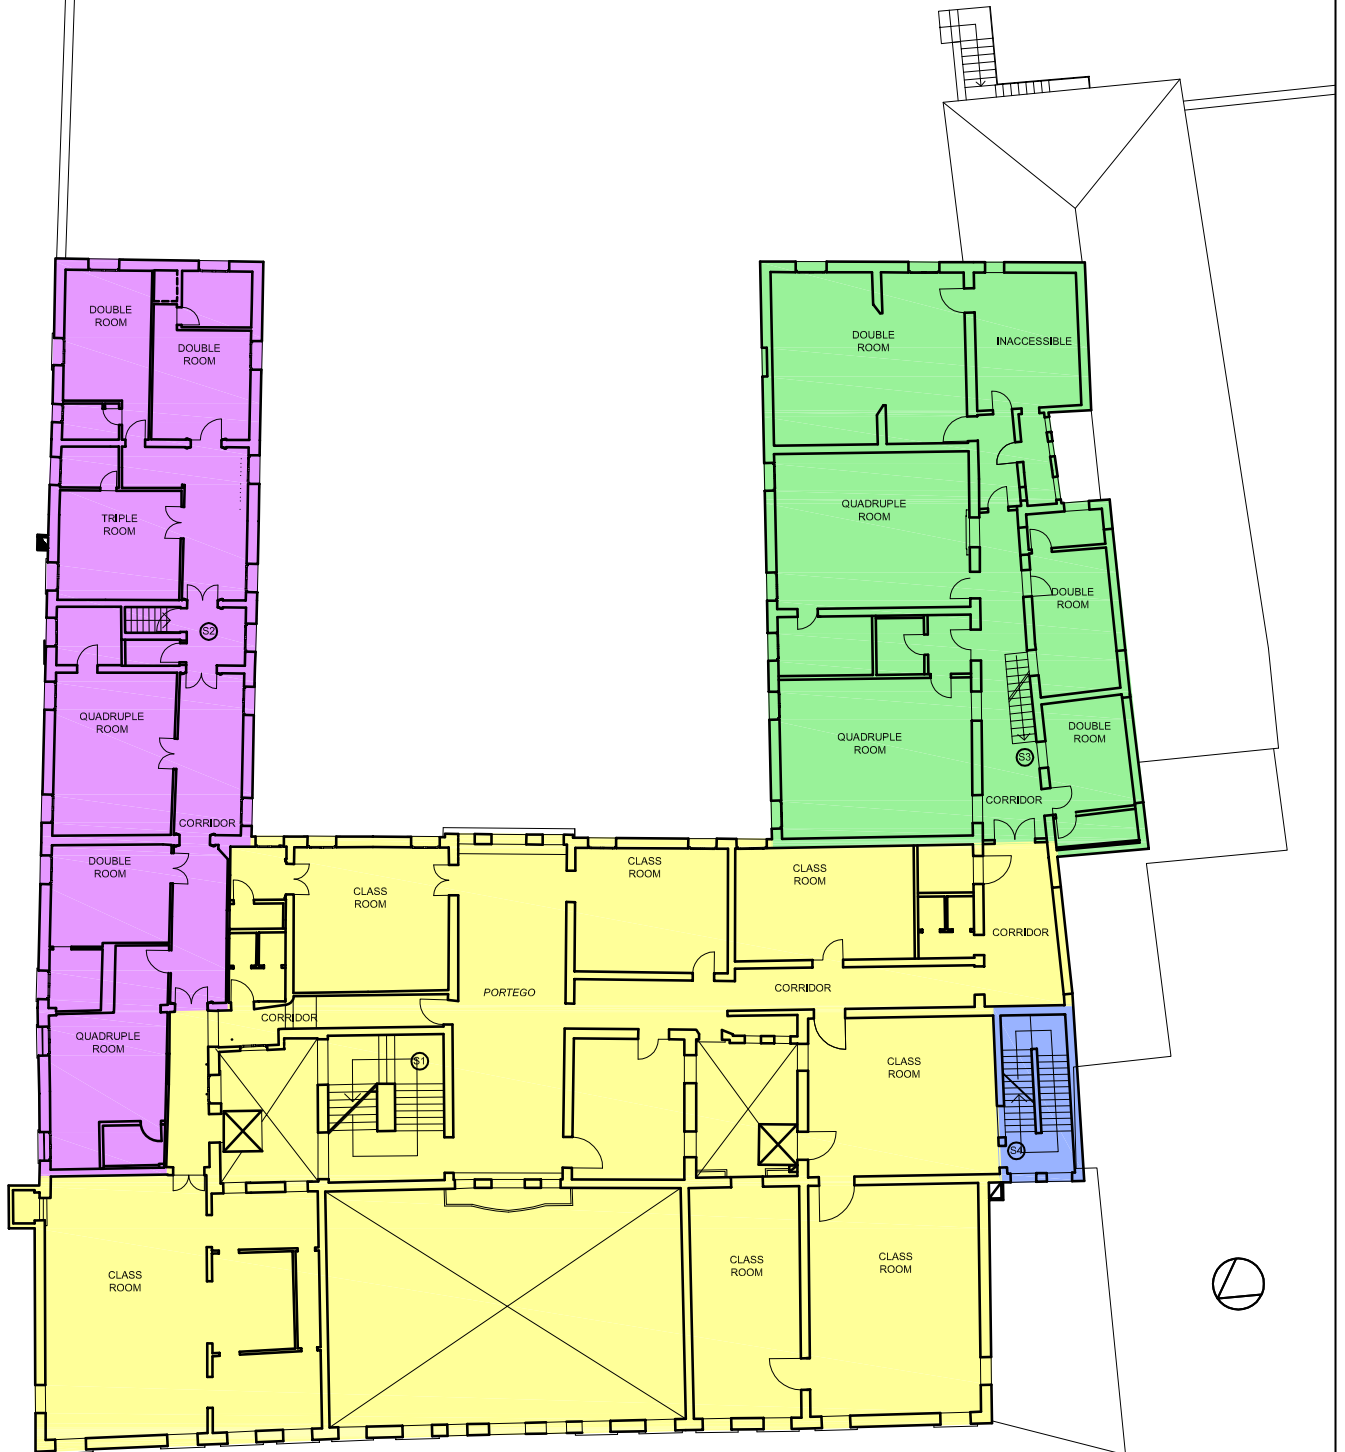
ZONING OF WORKS

AREAS: 1 (green) 2 (red) 3 (blue) 4 (purple) 5 (yellow) 6 (hatched)

SECOND FLOOR

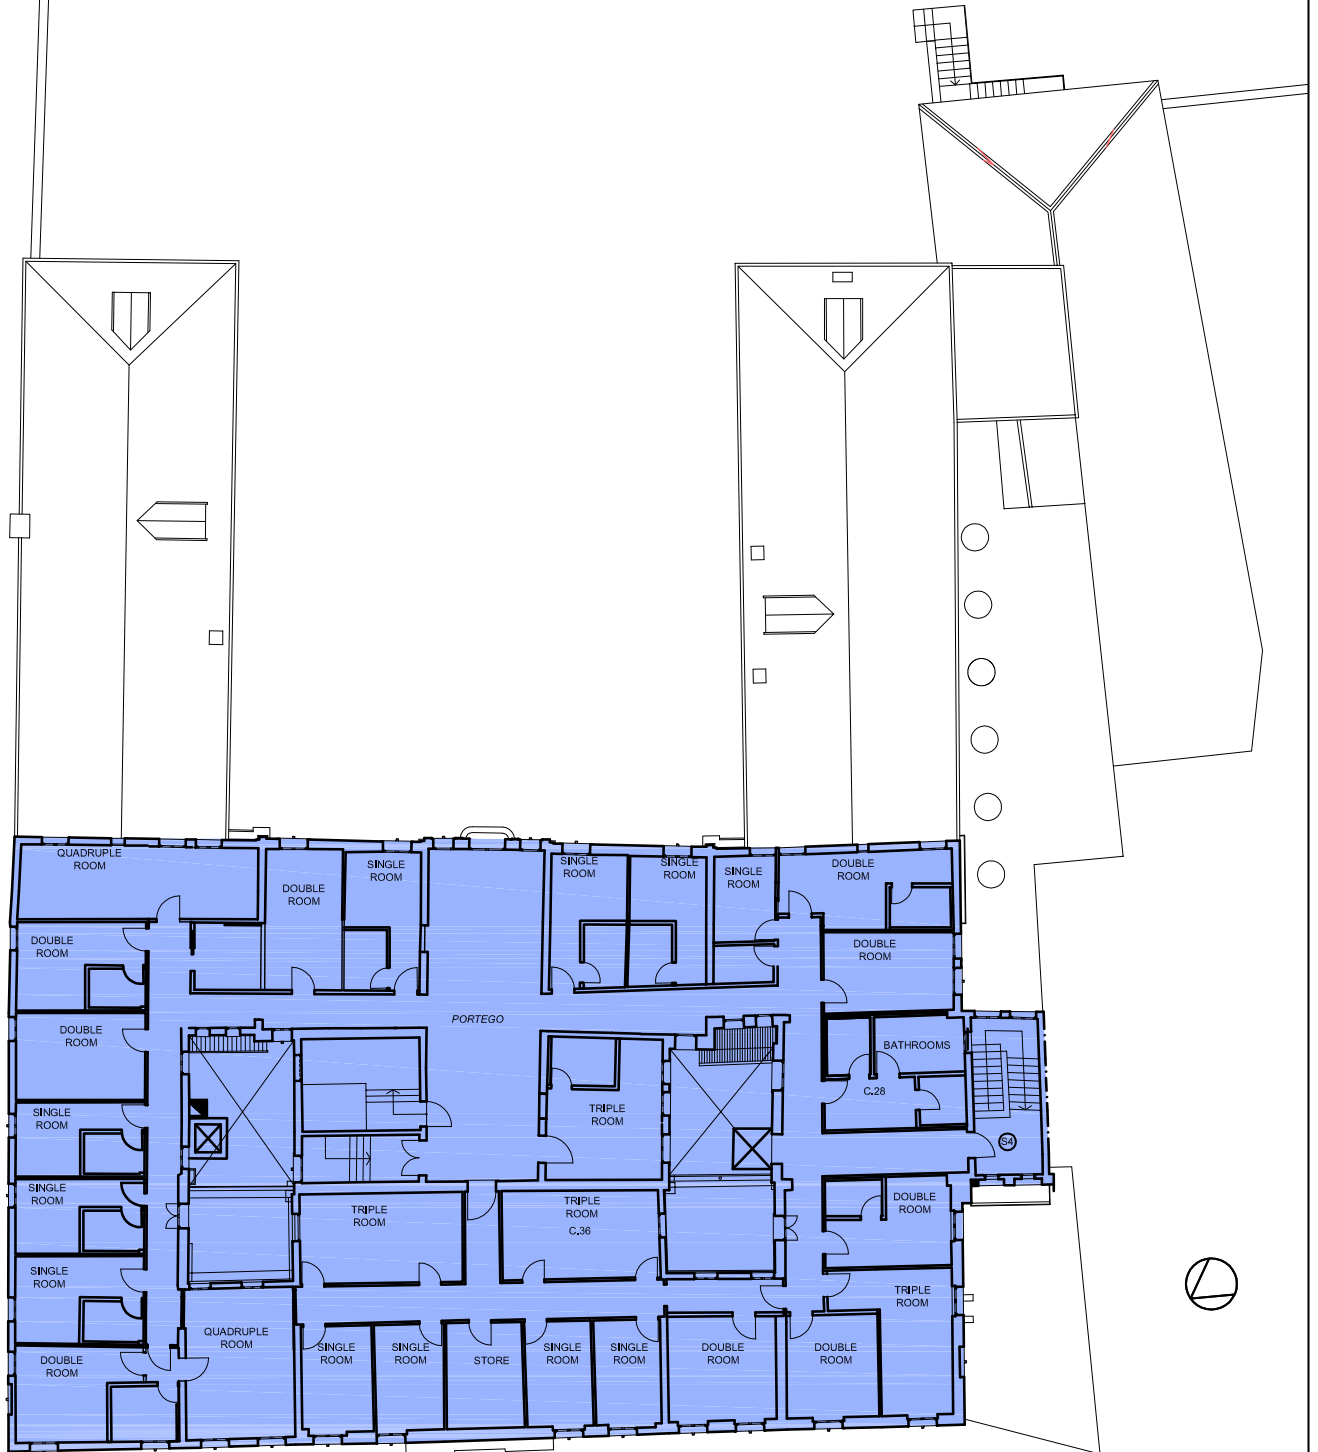
ZONING OF WORKS

AREAS: 1 (green) 2 (red) 3 (blue) 4 (purple) 5 (yellow) 6 (hatched)
