High Resolution TEM Characterisation of Hydrogen Peroxide Treated Tooth Structures

Research Article

Abstract

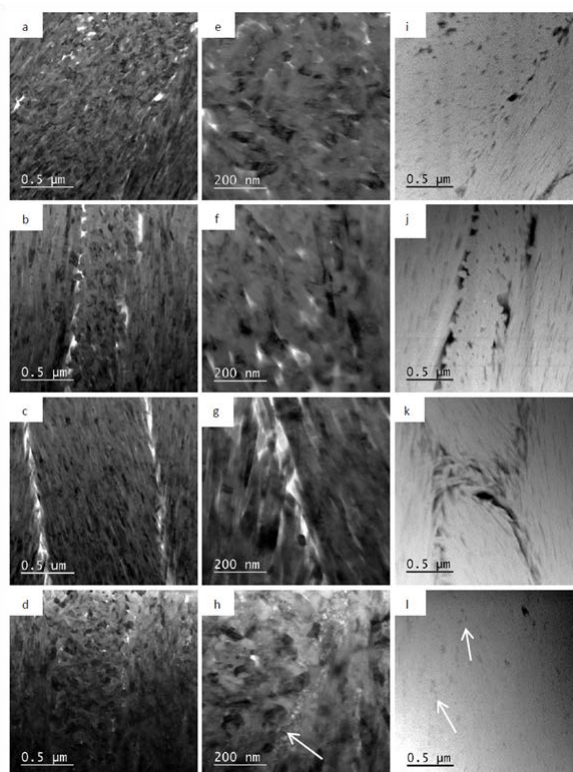
Figure 1. Images of enamel in TEM mode (a-h) and HAADF mode (i-l). Electron micrographs of sound enamel (a, e, i); treated with 30% HP solution, pH 3 (b, f, j); treated with 30% HP solution, pH 7 (c, g, k) and treated with NaOH (d, h, l).

Typical detailing of the ultra-structure of sound and 16 hours treated enamel samples were examined under transmission electron microscopy and are shown in Figure 1.

The structural analysis of sound enamel demonstrated rod and interrod structures (Figure 1a, i). The rods and interrods with numerous densely packed and well organised crystalline facets were clearly visible in the bright field image at higher magnification (Figure 1e). The HAADF image (Figure 1i) showed pores at the prism-junction as dark holes within the structure.

As observed in reference sample, the overview images of 30% HP (pH 3 and 7) treated enamel depicted the crystalline structure of rods and interrods (Figure 1b-c, 1f-g). In the TEM lamella, the rod structure could be differentiated clearly from the interrod structure with the difference in the orientation of crystals (Figure 1b). The interfaces between the rods displayed voids as the untreated sample. However, a wider region of rod sheath was observed for 30% HP treated samples (Figure 1b-c and 1j-k).

The characteristic crystalline structures within prisms were visible on enamel treated with NaOH (Figure 1d). However, a significant change in the overall structure of sample was observed with the absence of structured rods and well defined boundaries between rods and interrods. The crystals were merged and no regular spacing between the facets was visible. In the detailed HAADF image (Figure 1l), the characteristic voids representing the pores between the rods are absent. In Figure 1h, porous material was

visible at many of the prisms borders compared to other samples (denoted by white arrow). Using EDS, this porous material contain fluoride.

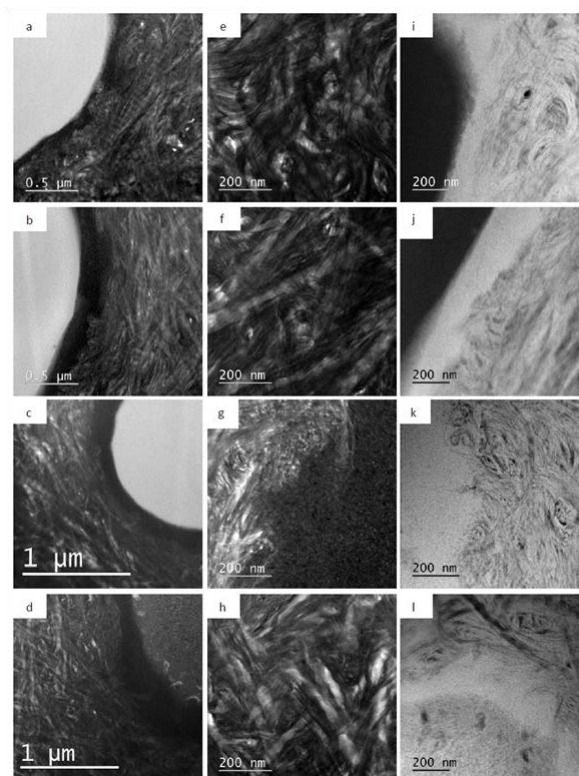
Figure 2. Electron micrograph of dentine in TEM and HAADF modes. Electron micrographs of sound dentine (a, e, i); treated with 30% HP solution, pH 3 (b, f, j); treated with 30% HP solution, pH 7 (c, g, k) and treated with NaOH (d, h, l).

The electron micrographs obtained from the dentine cross-sections of control and treated tooth samples in bright field TEM and HAADF-mode are shown here.

The examination of micrographs sound dentine at higher magnifications on TEM and HAADF mode revealed a highly dense peritubular (PT) region surrounding the tubule. In TEM, the PT is characterised as a dark region (Figure 2a) whereas it appeared as a bright region in HAADF image (Figure 2i). The dark speckles appeared in TEM of PT were not visible as bright speckles in HAADF, indicated that the speckles were not correlated to denser material but to the presence of crystals. In HAADF, small voids which are intrinsic to the tooth material were visible in the PT region. The intertubular region displayed a very open fibre structure and often these regions contain far less or no material. Collagen fibres are found in the intertubular regions, characterised by the periodic banding in contrast in both modes (Figure 2e, i).

The electron micrograph of dentine treated with 30% hydrogen peroxide solutions for 16h showed the presence of PT region that was asymmetric in positioning around the tubule and inhomogeneous in thickness (Figure 2b-c, j-k). Differences and inhomogeneities in the thickness of the peritubular region were observed for control and treated samples and hence the thickness of PT region cannot be used as a measurement from the impact of treatment (Figure 2i-l). As observed in the control sample,

collagen fibres were exposed, represented by the periodic banding (Figure 2f) and crystals were visible as small dark speckles in the denser material (Figure 2g).

The NaOH treated sample displayed the denser PT region and collagen fibres in the intertubular region (Figure 2d, h and l). The tubules were not filled with resin for this sample and this could be easily distinguished from other images. It appeared that the dental material was deposited into tubules during early stages of preparation. The dark dots in the denser material around the tubule are small crystals. HAADF image (Figure 2l) showed the denser material around the tubule. The image also showed small voids in the denser material of the sample similar to other samples.

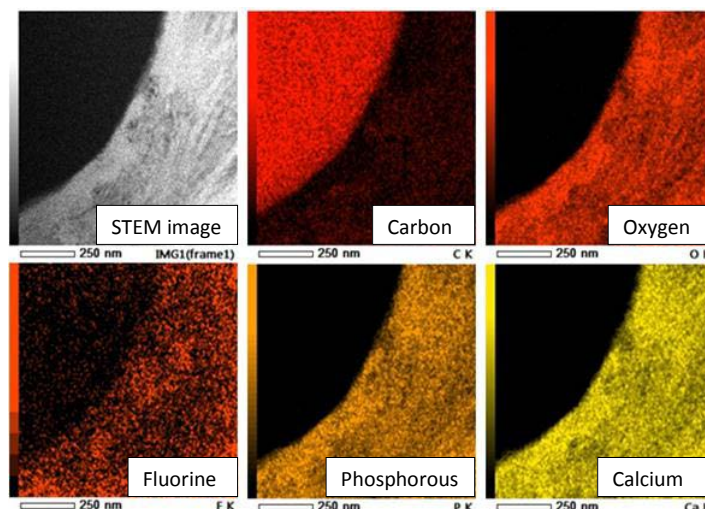
Figure 3. Raw counts EDS mappings (intensities represent counts) of untreated dentine sample. 256*256 pixels resolution (3x3L filter), 0.1 msec/pixel acquisition time, summation over 219 frames.

A representative EDS spectral mapping acquired from untreated dentine is shown in Figure 3. Apart from the major constituent elements such as Ca and P, minor amounts of N (6 atom %), F (about 1 atom %) and Mg, Na (< 0.5 atom %) were detected in the regions analysed.

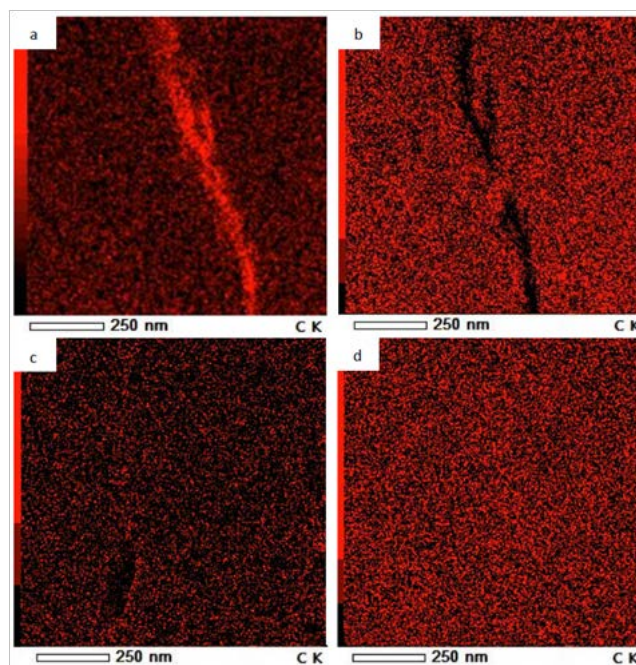
Figure 4. EDS mapping of carbon in (a) untreated (b) 30% H₂O₂, pH 7 (c) 30% H₂O₂, pH 3 (d) sodium hydroxide treated enamel samples.

Figure 4 shows the two-dimensional EDS map of carbon in the enamel as a function of treatment. Although C was detected in between the rods or rod sheath of untreated teeth, the signal was not acquired in hydrogen peroxide and sodium hydroxide treated enamel samples. The C content can be linked to the presence of protein material. It was reported earlier that HP and NaOH attacks proteins, which are C-based material [34] and this could explain the absence of C in treated sample.
