# The Value of Identifying and Recovering Lost GN&C Lessons Learned: Aeronautical, Spacecraft, and Launch Vehicle Examples

Cornelius J. Dennehy<sup>1</sup>  
*NASA Engineering and Safety Center (NESC)*

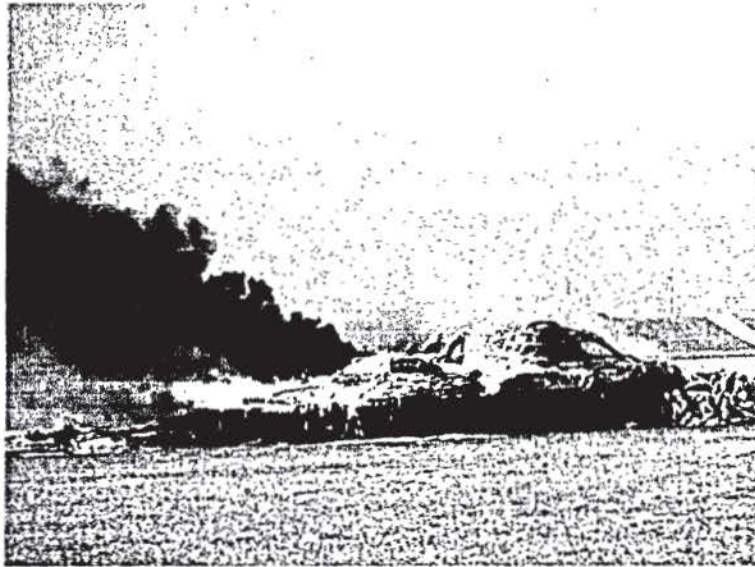
**Figure 1: The Crashed B-2 Bomber "Sprit of Kansas" at Andersen Air Force Base**

The B-2 "Spirit of Kansas" crash occurred on February 25th, 2008 at Andersen Air Force Base in Guam. Seventeen seconds after takeoff the bomber's crew was unable to control the aircraft and its left wing struck the ground. Before take-off, the plane's computers had called for an internal Air Data System (ADS) calibration. Because of Guam's humidity, there was moisture in the air data sensors during calibration. During taxi for takeoff, the moisture evaporated. The now mis-calibrated ADS sent skewed data to the Flight Control System (FCS), which in turn commanded the aircraft nose up to pitch up 30° upon takeoff. Unable to regain control of the vehicle, the B-2's two-member crew ejected safely just barely before the plane crashed and burst into flames (see Figure 1). The subsequent Air Force investigation concluded that an underlying root cause of the \$1.4B aircraft being totally destroyed was because critical information was not communicated effectively (Ref. 7 and Ref. 8)

The brief history behind this unfortunate incident is as follows. During the B-2's 2006 deployment in Guam, the extremely humid environment required frequent ADS calibrations. Line maintenance technicians telephoned the B-2 manufacturer technical representatives to ask advice on this new environmental issue. Support engineers recommended using the aircraft's pitot heater to dry the Port Transducer Unit's PTU's before calibrating the ADS. Pitot heat is supplied to prevent icing of pitot-static sensors in flight; extensive ground use could overheat and damage the pitot-static system. Several maintenance technicians used pitot heaters successfully to dry moist PTU's and accurately calibrate the ADS, but this technique was neither formalized by a change to the appropriate technical order (i.e., operational procedure) nor captured in a "Lessons Learned" report. The post-crash investigation determined that only some of the ground crews and pilots working with the B-2s during their 2007-2008 deployment were aware of the ADS's sensitivity to moisture and the pitot heat procedural workaround (Ref. 14 and Ref. 15).

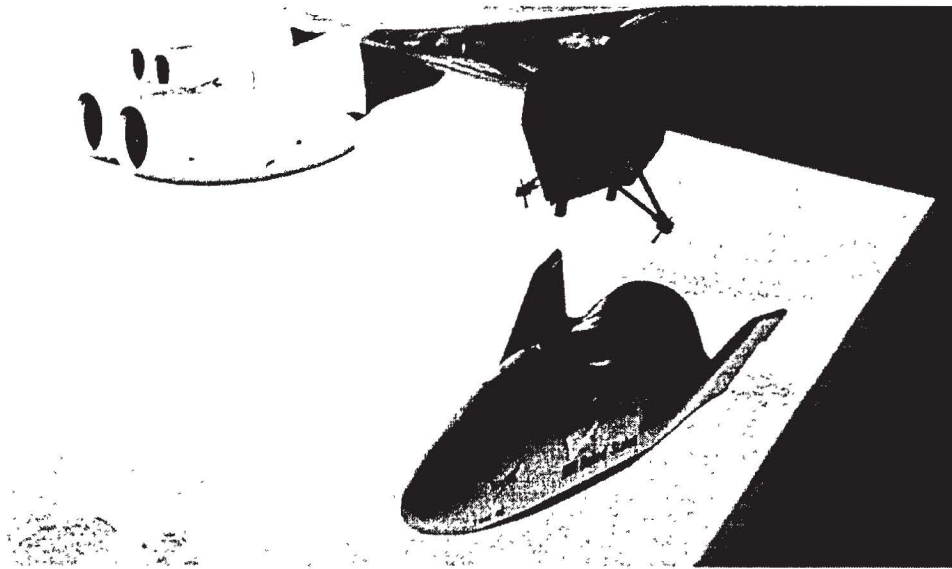
**Figure 2: B-52 Carrier Aircraft Drop of V131R X-38 Prototype**

On 2 November 2000 the X-38 prototype vehicle V131R, which was an 80% scale version of the Crew Return Vehicle (CRV), conducted its first drop test, or Free Flight One (FF1), over California's Mojave Desert near the NASA Dryden Flight Research Center. As depicted in Figure 2 the B-52 carrier aircraft dropped the V131R prototype at  $M=0.6$  at an altitude of 11,000 m (36,500 ft). Immediately following its release from the B-52 the V131R lifting body made an "unplanned" 360-degree right roll around the velocity vector after it was jettisoned. The vehicle paused at  $180^\circ$  and there was over 1 second of fully inverted flight (Figure 2). Fortunately a safe landing was accomplished with minimal structural damage and the vehicle was recovered intact which greatly supported the investigation of this In-Flight Anomaly (IFA).

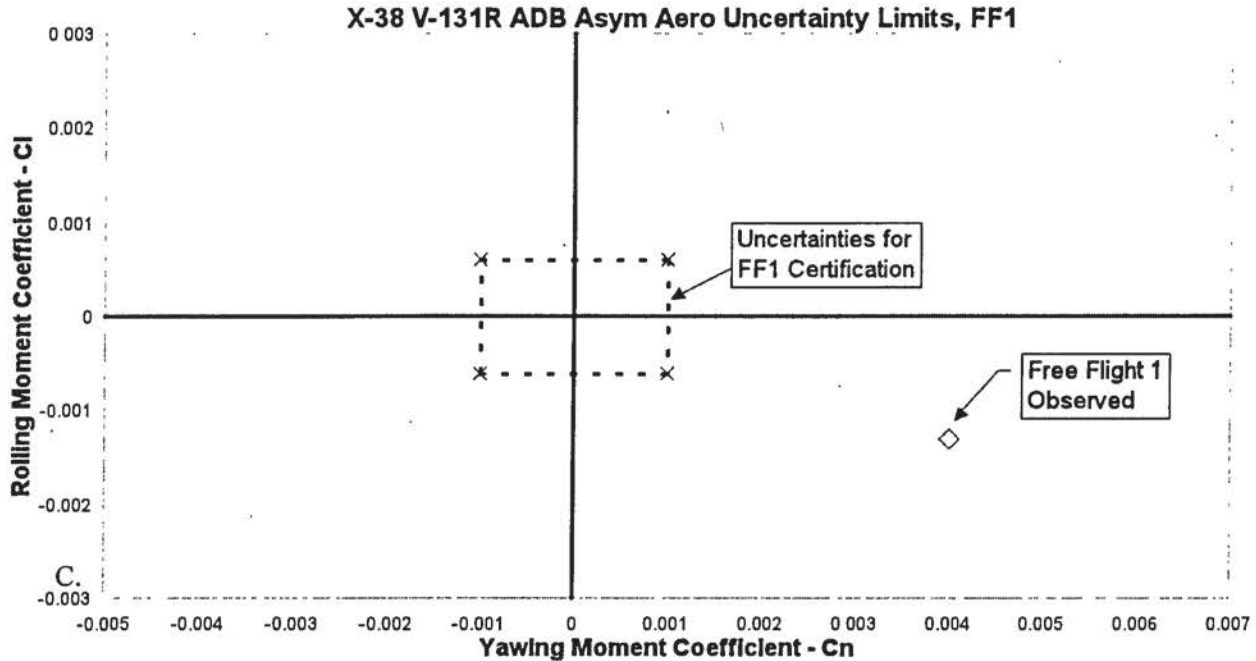
Figure 6. V131R FF1 Asymmetric Aerodynamics

Based upon what the investigation into the causes of the FF1 roll-over incident there were several changes made in the both the aerodynamic database and in the FCS design itself. New values of  $Cl_0$  &  $Cn_0$ , the roll and yaw aerodynamic bias terms, both nominal terms and the uncertain terms, were incorporated into the ADB.

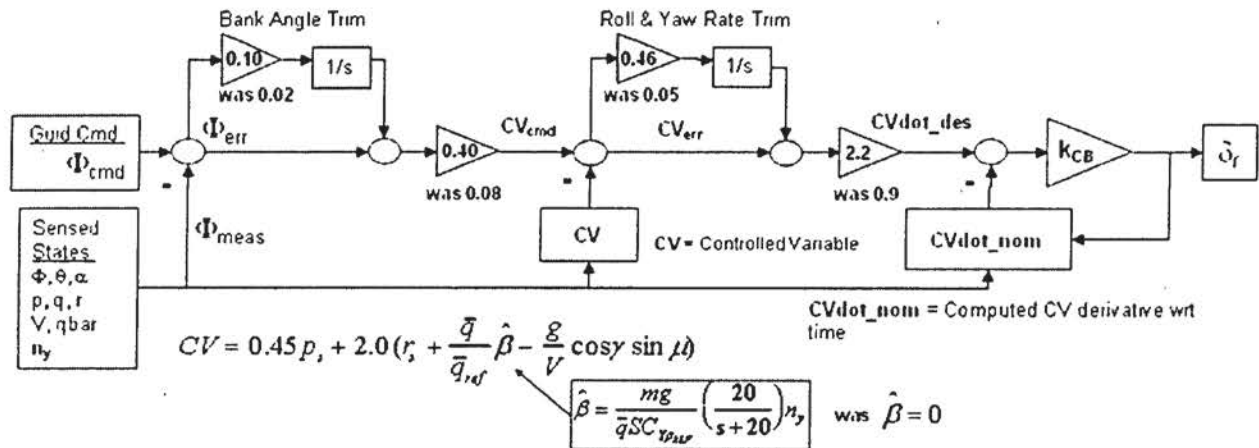
Figure 7. X-38 Flight Control System Modifications

The original FCS was seriously 'under-gained'. Figure 7 depicts, in yellow, the FCS design modifications resulting from the IFA investigation (Ref. 9). The FCS modifications included increased outer loop P&I gains to trade some stability margin for performance margin to meet new, tighter performance requirements. The loop gains were increased by a factor between 2X and 9X; the largest single gain increase occurred on the roll/yaw rate trim gain which was increased by a factor of nine (9). Figure 8 illustrates the greatly improved FCS roll axis step response performance achieved after the tuning up the FCS gains. Additionally, a sideslip approximation was added to the Controlled Variable (CV) with filtered lateral acceleration feedback. The FCS Onboard Aircraft (OBAC) model was based upon the off-nominal aerodynamics to maintain robust stability. Lastly anti-windup logic was added to CV integrator to improve the B-52 release transient response.

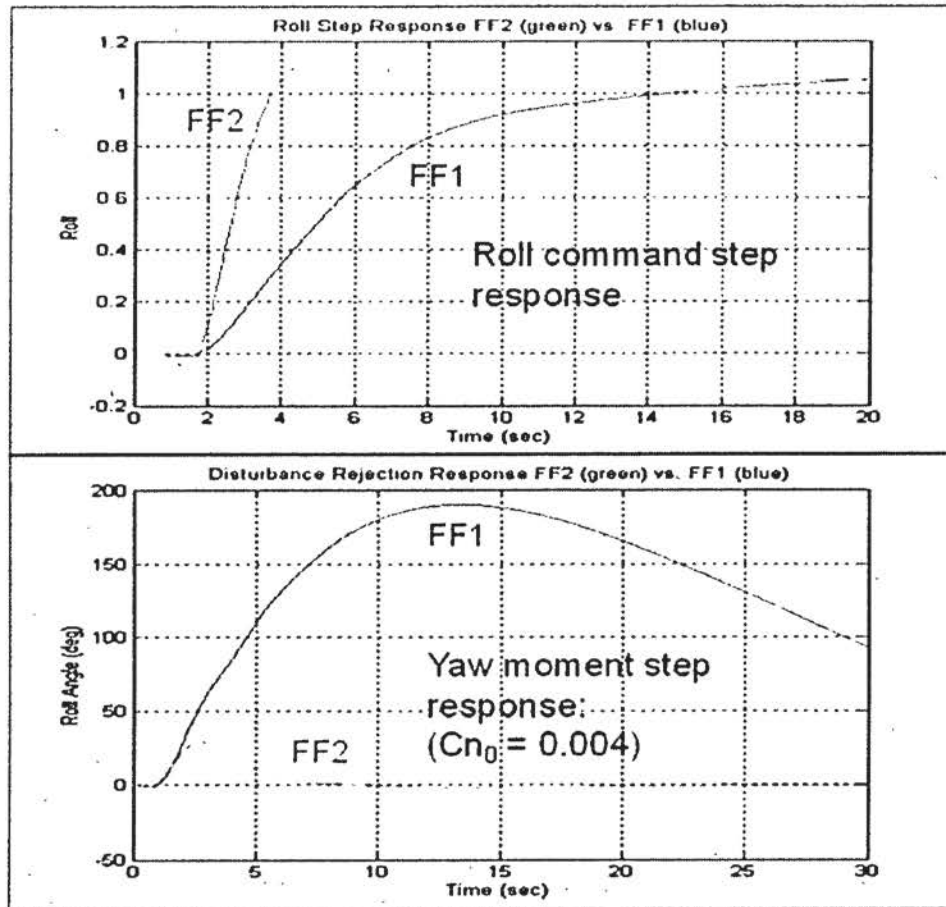
**Figure 8. X-38 Flight Control System Roll & Yaw Step Responses**

Looking back on this incident with 20-20 hindsight, one can see that a combination of inaccurate aerodynamic data and low FCS performance margin resulted in V131R FF1 roll-over. The improved ADB and FCS resulted in a nominal FF2 drop test where the maximum roll and pitch angles were within 1° of pre-test predictions.
