5. PREPARATORY INVESTIGATION

This chapter describes the results of the environmental, geotechnical and geophysical soil survey and the archaeological survey. It also examines the model trials of the inlet and outlet sluices. It is through these sluices that the Scheldt water will flow into and out of the flood control area with controlled reduced tide (FCA-CRT).

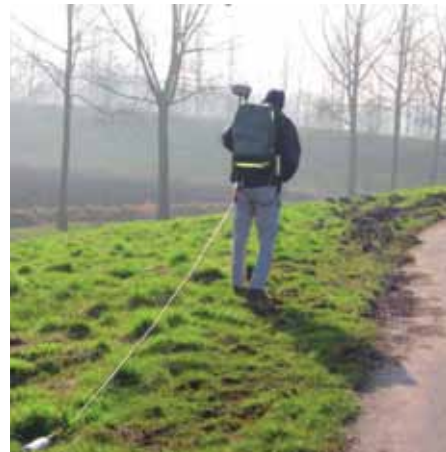
Figure 5.3. Equipment used for non-destructive geophysical tests

test of the Scheldt dyke. This consisted of a geophysical diagnosis using electromagnetic measurements and diagnosis via resistance tomography.

Electromagnetic measurements are designed to plot the electrical conductivity of the body of the dyke and the subsoil. The primary electromagnetic field generated by

the equipment will develop a secondary electromagnetic field in the vicinity. The phase displacement of the resulting field provides information about the apparent conductivity of the shallow soil. Variations in soil type, moisture content and electrically conducting objects will lead to variations in recorded apparent conductivity.

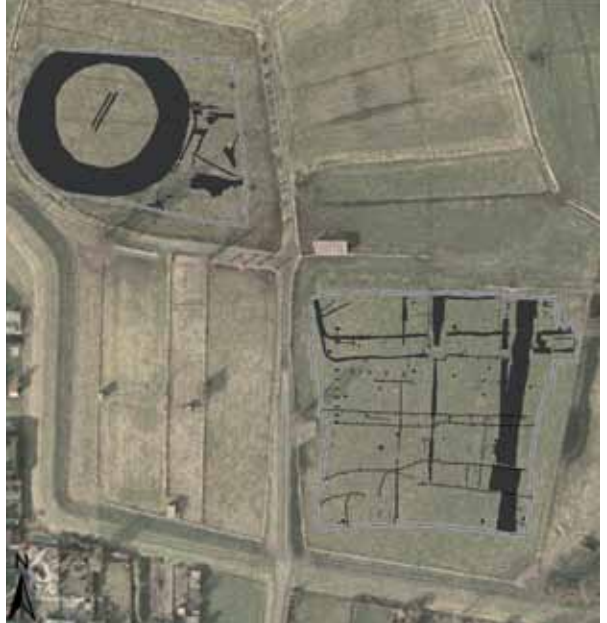
One of the most remarkable finds in Bergenmeersen comes from the later Middle Ages. Based on historical sources, the presence of a medieval “castle” had long been suspected in the area (Figure 5.11). In one of these sources, a plot was indicated with the name “motte”. That led people to suspect that this could be the site of a medieval castle. In 2009, geophysical measurements indicated that the subsoil of that plot could indeed contain a broad circular moat, which was confirmed by the excavation in 2012.

Figure 5.11. General excavation plan of Bergenmeersen. The moat from the castle site is in the north-west.

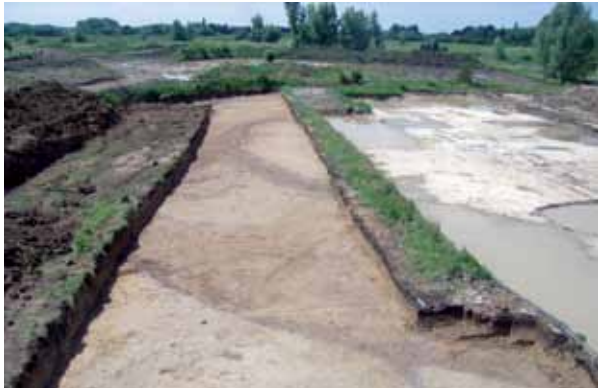
Figure 5.12. A section of the medieval moat

The moat, approximately 12 m wide and 2 m deep (Figures 5.12 and 5.13), surrounds a circular “island” approximately 40 m in diameter. Unfortunately, the central embankment of that island appeared to have been completely excavated, which meant no structures of the earlier edifice remained. One or two natural stone blocks and fragments of brick dumped on the inside of the moat recalled the presence of stone structures. Thanks to the other waste in the moat, mainly pottery, the site was able to be placed in the thirteenth to fourteenth century.

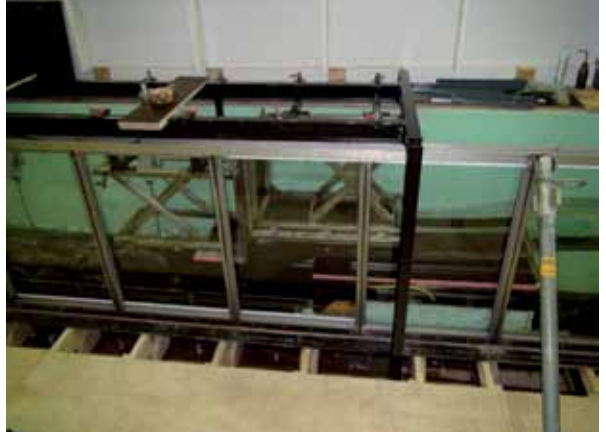
Figure 5.15. Possibilities for adjusting the scale model

To test the combined inlet and outlet constructions of several FCA-CRTs with a single scale model, a very simplified 2DV scale model was designed. 2DV means that the model is built into a channel; only the flow in a two-dimensional vertical plane is studied. The scale model has a geometrical scale of 1:8. The model zone is 0.56 m wide, 1 m tall and 15 m long. The geometry of the constructions under test is formed by flat plates, secured to movable scissor lifts. With this arrangement, not only can constructions easily be changed, geometric adjustments can also easily be made. Figure 5.15 shows the possibilities for adjusting the scale model.

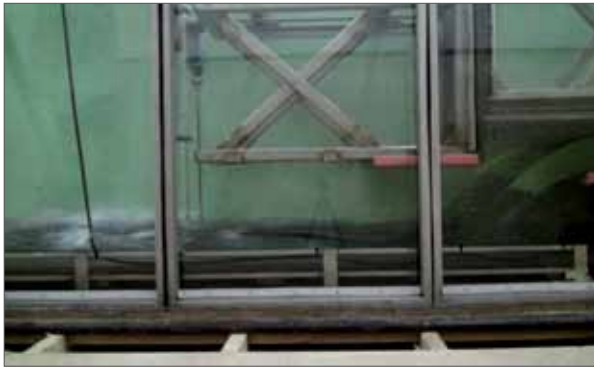
immediately after the drop is the “corresponding” level. The required corresponding level increases the higher the level of the Scheldt. Figure 5.16 illustrates the situation with a water level that is too low on the left and the situation with the corresponding level on the right.

Figure 5.16. The situation with a water level that is too low (left) and the corresponding level (right)

If the water level in the flood area is too low, the water flows into the area: the so-called supercritical flow. In the flood area, this is only converted into a subcritical flow via a hydraulic jump. Such a situation leads to unacceptable flow speeds above the gabions, and possibly to scouring at the point of the hydraulic jump downstream from the constructions. If the water level is equal to or higher than the corresponding level, the hydraulic jump occurs immediately after the drop (in the construction itself). Since the construction is made of concrete, that is not a problem.
