Adobe's Mechanical Characterization in Ancient Constructions: The Case of Aveiro's Region

Tiago Martins^{1,a} and Humberto Varum^{1,b}

¹Civil Engineering Department, University of Aveiro, 3810-193 Aveiro, Portugal

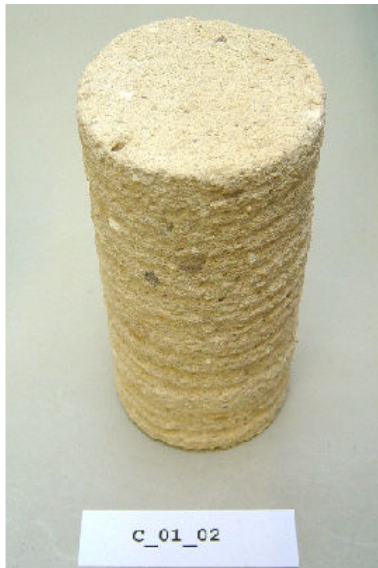
Fig. 1 – House specimen

properties. Considering this difficulty, for the mechanical behaviour characterisation, it was selected a set of specimens representative of the adobe traditionally used in Aveiro's region. Cylindrical specimens were extracted from three different constructions in adobe. One series of specimens were extracted from a small (Fig. 1) house and the other two series were extracted from two walls (Fig. 2 and 3). The constitution of these three adobe's are significantly different, and consequently the strength also reflects that, as will be presented in the test results.

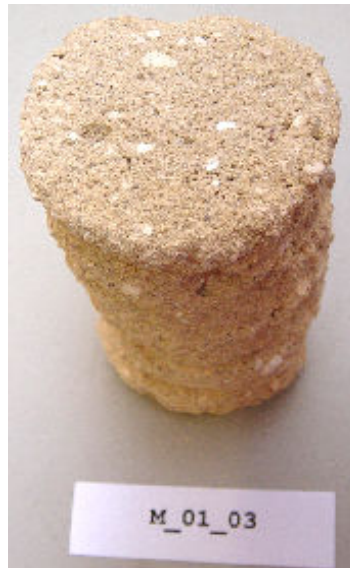
Fig. 2 – Wall 1 specimen

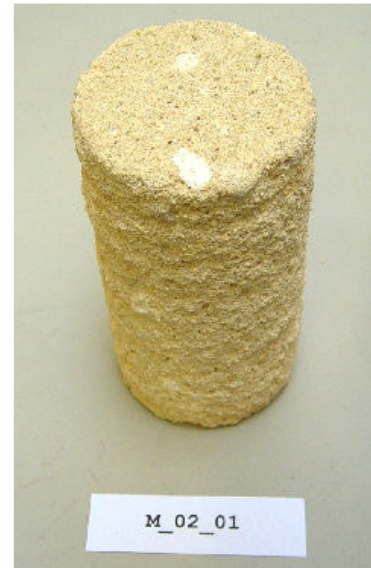
Fig. 3 – Wall 2 specimen

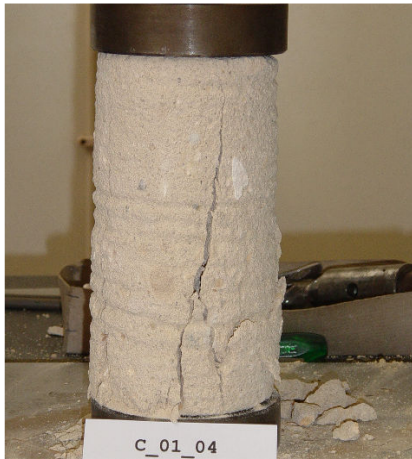
Fig. 4 – Compression tests

The specimens were divided in two groups, one to perform the compression tests (Fig. 4), and the other for the diametral compression tests (Fig. 5).

Due to adobe standard mechanical tests' inexistence, it were followed the RILEM technical recommendations for concrete specimen tests [4], to evaluate the compressive and tensile strength of the adobe specimens. The compressive strength was determined from the failure compression load divided by the specimen area resisting to the load and reported in units $[N/mm^2]$, as described in RILEM CPC4. The compressive strength is commonly used in the safety assessment and design of constructions.

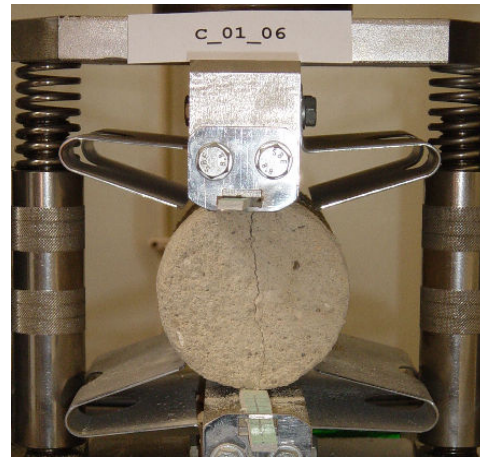
Fig. 5 – Diametral compression tests

The diametral compression test was used to determine the tensile strength of the adobe. A compressive load was applied across the diameter of the specimen creating a nearly uniform state of tension across a vertical plane. Tensile strength of the specimen was measured by increasing the compressive load until the specimen fails in tension. The tensile strength, as described in RILEM CPC6 [4], is given by:

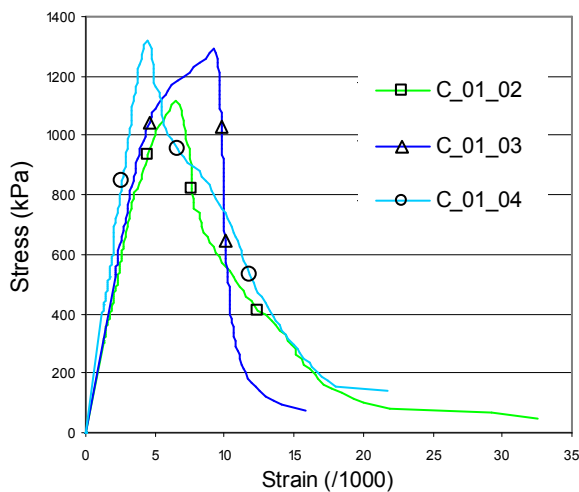
Fig. 6 – Compression test – House

In this section are presented the stress-strain behaviour curves obtained, for the compression and diametral compression tests (Fig. 6 to 9). The obtained results are discussed.

From the stress-strain behaviour curves, it was registered the peak strength (compressive strength and tensile strength, derived from the diametral compression test). The Young modulus was also estimated from the stress-strain curves for low levels of stress (between 10% and 20% of the specimen strength). In Table 1 are summarised the results obtained for each tested specimen. For the specimen M_01_05, the obtained curve was inconclusive, so this result was not included in the summary table.

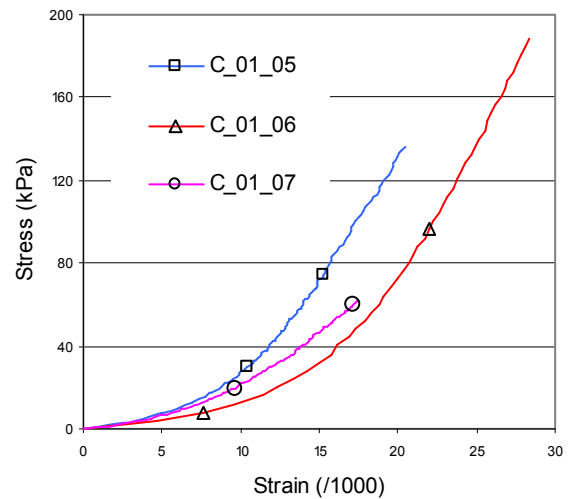
Fig. 7 – Diametral compression test – House

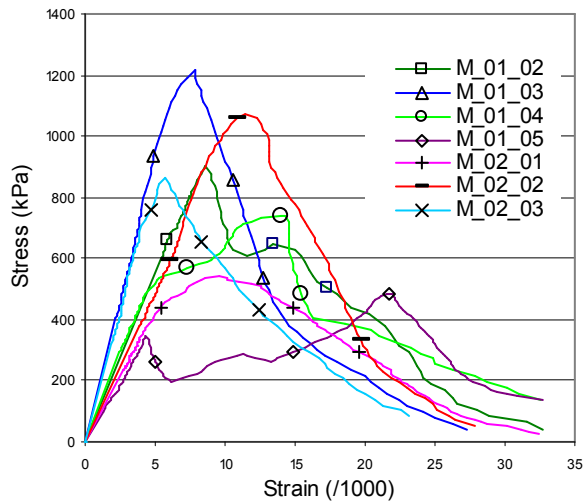
Fig. 8 – Compression test – Walls

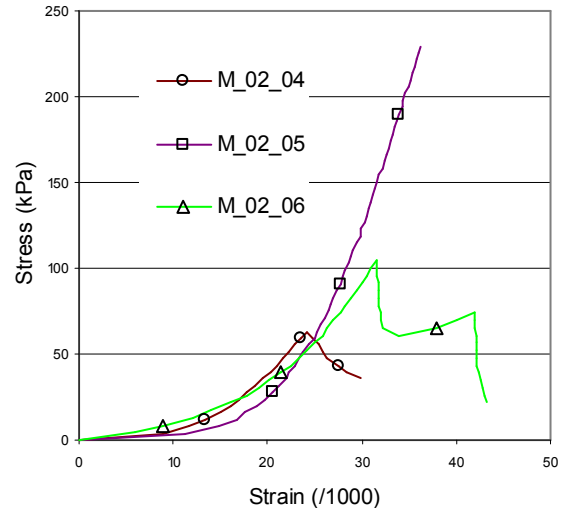
Fig. 9 – Diametral compression test – Walls

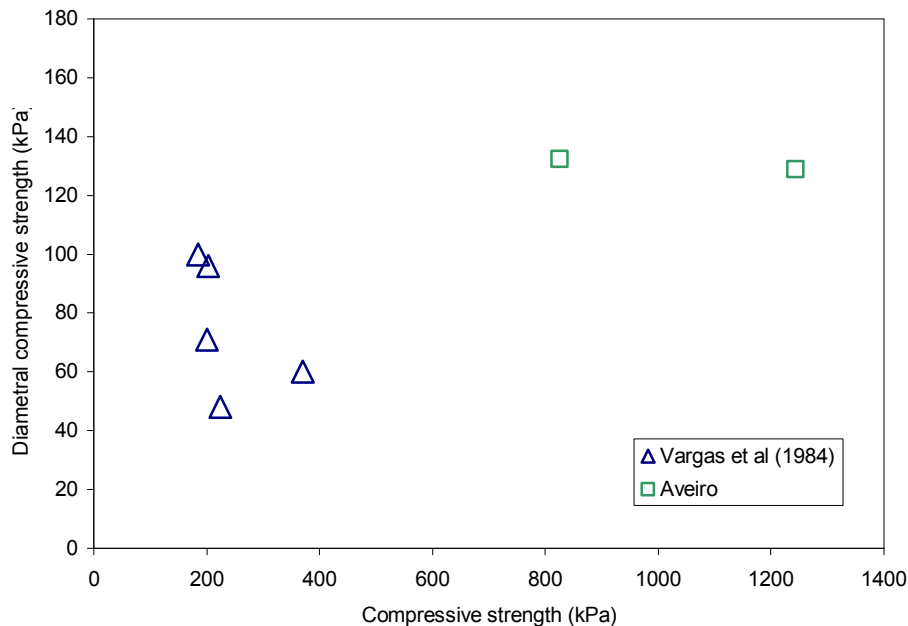
Fig. 10 – Compressive strength versus Diametral compressive strength

In Fig. 10 are plotted, for each test series, the average strength obtained from the compression test and from the diametral compression test.

In an attempt to find a correlation between the two strengths the obtained results for Aveiro's adobes were compared with the results presented in the study of Vargas *et al.* [1]. In this work, soils from six zones of Peru where adobe construction is traditional were selected, namely from Cajamarca, Cuzco, Huancayo, Huaraz, Pisco and PUC. It is underlined that in these zones the adobe is manufactured as a mixture of soil and water, without any additives. The soil samples were collected, prepared and tested to estimate the mechanical strength of the traditional adobe. For the mechanical characterization of these adobe samples, it was evaluated the compressive and tensile strength. In the graphic of Fig. 10, are confronted the mechanical strength results from the Aveiro

and Peru adobes's. The adobe from Aveiro has higher strength (compressive and tensile). It is possible to perceive also a tendency for a correlation between the compressive and tensile strength.
