NASA/TM-2018-219818
NESC-RP-14-00963

Simplified Aid for Extra-Vehicular Activity Rescue (SAFER) Battery Assessment

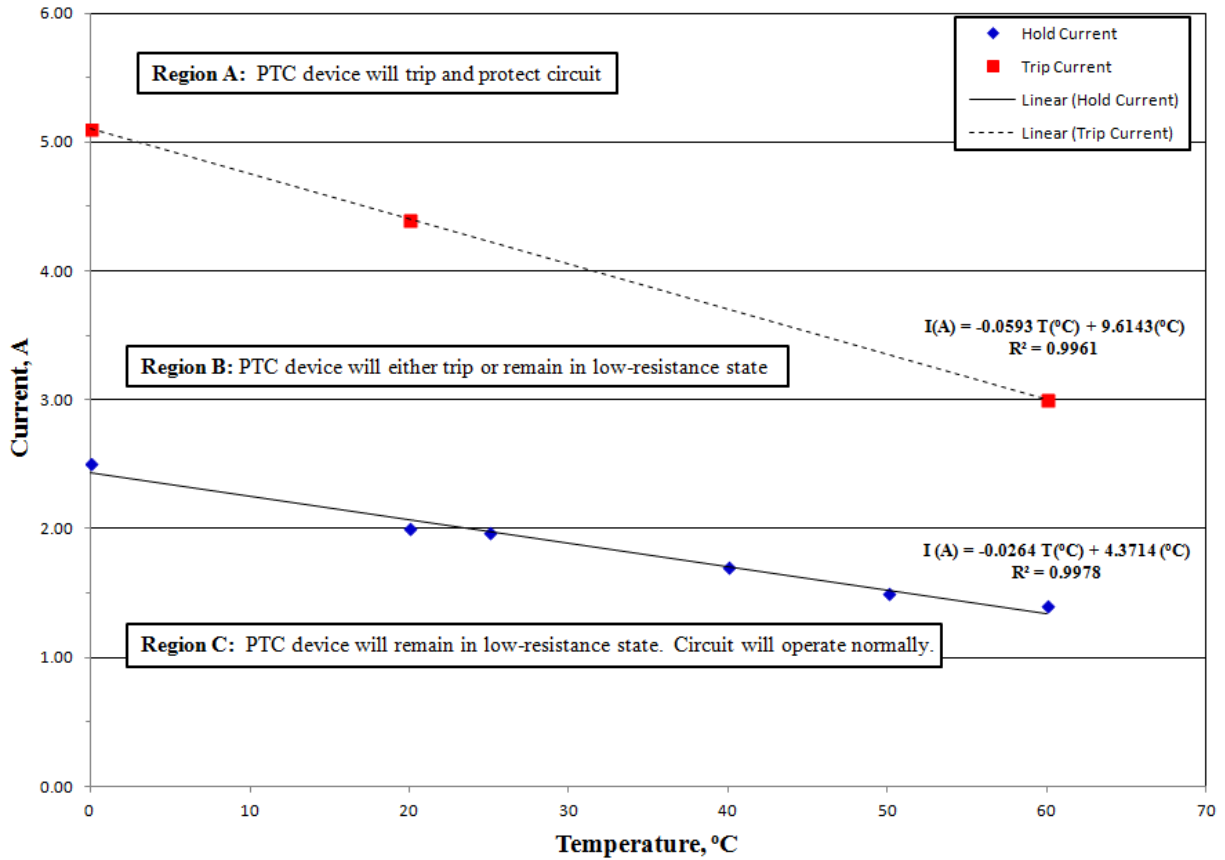
Figure 7.2-3. Effect of Temperature on Hold and Trip Currents for the SAFER Battery SRP-200F PTC Thermal Fuse [22,23]

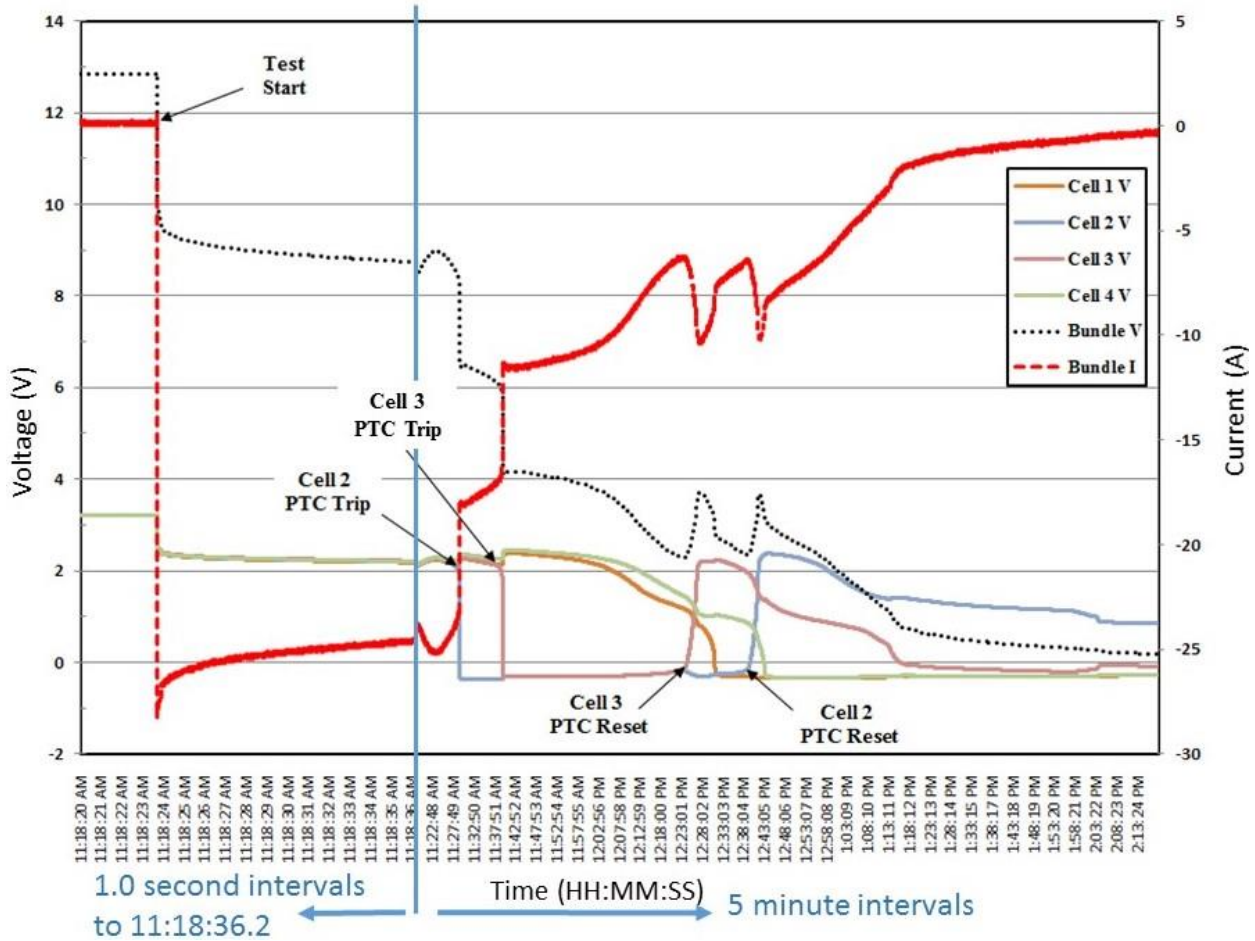
Note: External resistive load = 3.5 ohm; no external PTC device. Ambient temperature and pressure.

Figure 7.2-7. Voltage-current Characteristics for SAFER Battery 4S-cell Bundle External Short Test #12

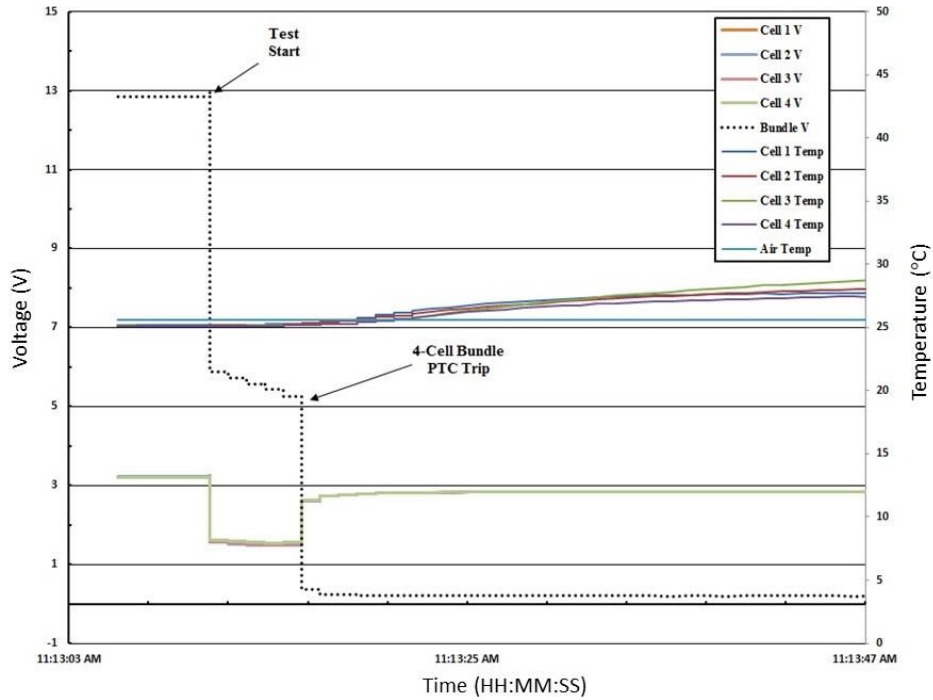
Note: External resistive load = 1.0 ohm; PTC device installed. All testing was conducted at ambient temperature and pressure.

Figure 7.2-13. Voltage-temperature Characteristics for SAFER Battery 4S-cell Bundle External Short Test #15

Test #13 was conducted to investigate the effectiveness of the installed SRP-200F external PTC device on a 4S-cell bundle during an external short. Test conditions for Tests #12 and #13 were identical, except the Test #13 4S-cell bundle had an external SRP-200F PTC thermal fuse installed (Figure 7.2-10). External short test results for Test #13 are shown in Figures 7.2-11 and 7.2-12. Cell #2 (cell ID #333) reached a peak temperature of 69.3 °C, which was less than Cell #2 (cell ID #344) from Test #12. The external PTC device tripped at approximately 65 °C and 23A. Subsequent to the external PTC thermal fuse trip event, the 4S-cell bundle temperature decreases with no evidence of any internal cell fuse trip events. The external PTC device was observed to function as expected for Tests #11, #15 (Figures 7.2-13 and 7.2-14), #17, and #19.

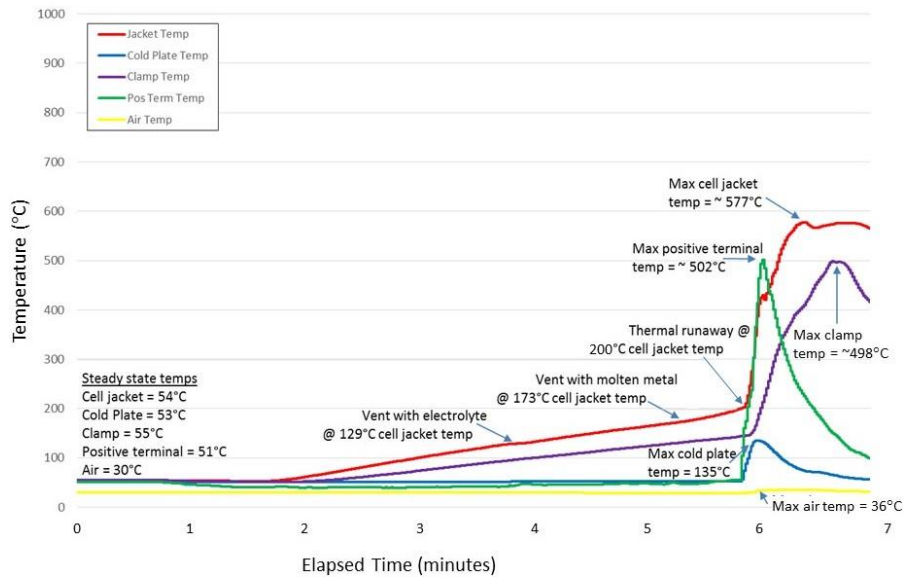
Figure 7.3-13. Temperature Response in Trigger Cell at 49 °C with 25-W Heater

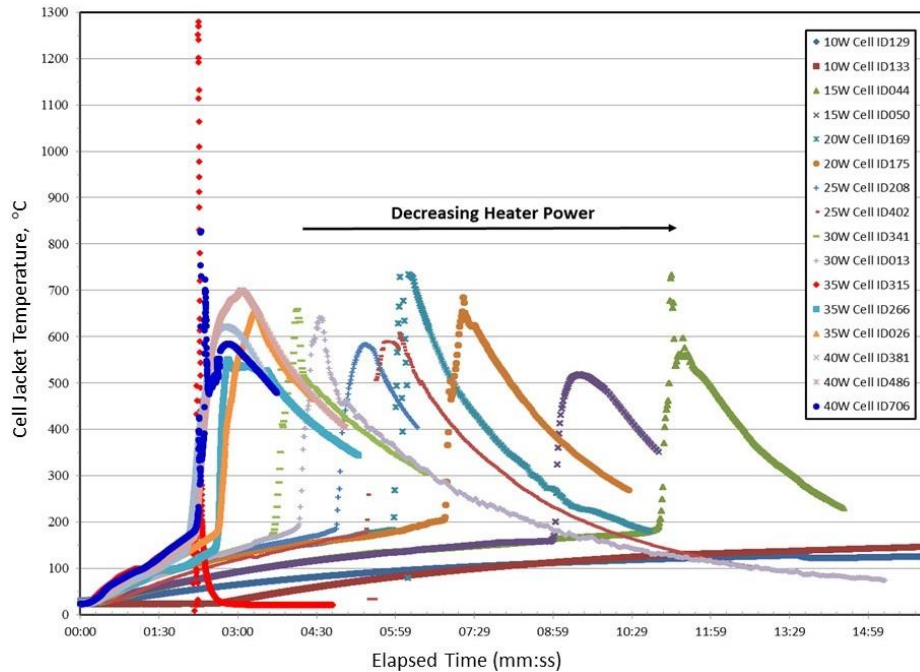
Figure 7.3-17. Effect of Heater Power on the Maximum Cell Jacket Temperature and Time to TR

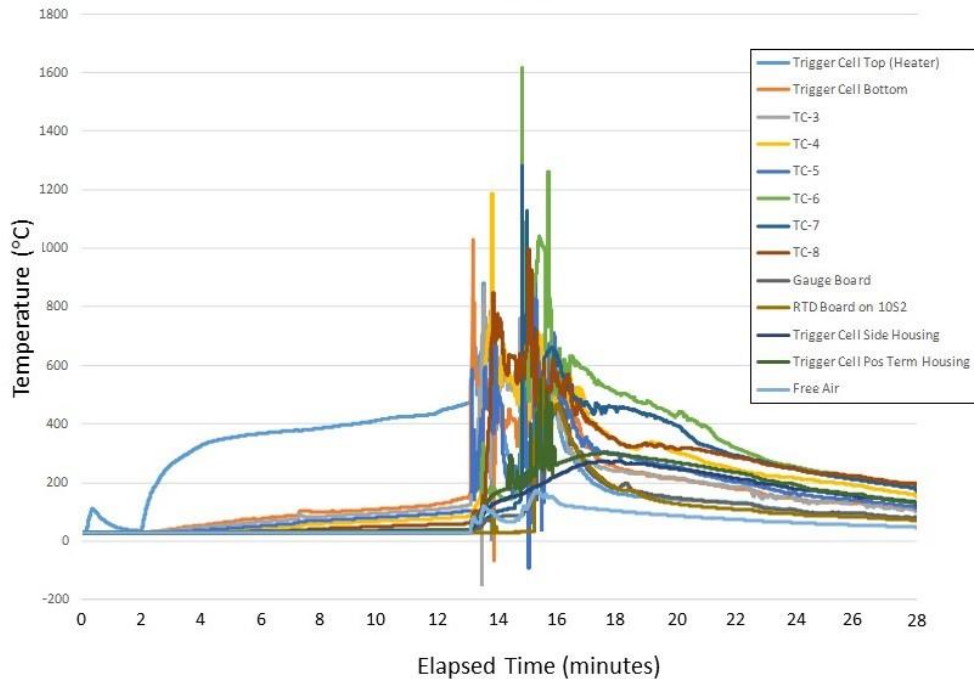
Figure 7.4-8. Thermocouple temperature plots for Test 1.

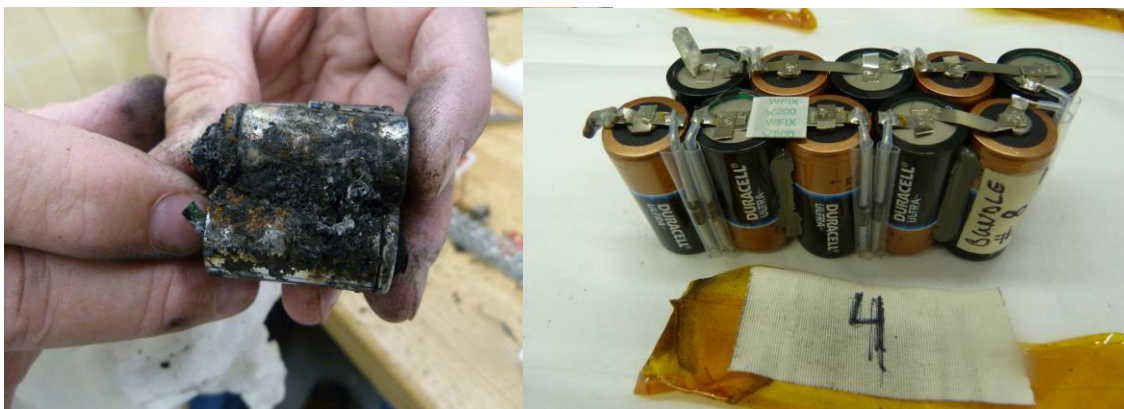
Figure 7.4-9. Test #1 Post-test Images of Exemplar Cells from 4S Bundle Side (left) and from 10S Bundle Side (right)

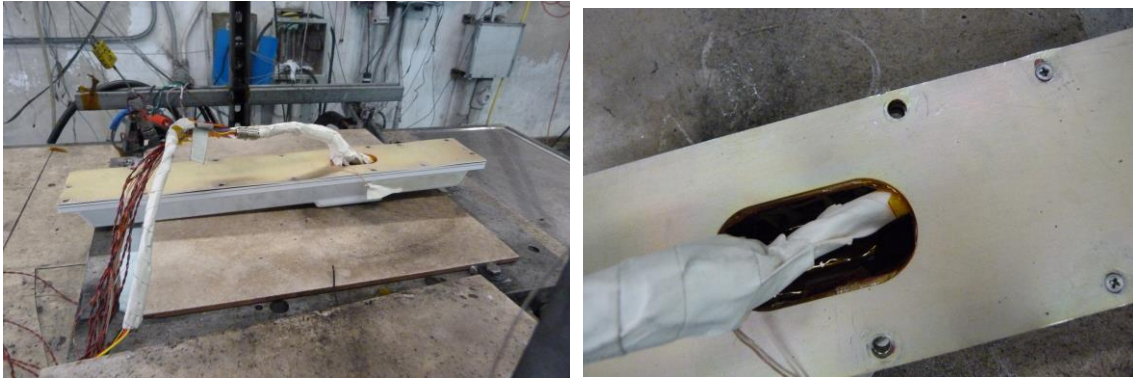
Figure 7.4-11. Test #2 Assembly

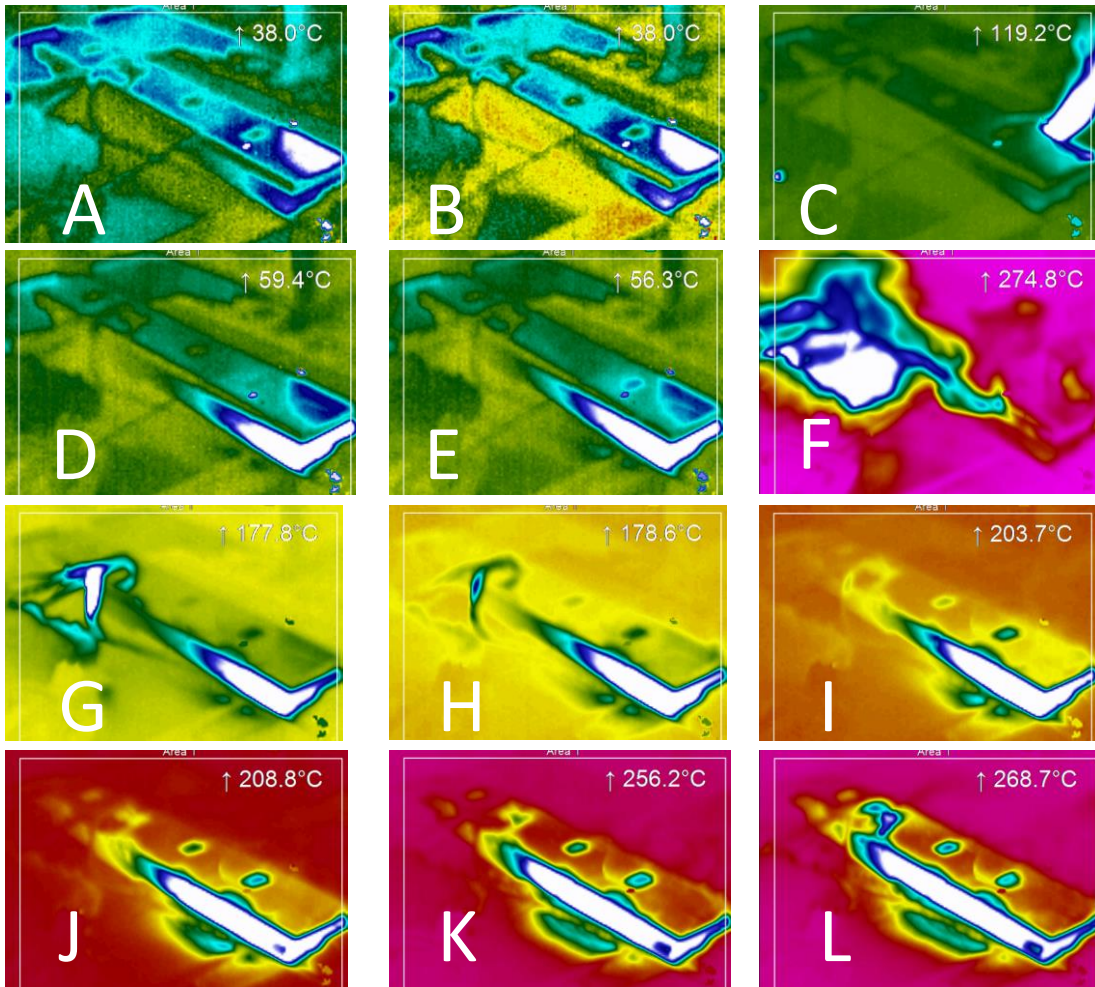
Figure 7.4-26. Test 4 IR Images at Various Times during SAFER Battery-level TR

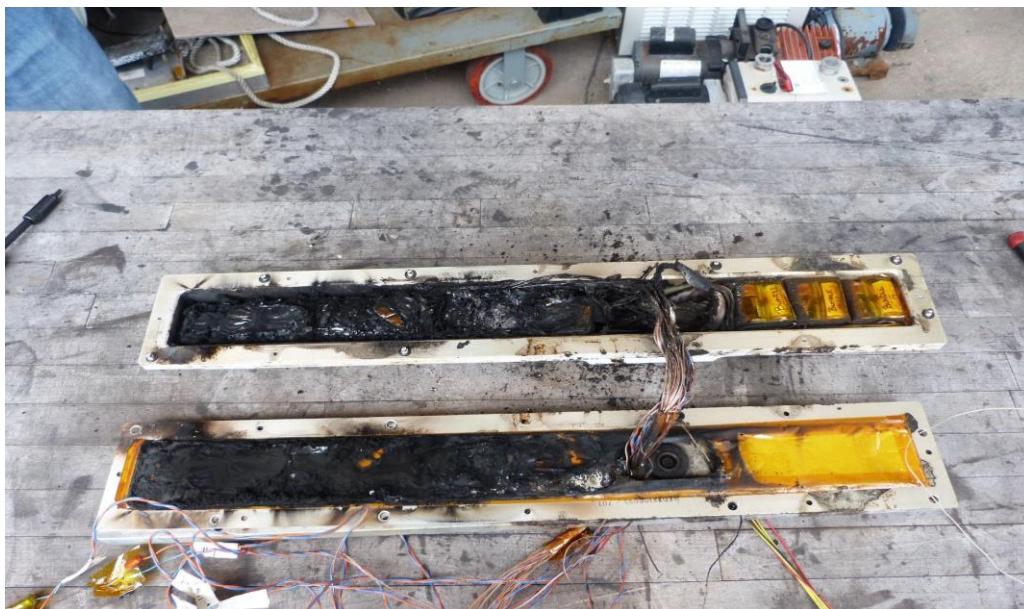
Figure 7.4-27. Test #4 Post-test Image of Open Battery Pack
