## **Human Factors Analysis of Predator B Crash**

MIT Humans and Automation Lab

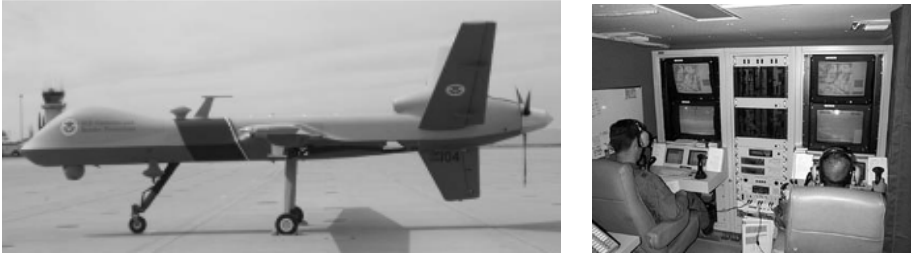
**Figure 1: DHS Predator B (left) and inside view of GCS (right) [3]**

The Nogales Predator B was flown by the Department of Homeland Security (DHS) for the purpose of border protection by the Customs and Border Patrol (CBP). The system consists of the UAV, a GCS, and the interfaces between the components. The GCS houses the pilot's and the sensor operator's work stations. These operators sit side by side at identical consoles, with the pilot normally in the left position (PPO-1) and the sensor operator on the right (PPO-2).
