The Demonstration of a Light Extinction Tomography System at the NASA Glenn Research Center's Icing Research Tunnel

Mark R. Woike¹, Timothy J. Bencic², Jonathon D. Ponder³, Judith F. Van Zante⁴,
Laura King-Steen⁵, Emily N. Timko⁶
NASA Glenn Research Center, Cleveland, Ohio, 44135

A prototype light extinction tomography system has been developed for acquiring real-time in-situ icing cloud uniformity and density measurements in the NASA Glenn Research Center's Icing Research Tunnel (IRT). These measurements are currently obtained manually during periodic cloud calibrations of the IRT. These manual measurements are time consuming and assume that cloud uniformity and density does not greatly vary between the periodic calibrations. It is envisioned that the new light extinction tomography system will provide the means to make these measurements in-situ in real-time and minimize the need for these manual measurements. This new system uses the principle of light extinction tomography to measure the spray density and distribution in the test section. The prototype system was installed and successfully demonstrated in the IRT in early 2018. Data sets were acquired for several typical spra

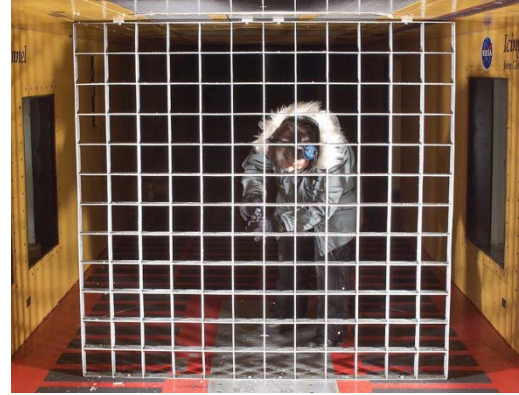
Figure 2.—Technician measuring the thickness of ice accreted on the Grid.

Periodic calibrations are conducted to characterize the icing cloud conditions and assure uniformity. Cloud uniformity is measured using a 6 by 6 ft grid in the test section. This grid extends floor to ceiling, and covers the central 6 ft of the 9 ft span. The grid mesh is 6 by 6 in. Mesh elements are 2 in. deep with a flat 1/8 in. face for ice accretion. During these calibrations, digital calipers are used to measure the ice thickness accreted at the center mesh points of the vertical elements. An image of a technician measuring ice on the grid during a typical calibration is shown in Figure 2. This manual method is time consuming and assumes that cloud uniformity and density does not greatly vary between the periodic calibrations.

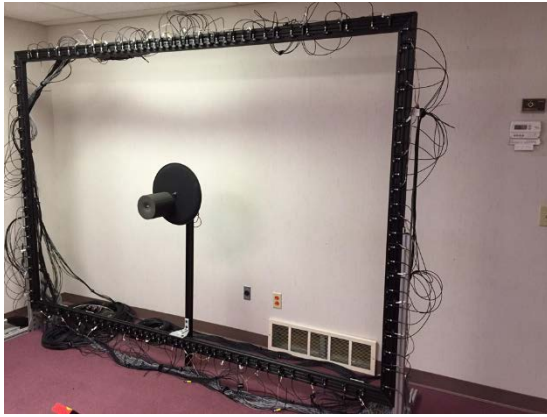
Figure 4. – Prototype IRT Light Extinction Tomography System. (a) Lab setup (b) Laser diodes and light detectors.

The prototype light extinction tomography system demonstrated in the Icing Research Tunnel consisted of sixty (60) laser diodes with sheet generating optics spaced every six degrees around the periphery of a 6 ft by 9 ft frame structure. In addition, one hundred twenty (120) fiber optically coupled detection elements were mounted every three degrees around this same structure. The conceptual layout of the system is shown in Figure 3 and the actual system set up in the lab for development work is shown in Figure 4a. A close up of the laser diodes and associated light detection elements is shown in Figure 4b.

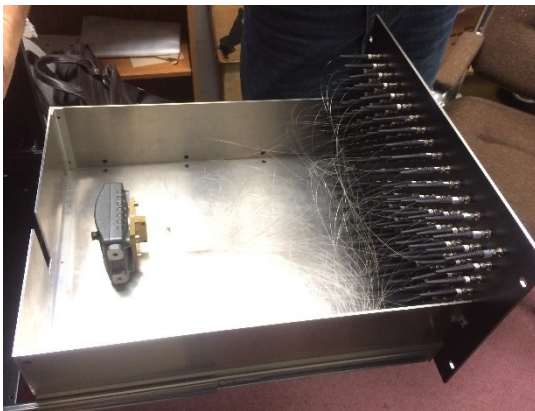
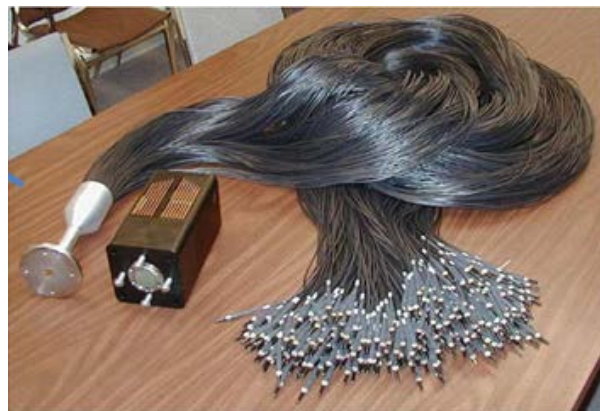
Figure 5. – Camera Configurations. (a) Line scan camera to fiber interface (b) Area scan camera to fiber interface.

Each detector utilized a flashed opal input diffuser at the fiber entrance which is coupled to the CCD camera for simultaneous sampling of all 120 light detector channels. The diffuser allows coupling of the laser light into the fibers at a very wide input angle of approximately ± 85 degrees with respect to the fiber face. The diffusers greatly increase the acceptance angle of the fibers at the cost of allowing only a small amount of the incident light to be coupled into the fiber. The laser diode sources (658nm wavelength) are pulsed sequentially while the detectors acquire line-of-sight extinction data for each laser pulse. A custom timing/trigging circuit was built in-house and used to pulse the laser diodes and control the data acquisition. The optical fibers are directly coupled to the CCD camera through a fiber optic faceplate. The fibers are directly butted up to the CCD to give a simultaneous snap shot of what the detectors are seeing for a given laser pulse. Two different CCD camera configurations were investigated for the purposes of reading the detector data for this prototype system. The first was a line scan camera with 12 bit depth (Fig. 5a). The second was a traditional area scan camera with 16 bit depth (Fig. 5b). Computed tomography algorithms were then used to reconstruct the data acquired from the detectors to provide a two dimensional image of the uniformity of the cloud flow through the test section. It was envisioned that the line scan camera would decrease the read time and result in faster response time. However, during the demonstration testing in the facility it was found that the area scan camera with its 16 bit depth provided the best overall results and will be used for future implementations of the system. More on this will be discussed in the following sections of this paper.

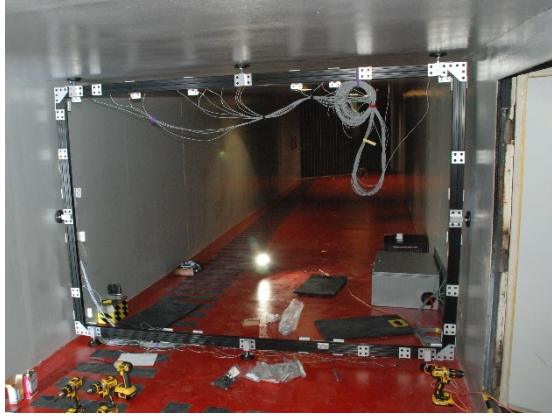
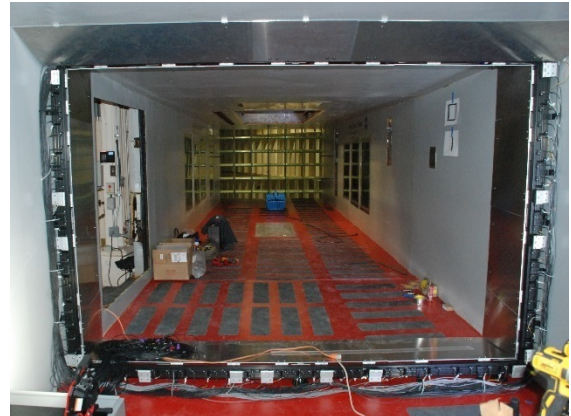
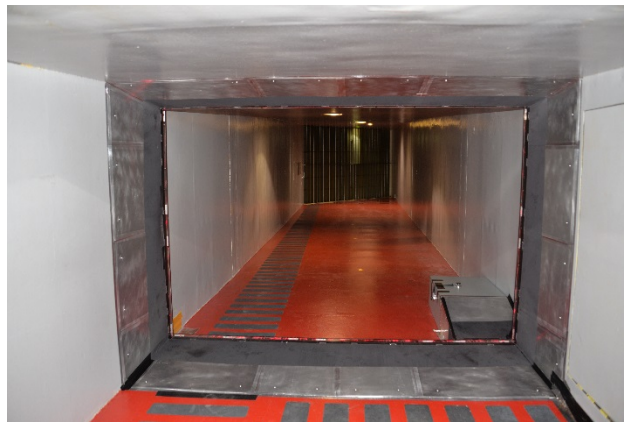
Figure 7. – Light extinction tomography system installation. (a) Frame being mounted in facility diffuser, looking downstream (b) Forward fairings installed, routing of laser and fiber optic cables on aft side in process, looking upstream (c) Installation complete, system ready for test operations, looking downstream.

The prototype system was installed in the facility diffuser, ~91 in. downstream from the end of the test section as this was found to be the location that would accommodate the prototype hardware's outside width and height while still being close to the test section. The conceptual layout of the prototype system is shown in Figure 6. The frame was bolted to the tunnel walls through the leveling feet that were installed to properly position the structure. Custom fabricated aluminum fairing panels were installed on both the upstream and downstream side of the tomography system's frame to guide the flow over and through the system along with providing protection to the optics and cabling. To prevent ice from building up on the optics and to further minimize flow disturbances, acrylic panels were installed along the periphery of the rig in the measurement plane where the optical access slots were located. Pictures showing the system during various steps of the installation are shown in Figures 7a and 7b. The system fully installed and ready for test operations is shown in Figure 7c.

In viewing the pictures of Figure 7, one can see that there were many compromises made in the installation for this initial proof-of-concept test. First, the off-the-shelf lab hardware did not have the low flow profile that will be needed in the final permanent version. This not only drove the location where it could be located in the facility, but it also created the need for the aluminum fairings on both the upstream and downstream side of the system to minimize flow disturbances and guide the flow over the hardware. This created a convergent-divergent area at the system that would not be present in the permanent version. Second, the lab hardware had limited lengths of cables for the lasers and fiber optic light detectors. This caused the controller for the laser and the camera for the light detectors to be located in a metal cabinet that was installed downstream of the system in the diffuser. This is shown on the lower right-hand corner of the system in Figure 7c. This had the potential to create a localized flow disturbance in this corner which would not be normally present in the facility's flow. For the permanent installation these components will be located outside of the test section with sufficient lengths of cabling and penetrations required to route the cabling through the test section walls, minimizing the amount of hardware in the flow path. In the end, even with these compromises, the ultimate goal of assessing the system's performance for this initial proof-of-concept test was achieved. It was felt by the authors' that it was better to validate the system's performance before pursuing a more costly installation that would eliminate all of these issues. These items will be addressed in the final system design for the permanent installation of this system into the IRT.

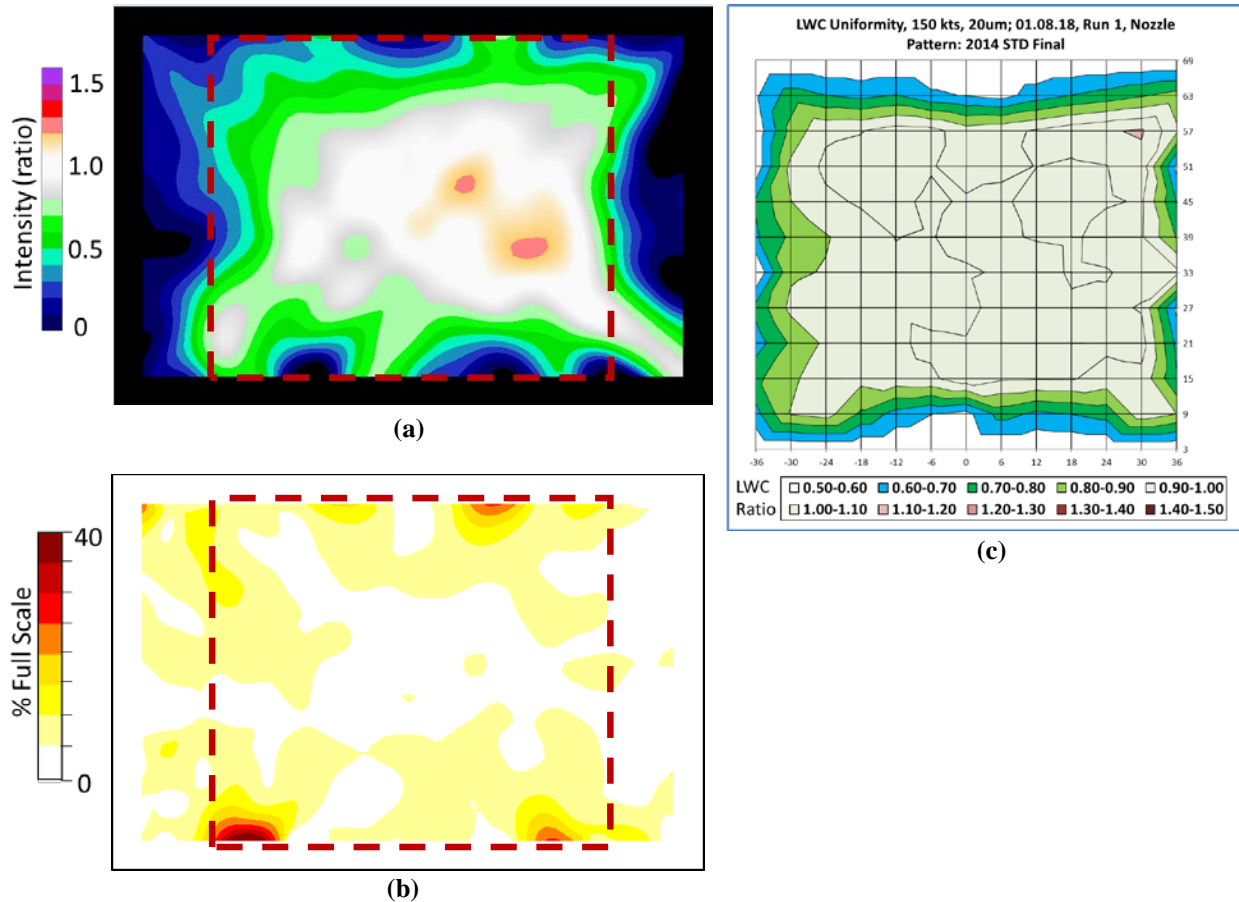
Figure 9. Standard baseline grid spray results. (a) Mean tomographic reconstruction (b) Standard deviation of tomographic reconstructions (c) Calibration grid map from Jan 2018.

The baseline grid sprays (Standard and Mod1) were conducted to determine how well the baseline grid spray uniformity, as measured by the tomography system, matched the uniformity data acquired from previous tunnel calibrations. In addition, several measurements of the same spray conditions were acquired at different times to assess variation in the cloud uniformity as measured by the system. The mean tomographic reconstruction for the standard baseline spray conditions is shown in Figure 9a. This mean was developed by averaging the results of the seven Standard baseline grid spray test runs that were conducted during the demonstration test (runs 29, 33, 43, 45, 55, 68,

and 75). The intensity values of this mean reconstruction were normalized to the intensity values located at the centerline of the test section. This was done in order to provide a better comparison to the LWC calibration plot (Fig. 9c) that was derived from a facility calibration conducted in January 2018, one month previous to this demonstration, using the manual icing measurement grid. This uniformity plot employs a similar type of normalization. The standard deviation for the seven standard baseline sprays measurements is shown in Figure 9b. The red dashed box in the plots of Figures 9a and 9b corresponds to the comparative cross sectional area of the manually-measured grid and denotes the primary area of interest for analysis.

From comparing the mean average of the Standard baseline grid spray as measured by tomography system (Fig. 9a) to the calibration map that was obtained from using the grid (Fig. 9c) it is evident that the results closely follow the same trends and have a similar shape. Each plot shows icing cloud uniformity with ratio values of 0.90 to 1.10 within the center core section of the tunnel flow. The tomographic system’s reconstruction does trend towards lower ratio values (0.70 to 0.80) along the edges of the core flow regime when compared to the calibration map’s ratios. In addition, the tomographic results show two high spots (ratios of ~1.2) in the core flow region that do not appear in the calibration map. These differences can be attributed to several reasons. First, the calibration map was generated by using the grid that is located in the test section as opposed to the diffuser section where the tomographic system was installed. The conditions in the diffuser may be slightly different than the condition previously measured in the test section. Uniformity data has not been previously acquired in the diffuser location. In addition, as mentioned in Section III, effects associated with the prototype tomographic system’s temporary installation in the diffuser such as convergent-divergent section caused by use of the aluminum fairing panels and the installation of the equipment box just downstream of the measurement plane may have contributed to the differences that were observed.

In regards to measurement variability between the data sets acquired during the seven baseline grid spray test runs, the standard deviation plot (Fig. 9b) shows 0 to 10% reading-to-reading variation in the center core section of the tunnel flow. This is within reason and was expected. The high variations at the outer edges are not of concern as this is a common observance with tomographic reconstructions. Artifacts like this occur at the edge of the measurement plane when a laser or light detector is out of alignment for one or more of the test runs. While this may create an undesired anomaly on the edge of the measurement plane, the system is robust enough to yield good measurements in the desired core center section where the tunnel flow is of most concern.

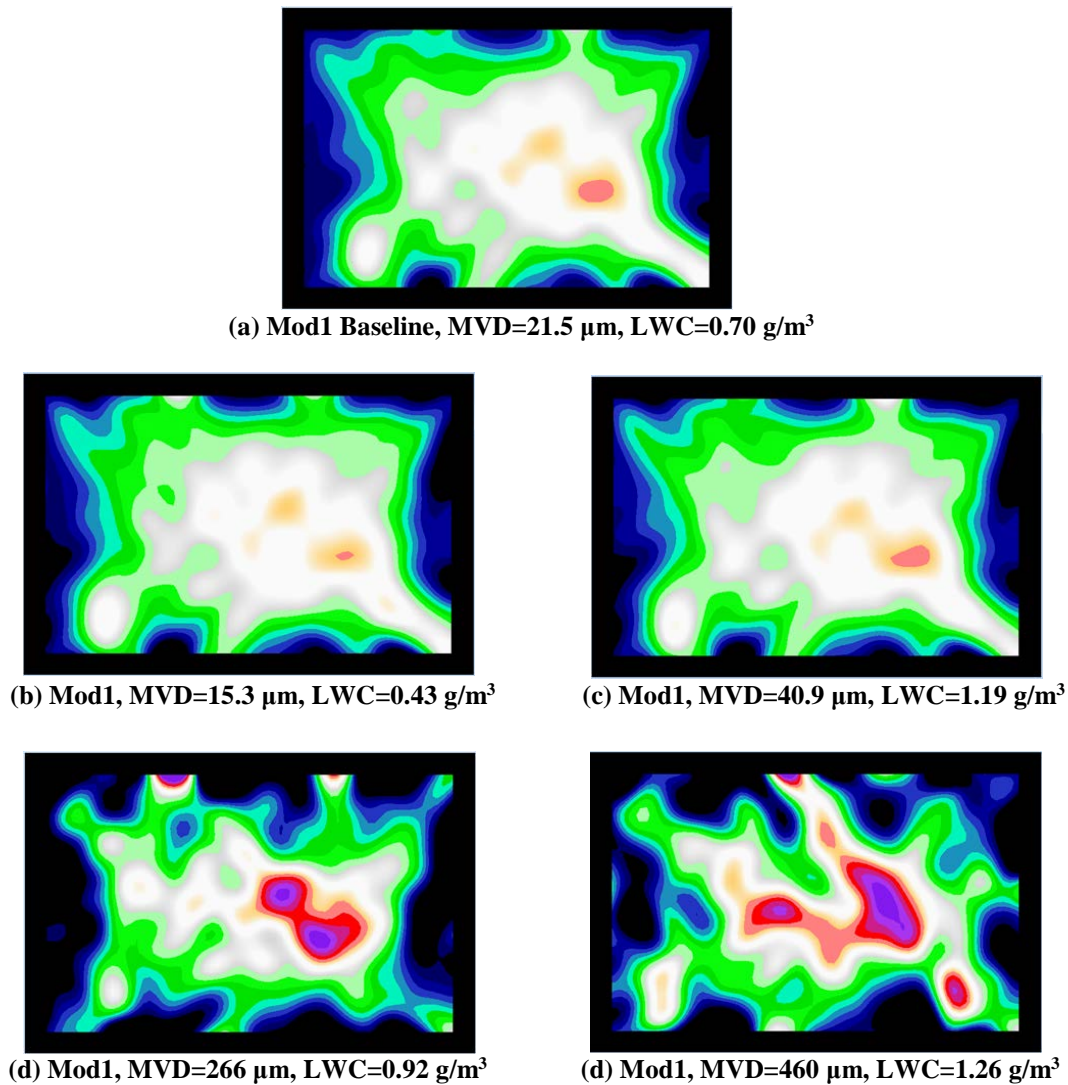
Figure 11. Mod1 spray variation results. (a) Mean of Mod1 baseline sprays (b) Test run #48 (c) Test run #49 (d) Test Run #52 (e) Test run #53

As described previously, the Sensitivity Checks involved operating the spray bars at the known calibrated configuration, but varying the MVD and LWC of the spray to determine if the tomography system could detect the change in cloud uniformity. Figure 11 shows the results acquired during several test runs of the Mod1 spray where the MVD was varied over a range of known configurations.

In analyzing Figure 11, minimal changes from the baseline Mod1 spray results with MVD=21.5 μm (Fig. 11a) are observed when the drop MVD is varied from 15 μm (Fig. 11b) to 41 μm (Fig. 11c). The cloud uniformity and shape as measured by the tomography system for these typical drop sizes are nearly identical. This is consistent with results observed in the previous manual grid measurements obtained in 2014⁴. However, noticeable variations are observed when the “large drop” size sprays were used (Figs. 11d & 11e). These test cases involved using sprays that had drop MVDs of 266 μm and 460 μm respectively. These conditions are on the upper end of the facility’s maximum drop diameter capabilities. In these two cases there is a noticeable shrinking of the cloud and higher concentrations in the central portion of the measurement plane. It is surmised that this cloud shrinkage is likely due to both the presence of larger drops which tend more towards test section center and the decreased flow mixing caused by lower nozzle air pressures. This was also consistent with the calibration in 2014. It should be noted that the results shown in Figure 11 are normalized to better assess uniformity. In looking at the raw images the overall intensity values do vary due to changes in overall LWC. This will be critical when the system is used to provide this measurement in addition to assessing uniformity. This will be further investigated in future test entries.
