DETERIORATION AND FRAGMENTATION OF RIVERS IN MALTA

S. M. HASLAM

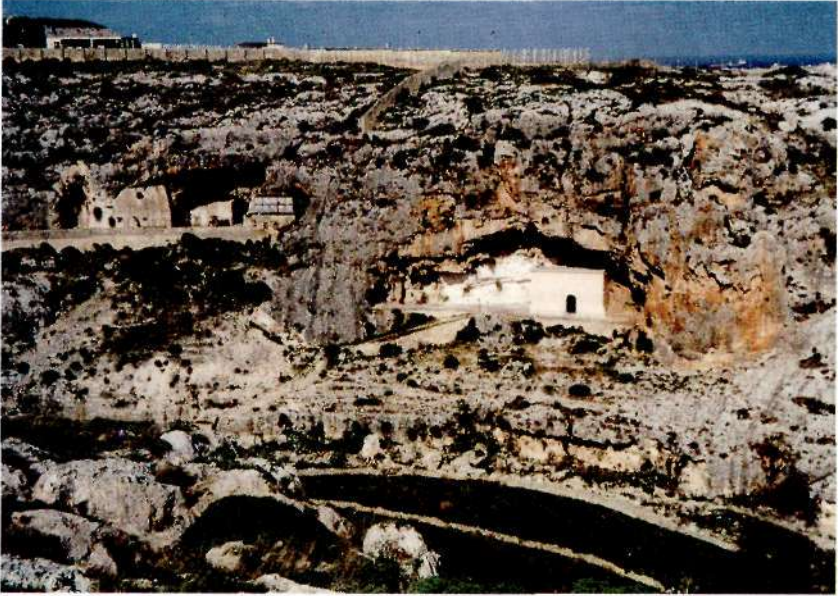
FIG. 1 (*on opposite page*). Two Maltese river-courses. *Above*: Saint Paul's Cave Church near Mosta (at centre of photograph), with the River Ghasel (at bottom of photograph). The bed of the river has dried out and now most of it is used to grow crops. *Below*: the River Sewda. The bed (left centre of photograph) has dried out and is overgrown with vegetation, a roadway has been built up on one side and rubble has been tipped to form a rough "bridge" across the old riverbed (at bottom of picture), forming a potential hazard in times of flood.

(4). 19th-century landscape pictures show rivers full of water. That in itself is not firm evidence, as the larger ones can still be so - occasionally. The pictures, though, show paths or tracks above this high water level and not, as now, below this level. An example is shown in Figure 1 (upper picture).

(5). Limestone is readily but differently eroded by rainwater and riverwater, making it possible to see (at suitable limestone outcrops) the old main river level. For one locality (Fig. 1, upper) there is also a mid-19th century picture, proving that the river level shown by the rock now is the same as that in the picture.
