CORROSION RESISTANCE OF THE WELDED AISI 316L AFTER VARIOUS SURFACE TREATMENTS

Monika Halamová^{1,*}, Ayman Alaskari², Tatiana Liptáková¹

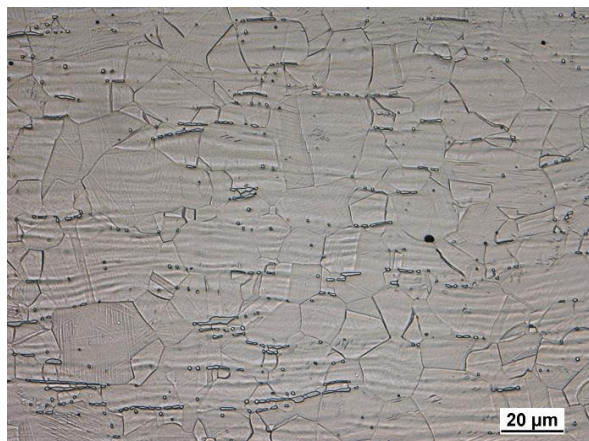
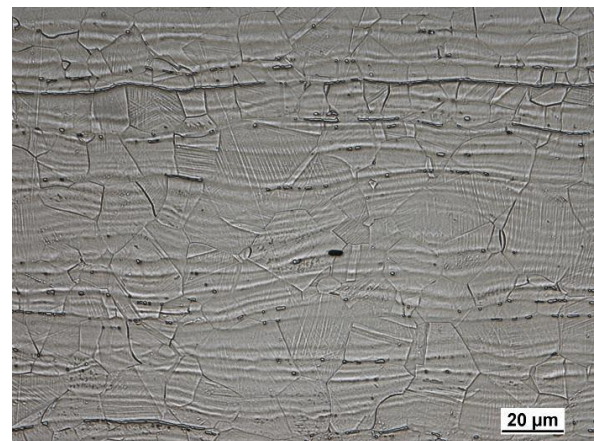
a) transverse section

b) longitudinal section

Fig. 1. AISI 316 L stainless steel microstructure, etch. 10 ml HF, 30 ml HNO₃, 20 ml glycerin.

The microstructure of the AISI 316L steel in transverse and longitudinal section is in Fig. 3. In transverse section (Fig. 1a) the base material microstructure is created by austenitic polyedric grains with row deformation texture and deformation twins. In longitudinal section is very strong deformation texture and presence of delta ferrite, inclusion (Fig. 1b).

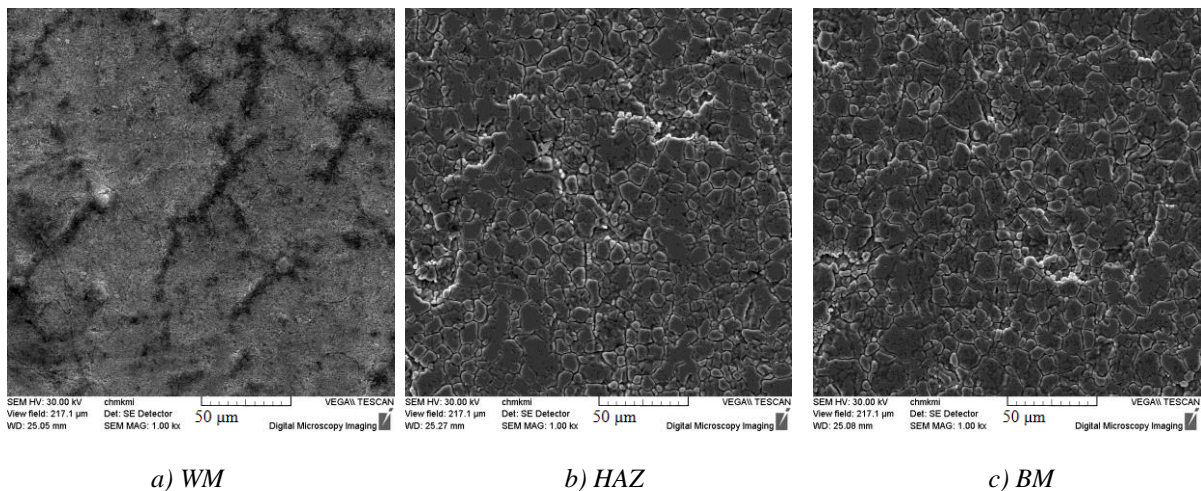
Fig. 2. Surface of the untreated specimen after welding in the locality of WM, HAZ and BM.

Surface of the specimens was assessed by scanning electron microscope (SEM). The analysis was focused on the character of the surface in the WM, HAZ and BM. Using EDX analysis it was examined and compared the chemical composition of the observed areas of the TIG welded specimens with filler metal. In Fig. 2 the surface of untreated specimen is shown. It is visible difference between surfaces of welded metal, heat affected zone and base material. The differences in chemical composition confirmed the EDX analysis too (Table 3). It was determined high amount of C in the weld metal created as weld residual. The increased oxygen content indicates very intensive surface oxidation in comparison with the oxygen content in the heat-affected zone and the base material.

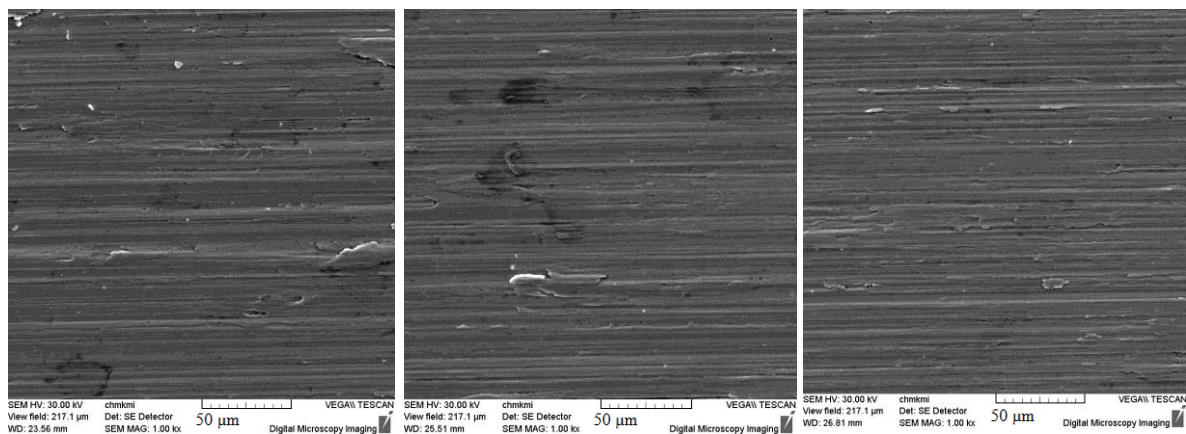
Fig. 3. Surface of the ground specimen after welding in the locality of WM, HAZ and BM.

Surface of specimens machined by grinding was study almost in the same areas. As it can be seen in Fig. 3 the character of grinding surface is in all observed areas similar as well as their chemical composition (Table 4). Products of reactions during welding were removed and the grinding surface became homogeneous. Surface treatment by blasting is not suitable finishing for this type of material. By this way it is not reached homogeneity in chemical composition of studied areas (Table 5). The roughness and surface topography are poor as it is seen in Fig. 4. In the created crevices corrosive solution can be concentrated resulting restriction of passive layer formation. The surface is also contaminated by blasting agents and some welding products are pushed into the metal surface. These factors can considerably influence susceptibility to local corrosion.

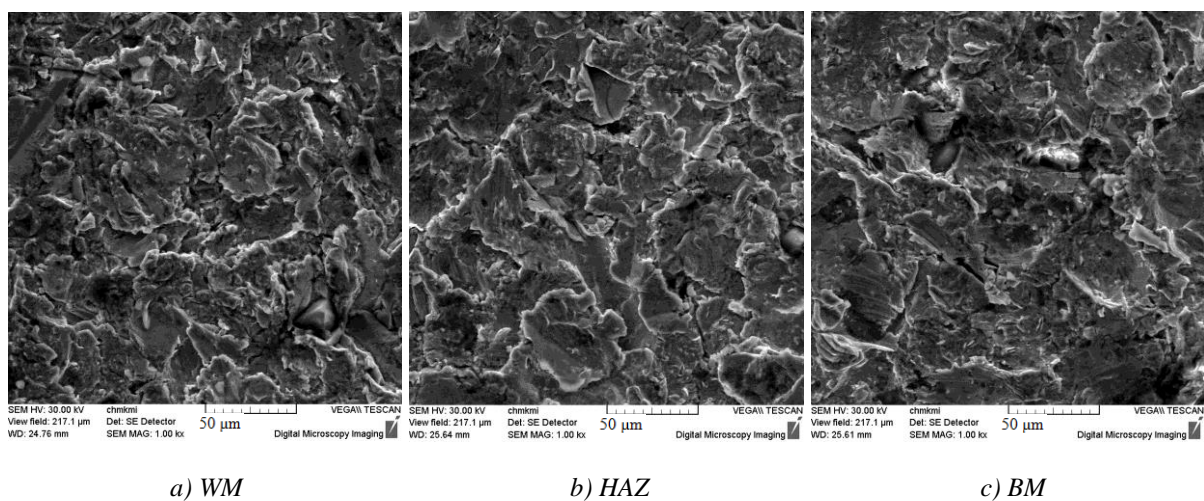
Fig. 4. Surface of the blasted specimen after welding in the locality of WM, HAZ and BM.

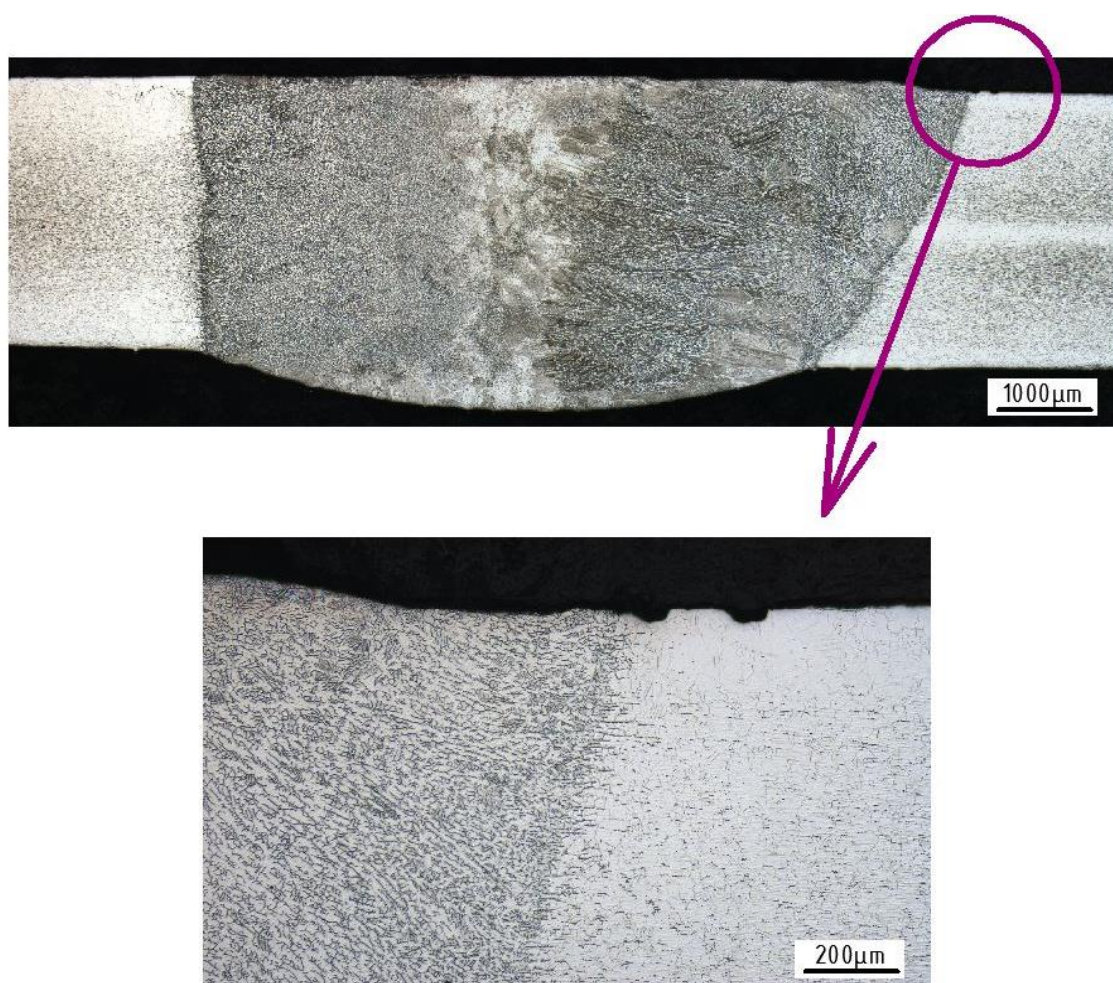
Fig. 5. Corrosion attack of the specimen with untreated surface.

The light metallography was used for evaluation of character and intensity of corrosion attack of the samples with different surface treatment (welded with and without filler metal). Untreated specimens welded with filler metal are attacked by corrosion mostly at the weld metal and heat affected zone (Fig. 5) as well as the specimens welded without filler metal. Surface-

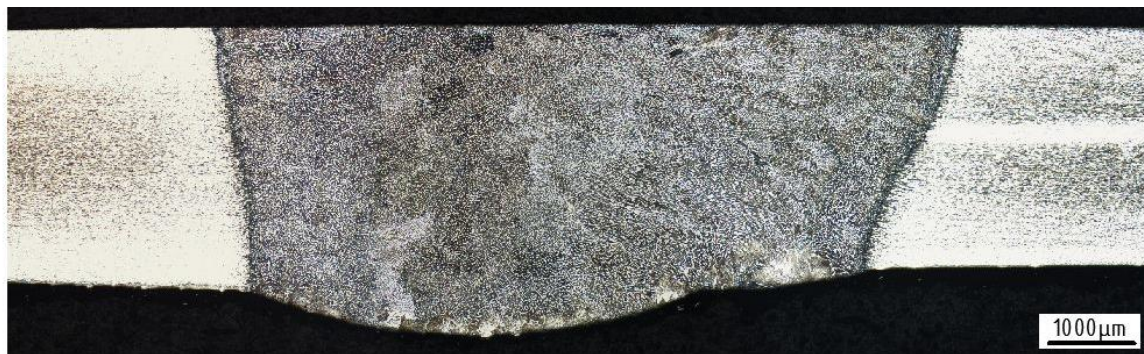
Fig. 6. Corrosion attack of the specimen with ground surface.

welded steel AISI 316L with filler, treated after welding by grinding (Fig. 6) was not visible attacked by corrosion. On the all specimen surfaces welded without filler only rare small corrosion pits were observed. In Fig.7 the intensive pitting corrosion on the blasted specimens after welding (without and with filler material) is seen. The metallographic evaluation is in a good agreement with calculated corrosion rates.

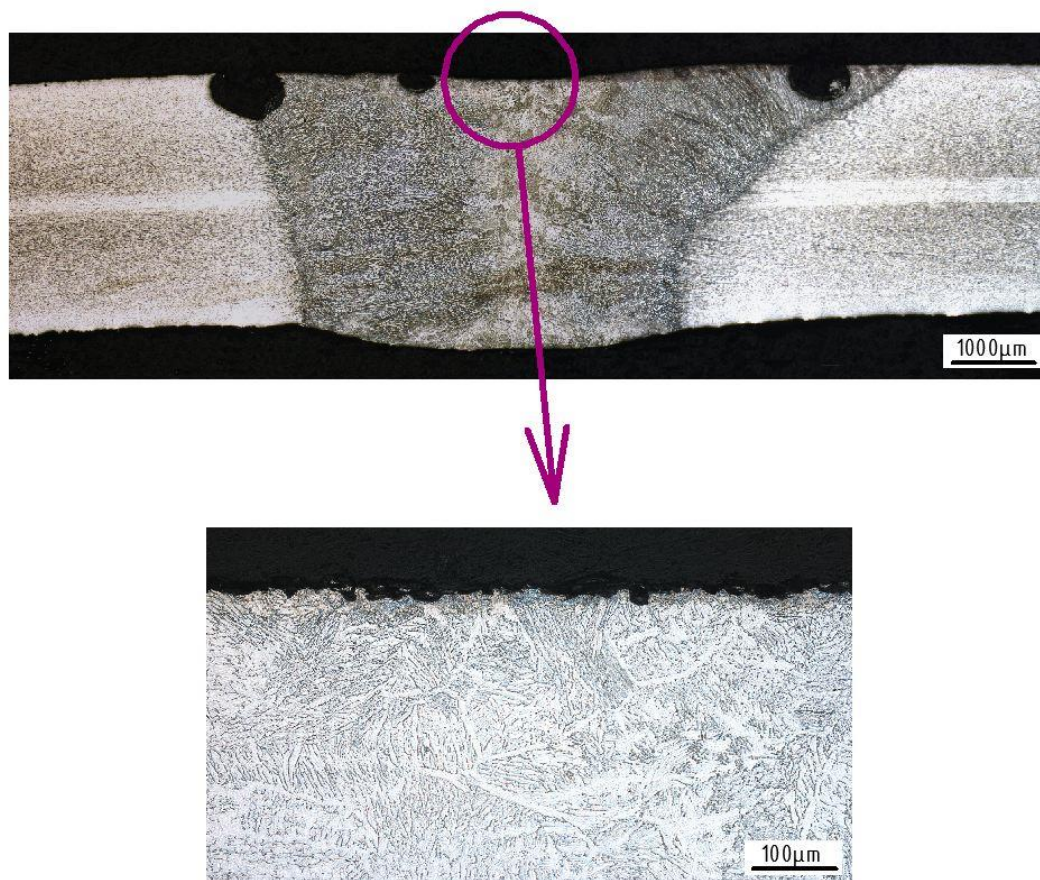
Fig. 7. Corrosion attack of the specimen with blasted surface.

- Blasting is unsatisfactory method of mechanical surface treatment of welds AISI 316L steel, because of corrosion process acceleration. This finishing increases the surface roughness and subsurface deformation occurs. The blasting agents and products of welding are pressed into the subsurface layers of material. These phenomena disturb the integrity of the passive layer and decrease the corrosion resistance.
