Overvoltages in DC Urban Light Railway Systems: Statistical Analysis and Possible Causes

# Overvoltages in DC Urban Light Railway Systems: Statistical Analysis and Possible Causes

**Abstract**—In DC light railway systems the equipment in the power substations and certain devices along the lines are protected against lightning overvoltages thanks to surge arresters. This paper analyses the overvoltages occurring on the tram network of Torino, Italy to discover the causes that brought to the explosion of several surge arresters in the past years. The cause is found to be the regenerative breaking of a particular type of vehicles, in conditions of low load in the system. The benefits of regenerative breaking are discussed in the light of the possible problems introduced. Finally, possible solutions are proposed.

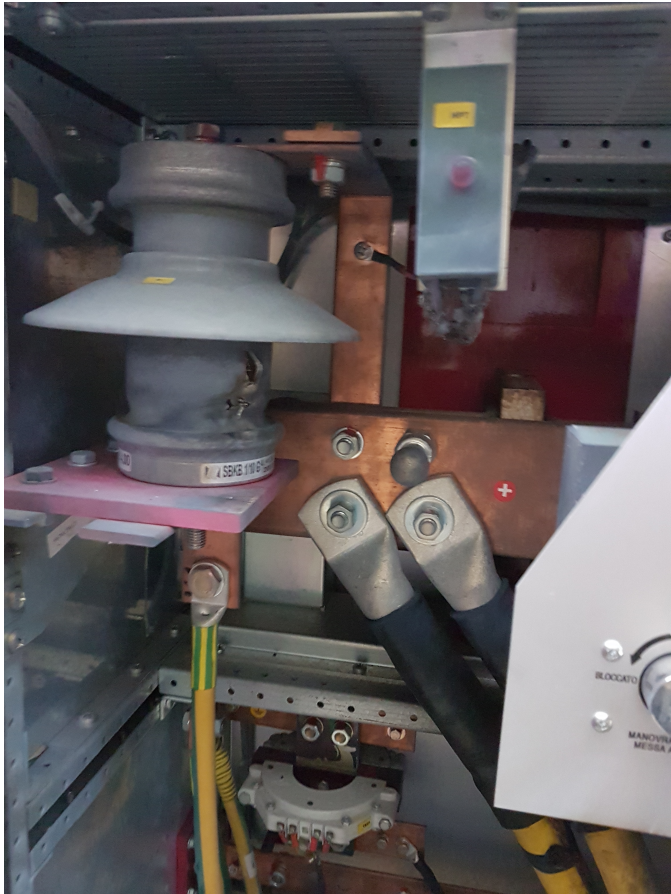
This paper deals with the problem of internal overvoltages in the tram network of Torino, Italy. In recent years, in fact, due to the change in the operation practice of the network and to the change of the number and type of circulating vehicles, several SPDs exploded, creating big damages in the switchboards inside the substations. This caused unacceptable service interruption and economic losses for the network operator. A picture of a damaged SPD is showed in Fig. 1 as an example.

Fig. 1. Exploded SPD.

The overvoltages, in fact, can create important economic damages to the system operator, in terms of service interruption and of damage to the components. One of the exploded surge arresters, for example, triggered an electric arc inside the switchboard in a substation, requiring the complete substitution of the switchboard cubicle. Before the operator was able to complete the cubicle substitution, an electric zone of the TES was left without possibility of reserve power supply, with a strong impact on system reliability.

A second and more interesting possibility is to substitute the arresters with higher class ones. The arresters installed in Torino are class A or class B arresters. Installing class C arresters would increase the charge transfer capability  $Q_t$  to 7.5 As, without negatively impacting the protection level and reducing the risk of explosion.

A substitution of the surge arresters is recommended, with the installation of class C devices, having a higher charge transfer capability. The installation of arresters with higher continuous operating voltage would reduce the risk of explosion, but is not recommended as it would expose the protected devices to higher overvoltages.
