Maintenance and risk management of rockfall protection net fences through numerical study of damage influence

Maintenance and risk management of rockfall protection net fences through numerical study of damage influence / Luciani, Andrea; Todaro, Carmine; Peila, Daniele. - In: FRATTURA E INTEGRITÀ STRUTTURALE. - ISSN 1971-8993. - STAMPA. - 12:43(2018), pp. 241-250.

## Maintenance and risk management of rockfall protection net fences through numerical study of damage influence

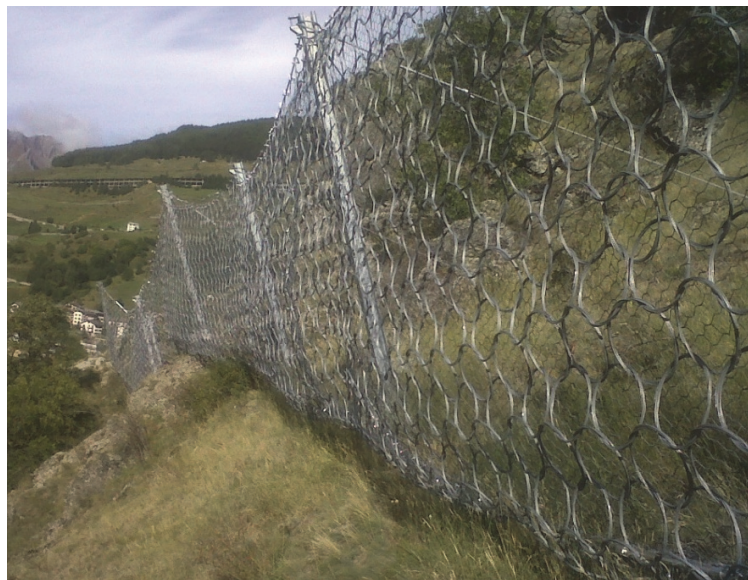
Figure 1: Photo of the studied rockfall protection net fence.

The support structure of this net fence has four HEA200 steel posts, 5 m high, restrained at the base by cylindrical hinges allowing rotation in the upstream-downstream direction. The interception structure is made of a principal steel ring net; each 350 mm ring is connected to six nearest rings. The connection structure comprises two longitudinal upper cables and two longitudinal lower cables, eight upstream cables and four lateral cables. Each cable has a diameter of 20 mm. The longitudinal cables are free to slide on the posts in the longitudinal direction. The net fence is provided with tubular energy dissipating devices, one on each upstream cable and three on each longitudinal cable.

Fig. 1 shows a photo of the net fence.

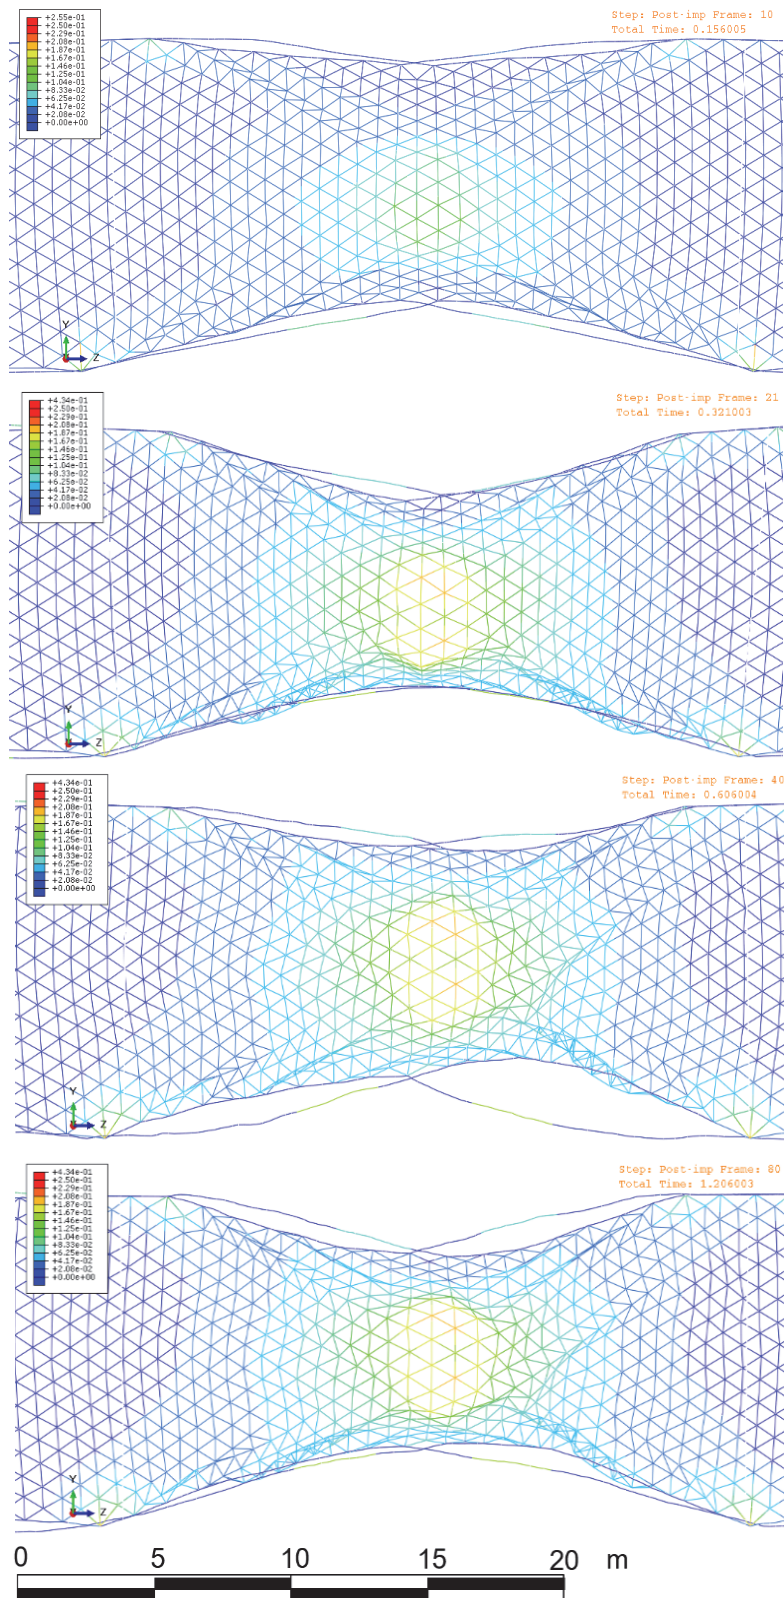
Figure 4: Comparison of the plastic strain in the central panel of the original model at different times during the impact. Time is in seconds [30].

On these six modified models impact tests were performed at different energy levels aiming to identify the maximum energy the modified net fence can withstand without failure of one of the principal elements. Failure of cables and energy dissipating devices was established when one of these elements reached a plastic strain bigger than that correlated to the ultimate stress. Since the model uses an equivalent net, the ultimate stress of the net was unknown, for it may be different from that of the real ring net. Therefore, the equivalent net was considered failed if at least one of the elements composing the net reached a plastic strain bigger than the maximum recorded during the MEL simulation.
