Glass Fiber Reinforced Polymer Dowel Bar Evaluation

WA-RD 795.1

Post-Construction Report
Experimental Feature 10-04

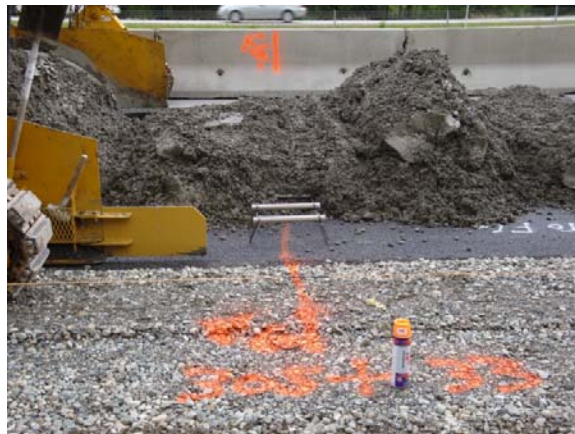
Figure 3. GFRP dowels used in new construction on I-5.

Standard construction practices were employed on all three projects as shown in the photos (Figures 3 through 13). MMFX dowel bars were used on the Starbird Road project as the control section. Epoxy coated dowel bars meeting ASTM A 934 (purple) were used on the two DBR projects. No construction problems were reported on the I-5 or the I-82, Grandview to Prosser projects.

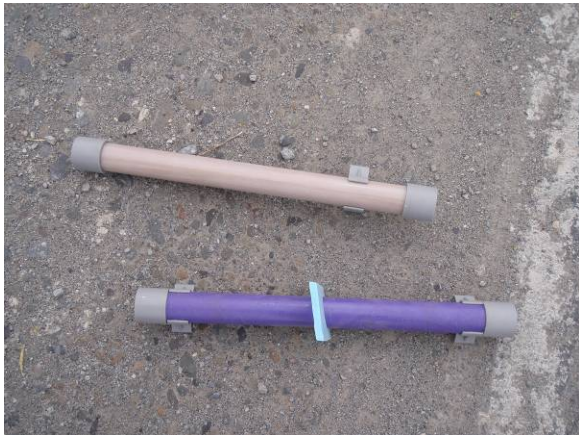
Figure 4. GFRP bar top, epoxy coated bar bottom.

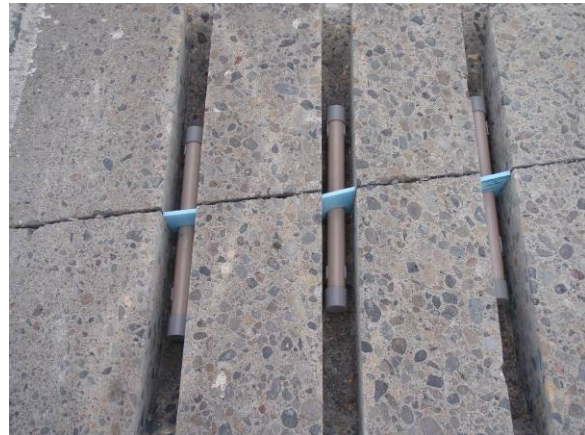
Figure 5. GFRP dowels placed in slots.

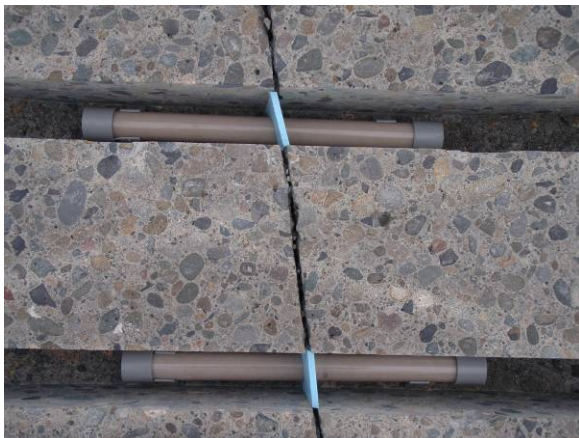
Figure 6. Close-up of dowels in slots.

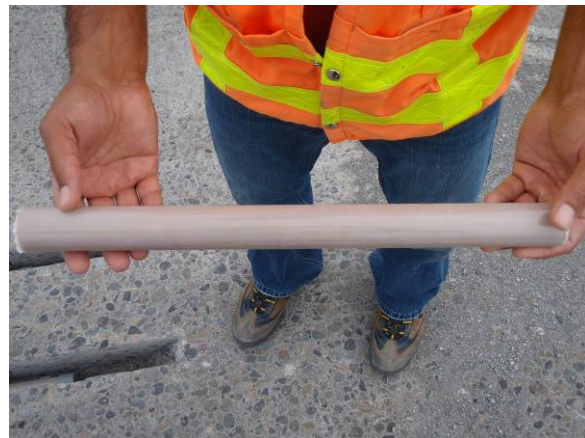
Figure 7. Close-up of GFRP dowel.

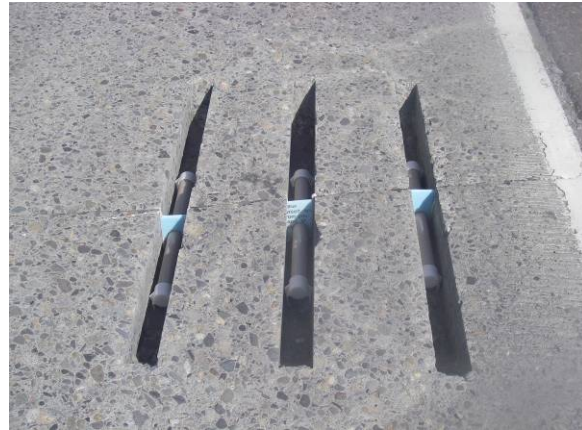
Figure 9. Dowels in slots.

The biggest problem on the I-82, Yakima River Bridge Vicinity to Granger job was movement of the foam insert away from the actual joint. A total of 29 of the 402 bars were removed due to this problem. The inspector also noted that the concrete patching material was sticking to the GFRP bars which did not happen with the epoxy coated bars. Author's note: the MateenDowels™ brochure states that a bond breaker is not required since the composite dowels are much slicker than steel. The Contractor's foremen also told the inspector that a number of the GFRP dowels that were removed had floated up and were out of vertical alignment possibly due to the vibration used to consolidate the patching material.

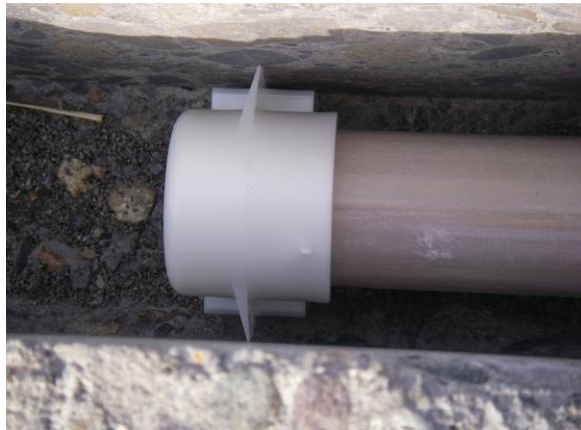
Figure 10. End caps on GFRP dowels.

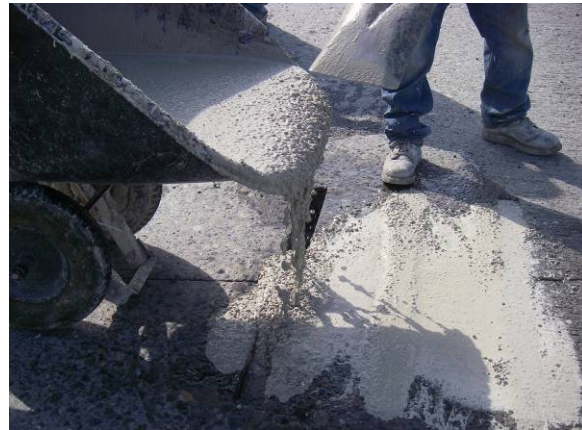
Figure 11. Slot filling.

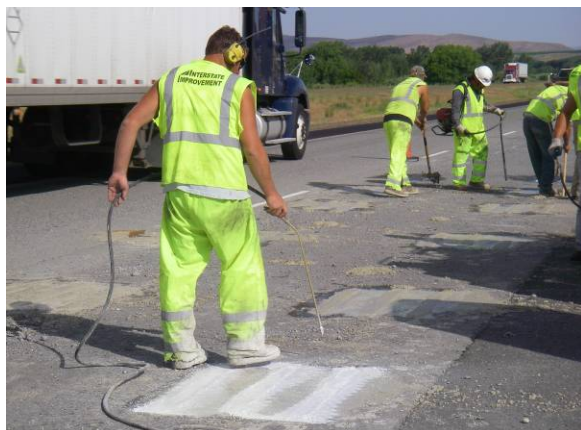
Figure 12. Application of curing compound.

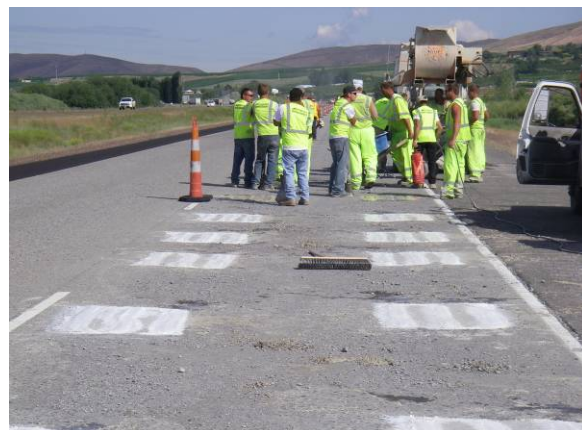
Figure 13. Finished installation prior to diamond grinding to remove faulting.

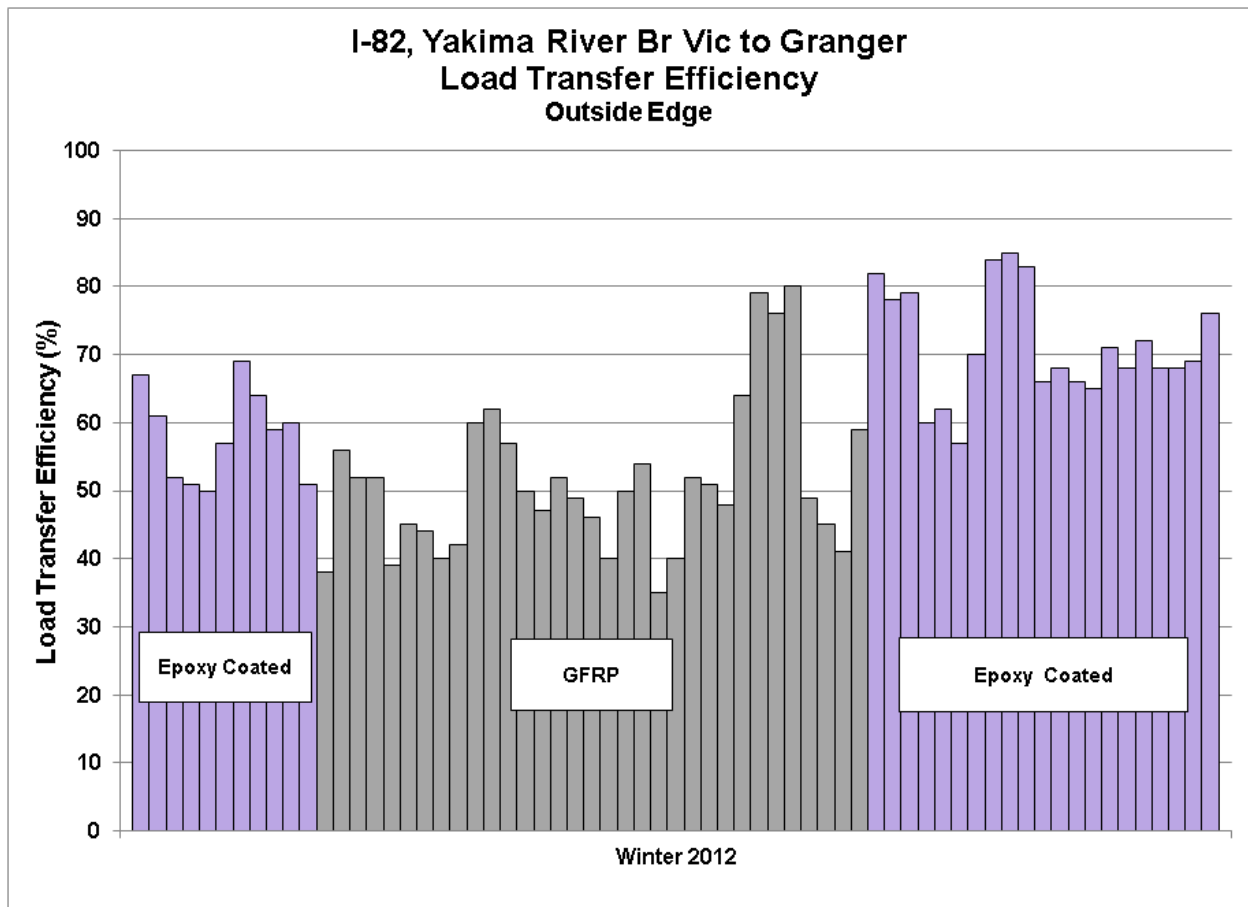
Figure 19. LTE for epoxy coated and GFRP dowel installed on I-82, Yakima River Bridge Vic. to Granger. Purple bars are for epoxy coated dowels, gray for GFRP dowels.

The average LTE of the GFRP dowels was 50 percent with a range of 35 to 80 percent and the average for the epoxy coated dowels was 67 percent with a range of 50 to 85 percent (Table 3). An analysis of the data revealed that there was a statistically significant difference between the mean value of the LTE's of the GFRP and epoxy coated dowels. This indicates that the epoxy coated dowels are currently outperforming the GFRP dowels with respect to load transfer efficiency. It is unclear at this time why LTE's for the GFRP dowels are lower than the epoxy coated dowels, but if this trend continues it might indicate that the GRRP dowels are not suitable for retrofit applications or that perhaps additional smaller diameter dowels spaced closer together is a better choice, as recommended in some of the literature.

The average LTE were identical for both types of dowels on the I-5 project. The small sample size does not allow for in-depth statistical analysis. The LTE data for the I-82, Grandview to Prosser project indicated that the GFRP dowels were performing better than the epoxy coated dowels. Again the small sample size does not warrant extensive analysis at this time. Future data may show trends that may prove to be significant.
