## Discussion on “Field Test Performance of Noncontact Ultrasonic Rail Inspection System”

Kaewunruen, Sakdirat

1 **Discussion of “Field Test Performance of Noncontact Ultrasonic Rail**  
2 **Inspection System” by Stefano Mariani, Thompson Nguyen, Xuan**  
3 **Zhu and Francesco Lanza di Scalea.**

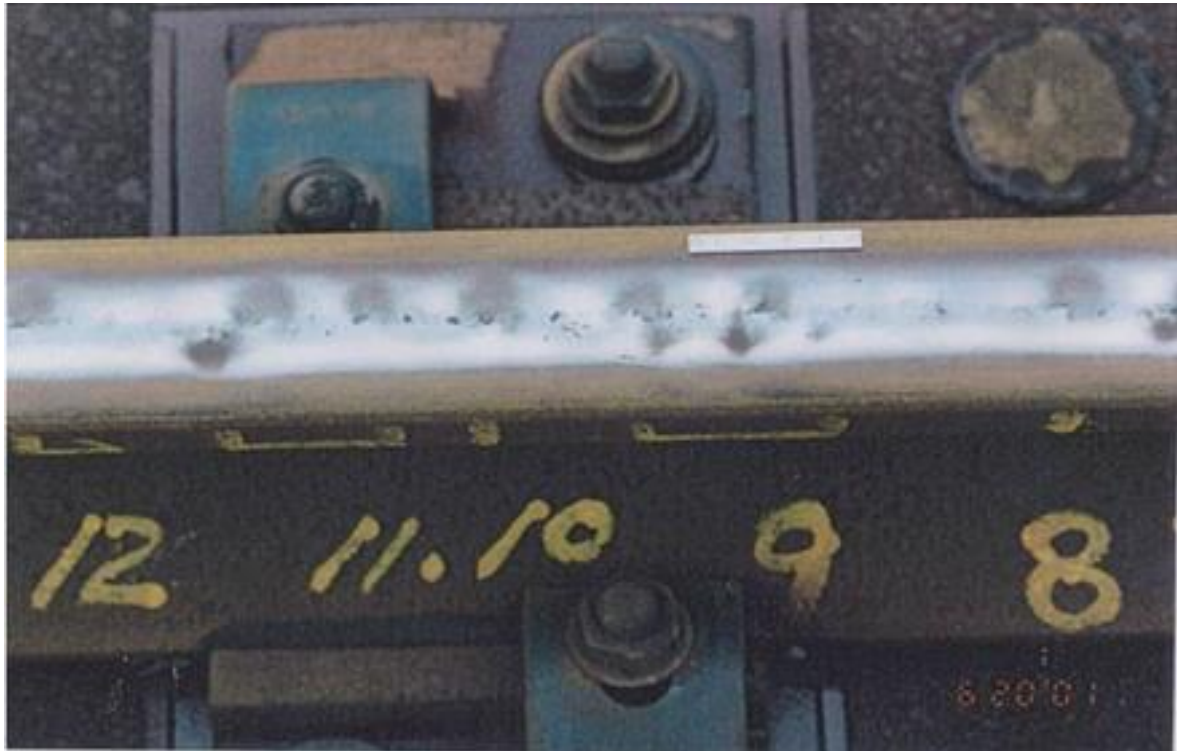
a) WEL-related stud (multiple squats)

**Figure 1.** Rail squats in railway tracks based on their initiation types (photos taken in 2012 by Sakdirat Kaewunruen)

36 corner'). This RCF defect can further grow and cause rail squats, rail studs, transverse  
37 defects and other modes of failure. Figure 1 shows an example of moderate rail  
38 squats. The real examples of various rail defects found on curved tracks can be seen in  
39 Ishida (1989; 2015), Li et al. (2008), Grassie (2012), Grassie et al. (2012), Wilson et  
40 al. (2012), Kaewunruen and Ishida (2014, 2016), Kaewunruen et al. (2014),  
41 Kaewunruen (2015), and Andersson (2015). Note that the type of defect, its size and  
42 severity help track engineers to prioritise inspection and maintenance tasks. On this  
43 ground, not only is the defect identification essential to rail industry, the classification  
44 of defect type and maintenance prioritisation is also mutually crucial to mitigate

50 The field data shown in Figure 1 demonstrates that rail surface defects can potentially  
51 spread over the rail head. Note that the field observations showed that rail surface  
52 defects can also develop at both low (inner) and high (outer) rails in curved tracks.  
53 The dimension and scale of rail defects are again dependent on various factors. If rail  
54 corrugations and wheel burns are present, additional vibration might also provide  
55 additional problems to the system in practice. As such, suitable device installation and  
56 noise cancelling technique will be required to enhance reliability of data analyses such  
57 as receiver operating characteristics (ROC), damage index (DI), probability of  
58 detection (PD), and probability of false alarms (PFA).

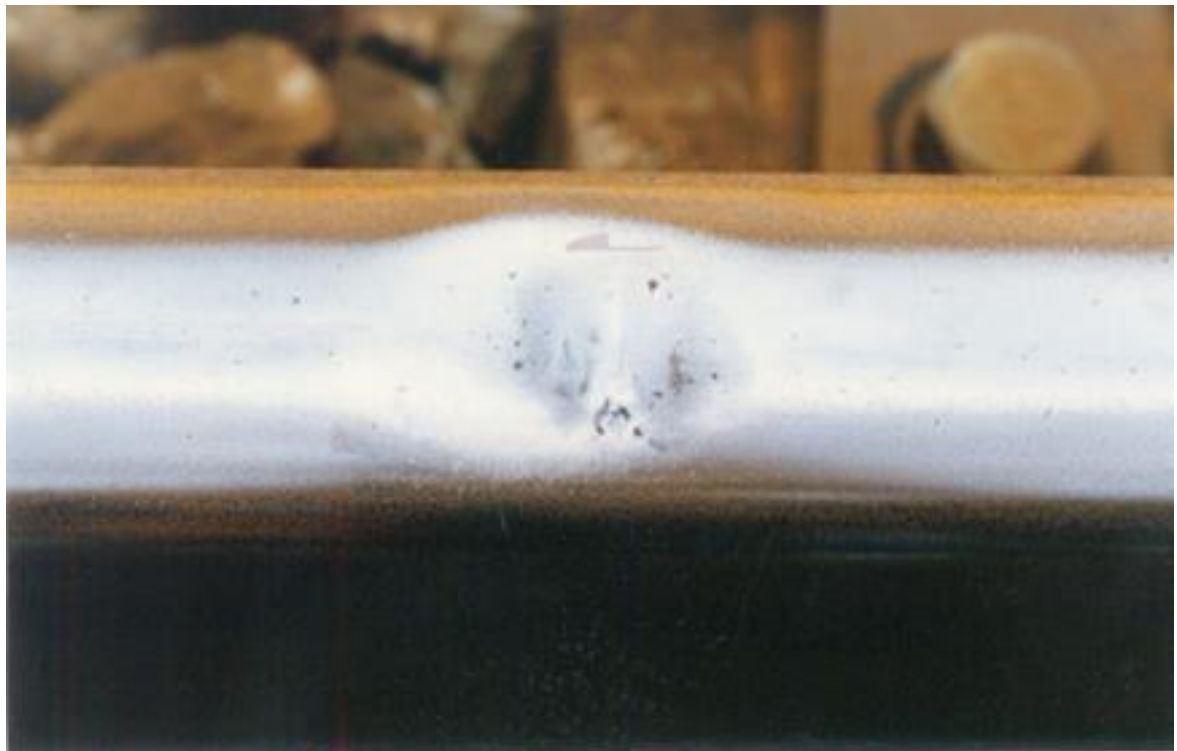
b) RCF-related squat (single squat)
