Management of Natural Disaster Mitigation Systems and Practical Examples

LANDSLIDES' INFLUENCE ON THE ENVIRONMENT

Mevlida Operta *¹, Jelena Golijanin **

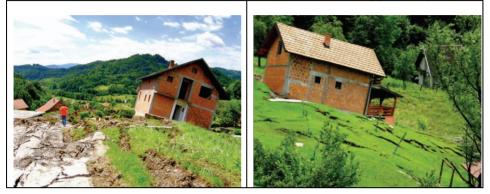
facilities, including leveling and filling from lower side, resulting imbalance of mass, disturb is natural balance conditions and then worst happens (Figure 2).

Figure 2 Demolition of houses in Suljaković (Municipality Maglaj – Bosnia and Herzegovina) http://www.crometeo.net/phpbb/viewtopic.php?f=5&t=6614

Landslides negatively influence on morphology of surface of area and it can be seen in examples of landslides in Suljaković near Maglaj and Bogatići at Trnovo. An example of the influence of landslides on vegetation is landslide Suljaković. According to the scale and catastrophic consequences, this landslide is one of the largest in BiH. During the construction of the M-17 there was already a landslide, which was then repaired. Landslide is certainly formed after recent rains. During the construction of houses, these were buried streams which are on the left and right sides of landslides. These streams were dragging surface water. Another cause is illegal construction. Cutting the slope at upper side of
