NASA TM X-948

# PHOTOGRAPHIC STUDY OF LIQUID-OXYGEN BOILING AND GAS INJECTION IN THE INJECTOR OF A CHUGGING ROCKET ENGINE

*by E. William Conrad, Ned P. Hannum,  
and Harry E. Bloomer*

*Lewis Research Center  
Cleveland, Ohio*

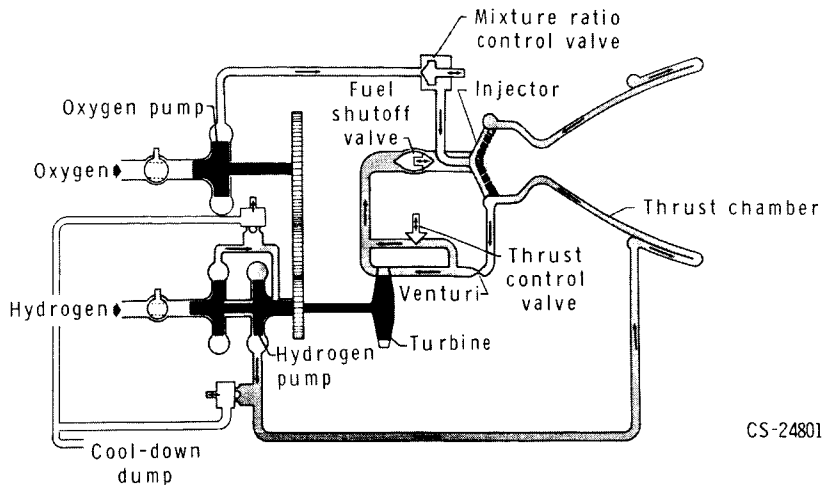
CS-24801

Figure 1. - Schematic of standard RL-10 engine cycle.

of 40. Figure 1 illustrates the standard RL-10 engine propellant flow schematic, and figure 2 shows the engine discussed herein, which was equipped with a "throttling kit" supplied by the engine manufacturer. As examination of the two figures shows, the throttling engine was provided with an additional turbine bypass valve and line to allow a greater amount of warm hydrogen from the cooling jacket to bypass the turbine and hence reduce pump speeds and resultant

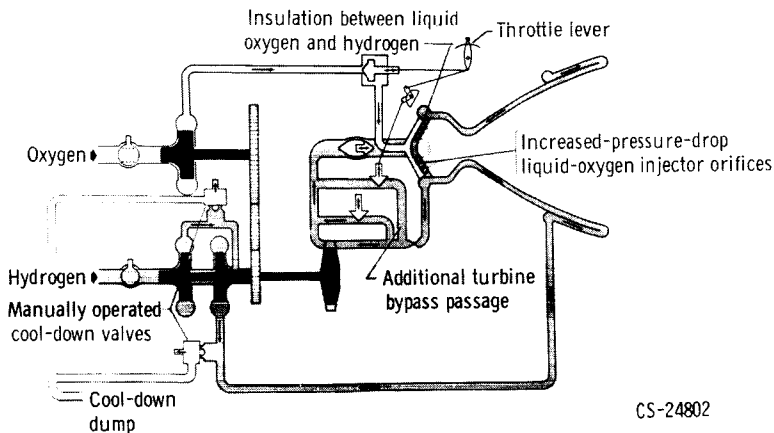
CS-24802

Figure 2. - Schematic of RL-10 engine cycle modified for throttling.

propellant flows. The engine can also be operated in a pressurized mode (without the pumps rotating) to permit operation below the 10-to-1 throttling range. Much of the engine system is not germane to the present subject and will not be discussed herein, but it should be noted that, before entering the injector cavity, the hydrogen is warmed to about 300° F while passing through the cooling jacket of the engine. Thus, the hydrogen in the injector is considerably warmer than the liquid oxygen (170° R), and heat transfer will occur.

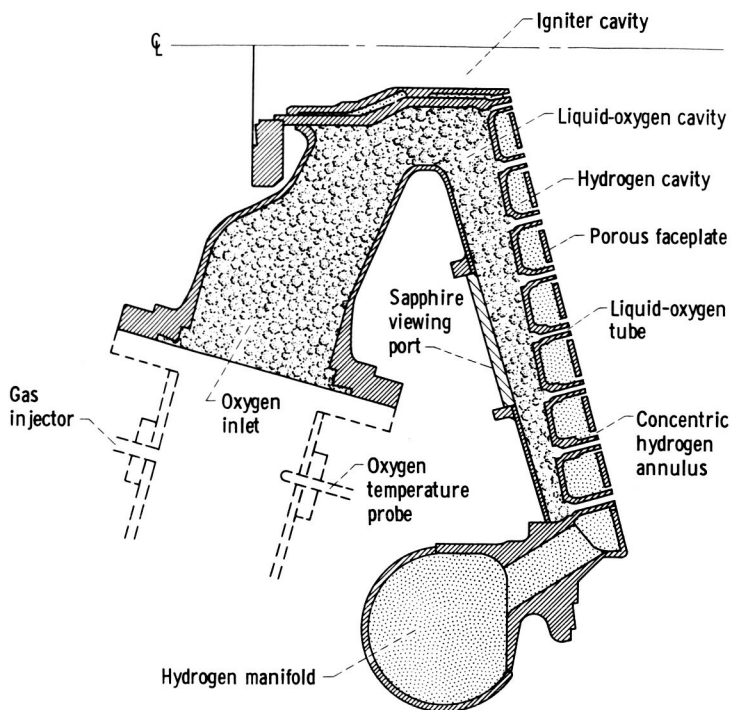
Figure 3. - Partial cross section of injector showing sapphire viewing port.

shown in figure 3. A concentric tube injector was used that had 216 elements with 6-turn-per-inch swirlers in the liquid-oxygen tubes. Liquid-oxygen pressure drop at rated engine thrust was 60 pounds per square inch. As shown in figures 3 and 4, a  $1\frac{1}{2}$ -inch-diameter sapphire port was installed in the outer wall of the liquid-oxygen cavity. An annular inert gas purge was provided on the outside of the port to prevent frosting.

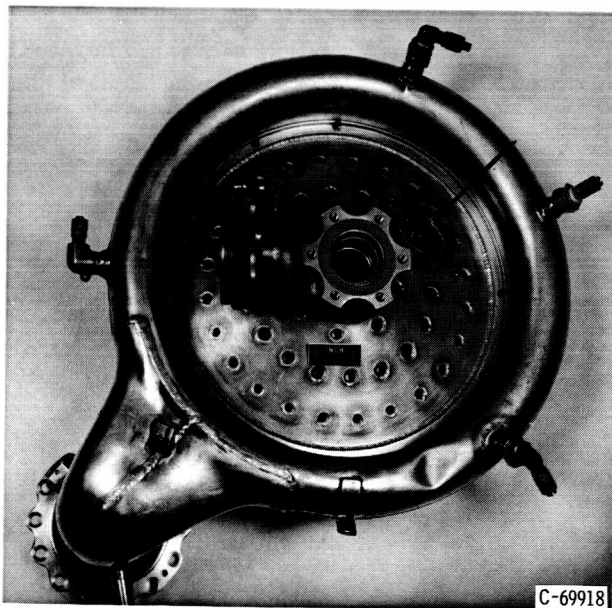
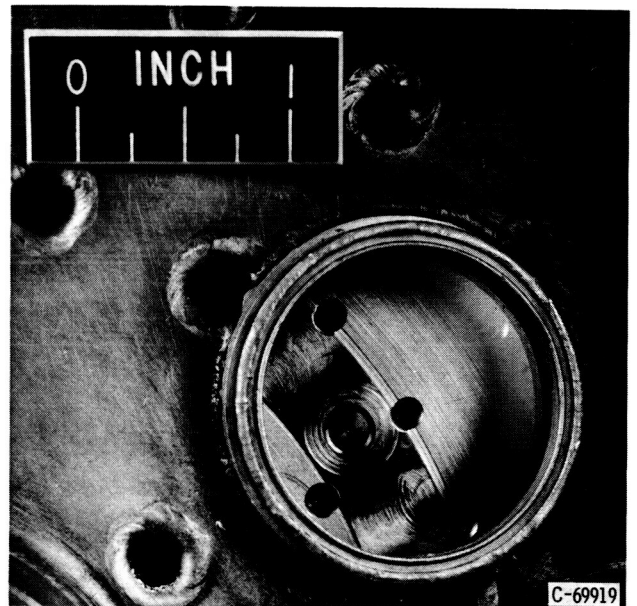
Figure 4. - Forward side of injector showing special viewing port.

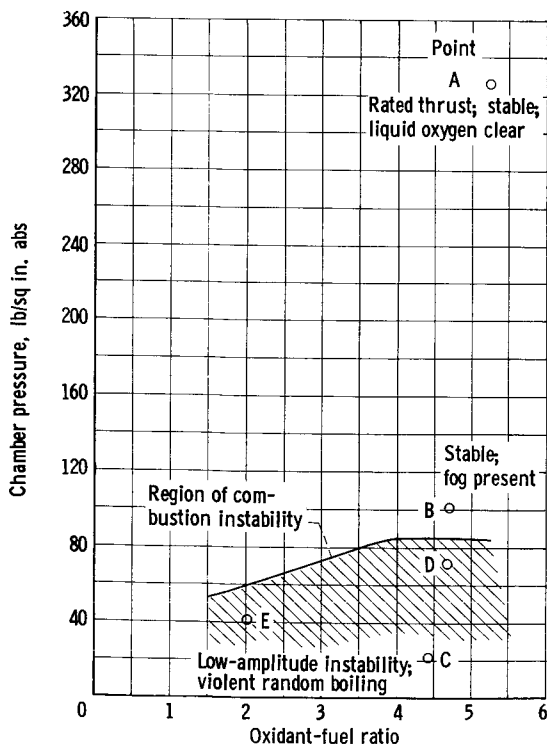
Figure 5. - Combustion stability limits (chugging).

The frames taken from the motion picture and presented herein are correlated with chamber pressure and oxidant-fuel ratio (O/F) by reference to the engine operating map of figure 5. The region of chugging instability is shown by the shaded area. The letters A to E are used to identify operating conditions depicted in the subsequent figures.

Point B corresponds to operation at a chamber pressure just above the chugging region (fig. 5). At this condition, large regions of fog randomly floated across the viewing area and obliterated the opposite face of the injector cavity. The fog apparently was comprised of extremely small bubbles, and their presence would indicate that saturation occurred (because of heat transfer to the liquid oxygen from the warm hydrogen) at least in localized regions of the cavity. The fog apparently broke away from these localized warm regions and flowed as an entrained gas along with the liquid-oxygen stream (radially outward); however, discrete bubbles were not discernible. Chamber pressure and liquid-oxygen cavity pressure traces were still smooth. Reference to a Mollier chart for liquid oxygen indicates that the saturation temperature is about 209° R at the measured liquid-oxygen cavity pressure of 116 pounds per square inch absolute; thus the liquid oxygen was essentially at saturation conditions.

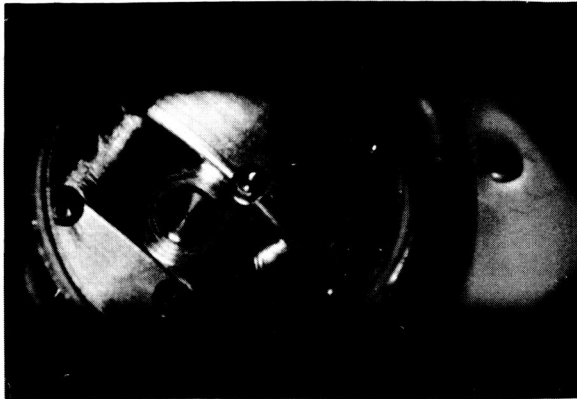
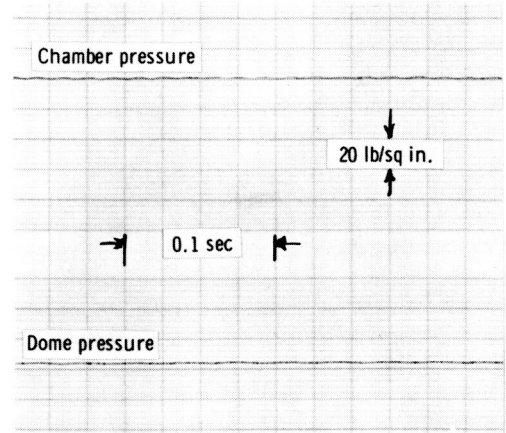
(a) Point A; rated thrust; stable; chamber pressure, 326 pounds per square inch absolute; oxidant-fuel ratio, 5.25; liquid-oxygen temperature, 242° R; liquid-oxygen dome pressure, 399 pounds per square inch absolute.

Figure 6. - Appearance of liquid oxygen in injector dome at various chamber pressures.

The photographs of figure 6 illustrate three liquid-oxygen conditions observed in the liquid-oxygen cavity during ostensibly steady operation and without inert gas injection. The liquid-oxygen temperatures indicated in the figure were measured in the supply line at the cavity inlet and, therefore, will be slightly lower than the temperature in the cavity itself. Point A corresponds essentially to operation at rated thrust. The liquid oxygen appears completely clear and free of bubbles, and the only optical evidence of its presence is occasional striations due to density gradients and subsequent changes in refractive index. The accompanying oscillograph traces show both chamber pressure and liquid-oxygen cavity pressure to be

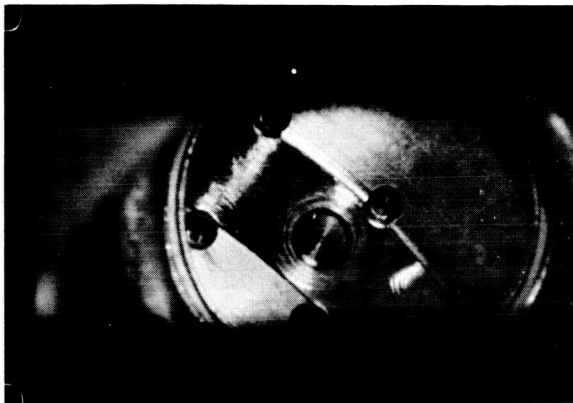
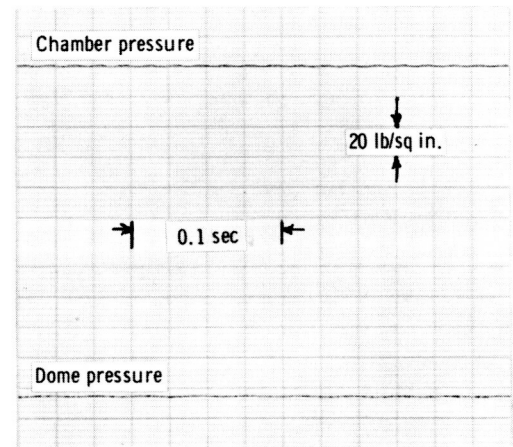
(b) Point B; stable; fog present; chamber pressure, 101 pounds per square inch absolute; oxidant-fuel ratio, 4.72; liquid-oxygen temperature, 205° R; liquid-oxygen dome pressure, 116.4 pounds per square inch absolute.

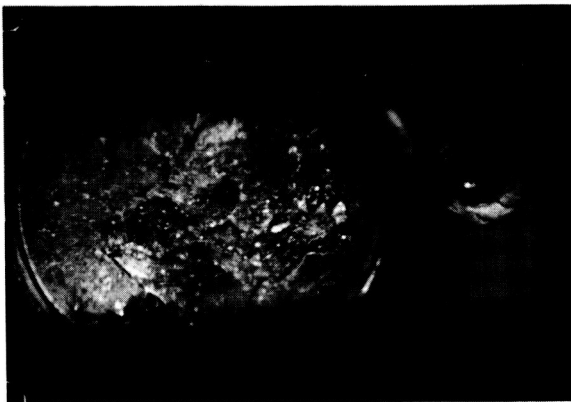
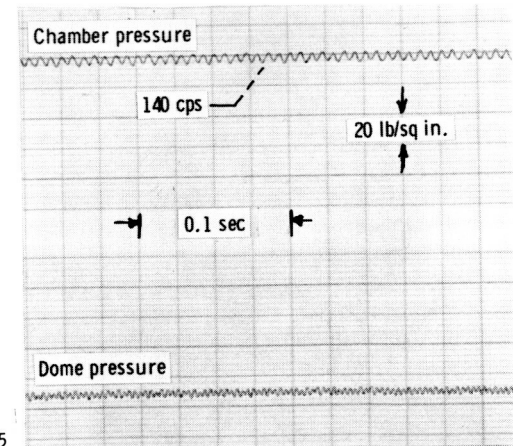
C-71285

(c) Point C; low-amplitude instability; violent random boiling; chamber pressure, 22 pounds per square inch absolute; oxidant-fuel ratio, 4.43; liquid-oxygen temperature, 169° R; liquid-oxygen dome pressure, 28.1 pounds per square inch absolute.

Point C was obtained at a chamber pressure of only 22 pounds per square inch absolute and was unique in that it was obtained with the engine pumps completely stopped and propellant supply occurring by tank pressure alone. This pressurized mode of operation, however, should have had no significant effect on the conditions in the liquid-oxygen cavity. Ostensibly, the engine operation was stable and was in the region previously determined (ref. 1) to be below the region of chugging. Careful examination of the accompanying chamber pressure trace (fig. 6), however, revealed that a very low amplitude pressure oscillation was present at a frequency of 140 cps. Violent random boiling occurred within the liquid-oxygen cavity. Many discrete bubbles could be seen, and large vapor pockets were observed forming and detaching in the outer right portion of the viewing area. The more violent boiling action near the outer edge corresponds with expectation inasmuch as the liquid-oxygen cavity is surrounded by the fuel manifold filled with warm hydrogen. A study of the film supplement to this report does not, however, disclose any visible cyclical disturbance in the liquid-oxygen cavity despite the small cyclical changes in chamber pressure.

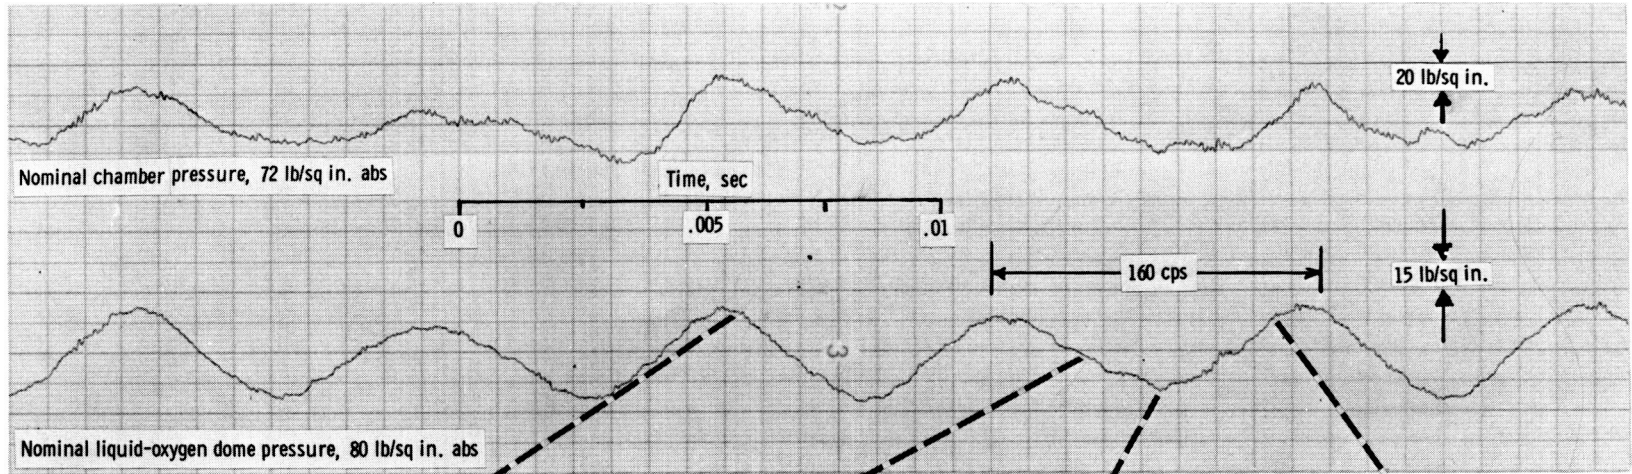
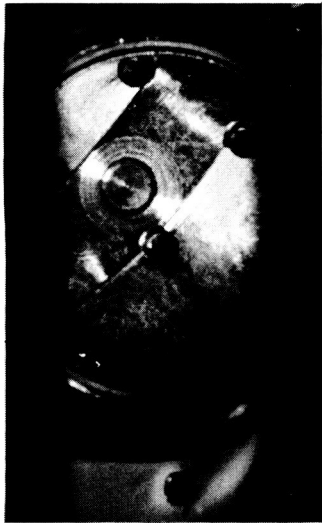
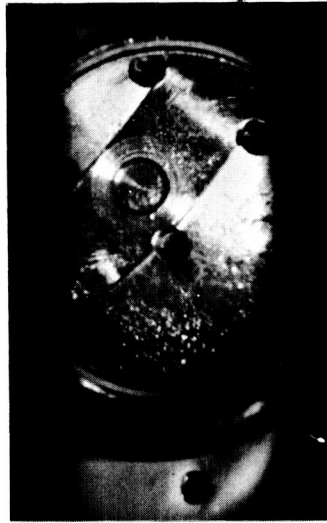
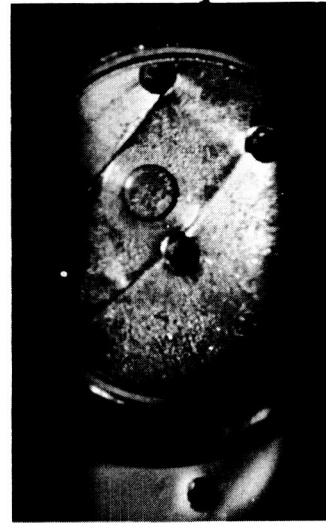
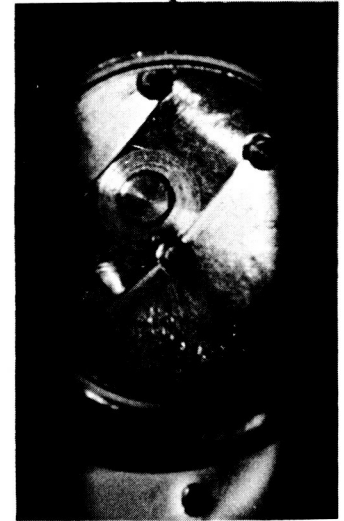
C-71286

Figure 7. - Appearance of liquid oxygen in injector dome during chugging operation.

Fully developed chugging of relatively low intensity occurred at point D and is illustrated in figure 7. Visually, chugging is seen as the formation and collapse of bubbles in the liquid-oxygen cavity at the same frequency as the oscillations in chamber pressure. This film sequence was taken before gaseous helium was introduced into the liquid-oxygen cavity supply line to stabilize the system. By visual correlation of the pictures with the accompanying pressure traces, the following sequence of events may be postulated. During each chugging cycle, a large number of bubbles appear in the liquid oxygen as the liquid-oxygen cavity pressure drops. The bubble size and population increase, the pressure drop across the injector increases, and propellant atomization and combustion improve. The subsequent rise in chamber pressure decreases the liquid-oxygen flow and raises the pressure in the liquid-oxygen cavity and thus drives the bubbles back into the liquid phase. The poorer atomization with the pure liquid oxygen (and low pressure drop accompanying this configuration) probably produces a decrease in combustion efficiency and chamber pressure and thus a decrease in liquid-oxygen cavity pressure. As the liquid-oxygen cavity pressure decreases, the saturation

pressure is again reached; bubbles evolve from the liquid state, and the cycle is repeated. While this model of likely events appears to fit the data at hand, it cannot yet be established conclusively because of the lack of precise timing correlation between the motion picture and the oscillograph records required to establish the exact phase relation.

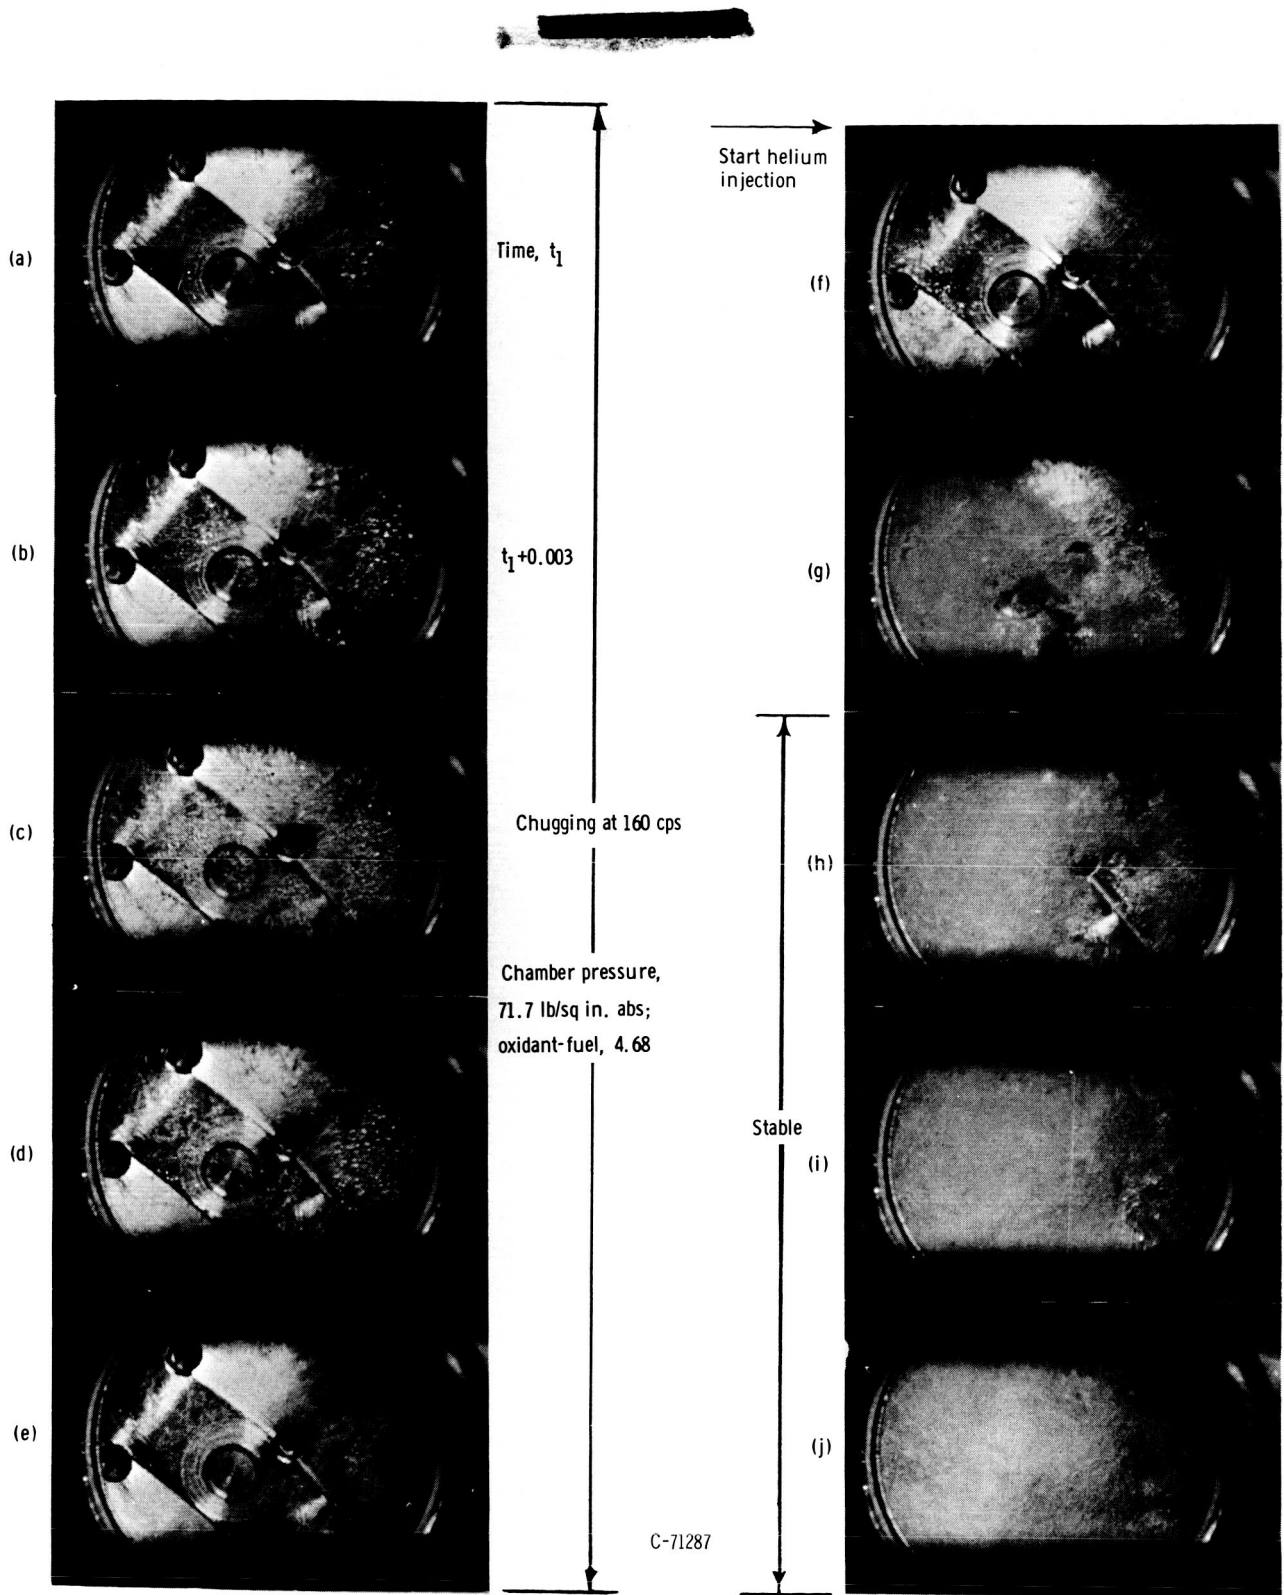
Figure 8. - Appearance of liquid oxygen during elimination of chugging by gaseous-helium injection. Helium flow rate, 0.4 percent of liquid-oxygen weight flow. Point D.

The sequence of stills in figure 8 (point D) shows the chugging cycle immediately prior to and following the introduction of gaseous helium, which appears as a fog in the lower left area of the pictures. (The liquid-oxygen supply tube attached to the center of the injector cavity was to the left and below the viewing window (fig. 4, p. 4). Discrete bubbles within the fog were too small to be seen, as was the case with the fog at point B, shown in figure 6 (p. 6). The fog quickly dispersed across the entire viewing port area at the velocity of the oxygen flow along a radius of the liquid-oxygen cavity. The combustion immediately became stable, and chugging was entirely eliminated.

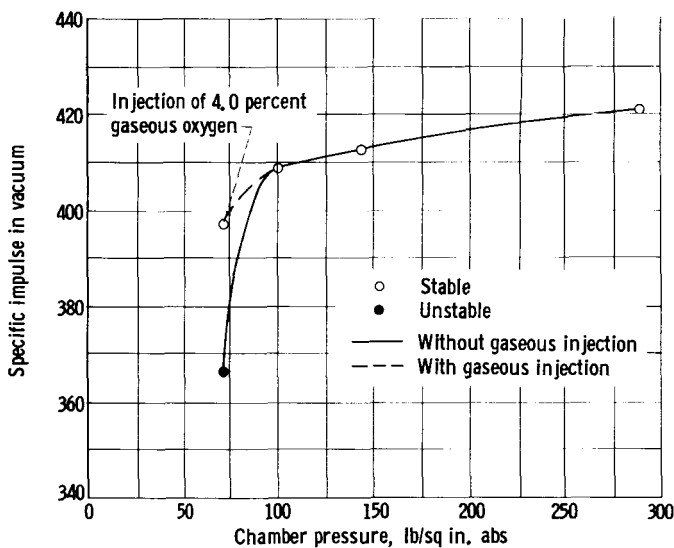
Figure 9. - Elimination of chugging and restoration of performance by gas injection. Oxidant-fuel ratio, 5.0.

The specific impulse increased about 30 points during gas injection. This increased impulse represented the level that would be expected from extrapolation if chugging had not occurred (fig. 9).

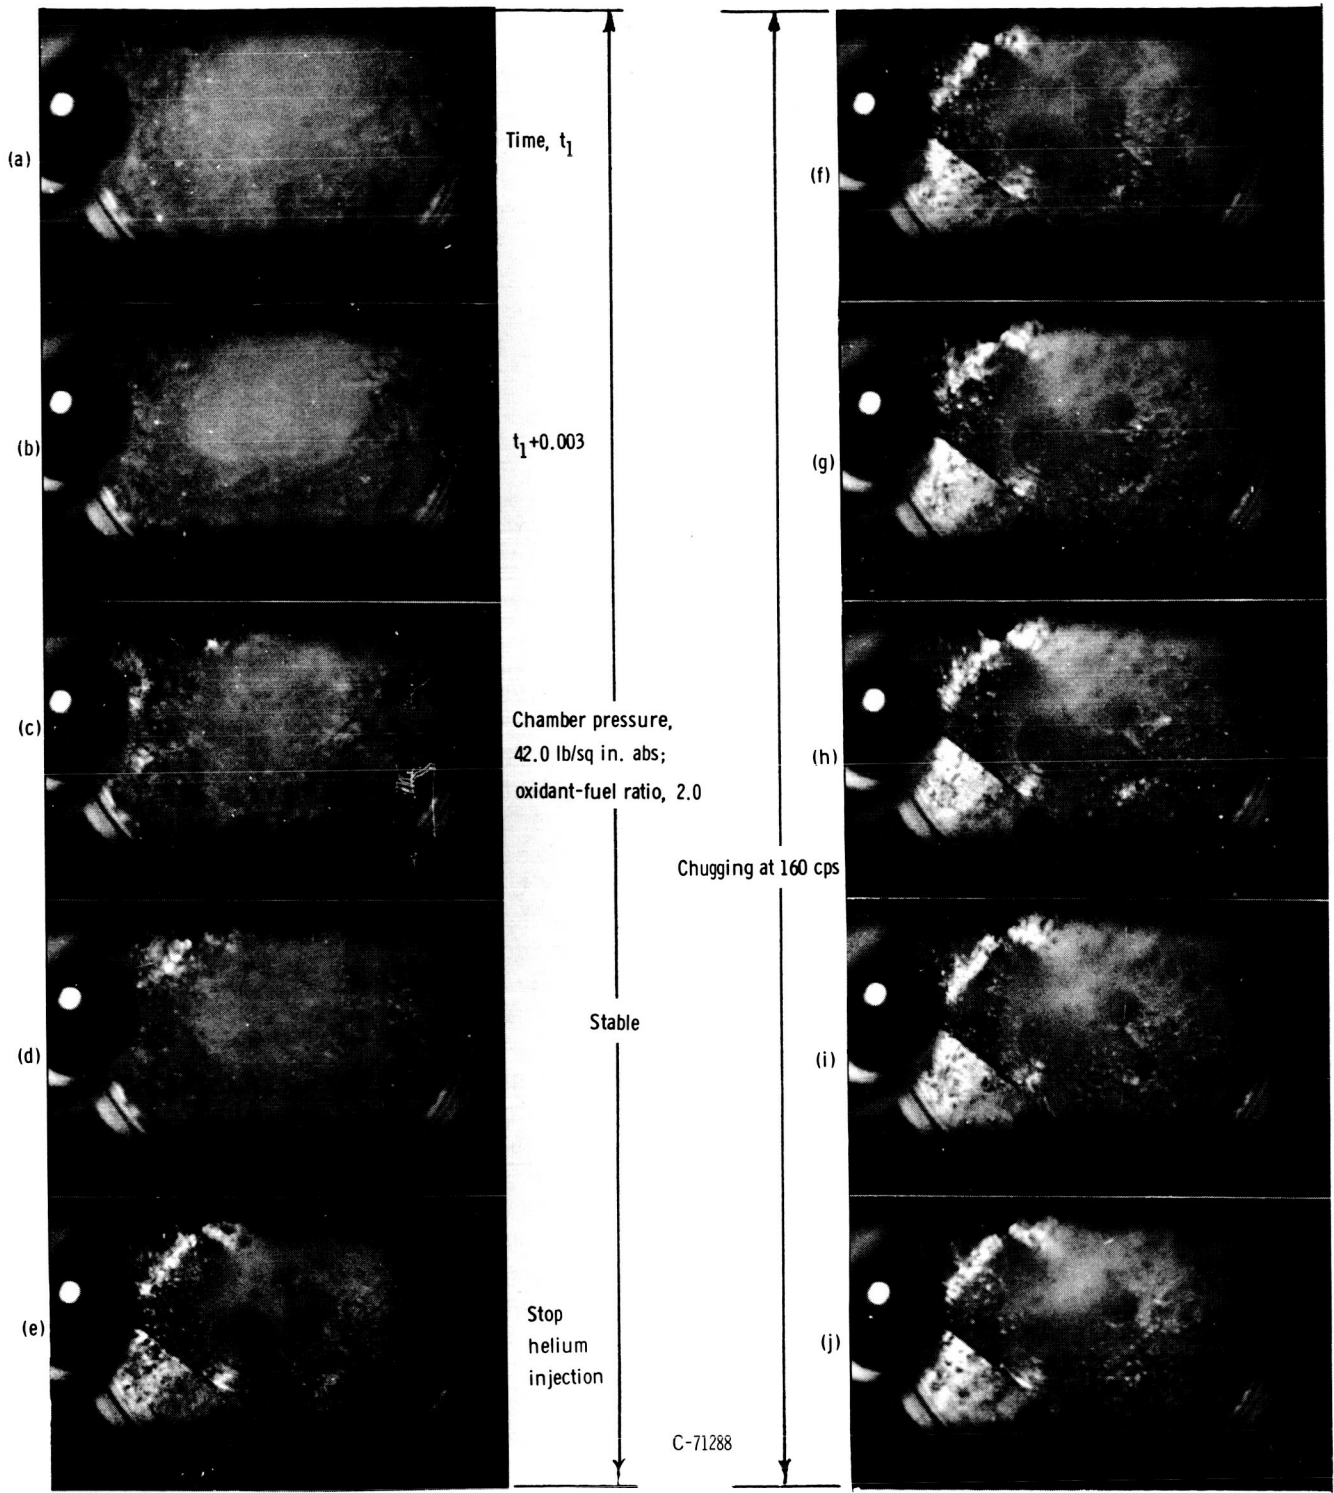
Figure 10. - Appearance of liquid oxygen as helium injection is stopped and chugging operation begins.  
Helium flow rate, 0.4 percent of liquid-oxygen weight flow. Point E.

The reverse sequence is illustrated in figure 10 for point E, which is within the region of maximum chugging amplitude. In this case, the engine, operating stably with gas injection, was caused to chug by shutting off the injectant. For both of the aforementioned tests the helium flow rate was approximately 0.012 pound per second or 0.4 percent of the liquid-oxygen flow by weight.

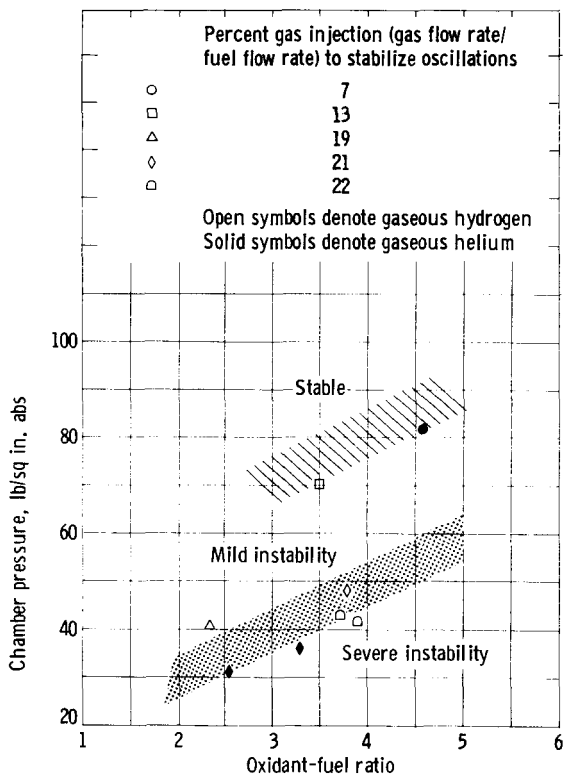
Figure 11. - Approximate region of fuel-system instability showing stabilizing effects of gas injection into fuel system.

Although gaseous injection and/or increased injector pressure drop can be used to eliminate chugging (unpublished data), a further problem prevents the achievement of a desired 10-to-1 throttling capability with the RL-10. This difficulty is the existence of a region of fuel-system instability of 1 to 5 cps. The region is approximated on the map of figure 11. The transition areas indicated between the stable and mild instability regions and also between the mild and severe instability regions are not well-defined lines but rather only approximate areas.

As can be seen from the data points in figure 11, gaseous weight flows, of either helium or hydrogen, approximately 20 percent of the liquid-hydrogen weight flow, did stabilize the fuel system in the region of severe oscillations (all data points represent stable operation); this result lends support to the hypothesis. With only a small amount of gas injection, the oscillations ceased being divergent and continued to decrease in amplitude with increased gas flow rate. At the high-amplitude condition, the frequency of oscillation was approximately 1 cps and increased to about 5 cps as the gas injection rate increased. This process of stabilizing the fuel-system oscillations does not establish clearly defined parameters in the system, but indicates that the amplitude is controlled by the abruptness of the phase change as it is affected by the gas injection flow rate. The gas injection rates are probably too high to be practical unless an engine cycle change is considered. This might be done by preheating some of the hydrogen gas and using it as the injectant and stabilizing influence. Insight gained by the experiment strongly suggests that mechanical devices such as screens might provide stability of the transition front in a manner analogous to a flameholder in a combustion system.

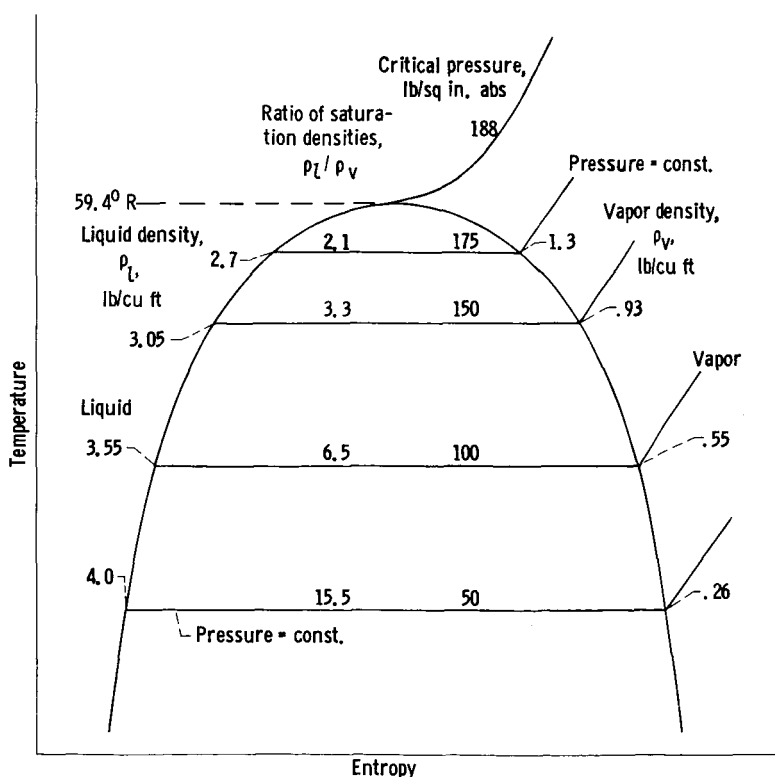
Figure 12. - Density change between saturated liquid and saturated vapor for parahydrogen.

It was reasoned that, if an unstable transition interface from liquid to vapor (such as those observed in ref. 1) were responsible for the system oscillation, anchoring this interface at a discrete location would reduce or eliminate the instability. In the region just upstream of such a transition interface, the hydrogen should be ready for transition, and it was expected that very small disturbances or heat inputs would produce an immediate phase change. To accomplish
