## Soil Contamination from PCB-Containing Buildings

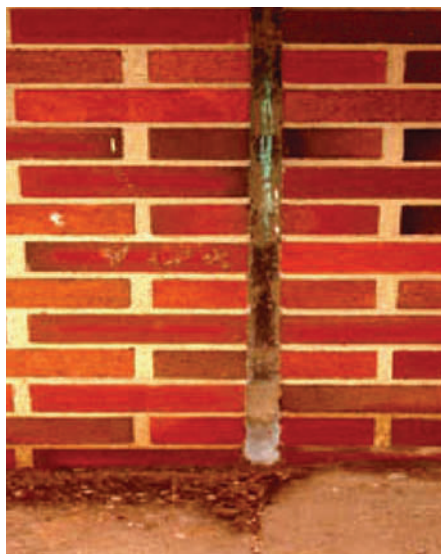
**Figure 1.** Deteriorated PCB caulking in a building expansion joint.
