# CORROSION RESISTANCE OF THE WELDED AISI 316L AFTER VARIOUS SURFACE TREATMENTS

Monika Halamová<sup>1,\*</sup>, Ayman Alaskari<sup>2</sup>, Tatiana Liptáková<sup>1</sup>

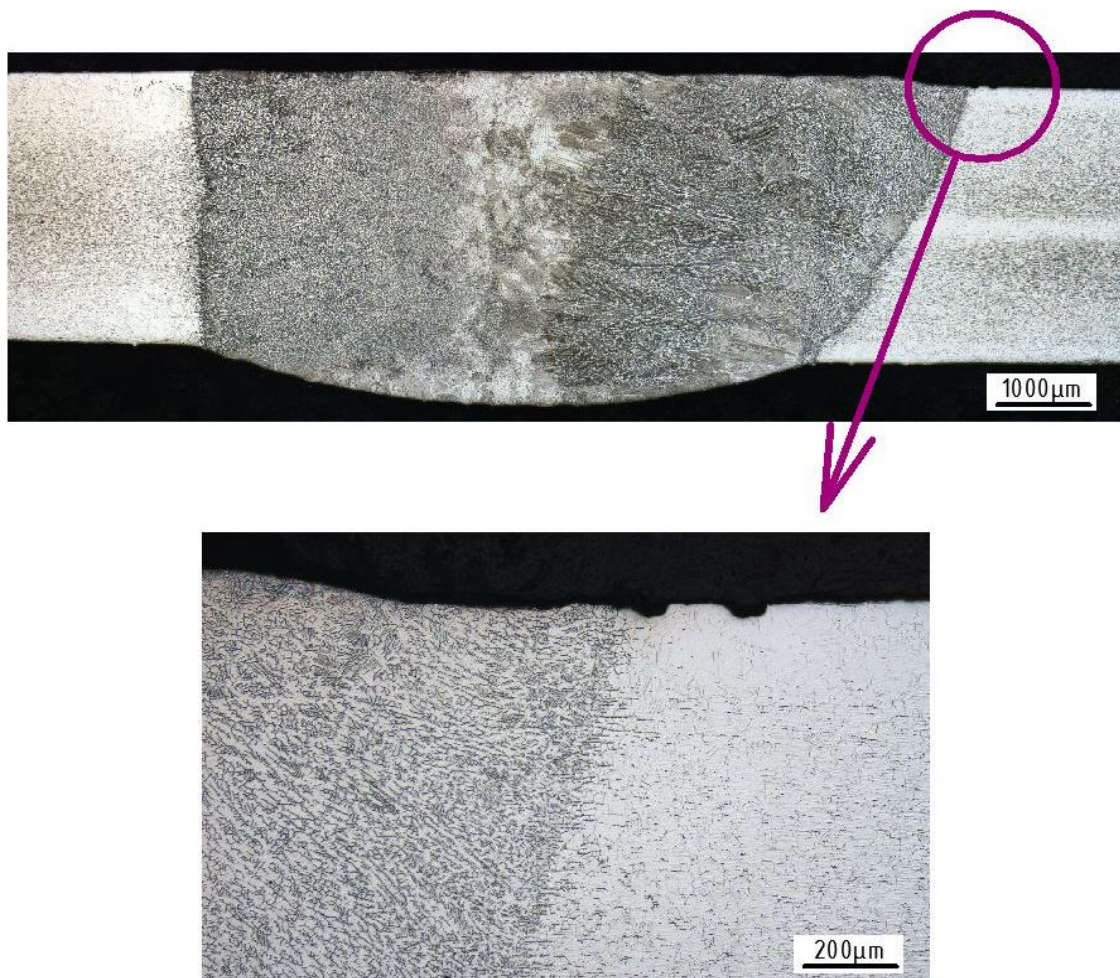
Fig. 5. Corrosion attack of the specimen with untreated surface.

The light metallography was used for evaluation of character and intensity of corrosion attack of the samples with different surface treatment (welded with and without filler metal). Untreated specimens welded with filler metal are attacked by corrosion mostly at the weld metal and heat affected zone (Fig. 5) as well as the specimens welded without filler metal. Surface-

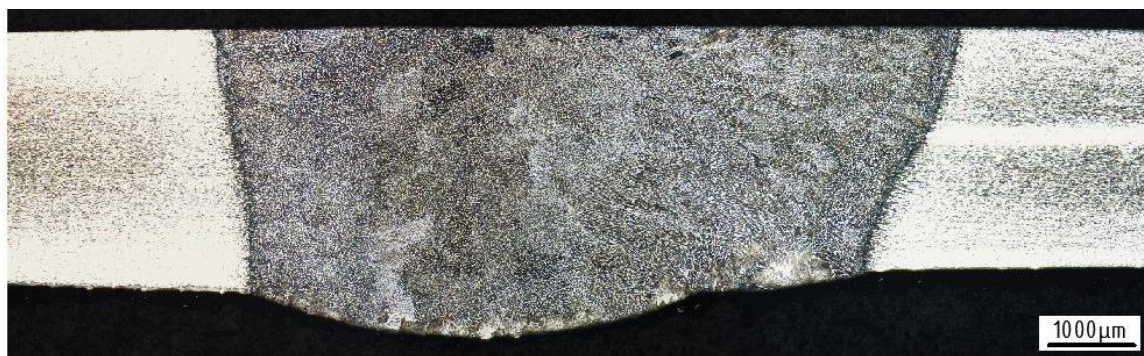
Fig. 6. Corrosion attack of the specimen with ground surface.

welded steel AISI 316L with filler, treated after welding by grinding (Fig. 6) was not visible attacked by corrosion. On the all specimen surfaces welded without filler only rare small corrosion pits were observed. In Fig.7 the intensive pitting corrosion on the blasted specimens after welding (without and with filler material) is seen. The metallographic evaluation is in a good agreement with calculated corrosion rates.
