Huang, S-S., Davison, B. and Burgess, I.W. (2013) *High-temperature tests on joints to steel and partially-encased H-section columns*. Journal of Constructional Steel Research, 80. 243 - 251.

High-Temperature Tests on Joints to Steel and Partially-Encased H-Section Columns

Shan-Shan Huang^{a,*}, Buick Davison^a and Ian W. Burgess^a

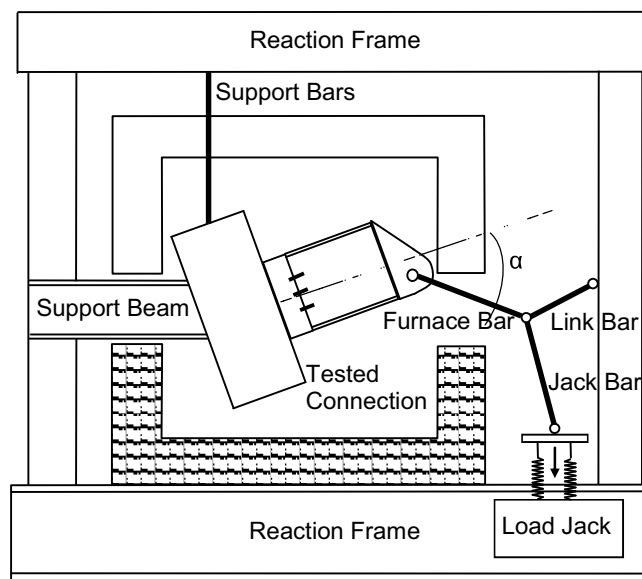
Figure 1 The test setup.

1 The beam-to-column connection was placed in the middle of the furnace. A
2 cantilevered support beam of UC203×86 kg/m section extended from the left-hand
3 hole in the furnace wall, and was connected to the column via an oversized endplate.
4
5 For this connection, bolts were partially cast into the concrete infill when specimens
6
7 using composite steel-concrete columns were tested. Two Φ 25mm Grade 1030
8
9 Macalloy bars from the reaction frame were additionally used to support the column
10
11 top.
12
13
14
15
16
17

18 The loaded end of the beam, the end connector and the bottom of the column were
19 wrapped in thermal insulation blanket. The support bars and the support beam, as
20
21 well as its connection to the column, were also protected by thermal blanket, and
22
23 the two openings were filled with thermal insulation to prevent heat leakage. The
24
25 connection, the column, and a significant length of the beam were left unprotected.
26
27
28
29
30
31

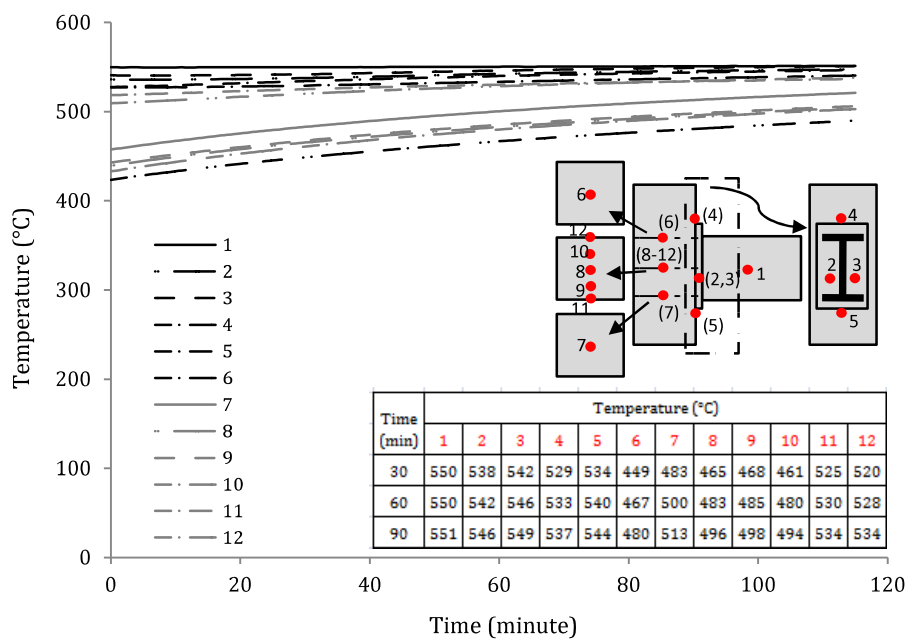
Figure 2 Temperature distribution during loading in Test 1.

46 In the first test (a flush endplate connection to a partially-encased column), 12
47
48 thermocouples were installed to monitor the temperature distribution in the
49
50 connection, as shown in Figure 2. From this test, differences in temperature
51
52 between various locations of the exposed steel parts were determined to be less
53
54 than 25°C before load was applied. It was not possible to achieve such small
55
56
57
58
59
60
61

1 differences within the concrete infill of the composite column within any reasonable
2 heating time, but the distribution was found to be reasonably symmetric throughout
3 the cross section from the front to the back of the furnace, and reasonably uniform
4 along the column length.
5
6
7
8
9

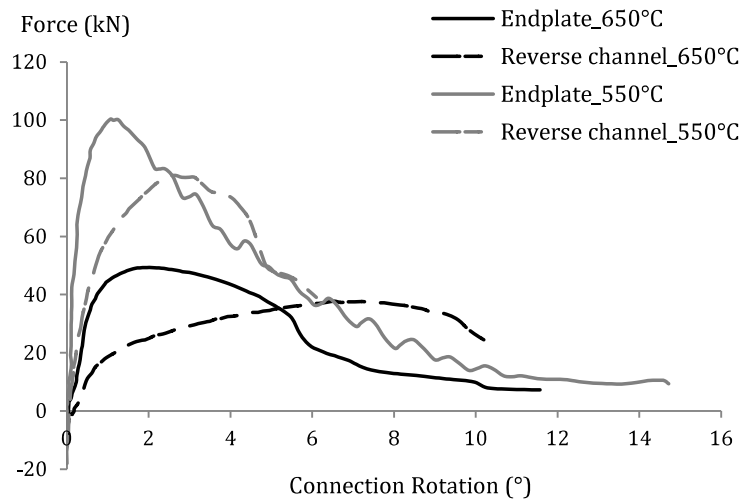
Figure 7 The force-rotation relationships of the connections to partially-encased columns.

Plots of the furnace-bar force versus the connection rotation for the four tests are given together for comparison in Figure 7, and Figure 8 shows the failure modes of the two endplate connections. The rotation of the connection is calculated as the rotation of the beam minus the rotation of the column. In the first test, on an

endplate connection at 550°C, the specimen failed by thread-stripping on all the bolts. For this reason the force can be seen to decrease very rapidly after a rotation of 1.07°. To avoid similar behaviour in the remaining tests, double nuts were used to bolt the beam endplate to the column or to the reverse channel.

At 650°C the failure was also controlled by bolt behaviour, but the failure mode switched to tensile fracture due to the use of double nuts. For both tests, apart from the bolts, the specimen barely deformed. At 650°C the concrete cracked around the connection, but these cracks were modest and seemed to initiate from the holes accommodating the thermocouples. The resistance of the connection reduced rapidly with increase of temperature. Compared with the previous tests on specimens of similar dimensions [7], the use of a relatively thick (20mm) endplate enhances the resistance but significantly reduces the ductility.

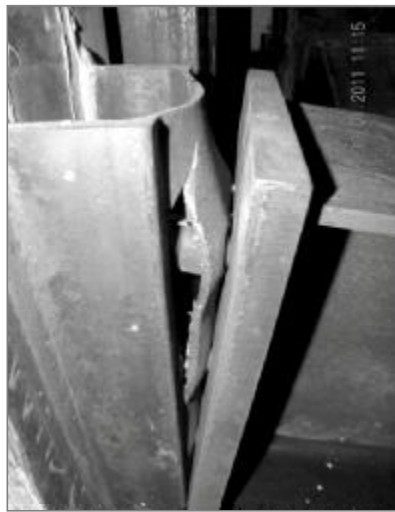
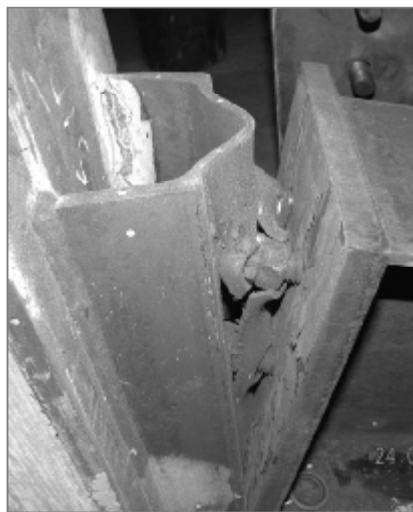
(a) Tested at 550 °C (Test 3)

(b) Tested at 650 °C (Test 4)

Figure 9 Failure of the reverse-channel connections to partially-encased columns.

The failure of the reverse-channel connections to partially-encased columns is shown in Figure 9. The ductility induced by the reverse channel gave this connection type around three times more rotational capacity, with comparable ultimate strength, than the flush endplate connections tested at the same temperature. For both of Tests 3 and 4, there was no noticeable deformation in the partially-encased columns or in the steel beams; neither was any damage found in the connection welds. The failure was controlled by the reverse channel. In both cases, the web of the reverse channel was pulled outwards at the top. Since the flanges of the hot-rolled channel were significantly thicker than the web, they remained straight, but the two flanges moved slightly towards each other at the top, due to the bending deformation of the channel web. Unsurprisingly, these deformations of the channel web and flanges

1 became more severe with increasing temperature. The failure modes of these two
2 tests differed. At 550°C the web of the reverse channel fractured in the regions
3 adjacent to the flanges, whereas at 650°C the top rows of bolts punched through the
4
5 bolt holes in the web of the reverse channel, and the channel web fractured around
6
7 the bolt holes; these fractures eventually spread to the regions adjacent to the
8
9 flanges.
10
11
12
13
14
15
16

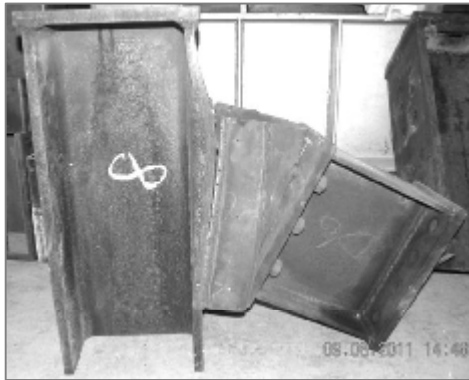
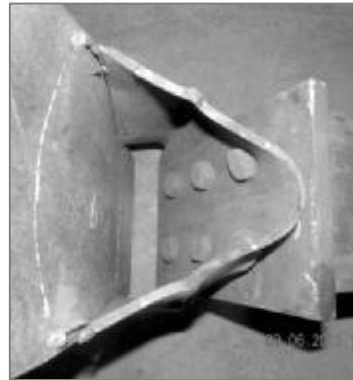
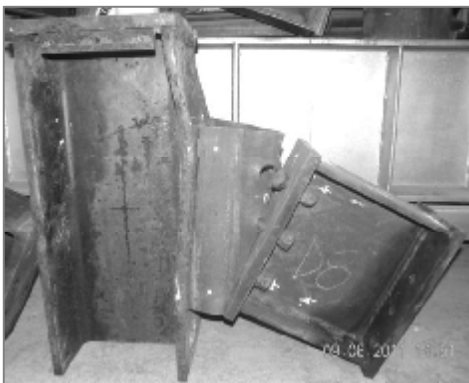
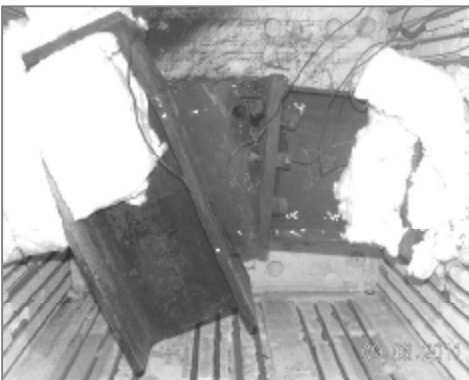
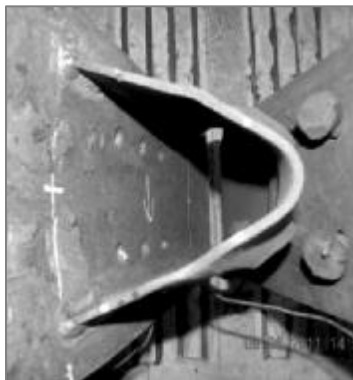
(a) Reverse channel cut from SHS250x8 (Test 5)

(b) Reverse channel cut from SHS200x6 (Test 6)

(c) Reverse channel cut from SHS180x6 (Test 7)

Figure 10 Post-test photographs of the tests on the reverse-channel connections to steel H-section columns.

18
19 Figure 10 shows the aftermath of these tests. The reverse channels which were cut
20
21 from SHS tube provided extremely high deformability (even higher than that of the
22
23 hot-rolled channels) because their flanges were considerably thinner than those of
24
25 the hot-rolled channels. In all three cases, the channel web was pulled outwards and
26
27 the flanges turned inwards at the top, with deformation so large that the corners of
28
29 the channel effectively unfolded. The bolts, especially those on the top rows, were
30
31 stretched and bent. The column flange was also pulled outwards when this large
32
33 deformation took place. These deformations of the column flanges increased as the
34
35 channel width increased. At the bottom the channel web was pushed inwards,
36
37 which bent the channel flanges as well, due to the rotation of the connection. There
38
39 were no noticeable deformations in the steel beams and their endplates, because of

51 Tests 6 and 7 were successfully continued to failure. For both cases, the failure
52
53 occurred at very large connection rotation, and was controlled by the top rows of
54
55 bolts punching through their bolt holes in the reverse-channel web, which deformed
56
57 significantly and locally around the holes. The global deformability of the reverse
58
59
60
61

channel increases with increase of the channel width. The specimen with the widest reverse channel (Test 5) deformed so highly that it exceeded the space limits of the furnace (the furnace bar touched the furnace wall) and hence this test had to be stopped before failure occurred. It can be anticipated that its failure mode would either be the same as that of Tests 6 and 7, or be controlled by the tensile fracture of the top row of bolts as experienced in previous tests.

In addition, for the two tests using wider reverse channels (Tests 5 and 6), the welds between the top of the channels and column split. It should be noted that these did not occur during testing but were caused by the rapid drop of temperature after opening the furnace.

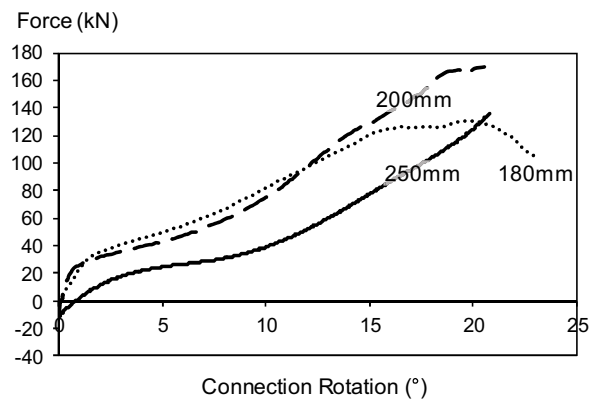
Figure 11 The force-rotation relationships of the reverse-channel connections to steel H-section columns.

The results of these three tests are shown in Table 3, whose column titles are as defined for Table 2. Since Test 5 was stopped before failure, the values of force and rotation given for this test are the final measurements rather than those at maximum capacity. The relationship between the furnace-bar force and the connection rotations in these tests are compared in Figure 11. The width of the reverse channel of each specimen is marked on the corresponding curve on this figure. The curves for the two tests with wider channels do not have descending post-failure parts. This is because these two tests were stopped either at failure (Test 6) or before failure (Test 5), due to the excessively large deformations of the specimens which reached the space limit of the furnace. It is nearly certain that Test 5 would have carried on if this had been possible, which means that both the rotation capacity and ultimate strength would definitely have been higher than the final measurements. As observed from the tests, both the deformability of the

1 reverse channel and that of the column flanges increase as the channel width
2 increases. This is reflected by an increase of the rotational capacity of the whole
3 joint as the channel width increases.
4
5
6
7
