# Modernist unreinforced masonry (URM) buildings of Barcelona. Seismic vulnerability and risk assessment

The main objective of this work is to assess the vulnerability and seismic risk of typical existing URM modernist buildings and aggregates situated in the Eixample district of Barcelona, part of the architectural heritage of the city. The context of the analysis is the methodology proposed by the Risk-UE project. The buildings are characterized by their capacity spectrum and the earthquake demand is defined by the 5% damped elastic response spectrum, considering deterministic and probabilistic earthquake scenarios. A discussion is made regarding the basis of the seismic damage states probabilities and the calculated damage index. An important research effort has been focused on the buildings modelling. All the architectural elements and their mechanical properties have been studied and evaluated accurately. It has been evidenced that a detailed and complete knowledge of all the structural elements existing in this type of buildings influence directly their behavior and hence the calculations and the results. The analysis of the isolated buildings and of the aggregate building h

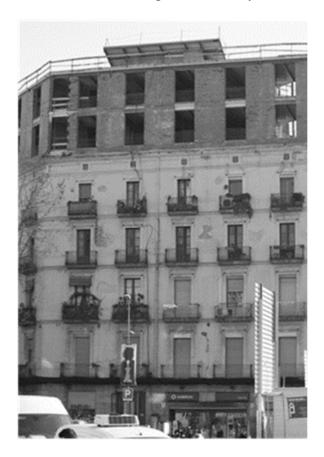
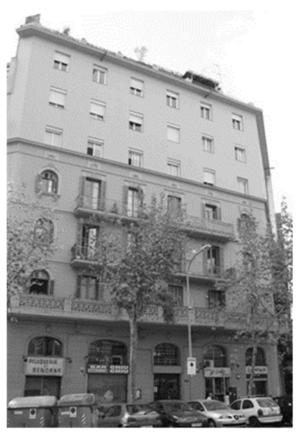
Figure 1. Example of URM buildings with high seismic vulnerability. The addition of top levels to the original buildings increases even more their seismic vulnerability.

building load conditions, increased their overall vulnerability (Figure 1). Therefore, the vulnerability of these URM buildings, the important population density and the not negligible seismic hazard in the region, decisively increased the seismic risk in these urban areas.

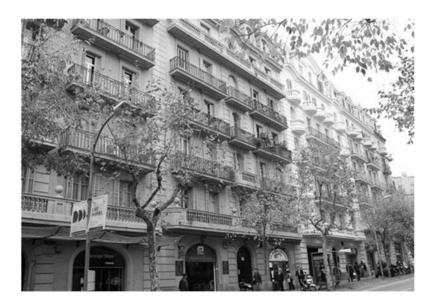
Figure 4. Façades of the analyzed buildings located in Barcelona.

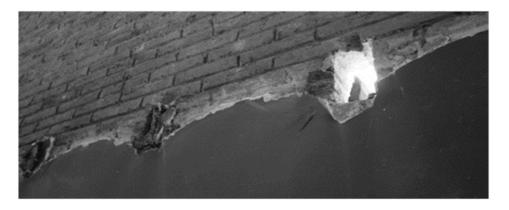
Figure 7. Iron beams (sliced) simply supported on the wall.

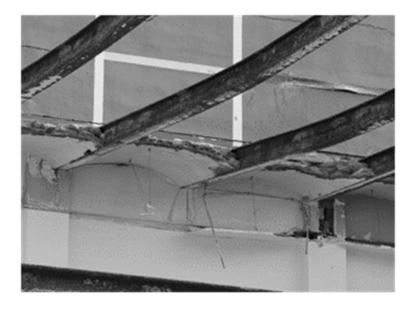
Figure 10. Details of a floor system observed during the demolition of an Eixample building.

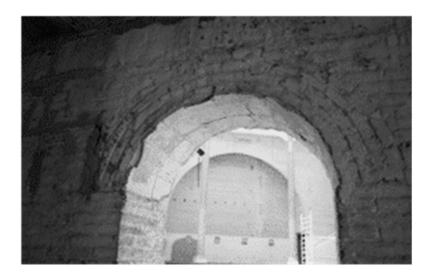
Figure 11. Example of distribution of the arches above openings.

In the URM buildings of the Eixample, the doorways and window spans use discharging arches or iron lintels (Figure 11). For openings in thin walls, as is the case of the distribution walls, the option was to use wood elements for the lintels of the doorways and windows. In big openings, the lintels are made with two, three or more beams, according to the wall thickness (one beam for each 15 cm of wall thickness), and are placed parallel to each other. The beams are fastened with bolts housed into iron tubes that maintain the beams at the required distance. The length of the beams support onto the walls can be taken as the edge length of the beam but, in any case, it is inferior to 20 cm (Figure 12).

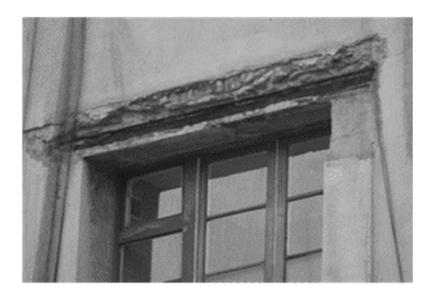
Figure 12. Support length for the beams located above openings.
