# Effectiveness of Surface Treatment Techniques for Composite Bonding with Different Contamination Levels

Xiaomei Fang<sup>1</sup>, Gurbinder S. Sarao<sup>2</sup>, Wenping Zhao<sup>3</sup>, Daniel G. Goberman<sup>3</sup>, and John W. Connell<sup>4</sup>

## ABSTRACT

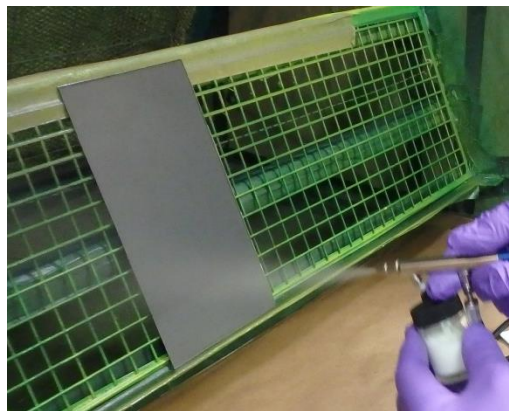
Figure 1. Contaminant sprayed with an airbrush

Low contamination level: the diluted mold release (1:1 by acetone) was sprayed on the pre-bond surfaces with an airbrush, as shown in Figure 1, and dried at room temperature inside a hood over 4 hours. The resulting contaminant deposit was around 0.06 g/m<sup>2</sup>.

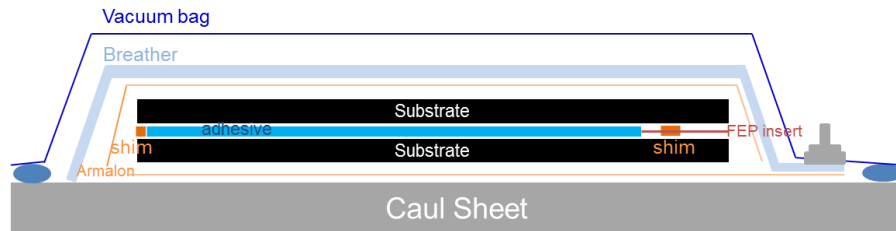
Figure2. Schematic of DCB panel fabrication

Composite double cantilever beam panels, 15.2-30.5 cm by 30.5 cm (6-12 inch by 12 inch), were produced with adhesive bonded substrates in an autoclave. The adhesives were applied on the testing bondline with a 6.35 to 7.6 cm (2.5 to 3 in) long fluorinated ethylene propylene (FEP) film insert, as illustrated in Figure 2. The panels were heated at 1.7  $^{\circ}\text{C}/\text{min}$  (3 $^{\circ}$  F/min) to an ultimate cure temperature under 0.275 MPa (40 psi), held for 2 hrs, and then cooled down at 1.7  $^{\circ}\text{C}/\text{min}$  (3 $^{\circ}$  F/min) 3 $^{\circ}$ F/min under pressure. Full vacuum was applied at the beginning and released when pressure reached 0.137 MPa (20 psi).

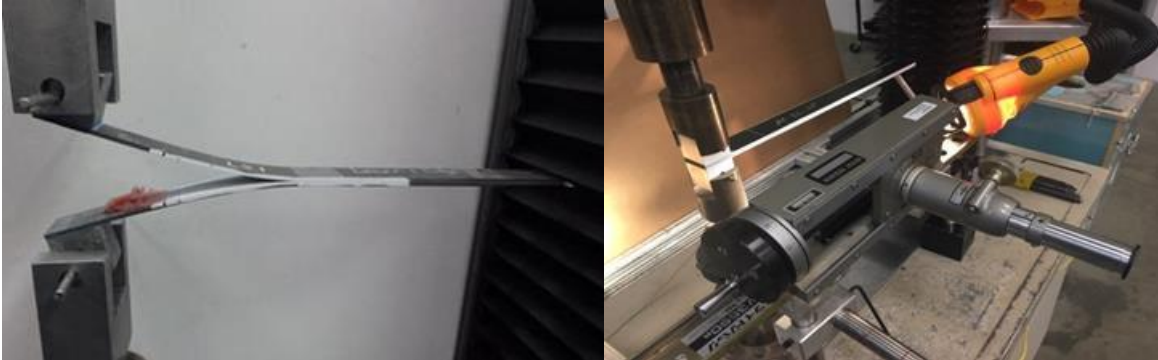
Figure 3. Double cantilever beam testing

*Mechanical testing:* DCB panels were water jet cut into 1" wide coupons. Each coupon was pre-cracked by a 1" wide wedge. The coupon edges were painted white for the observation of crack propagation. The DCB tests were performed similar to ASTM D5528, as shown in Figure 3. Three to five coupons were measured for each panel. Fracture toughness of adhesive bond ( $G_{Ic\text{ avg}}$ ) was determined by equation (1) as follows.

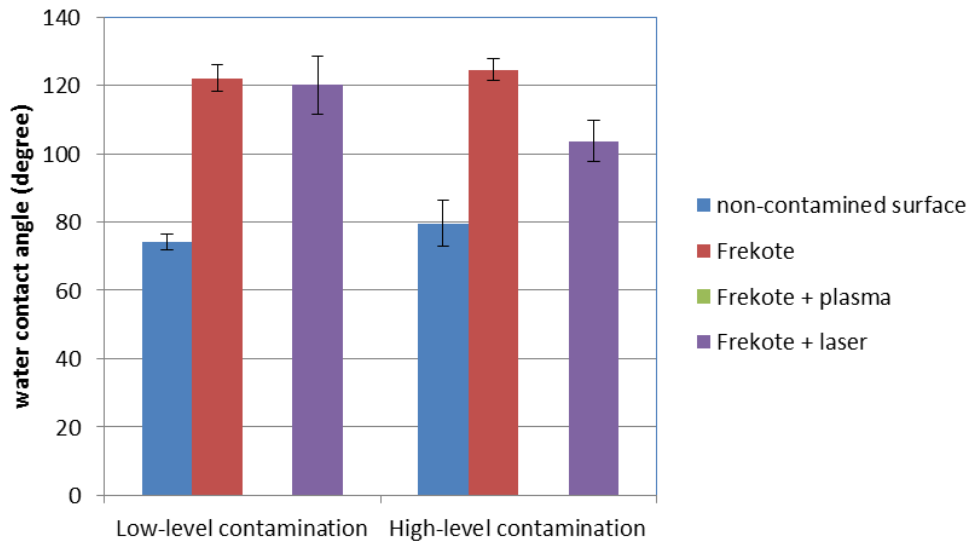
Figure 4. Water contact angle results

According to adsorption theory, adherend wetting is critical to adhesive bond performance. Higher surface tension exhibits lower water contact angles providing stronger adhesive bonding. In a goniometry test, water contact angles were assessed after each water drop was stabilized on a pre-bond surface. The results on different contamination levels and the effect of surface treatments are summarized in Figure 4.

Surfaces contaminated with Frekote® showed much higher water contact angles than pristine surfaces due to poor wettability of low surface tension chemicals on the contaminated surfaces. Similar water contact angles were observed on the contaminated surfaces with high and low concentrations of Frekote® mold release. Plasma surface treatment displayed more significant changes in water contact angles than laser surface treatment reducing the surface tension so sharply that water contact angles became almost zero, i.e. water drops spread out quickly with no measurable water contact angles. On the contrary, laser surface treatment did not induce any dramatic changes in water contact angles. The laser ablation process creates surface topography which influenced the water contact angle whereas the plasma treatment does not.

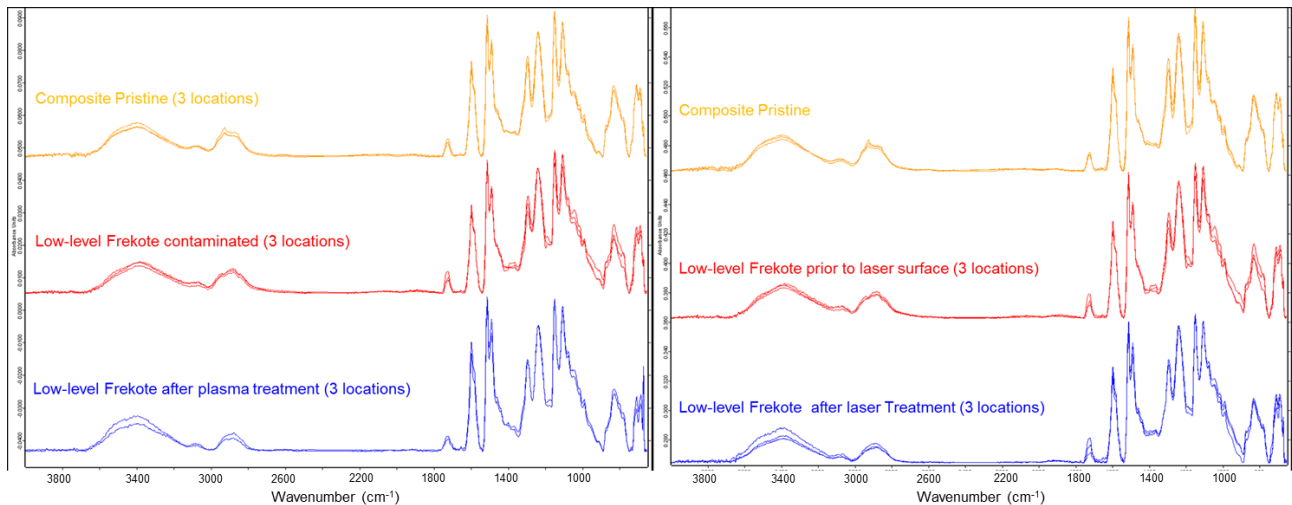
Figure 5. FTIR Spectra Comparison of composite baseline, low contamination level and surface treatments

FTIR analysis was not sensitive to low contamination levels. As displayed in Figure 5, non-contaminated and low-level contaminated composite surfaces gave very similar FTIR spectra. No obvious difference in FTIR spectra was observed after plasma and laser surface treatments.

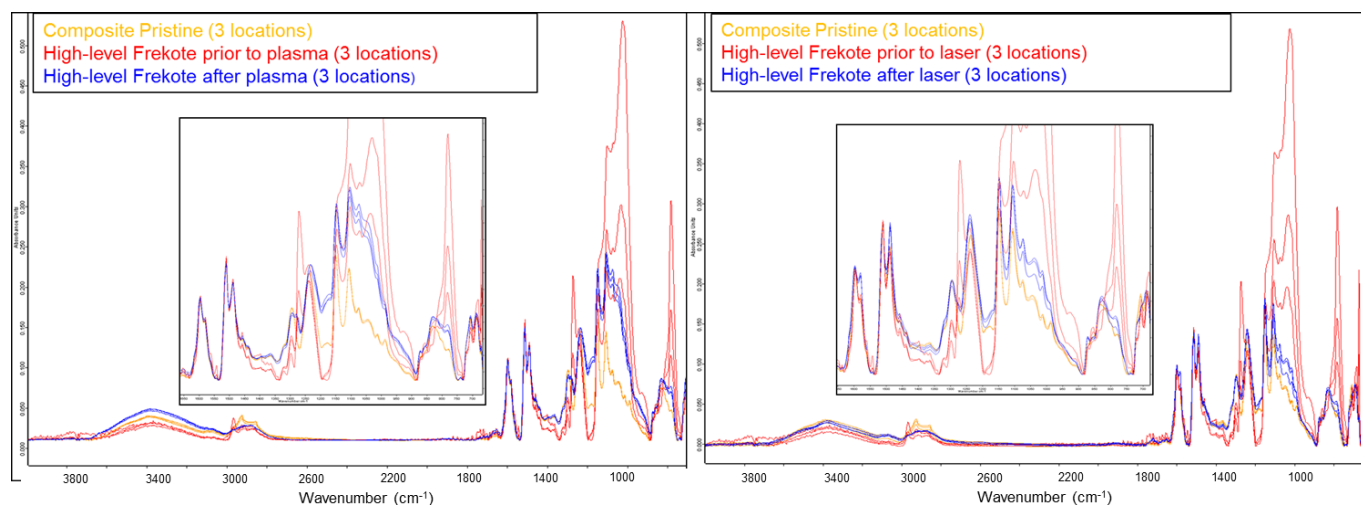
Figure 6. FTIR Spectra Comparison of composite baseline, high contamination level and surface treatments

FTIR spectra detected high concentrations of silicone compounds on high-level contaminated surfaces. As shown in Figure 6, significant amount of the functional groups Si-CH<sub>3</sub> (absorbance peaks at 1275 cm<sup>-1</sup> and 780 cm<sup>-1</sup>) and Si-O (absorbance peak at 1045 cm<sup>-1</sup>)<sup>[13]</sup> were observed. The data showed that the silicone level was significantly decreased with either plasma or laser surface treatment, but silicon-related functionalities still existed.

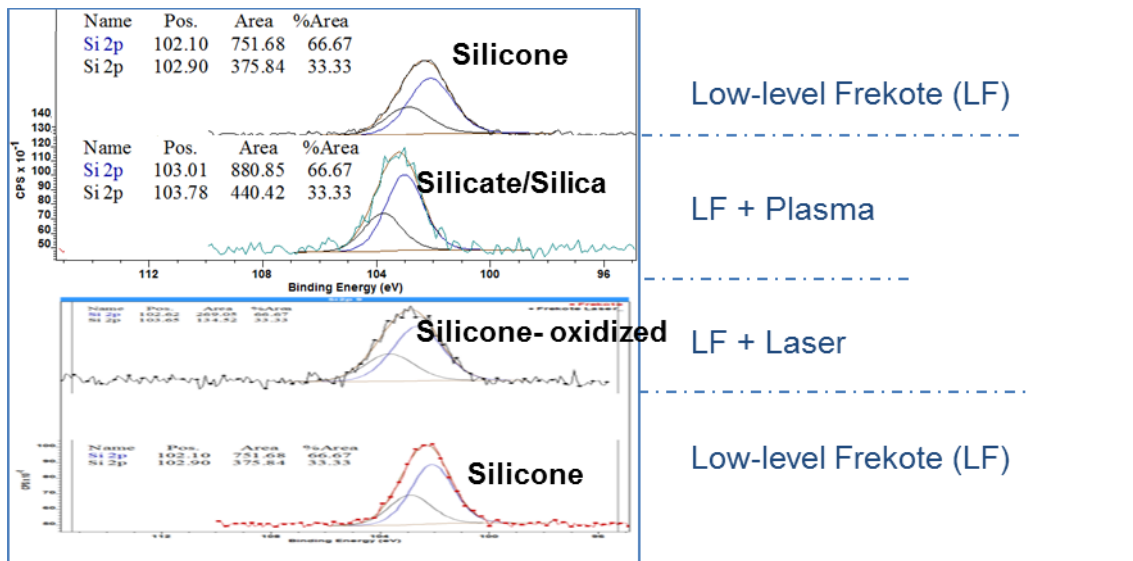
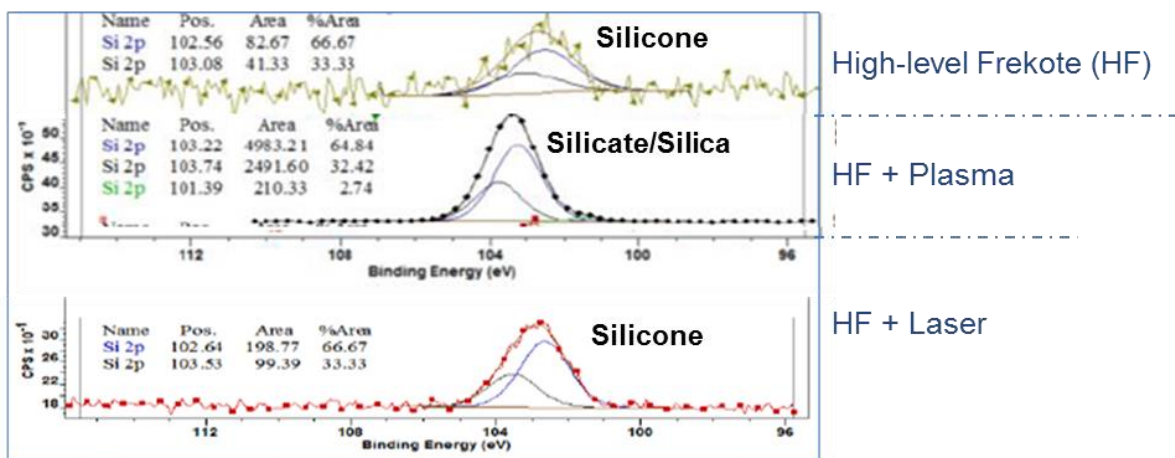
a. Low Frekote® contamination level

b. High Frekote® contamination level

Figure 7. Silicon functional groups associated with plasma and laser surface treatments

The effect of plasma and laser surface treatments on silicon functionalities are displayed in Figure 7. For both high and low Frekote® contamination levels, plasma treatment rendered a complete transformation of silicon-based contaminated surfaces from silicone functionalities to silicate & silica functionalities. The existence of silicone on pre-bond surfaces generates weak bonds due to poor bond strength between epoxy adhesive and silicone. The chemical transformation from silicone to silicate or silica would eliminate weak bond sources and recover bond performance. The effect of laser surface treatment on the Frekote® contaminated surface varied with contamination levels. For the low contamination levels, laser treatment resulted in certain reduction and oxidation of silicone functional groups. However, for the high contamination levels, significant silicone content remained after the laser surface treatment (Figure 7b). This strongly indicated that the ablation from this specific laser treatment process may not be sufficient to remove high concentrations of the contaminant. Higher laser power, multiple laser ablation processes or extended treatment time should be implemented for high contamination level pre-bond surfaces.

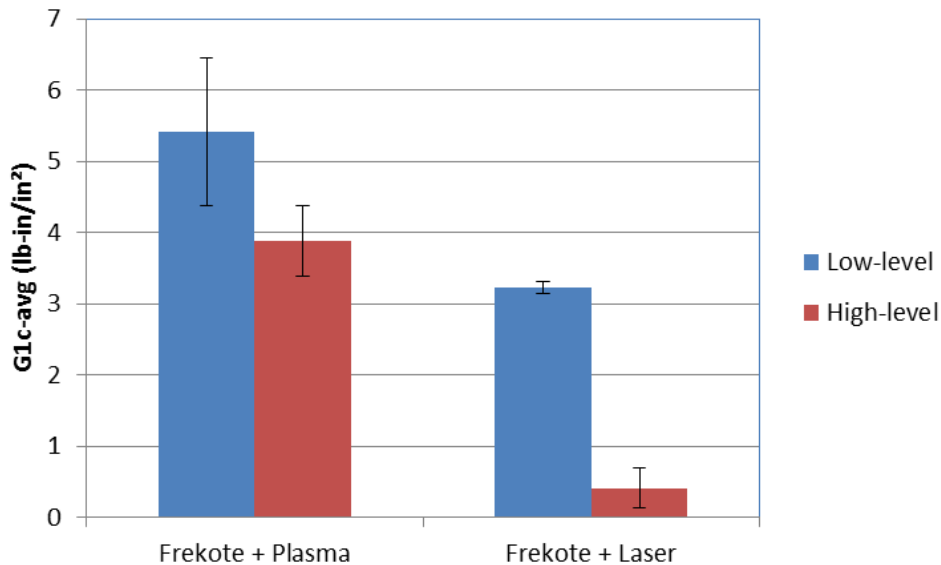
Figure 8. Effect of plasma and laser surface treatments on Mode I fracture toughness

Increased fracture toughness indicates higher resistance to disbond or disbond propagation. The effect of plasma and laser surface treatments on Mode I fracture toughness is summarized in Figure 8. Plasma surface treatment was particularly effective in enhancing bond performance for both high and low contamination levels with Frekote®. Laser surface treatment also exhibited the capability to restore bond performance at low contamination levels. However, low fracture toughness values were measured with laser surface treatment on high-level contaminated surfaces, suggesting that some residual Frekote® contaminant remained on the pre-bond surfaces. In addition, plasma treatment produced even higher fracture toughness than laser treatment with both high and low contamination levels. DCB results were well aligned with the surface characterization results from XPS. Plasma surface treatment activated the contaminated surfaces by completely transforming silicone contaminants to silicate/silica. Whereas laser surface treatment mainly removed surface contaminants by ablation, and induced some oxidation on silicone at the low contamination level. Prior work has shown that higher concentrations of silicone contaminants are removed using higher laser power than that used in this study<sup>14</sup>.

Weak bonds from the insufficient removal of contaminant displayed predominantly adhesive failure between the contaminated composite surface and the adhesive material. Strong bonds from the plasma at high & low contamination levels, and laser surface treatment on low contamination levels, showed mixed mode failures including cohesive failure within adhesive material plus ply delamination of composite laminates, with no disbonds on the contaminated surfaces. The roughness induced by laser ablation can cause fiber tear failure modes to occur leading to a lower G<sub>1c</sub>, since it is a mixture of the fracture toughness of both the matrix resin and the adhesive.
