RESEARCH NOTE

CONSTRUCTION PRACTICES AND THEIR RELATIONSHIP TO TERMITE INFESTATIONS

ABDUL HAFIZ, A.M.* and ABU HASSAN, A.

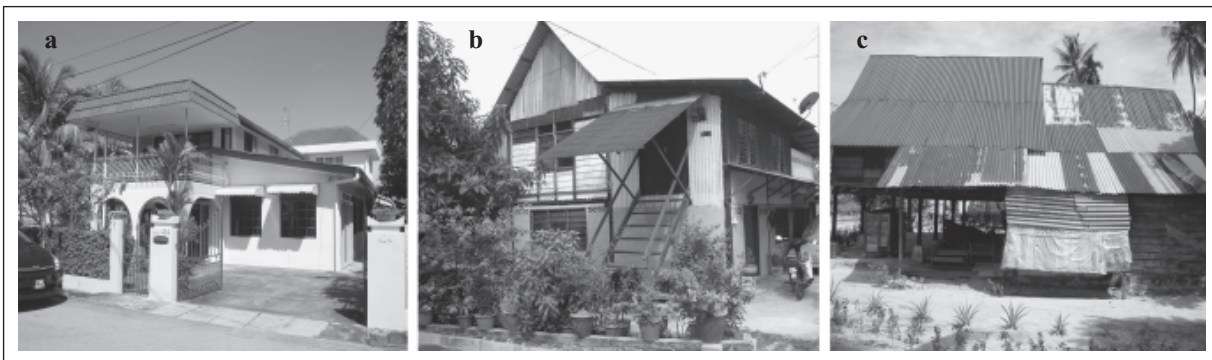
Fig. 1. Building structure in Penang (a) Permanent structure (b) Semi – permanent structure (c) Temporary structure

All of the most common structures infested by termites was identified and classified based on building morphology. Structures were classified as permanent, semi-permanent or temporary (Ab Majid, personal communication, January 1, 2005). Permanent structures consisted of concrete or brick (Fig. 1a). Semi-permanent structures consisted of concrete plus timber (Fig. 1b) whereas temporary structures consisted of timber only (Fig. 1c). In addition, these were divided into terrace house, semi-detached, and bungalow.
