Improving navigation conditions
in the **Westerschelde**
and managing its estuarine environment

How to harmonize accessibility, safety and naturalness?

January 2001

J. J. Peters
R. H. Meade
W. R. Parker
M. A. Stevens

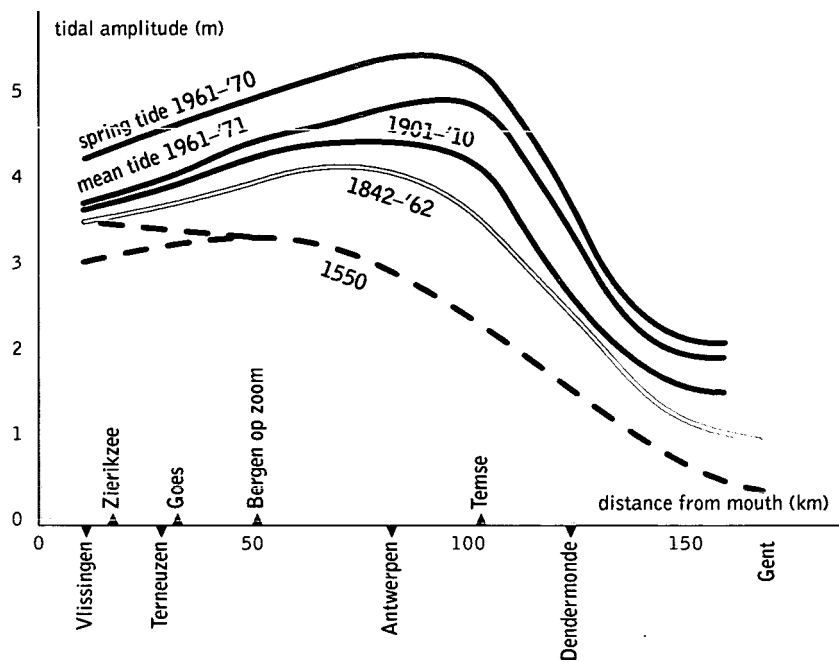
2.1-05 Evolution of tidal amplitude along the Schelde from 1550 till 1970

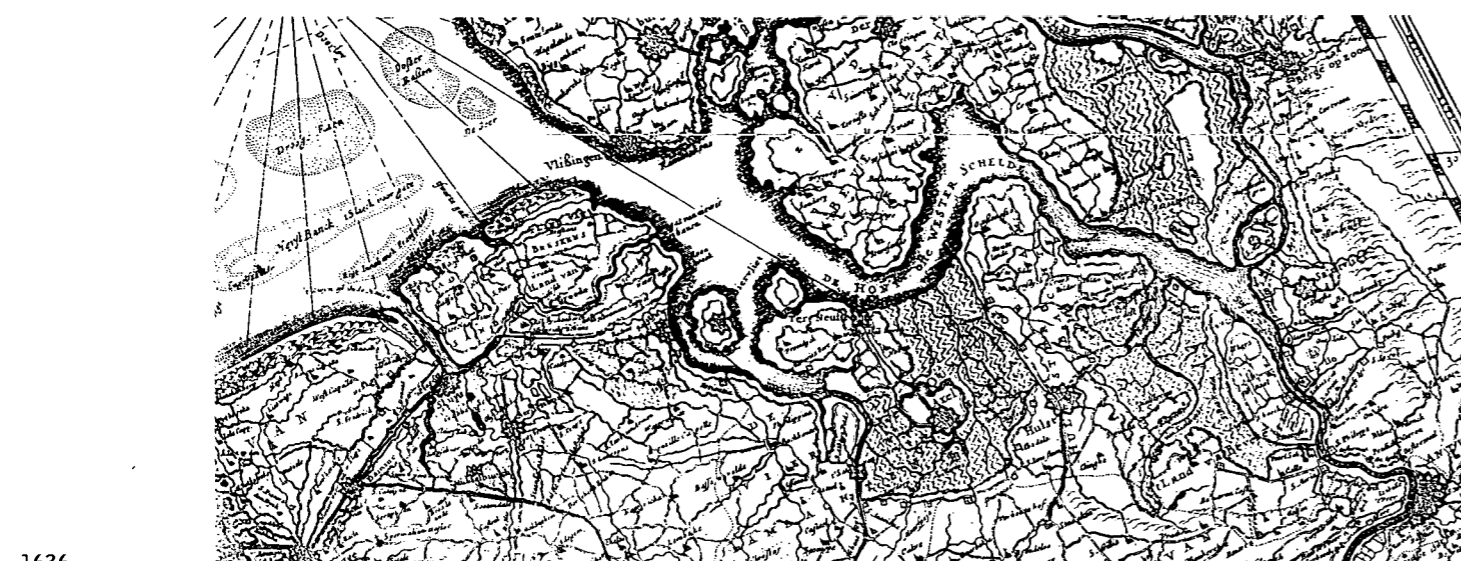
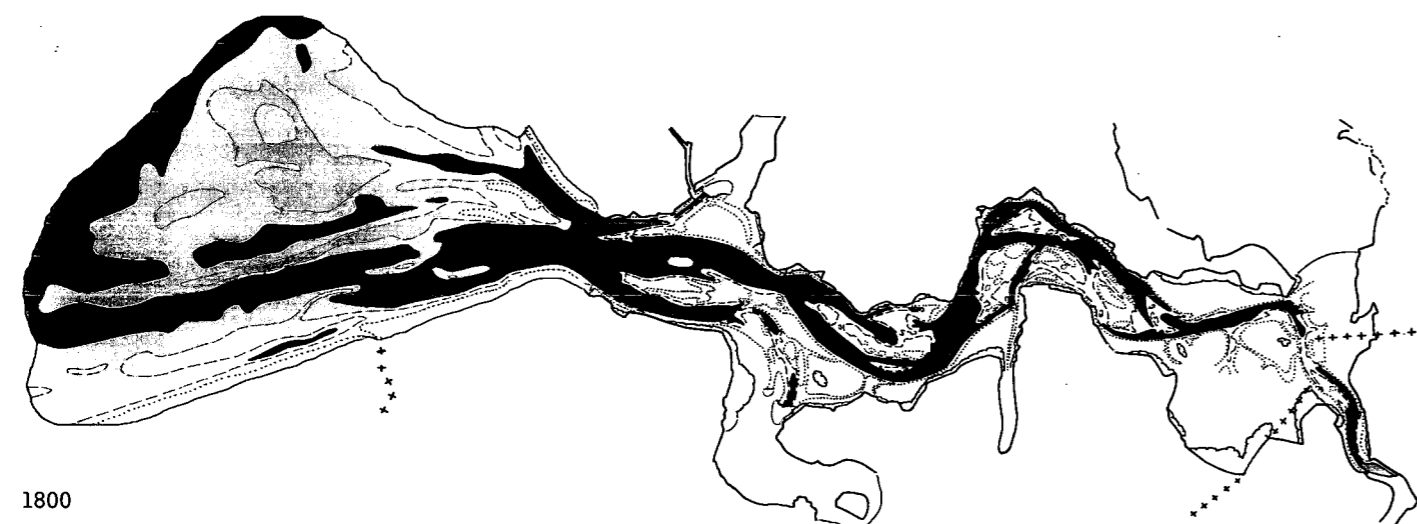
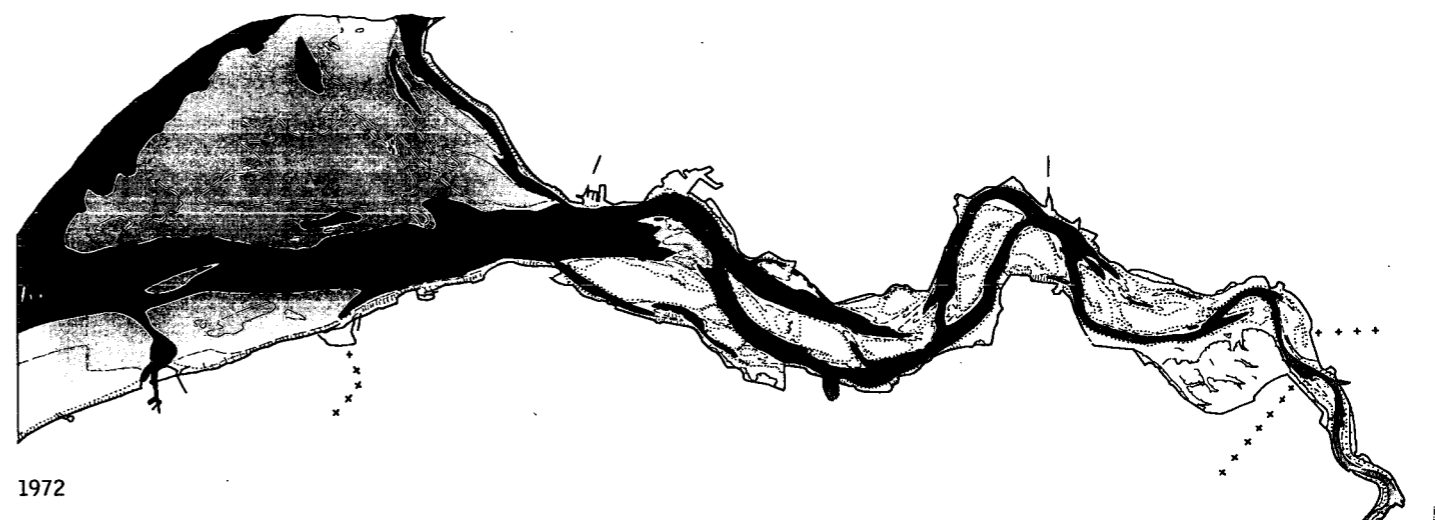
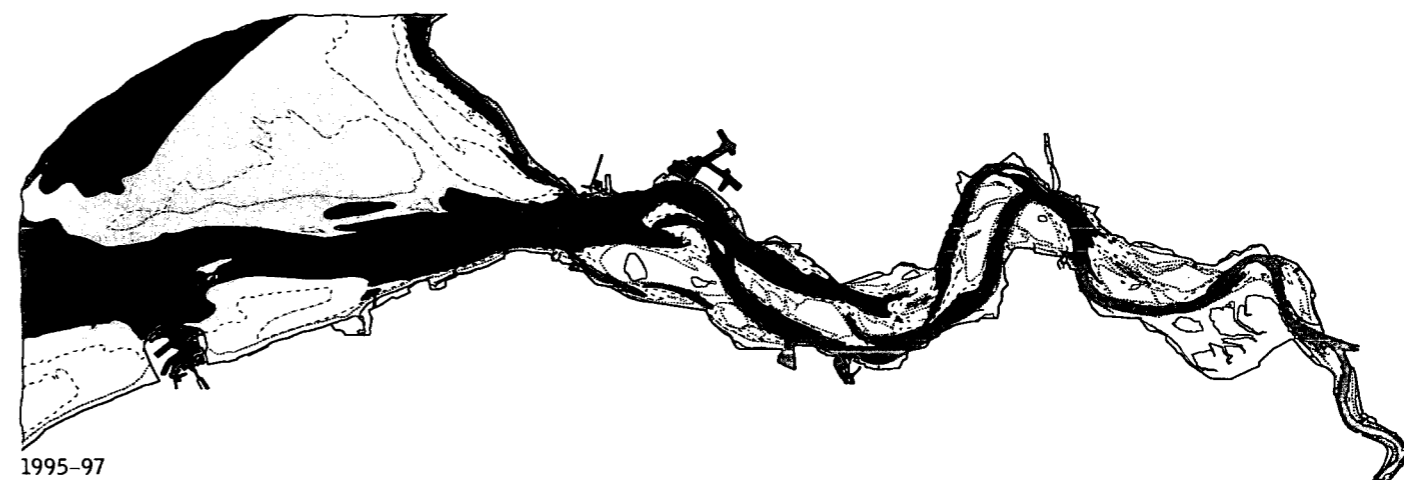
2.2-02 The morphological changes of the Westerschelde from the 17th Century to 1997

With reliable charts becoming available since the beginning of the 19th century, it is possible to assess quantitatively the impact of human interventions (Fig. 2.2-02). From these charts and from the older, more qualitative maps, it may be concluded that

Comparative consideration of the temporal changes in tidal characteristics and intertidal area is informative. Between 1800 and 1980, some 58% of the initial (1800) intertidal area has been lost to poldering. It is concluded that this may be the principal anthropogenic factor causing the changes in tidal propagation during the period of observations. It is likely that dredging since 1970 has contributed to the easier penetration of the tidal wave in the estuary. In a recent paper, Arends and Langerak (2000) came to a similar conclusion. However, they do not corroborate with facts their statement that "channel enlarging by dredging dominated (since 1970) the development of the estuary." The graphs they present (Fig. 2.3-01 & 2.3-02) are in line with the trend over the past millennium and correspond to the changes due to natural factors. This is not to say that dredging has no effect but rather that it is one factor amongst several others and that the relative significance of the different factors is still unknown. Major and continuing changes in channel geometry have been observed in the past decades. A typical example is the change of the Middelgat, between Terneuzen and Hansweert, from a predominantly flood channel in the 1960's to a predominantly ebb channel by the 1970's, the Gat van Ossensisse taking over as the flood channel (see Fig. 2.2-02).

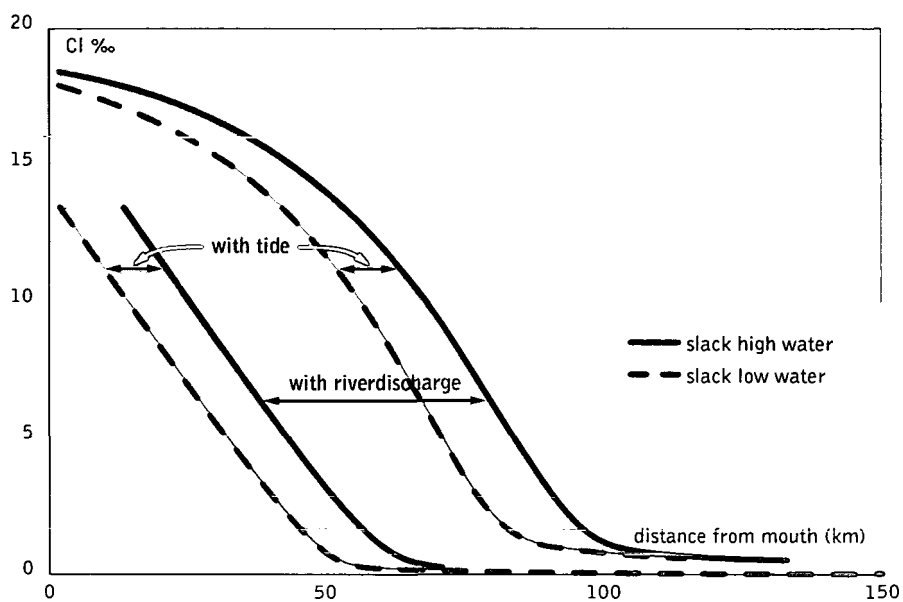
2.4-01 Longitudinal salinity profile and its shift with tide and river discharge

Several authors have reported results of measurements of the longitudinal, transversal and vertical structure of salinity in the Westerschelde (Fig. 2.4-01)(De Pauw & Peters, 1973; Peters, 1975; Peters & Sterling, 1976; Peters & Wollast, 1976; Peters & Wollast, 1980). These studies showed that the Schelde Estuary may be subdivided in 3 zones, where water and salt circulation have different patterns. They reveal the high mixing potential in the Westerschelde downstream of Hansweert, where the distinctive flood and ebb channels recirculate the water around and over the large shoal areas. Mixing is enhanced by the presence of areas where water can be retained during some time - areas that can be called temporary dead zones - while the rest of the flow continues moving. The mixing power of the flood and ebb channel patterns diminishes progressively upstream of Hansweert, as the morphology changes steadily from the distinct multiple-channel towards a single channel pattern.

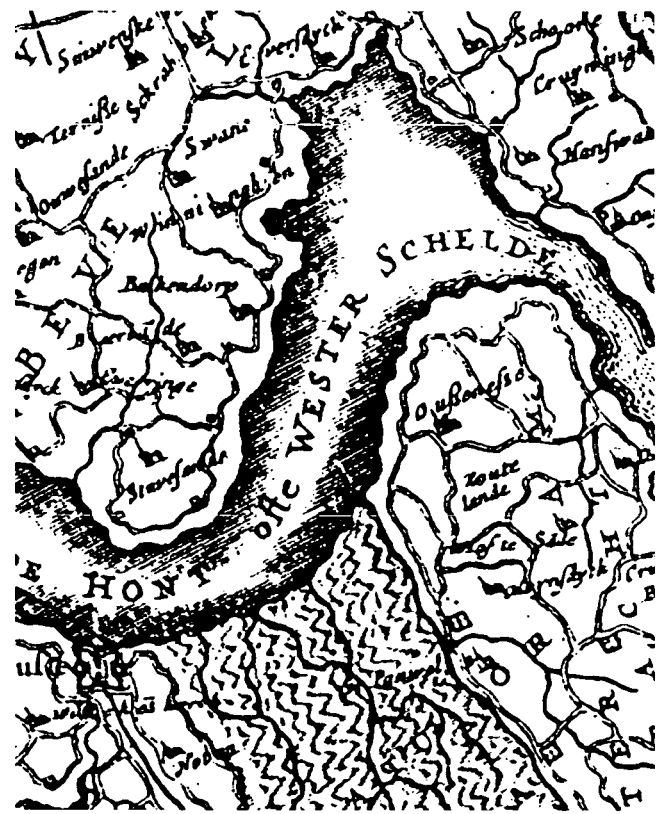
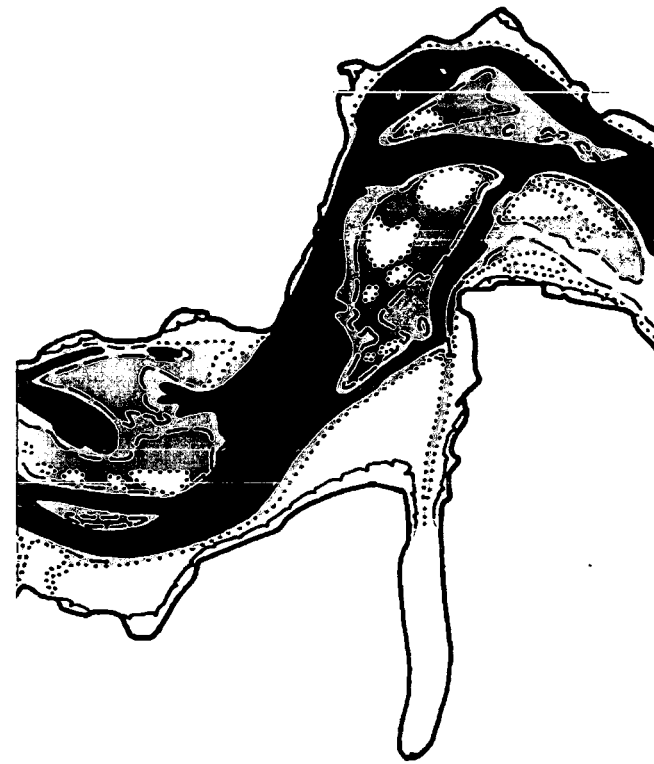
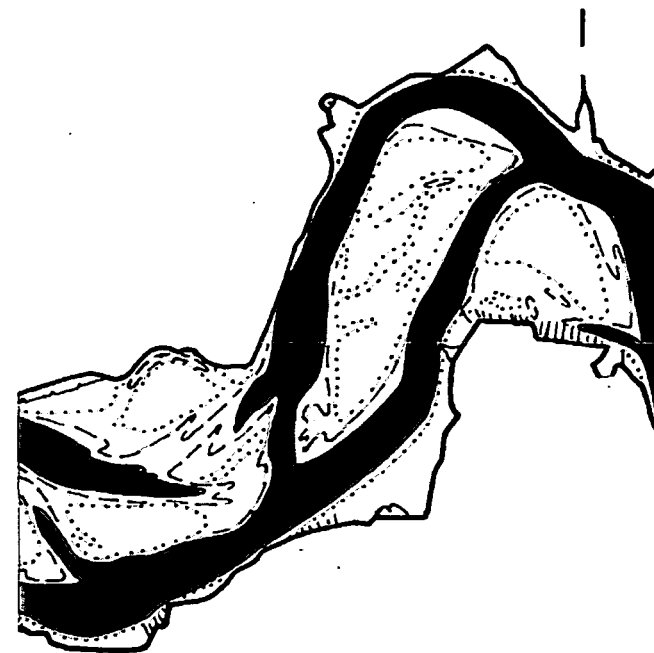
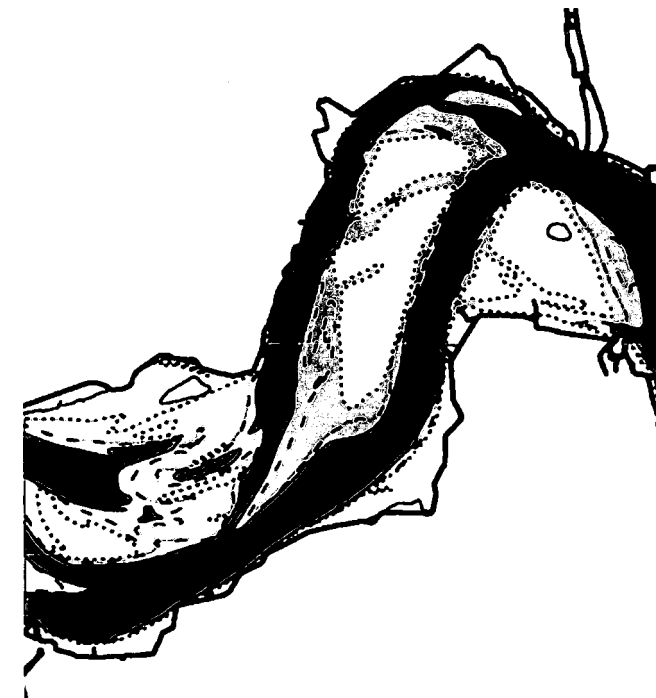
2.5-01 Evolution of the Westerschelde between Terneuzen and Walsvoorden from the 17th Century to 1997

The morphodynamic behaviour of the Westerschelde upstream Vlissingen is determined by the sediment transport capacity of the channels and their degree of freedom to move laterally. This is best illustrated in Figure 2.5-01. When observing these charts, it should

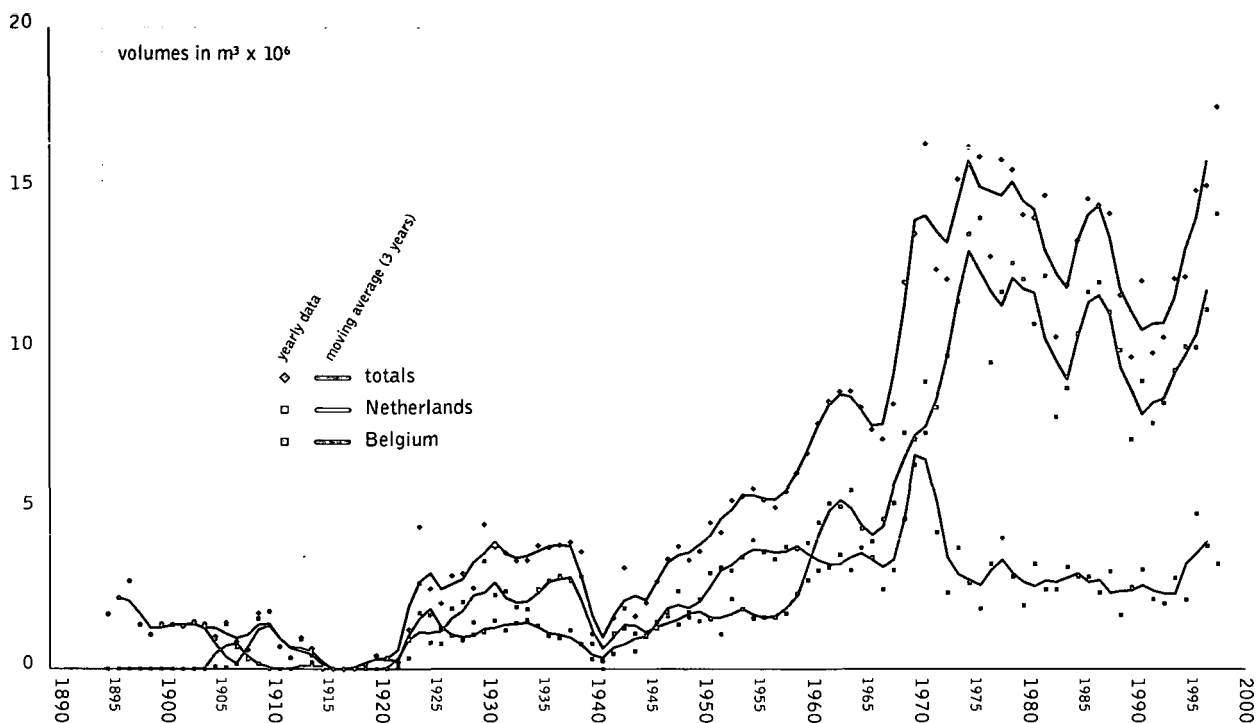
3.2-01 Time series of annual dredged volumes from 1895 to 1998

The lines with 3-year moving average data indicate the broad trends

The dredging activities for improving the navigation conditions in the Westerschelde started at the end of the 19th century (Fig. 3.2-01). Initially, maintenance dredging was mainly needed in Belgium. After 1927, dredge sites were also found in The Netherlands, upstream of Hansweert. Since World War II, the volume of sediment dredged in the Westerschelde (capital and maintenance) increased steadily, from about 2 million cubic metres in 1945 to about 8 million at the end of the sixties. The dredging locations extended progressively seawards, reaching the bottleneck area of the estuary between Vlissingen and Breskens in 1973, with the dredge site of Borssele.
