MORPHOLOGICAL MANAGEMENT IN ESTUARIES CONCILIATING NATURE PRESERVATION AND PORT ACCESSIBILITY

Yves M.G. Plancke¹, Jean Jacques Peters² and Stefaan J. Ides¹

Abstract

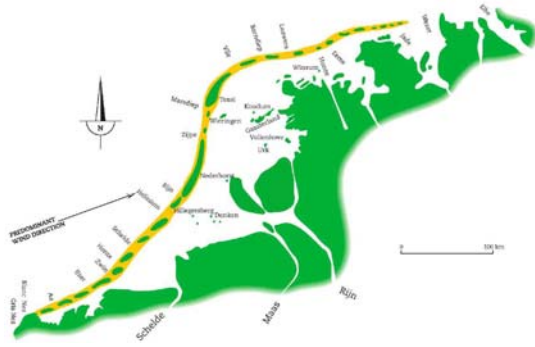
Fig. 1. Situation during the Roman times.

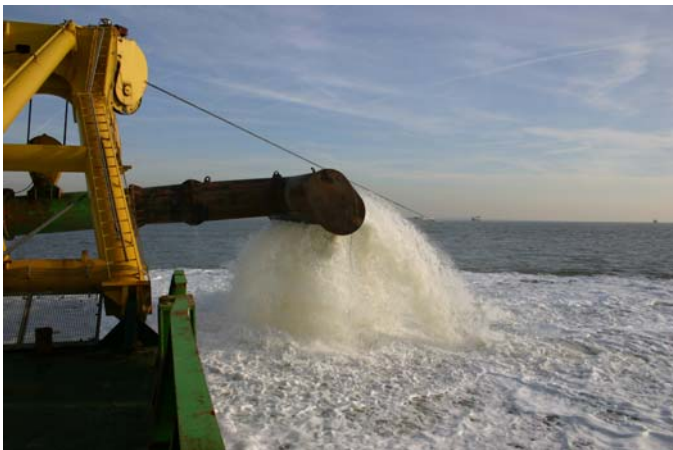
Fig. 10. Detail of the diffuser.

The execution of an *in situ* disposal test had to bring final proof of the feasibility of the alternative disposal strategy. The idea of the *in situ* test was to dispose quietly and precisely 500,000m³ of sand with a diffuser on the bottom. The dredging vessel (self-discharging hopper dredger) was connected to a floating pipeline through which the sand is transported to a pontoon 'Bayard II' (Fig. 6). On this pontoon the sand is pumped to a diffuser (Fig. 10) that disposes the sediment in a precise way on to the bottom. The use of the diffuser required an adjustment of the disposal license. The amount of 500,000m³ was chosen because it is on one hand large enough to affect significantly the bottom morphology, however on the other hand small enough to be reversible if something would go wrong. The choice of the disposal location was based on the results of the feasibility study. The float measurements, the results of the numerical simulations and the physical scale model tests with moveable material on fixed bed indicated that an area between the northern sand spit and the tip of the plate was most suitable for an *in situ* disposal test (Fig. 11). From 17 November to 20 December 2004, 500,000m³ of sand was almost continuously disposed in the proposed area.

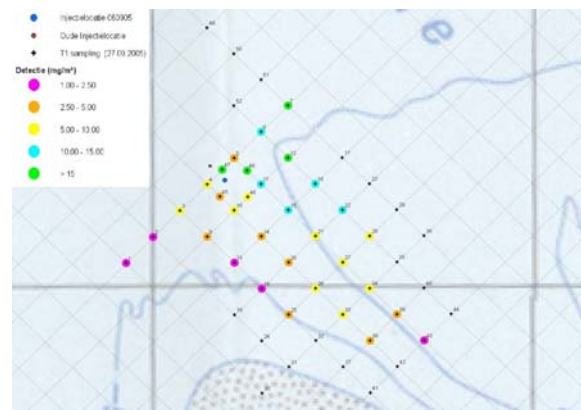
Fig. 18. Tracer concentration one month after injection.

added. In total 500kg of tracer material was prepared. The fluorescence allows already a first indication of available tracer material in the samples taken in the field. Afterwards the positive samples are activated in the laboratory so that the concentration of tracer material can be determined. A first tracer experiment was executed in February 2005 with 500kg of tracer material. The material, packed in small containers (50kg each), was lowered down to 0.50m above the bottom during slack where they were opened. Five sampling campaigns were planned, using the Van Veen grab to collect approximately 50 samples during each campaign. The first samples did not contain any tracer material. Possible explanations could be either that bedforms covered the tracer or that the tracer material was too fine and dispersed during a storm in the weeks after the injection. A second campaign using vibro-core sampling technique did not produce better results. Therefore a new injection was executed in September 2005. This time the tracer material (500kg) was mixed in advance with 500kg sand with grain size comparable to the deposited sediments. The injection was executed by a diver, who placed the sediments onto the bottom. A first sampling campaign, the day after the injection, revealed some transport of the tracer material in up-estuary direction (Fig. 17). In a second campaign tracer material was found in several points of the sampling grid (Fig. 18). The highest concentrations were found near the injection point, with the predominant transport indicating mainly an up-estuary movement towards the sandbar. In a third sampling campaign (November 2005), no significant concentrations of tracer material were found. The question remains why no concentrations were found. This may sustain the hypothesis of bedforms covering up the tracer material. Despite the limited recovery of tracer material, the initial results confirm the trends from the bathymetric surveys: the disposed material that is eroded, is transported in the up-estuary direction towards the sandbar.
