EXPERIMENTAL MULTI-LEVEL SEISMIC PERFORMANCE ASSESSMENT OF 3D RC FRAME DESIGNED FOR DAMAGE AVOIDANCE

Brendon A Bradley^{1*}, Rajesh P Dhakal¹, John B Mander¹, Louman Li¹.

¹Department of Civil Engineering, University of Canterbury, Private Bag 4800, Christchurch 8020, New Zealand

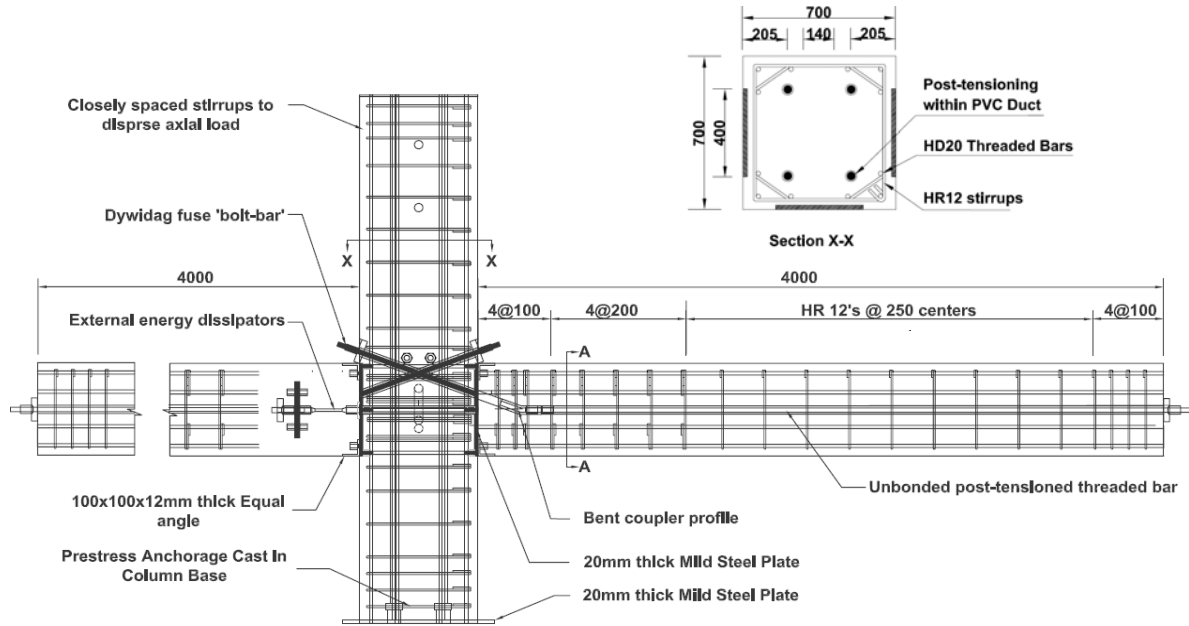
(a) Front (east-west) view of the test sub-assembly.

Figure 1: Prototype building structure and reinforcement details of sub-assembly.

In conventional monolithic structures, seismic energy imparted to the structure during earthquake excitation is dissipated through the development of plastic hinges at critical locations which cause damage requiring post-earthquake repair. In jointed precast systems designed in accordance with DAD principles the drift demand is accommodated via gap opening at the rocking connections, and the energy dissipation due to plastic hinge formation does not occur. It has been previously claimed [2] that jointed precast systems with insufficient energy dissipation capacity are subjected to higher displacement demands than equivalent ductile monolithic structures. It is therefore necessary to have a supplemental damping system to provide this required energy dissipation, while maintaining the DAD philosophy by limiting damage to replaceable components. Tension-compression dissipators in the form of machined mild steel rods were used for these experiments. These dissipators were connected across the beam-column interface by screwing to the column at one side and to steel plates cast into the beams at the other side (Figures 1a and 1c). Further details of the specimen design are given in [11].

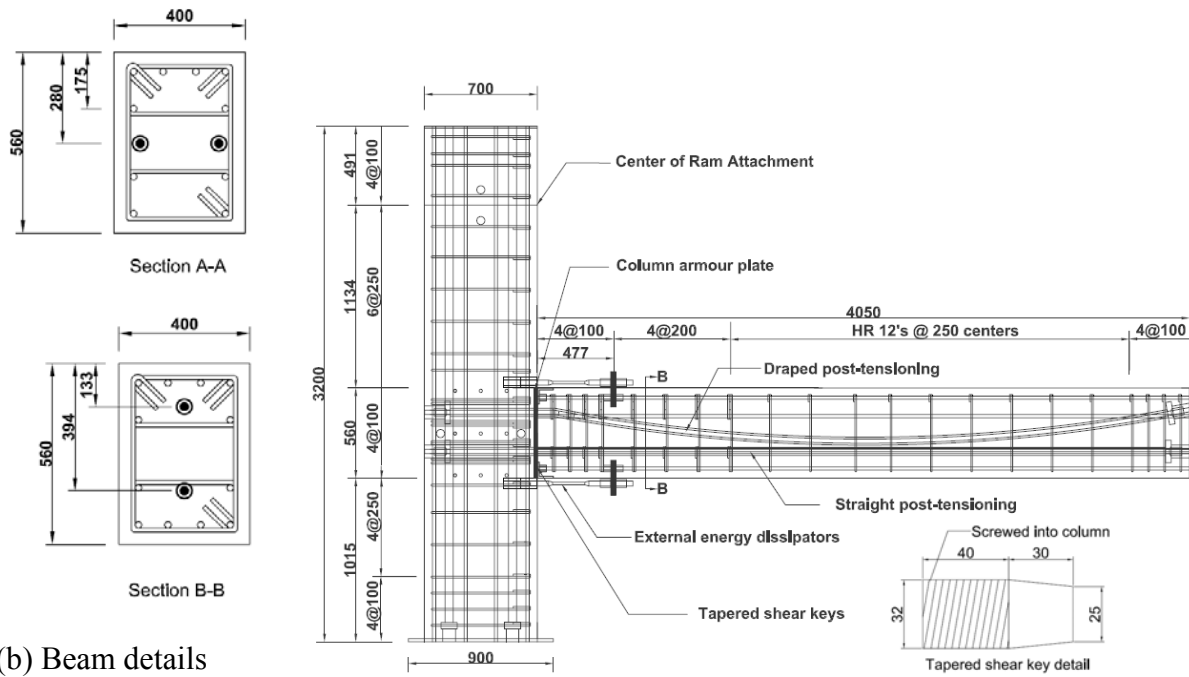
(b) Beam details

(c) Side (north-south) view of the test sub-assembly

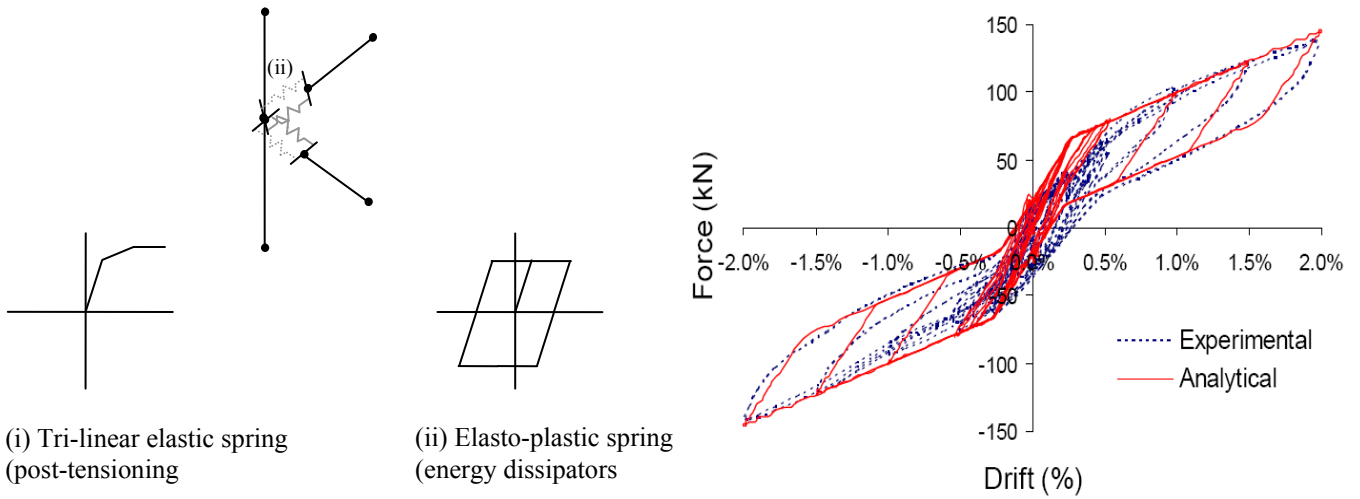
(a) Computational modelling

(b) Computational – experimental comparison

In order to perform IDA, an analytical model of the beam-column joint sub-assembly was conceptualised using Ruaumoko3D [19]. The beams and columns were represented using frame elements with an elastic hysteresis, which is inline with the expectation of DAD philosophy that all components/members (except for the rocking connections) behave elastically. The inelastic and nonlinear behaviour of the rocking joint was described using two springs of zero length in parallel (Figure 2a). The first spring represented the behaviour of the unbonded post-tensioning tendon and had a tri-linear elastic hysteresis to represent the

The parameters of the springs representing the rocking joints were calibrated based on the results of preliminary quasi-static tests [11]. These preliminary tests were up to drifts of 2%, which was sufficient to characterise: (i) the initial stiffness; (ii) drift at gap opening; (iii) post gapping stiffness; and (iv) energy dissipation. The drift at which tendon yield occurred was based on design calculations given elsewhere [11]. Although it has been shown in some cases that the Monolithic Beam Analogy [20] can approximate these points relatively well, the preliminary tests were conducted for further verification, which was enabled due to the ‘damage-free’ properties of the specimen. A typical comparison between the experimental and calibrated analytical results is shown in Figure 2b for unidirectional cyclic test up to 2% drift.

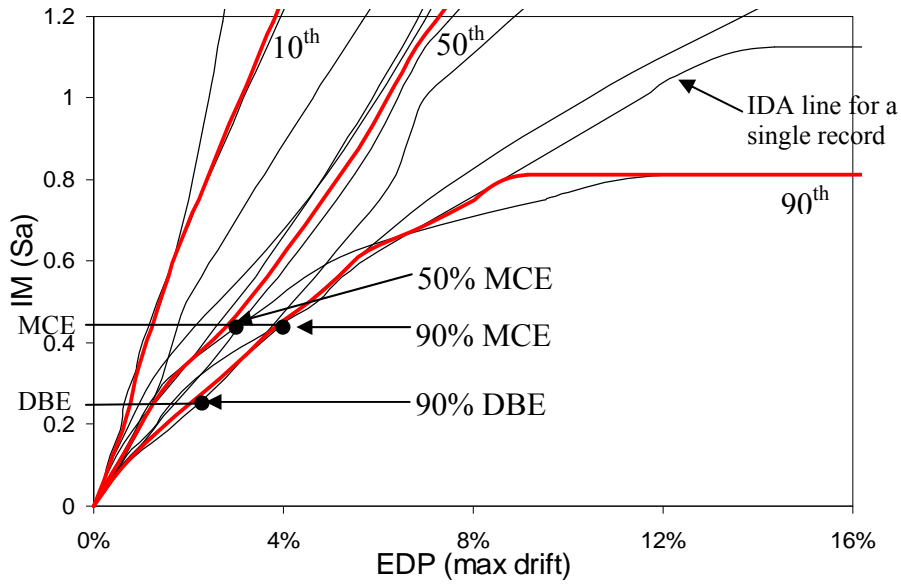
(c) Incremental dynamic analysis curves for near source suite

Figure 2: Loading protocol.

These analyses resulted in a matrix of data points on an EDP (i.e. maximum inter-storey drift θ_{max}) versus IM (S_a) plot, which were connected to obtain the IDA curve for all earthquake records in the suites. The resulting IDA curves for the suite of near-source earthquakes are shown in Figure 2c. From the generated IDA curves the structural behaviour was assessed at three different levels of performance. The first performance criterion is that

It is also noted that existing shake-table or pseudo dynamic test procedures (which use the same ground motion record scaled to various levels of intensity) effectively relate to having only one line on the IDA plot given in Figure 2c. Hence by conducting these existing test procedures, the experimenter has no concept of the confidence in the performance of the structure at various levels of ground motion intensity. This therefore illustrates the need for the MSPA in experimental testing of structures subjected to earthquake loadings.

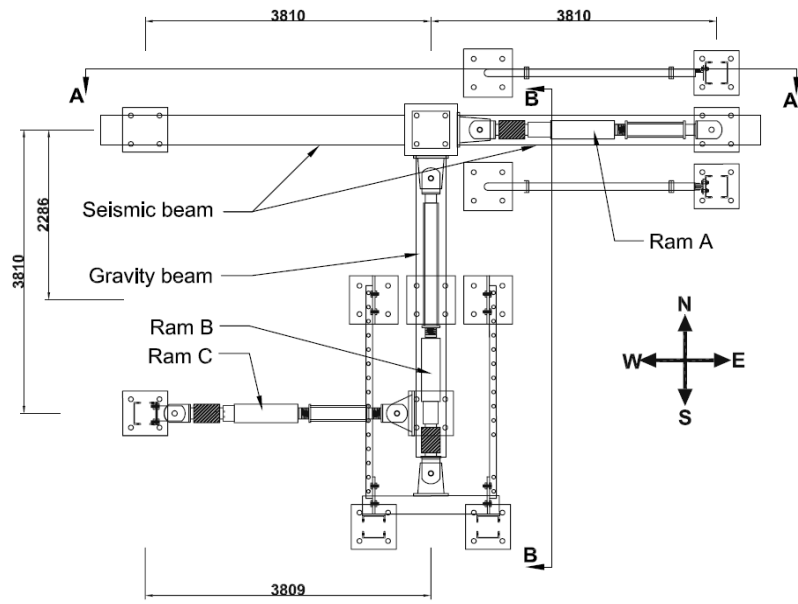
(a) Plan view

Figure 3: Experimental setup

Figures 3a, 3b, and 3c present plan view and elevation views of the experimental setup. Loading was performed by three hydraulic actuators (Ram A, B, C). Two large actuators, one along the East-West direction (Ram A), and the other along the North-South direction (Ram

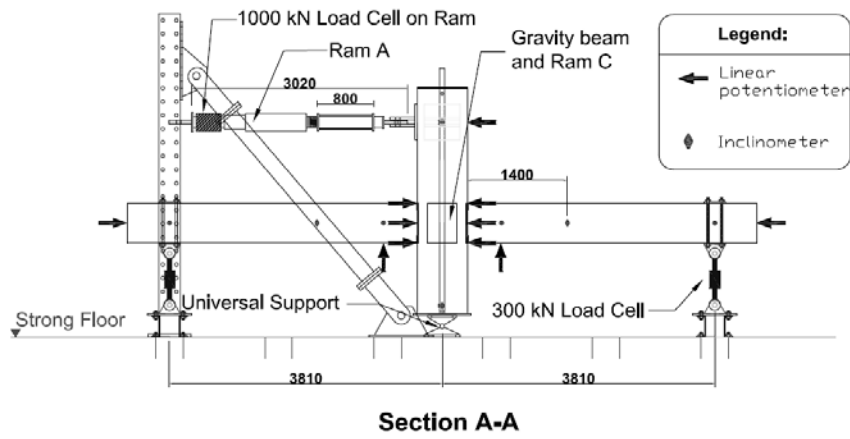
(b) Front elevation

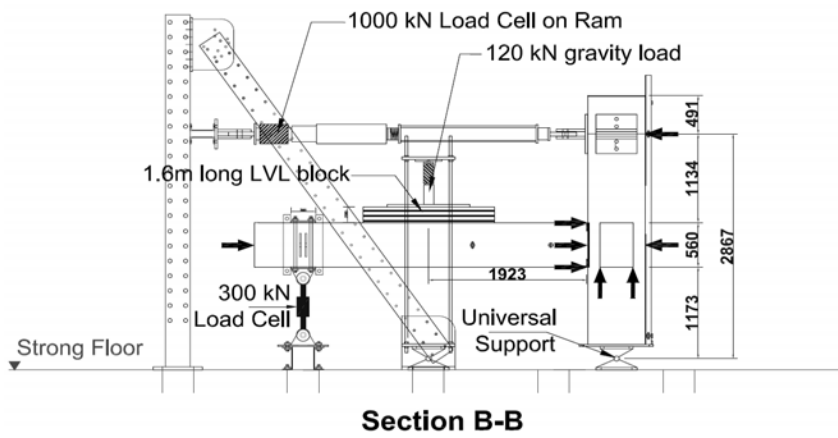
(c) End elevation

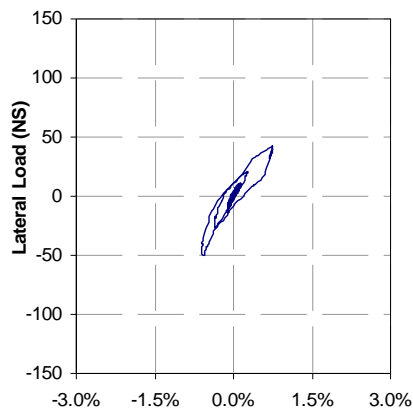
(a) N-S hysteretic response

Figure 4: Experimental results for the 90% DBE near source ground motion (EQ40).

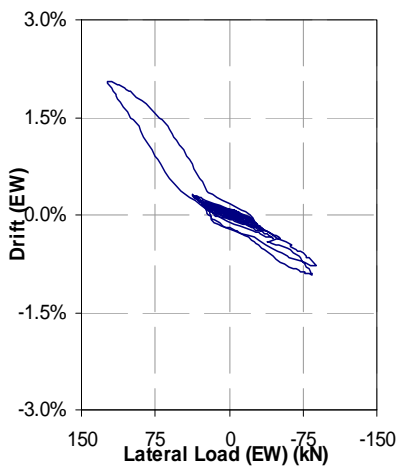
(b) E-W hysteretic response

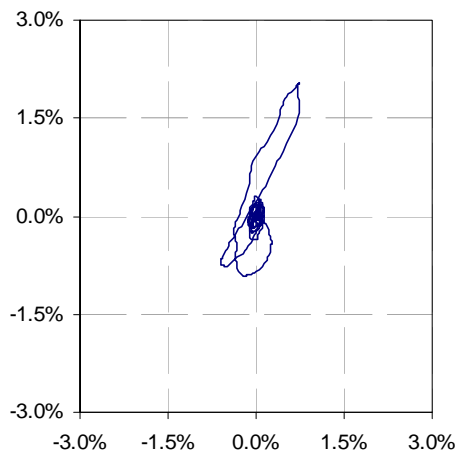
(c) 2D orbit of column

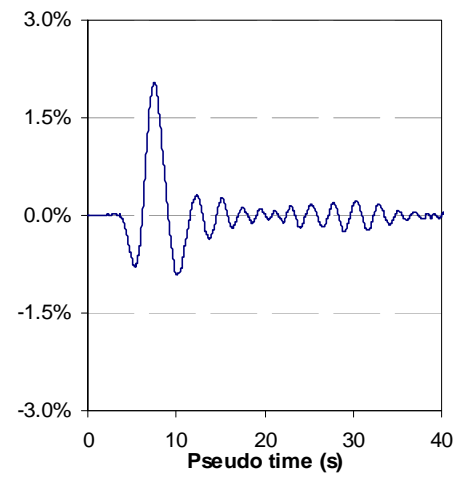
(d) E-W displacement time history

The near source ground motion causing the 90th percentile response at DBE (with a return period 475 years) was EQ40 which induced a maximum drift of 2.1%. Figures 4d and 4f shows the input drifts applied to the sub-assembly, while Figure 4c shows the drift orbit of the top of the column. Figures 4e and 4g show gap opening on the east and west seismic beams respectively at a drift of 2.13%. Note that as previously mentioned, preliminary quasi-static tests were conducted on these specimens [11] whose results were used to calibrate the analytical models. Moreover, the displacement time-history corresponding to EQ7 (90th percentile DBE medium source record) had also been applied to the sub-assembly prior to the QED test for EQ40. During these tests, some cracks had emerged in the beam near the rocking interface. Consequently, some cracks in the top-half depth and minor spalling in the

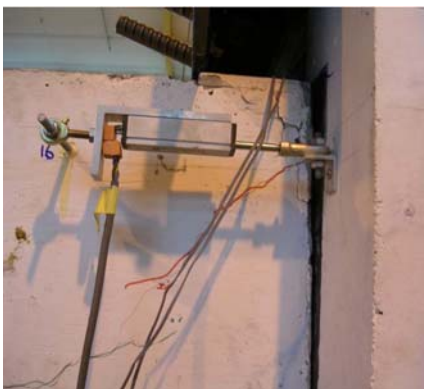
(e) Top of connection at 2% drift

Figures 4e and 4g show a gap opening of approximately 5 mm at the edge of the beam, however at the mid-depth of the beam there is no gap opening, indicating that the expectation of rigid body movement at the rocking interface was not fully achieved. Due to the nature of near source records, the input drifts are comprised primarily of one peak occurring simultaneously in both orthogonal directions. The peak drifts on this cycle were 1.95% and 0.64% in EW and NS directions, respectively. The corresponding lateral forces for the EW and NS directions were 118.9 kN and 38.1 kN, respectively. On the maximum drift cycle, the supplemental energy dissipators on the seismic beams yielded partially, however no noticeable buckling occurred during unloading. The partial yielding of the dissipators is also indicated by the moderate energy dissipation occurring during the peak drift cycle (Figure 4b). Overall, the specimen performed satisfactorily, and as there were no visual signs of damage requiring repair then it can be concluded that no repair of the structural system would be required to restore functionality after this test.

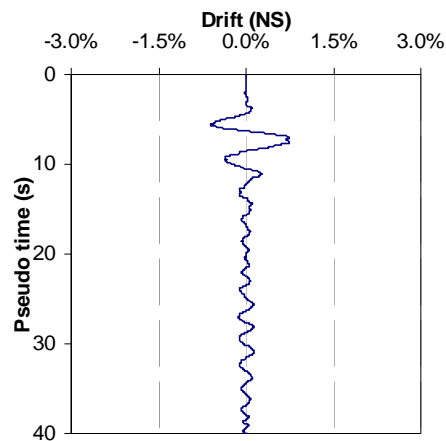
(f) N-S displacement time history

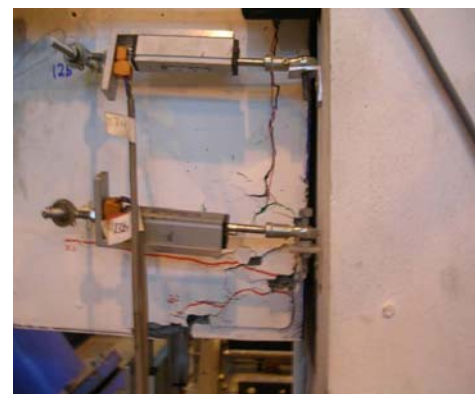
(g) Bottom of connection at 2% drift

inside of the bottom steel angle can be seen in Figure 4g.

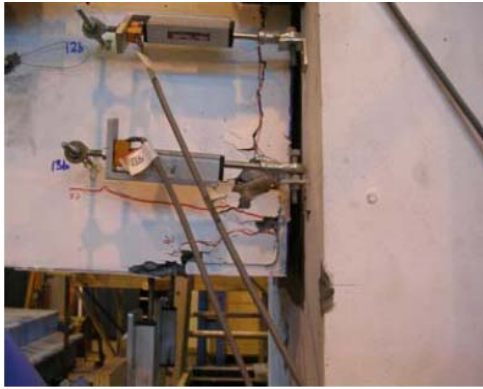
(a) Cover spalling at seismic beam connection

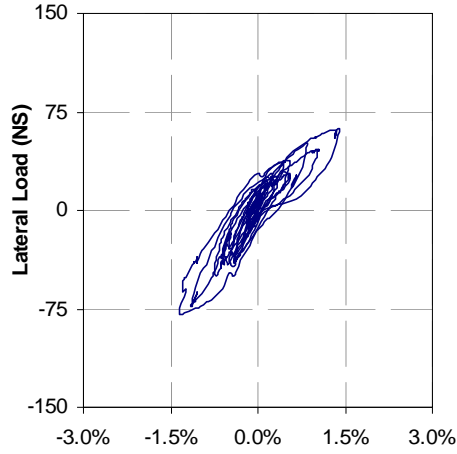
(b) N-S hysteretic response

Figure 5: Experimental Results for the 50% MCE near source ground motion (EQ30).

The lateral load vs. drift hysteretic response in the NS direction (Figure 5b) shows good energy dissipation during the peak drift cycles. Figure 5i shows the gravity-beam to column connection at NS drift of 1.5%, where the beam undergoes ‘partial rocking’ (when the beam at the beam-column interface does not rock (almost) rigidly on the column face, due to the insufficient stiffness of the steel angles). Upon re-centering of the gravity beam from the maximum drift cycles in either direction, buckling of supplemental energy dissipators occurred (Figure 5g). The lateral load vs. drift response in the EW direction (Figure 5d) shows very good energy dissipation during the peak drift cycles, which occurred at 18 and 21 seconds in the positive and negative directions, respectively. However, in the aftermath of these large drift cycles, energy dissipation at subsequent cycles of lower drift is noticeably smaller. This is thought to be due mainly to the buckling of the external energy dissipators.

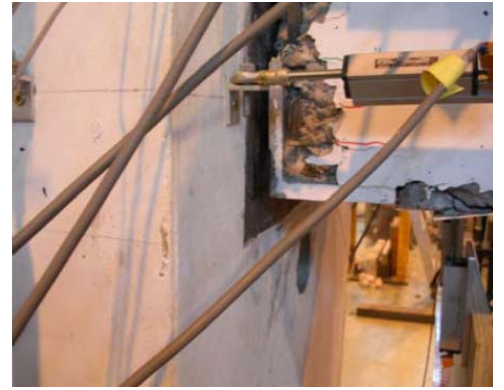
(c) Cover spalling at gravity beam connection

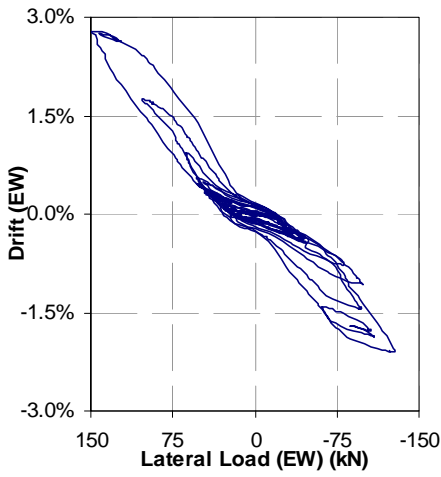
(d) E-W hysteretic response

Minor strength degradation is apparent during the two large cycles in the negative EW drift direction (Figure 5d). As the damage in the specimen at this stage was not significant, it was deduced that damage was not contributing much to the strength degradation. The cause of this is believed to be the reduction in efficiency of dissipators due to buckling, which occurred during unloading (i.e. re-centering) from the previous large drift cycle in the positive EW direction. Figures 5a and 5c show the lower steel angle on the west-side seismic beam viewed from the north and south, respectively. Minor crushing and spalling from the previous tests caused a reduction in load carrying capacity of concrete around these affected regions, and at the peak drift of 2.84% some spalled concrete fell off the beam. The lack of apparent re-centering mentioned previously appeared less significant as the absolute value of the drift

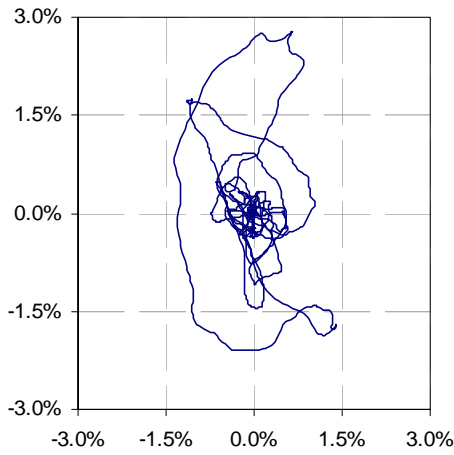
(e) 2D orbit of column

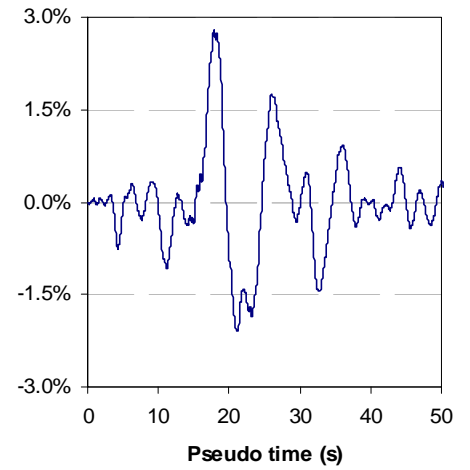
(f) E-W displacement time history

The near source ground motion causing the 50th percentile response at MCE (with a return period 2475 years) was EQ30 which induced a maximum drift of 2.8%. Figures 5f and 5h show the input drifts in the two directions, while Figure 5e shows the drift orbit of the top of the column. The peak drifts were 2.8% in the EW direction and 1.77% in the NS direction. The corresponding lateral forces in EW and NS directions were 149.4 kN and 77.5 kN, respectively. As can be seen in Figures 5b and 5d, the drifts are not exactly zero when the lateral load was fully unloaded. It was similar during the quasi-static tests conducted for the verification of the computational model (Figure 2b) and during the previous QED tests with EQ7 and EQ40 (Figures 4a and 4b). This apparent lack of re-centering capability in the lateral load vs. drift plot was due to the large friction forces that occurred between the bolt bar

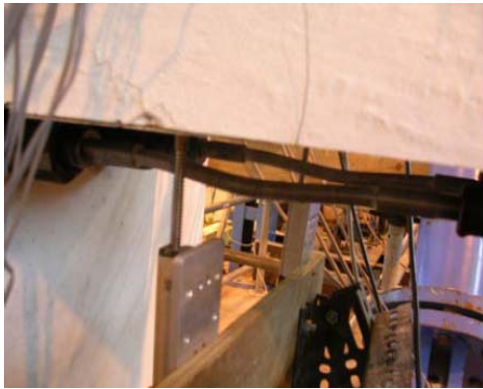
(g) Buckled gravity beam dissipators

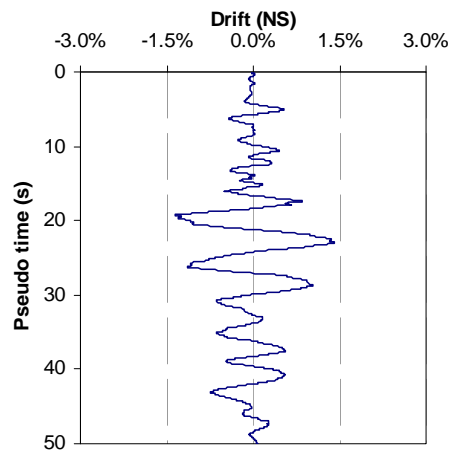
(h) N-S displacement time history

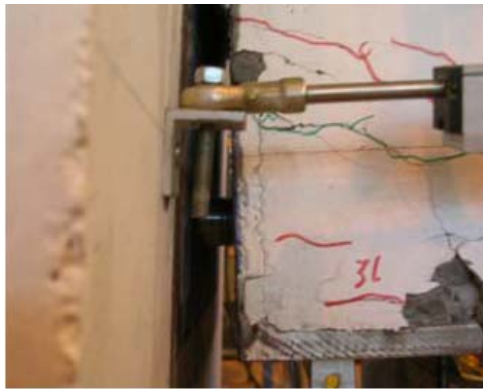
(a) Exposed shear key

Shear keys: - Figure 6a shows the exposed shear keys at the maximum drift of 4.8% during the final test. As no problems occurred in the shear keys during all six tests, the performance of the shear keys at high drift levels was verified. Large axial rotation of the gravity beam was observed during the maximum drift in the seismic frame direction, indicating the adequacy of shear keys in providing torsional restraint.

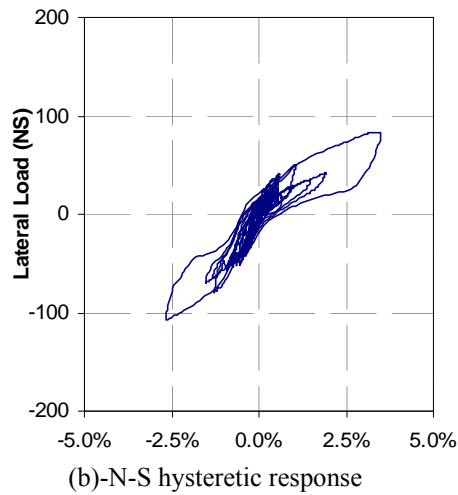
(b) N-S hysteretic response

Figure 6: Experimental Results for the 90% MCE medium source ground motion (EQ11).

The lateral load vs. drift response in the NS direction is shown in Figure 6b, which shows good energy dissipation during the peak drift cycles in both positive and negative directions. No significant damage occurred in the gravity beam other than very minor spalling at corners of the connection and a few hairline flexural cracks. The EW lateral load vs. drift hysteresis is also shown in Figure 6d. It can be seen that good energy dissipation was provided by the external energy dissipation system. The peak drift of 4.68% in the EW

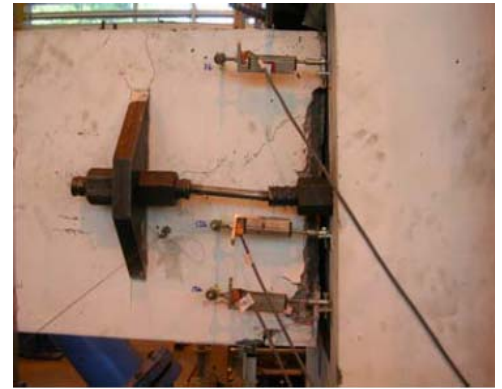
(c) Gap-opening at 4.7% drift

direction caused additional damage to the beam in the form of concrete spalling/crushing at rocking edges as shown in Figure 6c. Large drifts in the EW direction also led to slip in the connection between the energy dissipators and column, which occurred after un-loading from the maximum positive drift of 4.25%. It can be seen that after the maximum drift cycles in both NS and EW directions, energy dissipation for subsequent smaller drift cycles is relatively small (Figure 6d). This occurred because of the buckling of dissipators (Figure 6i) upon re-centering from the maximum drift cycles.

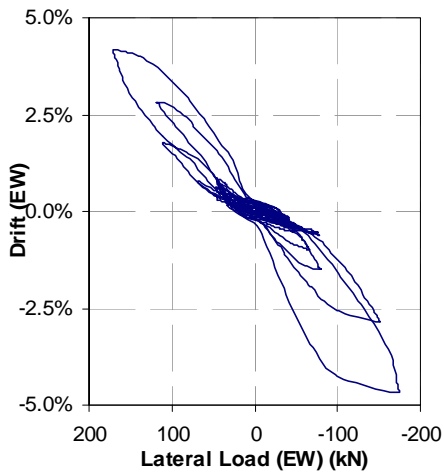
(d) E-W hysteretic response

As can be observed from the hysteresis loop corresponding to the maximum EW drift of 4.7% in Figure 6d, a flat plateau exists near the peak and also a significantly higher energy dissipation is apparent in the hysteresis loop. This is because of yielding of all four fuse bars in the EW beams. Despite this yielding, the sub-assembly's re-centering capability did not deteriorate; it had a residual drift of only 0.2% (6 mm). However, inelastic strain caused by yielding of the tendons did reduce post-tensioning forces, and as a result the bi-linear stiffness of the sub-assembly reduced during subsequent cycles. The test indicated that the specimen needed to be repaired and the post-tensioning tendons may need to be tightened to overcome the loss of prestress level due to yielding.

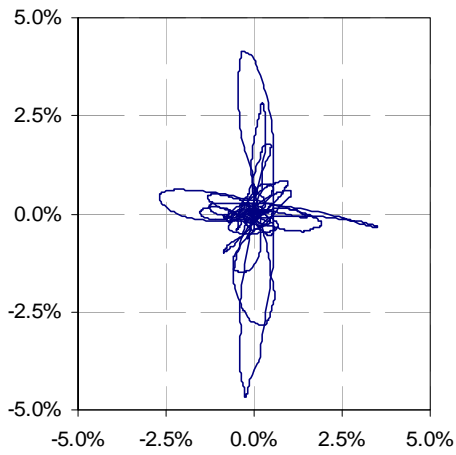
(e) 2D orbit of column

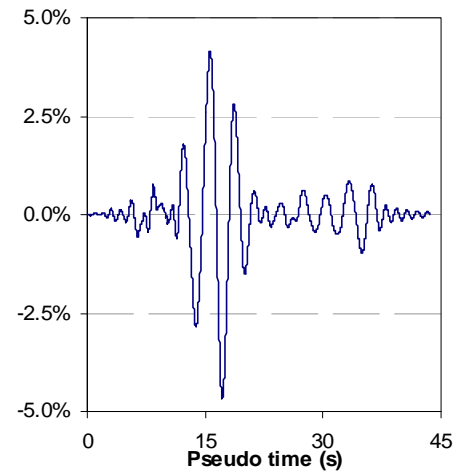
(f) E-W displacement time history

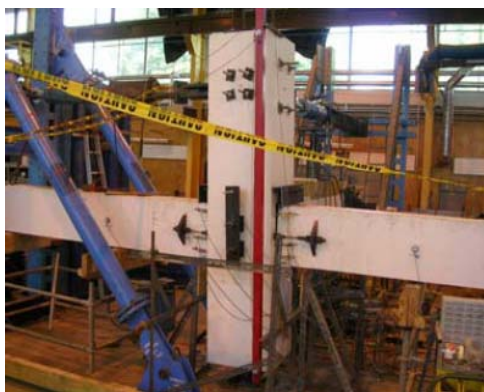
(g) Sub-assembly elevation

The medium source ground motion generating the 90% percentile response at the MCE intensity level was EQ11 which induced a maximum drift of 4.7%. Figure 6g shows an elevation of the specimen at the maximum drift. The QED test results for EQ11 are shown in various forms in Figure 6. Figures 6f and 6h show the input drifts in the two directions, while Figure 6e shows the drift orbit of the top of the column. Peak drifts were 4.7% in the EW direction and 3.5% in the NS direction. The corresponding lateral forces in EW and NS directions were 171.5 kN and 77.8 kN, respectively. Note that unlike the five previous tests which had drift demands in the NS (gravity-frame) direction less than 40% of that in the EW (seismic-frame direction), the NS drift demand in this test was more than 70% of the EW drift demand.

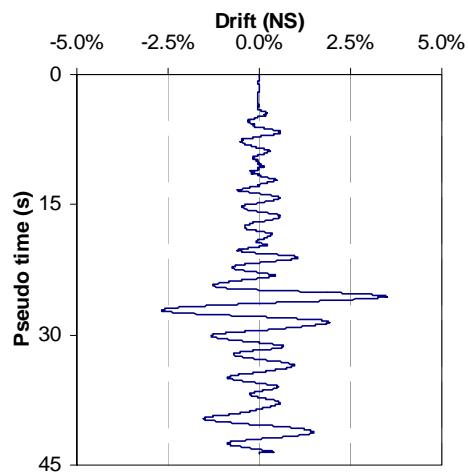
(h) N-S displacement time history

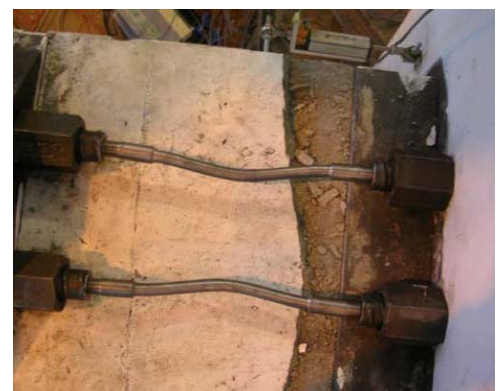
(i) Top view of buckled dissipators after re-centering

Supplemental energy dissipator: - The performance of the damping system was verified as the hysteretic curves showed large energy dissipation. Nevertheless, the dissipators buckled while re-centering after large drift cycles. More robust energy dissipating devices need to be developed to provide high damping for a broad range of loading regimes, while keeping with the DAD philosophy of being easy to replace if damaged.
