This is a repository copy of *Improving Rail Wear and RCF Performance using Laser Cladding*.

Lewis, S.R., Fretwell-Smith, S., Goodwin, P.S. et al. (6 more authors) (2016) Improving Rail Wear and RCF Performance using Laser Cladding. In: *Wear. 10th International Conference on Contact Mechanics and Wear of Rail/Wheel Systems*, 30 Aug - 03 Sep 2015, Colorado, USA. Elsevier , pp. 268-278.

Improving Rail Wear and RCF Performance using Laser Cladding

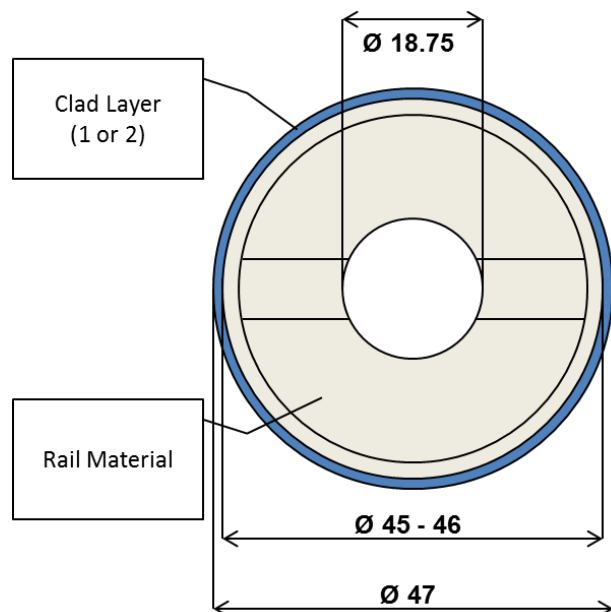
Figure 1. Schematic of a twin-disc specimen

running surface of SUROS discs machined from R260 grade rail. Materials were deposited in nominally 1 mm thick layers. 1 or 2 layers were applied, as shown in Figure 1. The width of a layer of deposit is typically 1 mm and several layers are required to cover the 10 mm wide running band of a twin-disc specimen. Once the surface of a specimen is covered and the deposit cooled the surface as a “ploughed field appearance due to the adjacent beads of deposit. After the required number of layers are applied the discs then need to be ground to achieve the final test surface finish.

A Twin-Disc machine, shown in Figure 2a, was used in this study and is described in detail in [2]. The test samples were machined from sections of wheel and rail. A candidate material was then deposited on to the running band of each sample as shown in Figure 1.
