The Human Factors of an Early Space Accident: Flight 3-65 of the X-15

Immanuel Barshi, NASA Ames Research Center
Irving C. Statler, NASA, Ames Associate (retired)
With Jeb S. Orr, The Charles Stark Draper Laboratory, Inc.

INVESTIGATION OF THE CRASH OF THE X-15-3 AIRCRAFT ON NOVEMBER 15, 1967

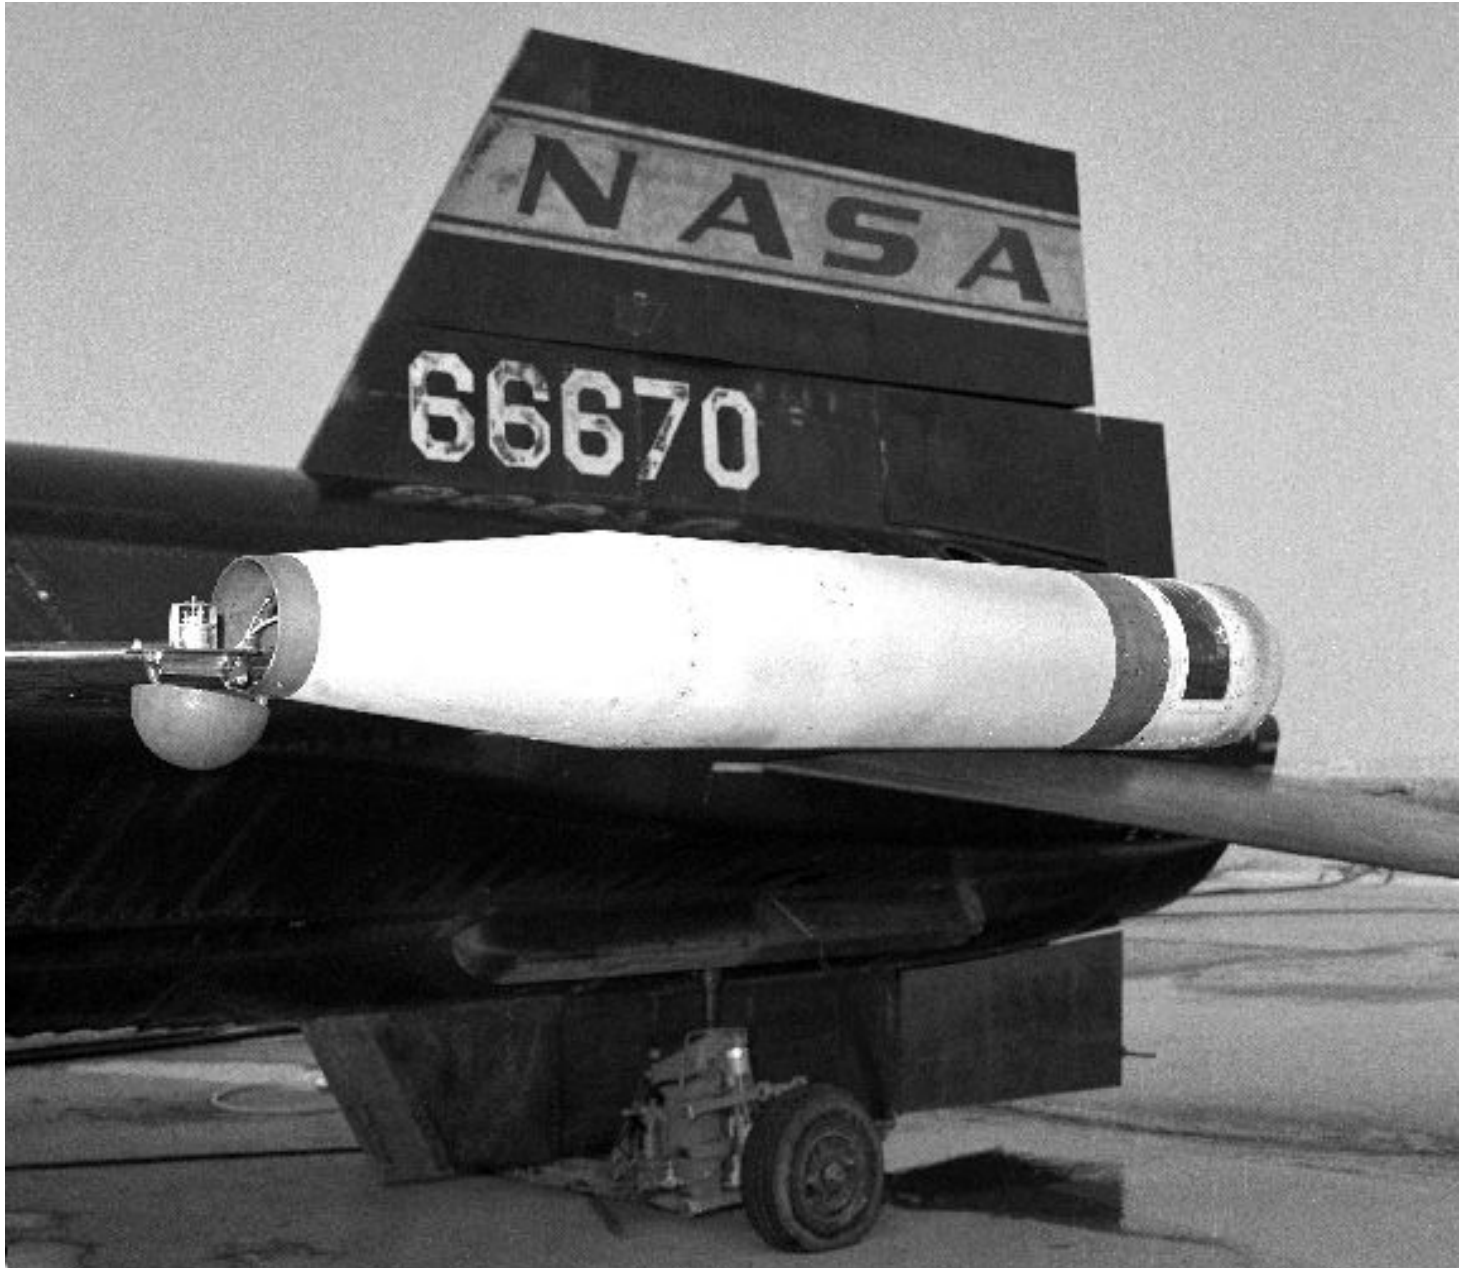
The Wing-tip Pod for Experiment Installation

- 65th flight of the X-15-3.
- A high altitude flight –max altitude ~ 250,000 feet.
- Flight plan and configuration similar to previous two X-15-3 flights.
- Flight 3-65 had a full schedule of maneuvers and experiments including:
 - bow-shock standoff measurement,
 - solar-spectrum measurements,
 - ultraviolet exhaust-plume measurements, and
 - micrometeorite collection.
- Differences in configuration of the X-15-3 for Flight 3-65 included a traversing probe installed in the pod of its right wingtip that was operated for the first time in a high-altitude flight.

10:31:07 – at about 90,000', arcing from the motor drive of the traversing probe caused an electrical disturbance to the aircraft's electrical system that continued until 10:33:53. Noise begins in all telemetered data channels.
